Inspection Photos
Location Name: IRISH EYES 33-21 FOLLOWUP
API #: 05-071-08658
INSP. #:695101364

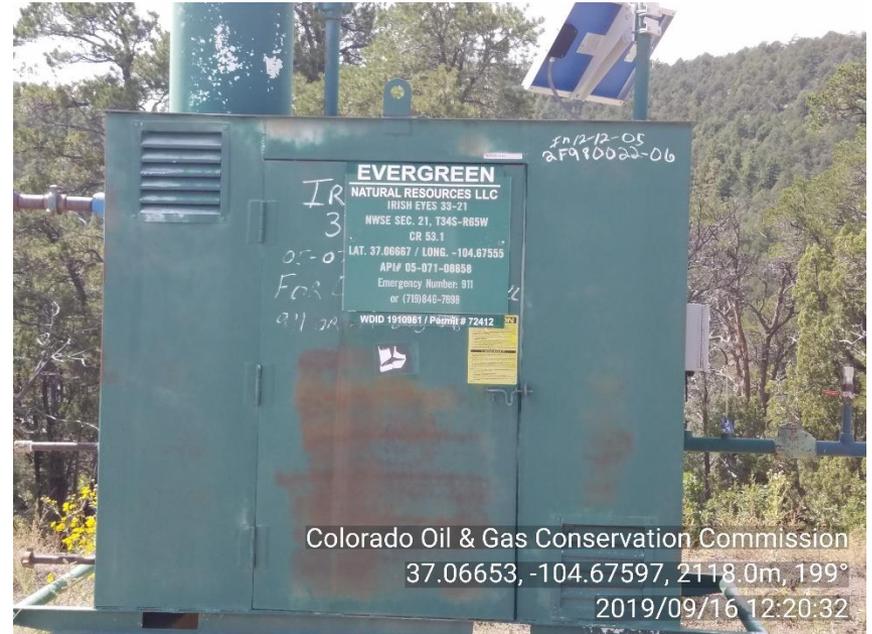
PHOTO 2: WELL SIGN, CORRECTIVE ACTION FROM PREVIOUS INSPECTION HAS BEEN ADDRESSED.

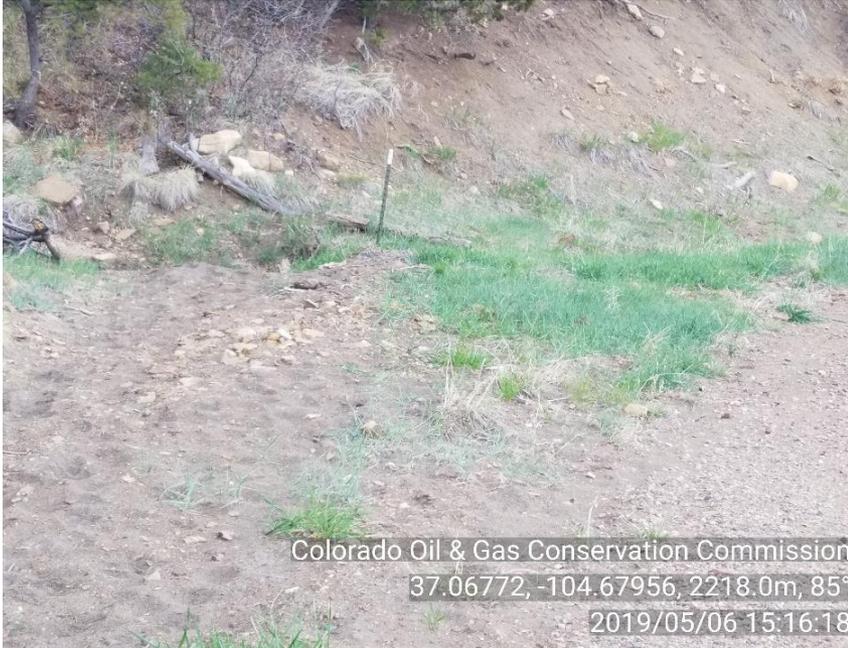
PHOTO 3: THIS IS A PHOTO AND CORRECTIVE ACTION FROM PREVIOUS INSPECTION DOC#695100599. SEDIMENT HAS FILLED STORMWATER DRAIN ON UPSLOPE SIDE OF PLUGGED CULVERT

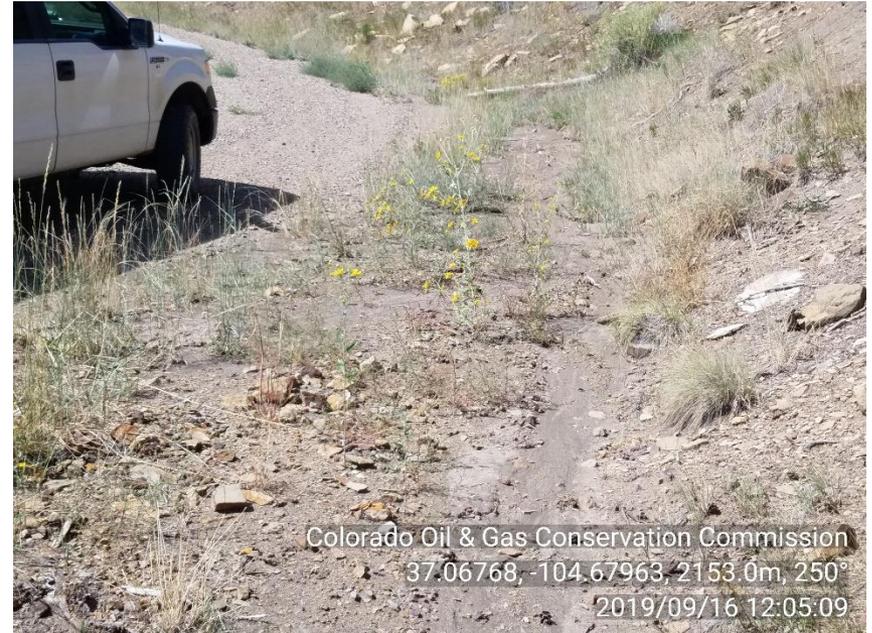
PHOTO 4: THIS IS THE CURENVT PHOTO AND CORECTIVE ACTION FOR THIS INSPECTION. SEDIMENT HAS FILLED STORMWATER DRAIN ON UPSLOPE SIDE OF PLUGGED CULVERT. CLEAN AND MAINTAIN BMP DITCH PER RULE 1002.f. CA DATE 10-16-19

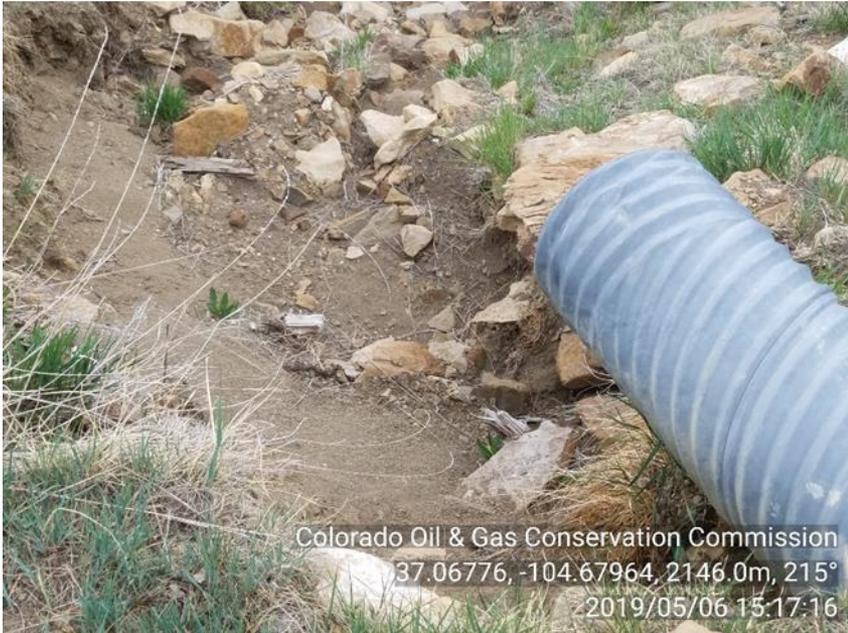
PHOTO 5: THIS IS A PHOTO AND CORRECTIVE ACTION FROM PREVIOUS INSPECTION DOC#695100599. STORMWATER EROSION AROUND CULVERT OUTLET. Install or repair required BMPs per Rule 1002.f

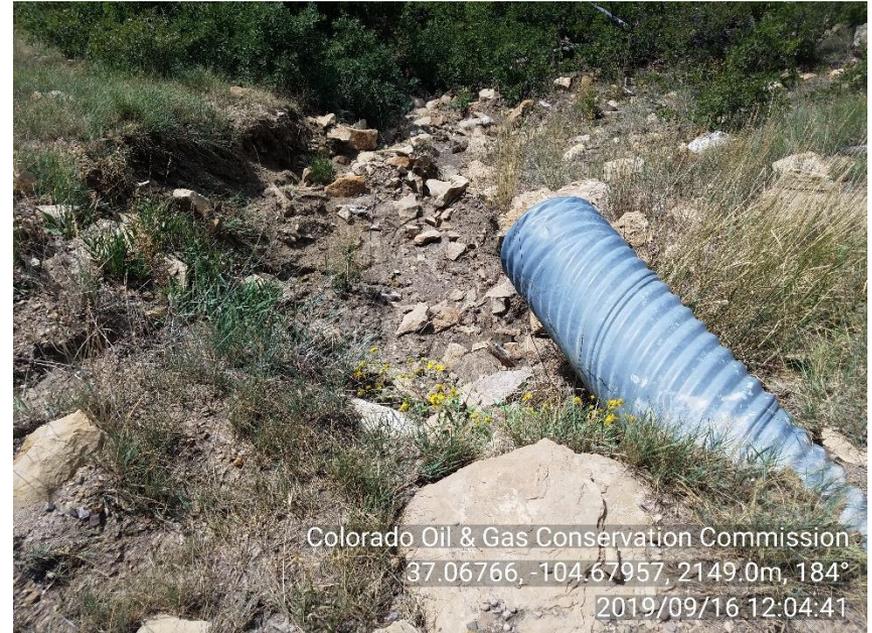
PHOTO 6: THIS IS A CURRENT PHOTO AND CA FOR THIS INSPECTION. STORMWATER EROSION AROUND CULVERT OUTLET. Install or repair required BMPs per Rule 1002.f. CA DATE IS IMMEDIATELY BEGIN WORK TO REPAIR EROSION.

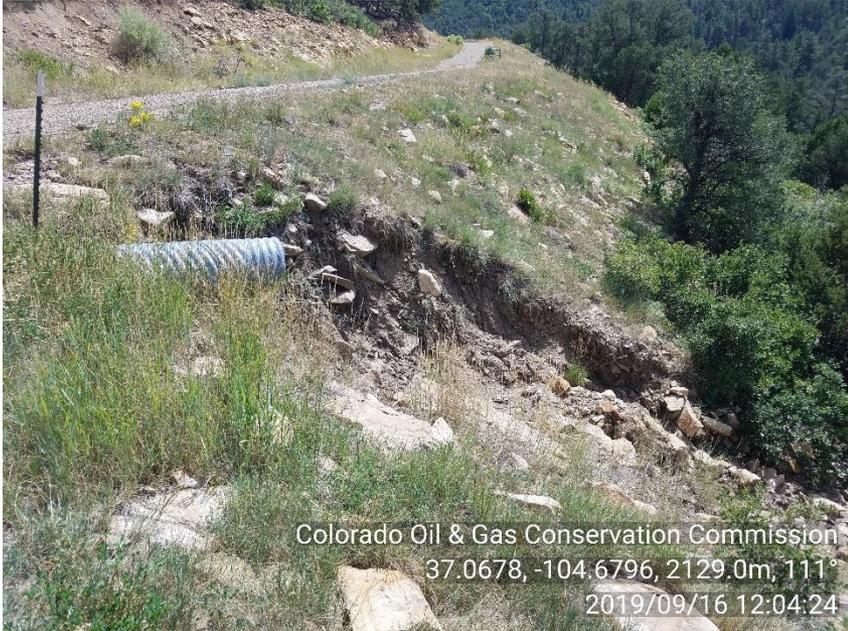
**PHOTO 7: ANOTHER VIEW OF EROSION AROUND CULVERT
OUTLET.**

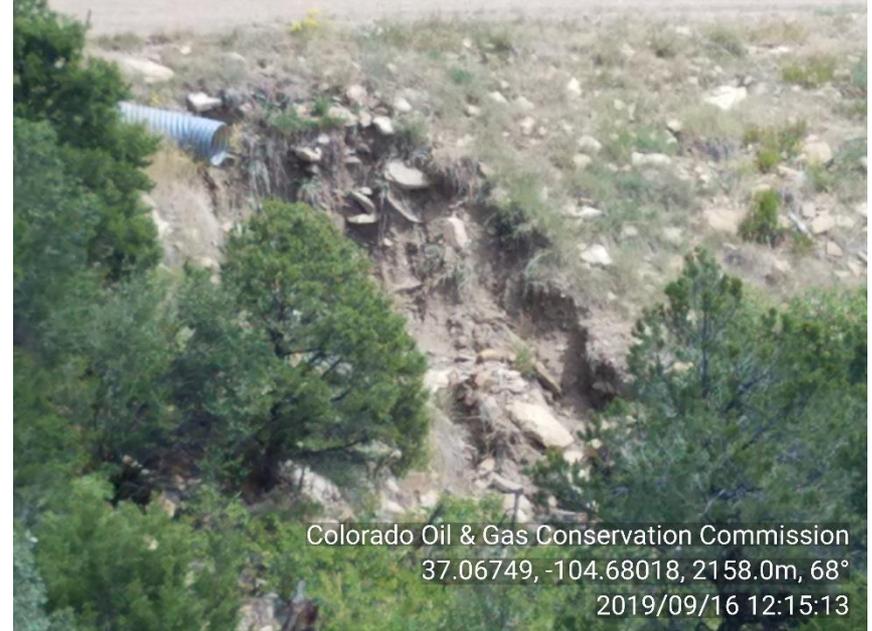
**PHOTO 8: ANOTHER VIEW OF EROSION AROUND CULVERT
OUTLET.**

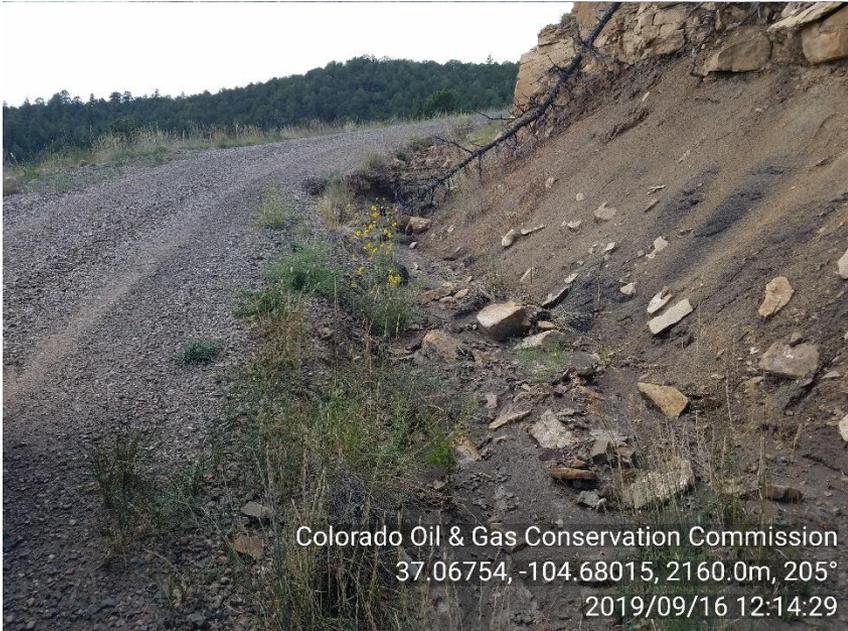
**PHOTO 9: EROSION IN BMP DITCH ALONG ROW
NORTHWEST OF LOCATION. REPAIR EROSION AND
INSTALL ADEQUATER BMP'S TO PREVENT OR
REDUCE EROSION, COMPLY WITH RULE 1002.f. CA
DATE 10-16-19**

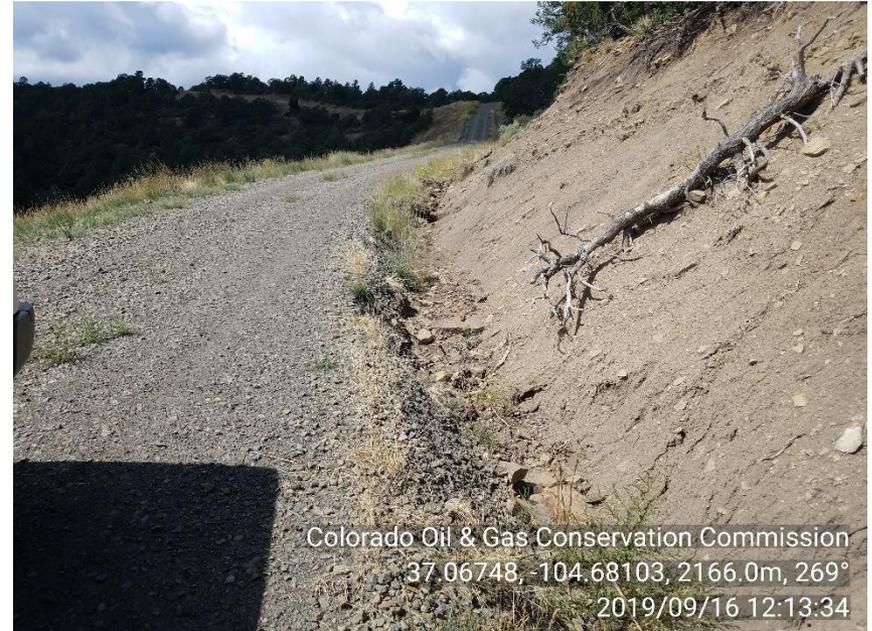
**PHOTO 10: EROSION IN BMP DITCH ALONG ROW
NORTHWEST OF LOCATION. REPAIR EROSION AND
INSTALL ADEQUATER BMP'S TO PREVENT OR
REDUCE EROSION, COMPLY WITH RULE 1002.f. CA
DATE 10-16-19**

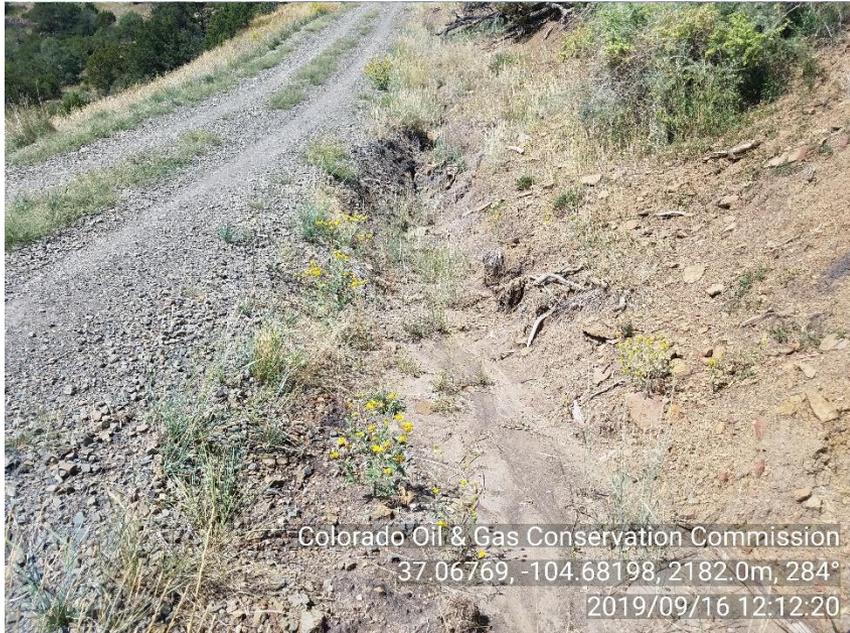
**PHOTO 11: EROSION IN BMP DITCH ALONG ROW
NORTHWEST OF LOCATION. REPAIR EROSION AND
INSTALL ADEQUATE BMP'S TO PREVENT OR
REDUCE EROSION, COMPLY WITH RULE 1002.f. CA
DATE 10-16-19**

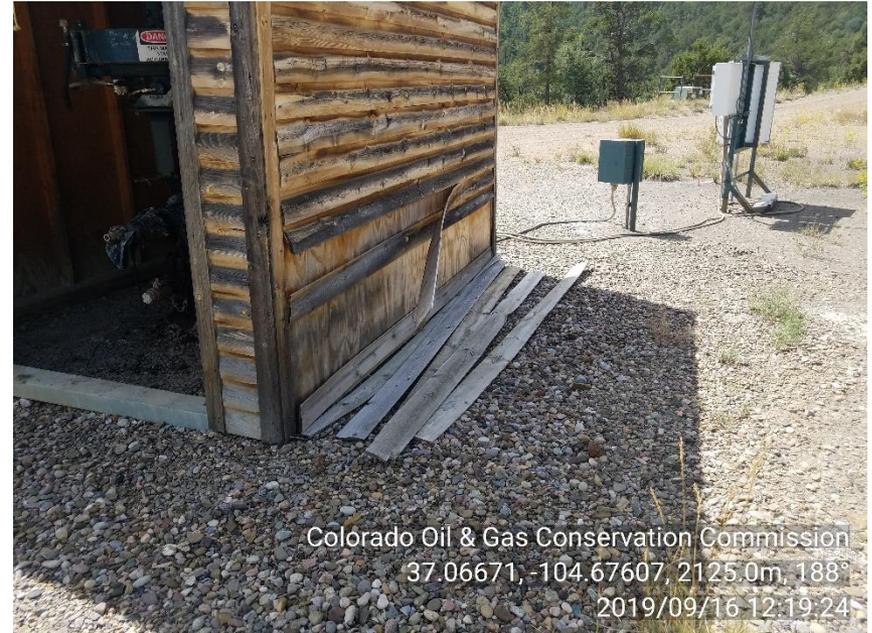
**PHOTO 12: UNUSED EQUIPMENT STORED ON
LOCATION. REMOVE UNUSED EQUIPMENT, COMPLY
WITH RULE 603.f. CA DATE 10-16-19**

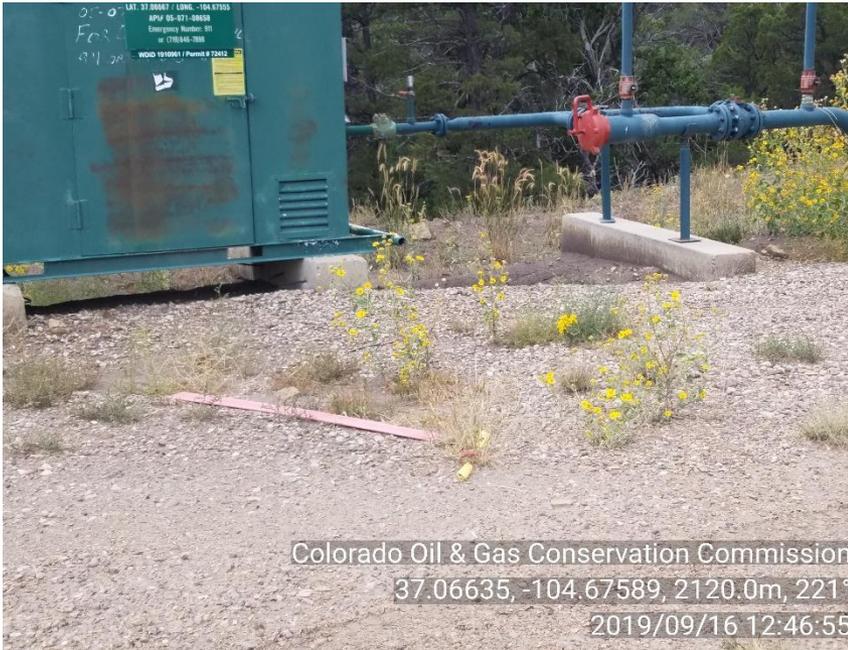
**PHOTO 13: GUY LINE ANCHOR MARKER IS DOWN.
INSTALL GUY LINE ANCHOR MARKER COMPLY WITH
RULE 1003.a. CA DATE 10-16-19**
