Anderson 17-1
API: 05-103-40003
Inspection: 679705525

COLORADO
Oil & Gas Conservation
Commission
Department of Natural Resources

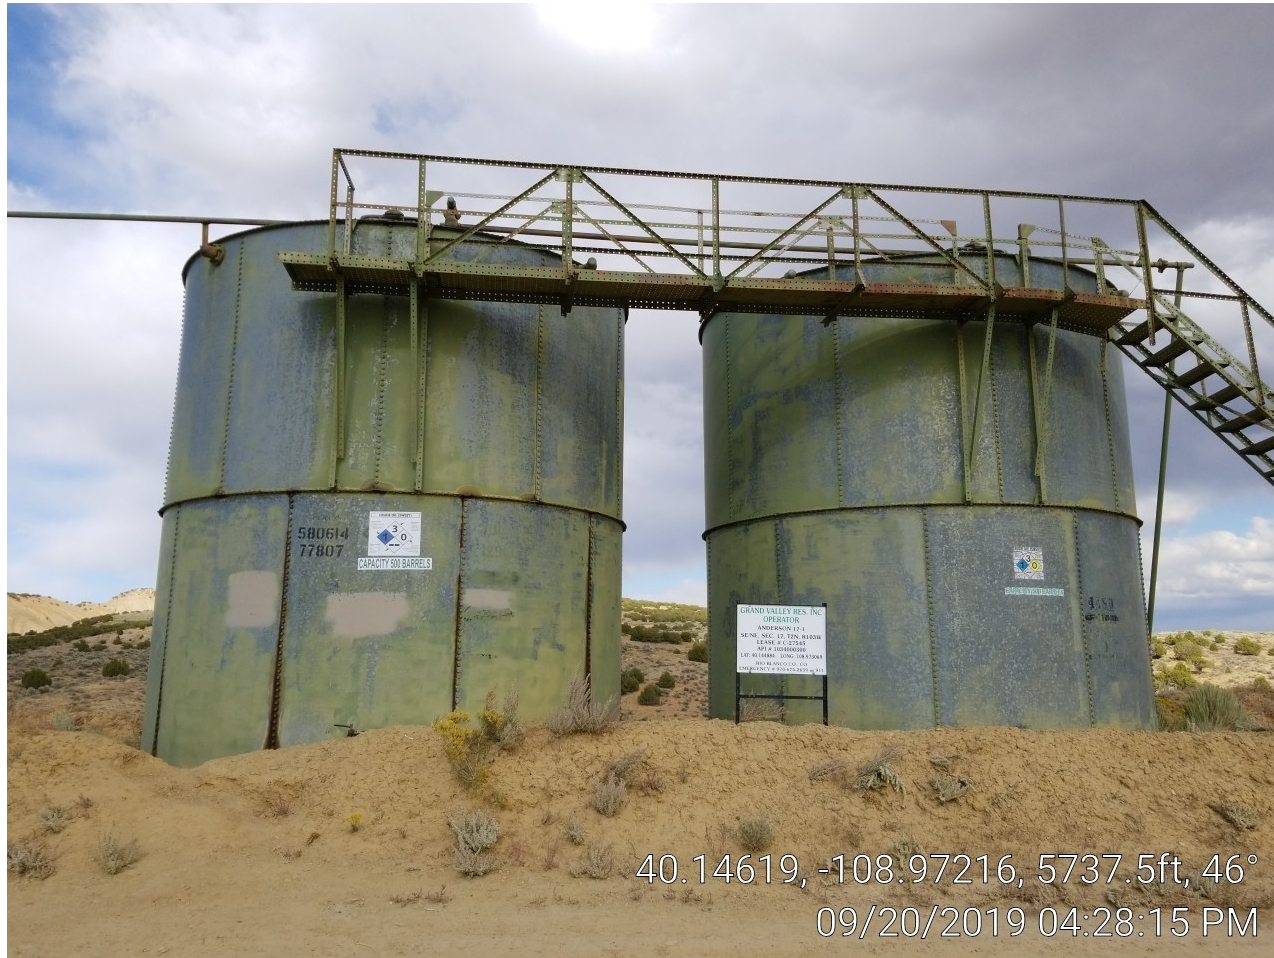
Photo 1. Tank battery.

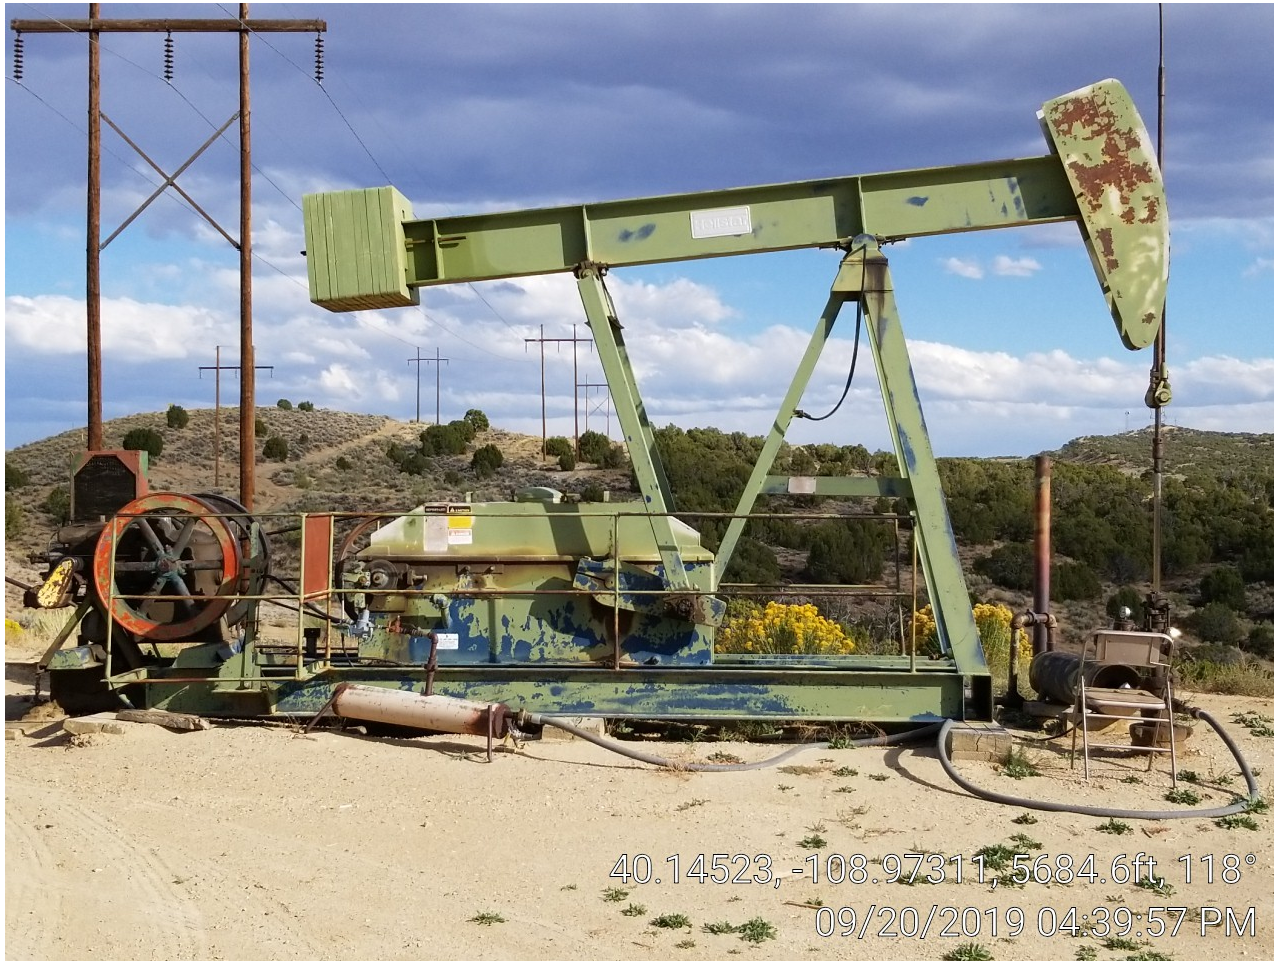
Photo 2. Pump jack.

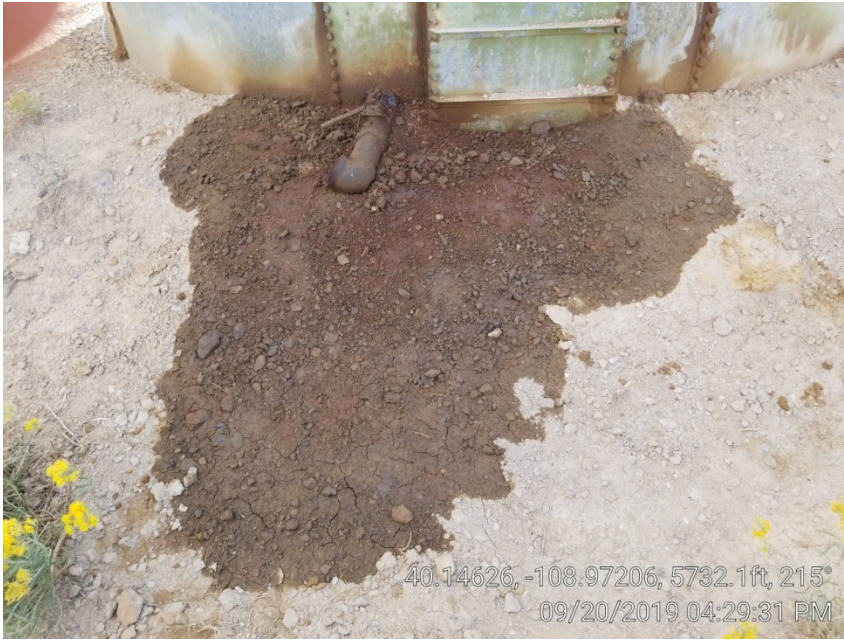
Photo 3. Stained soil at crude oil tank valve.

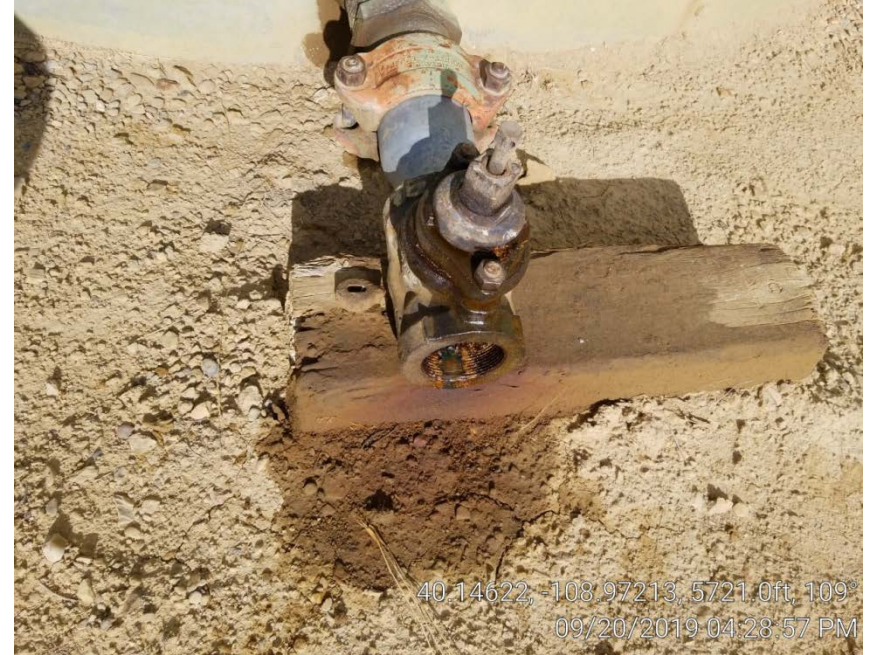
Photo 4. Stained soil at crude oil tank valve.

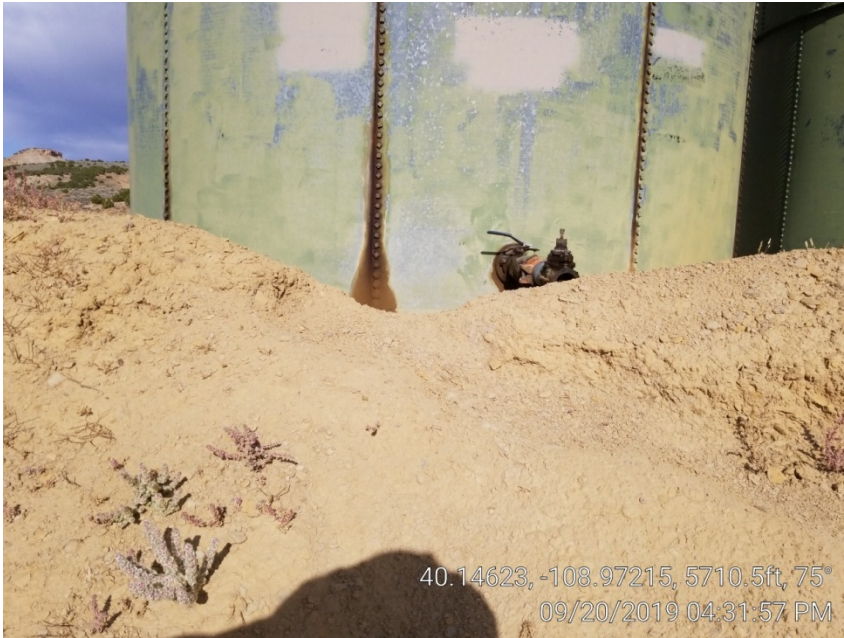
Photo 5. Low spot in tank berm.

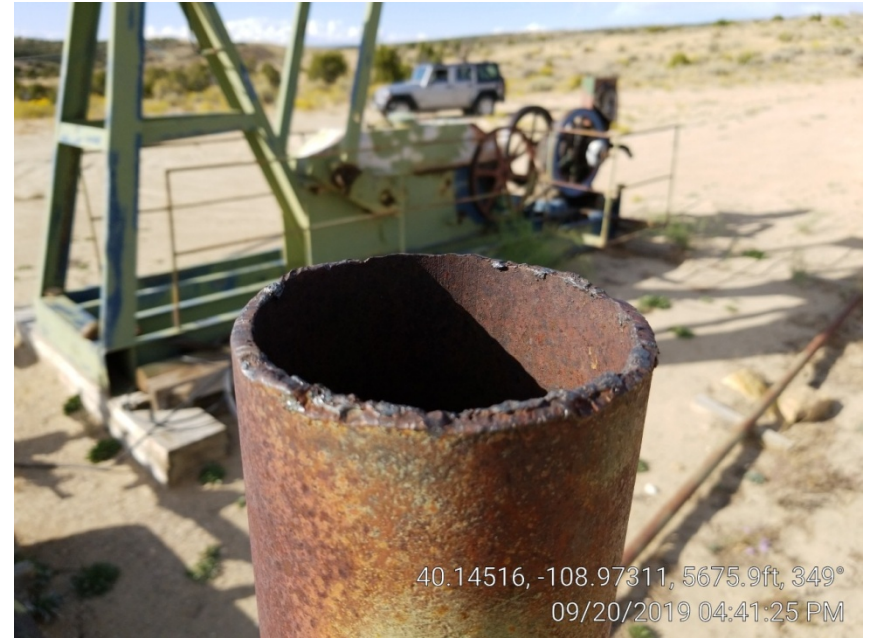
Photo 6. Stack by pump jack without bird screen.

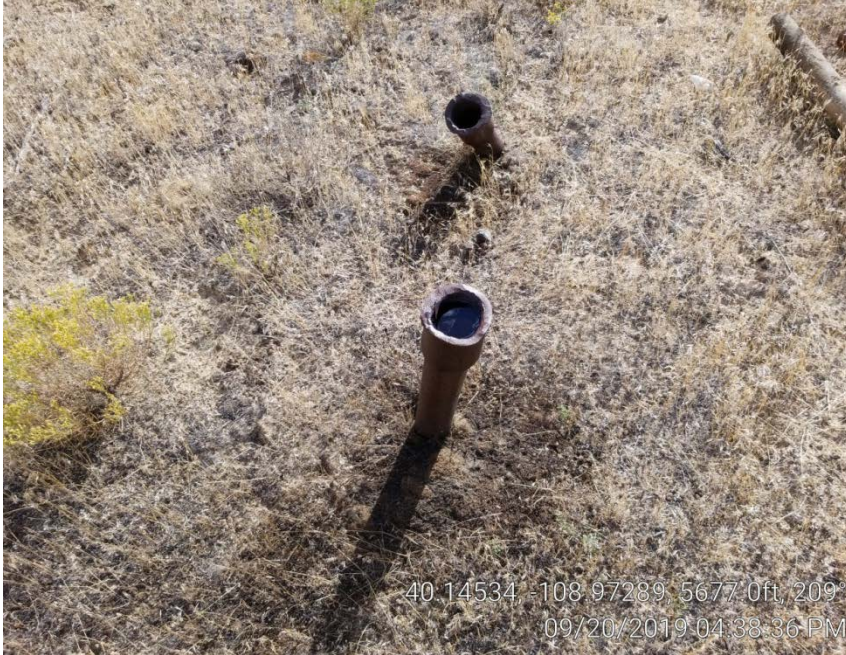
Photo 7. Uncapped flowlines.

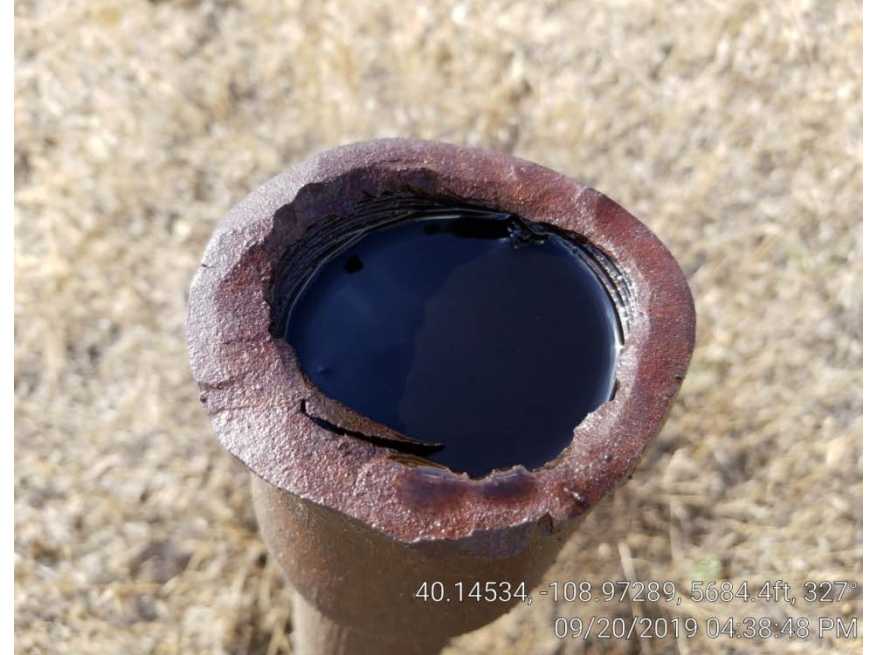
Photo 8. Flowline filled with oil to top.

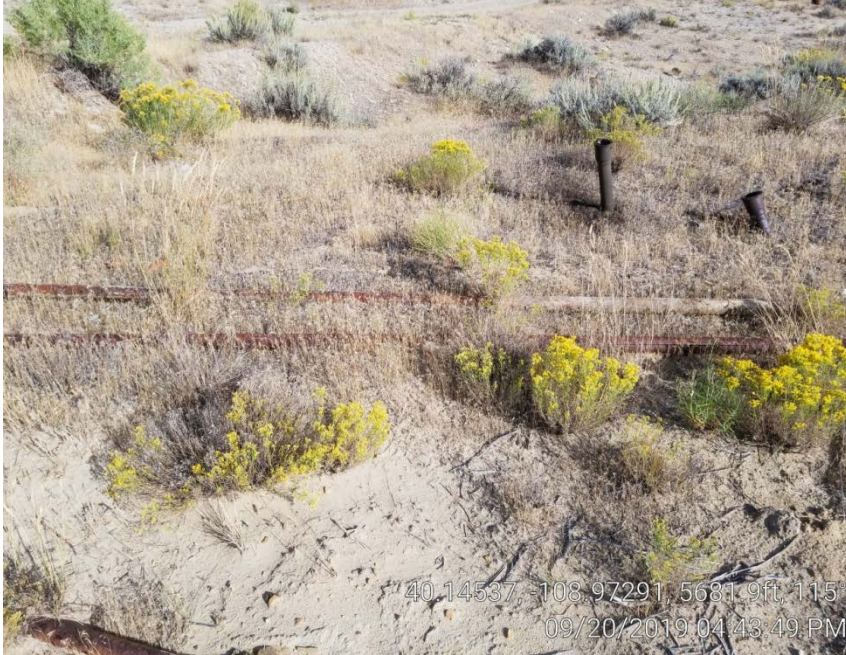
Photo 9. Two split 10 foot long flowlines sections located 80 feet north of pump jack.

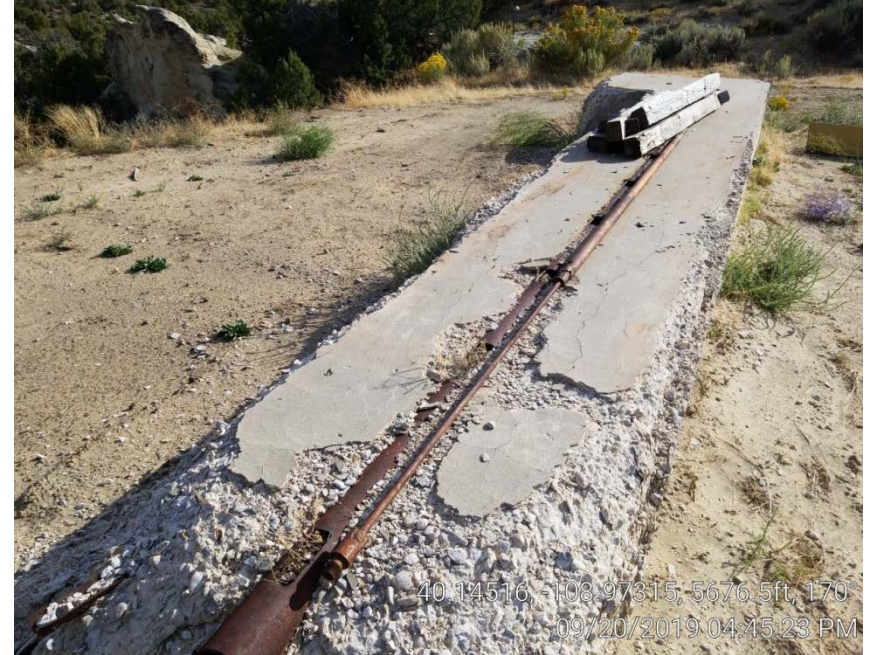
Photo 10. Rod & timbers.
