# Inspection Photos

09/20/2019

Operator: BISON OIL & GAS II LLC # 10661

Location ID: 452871

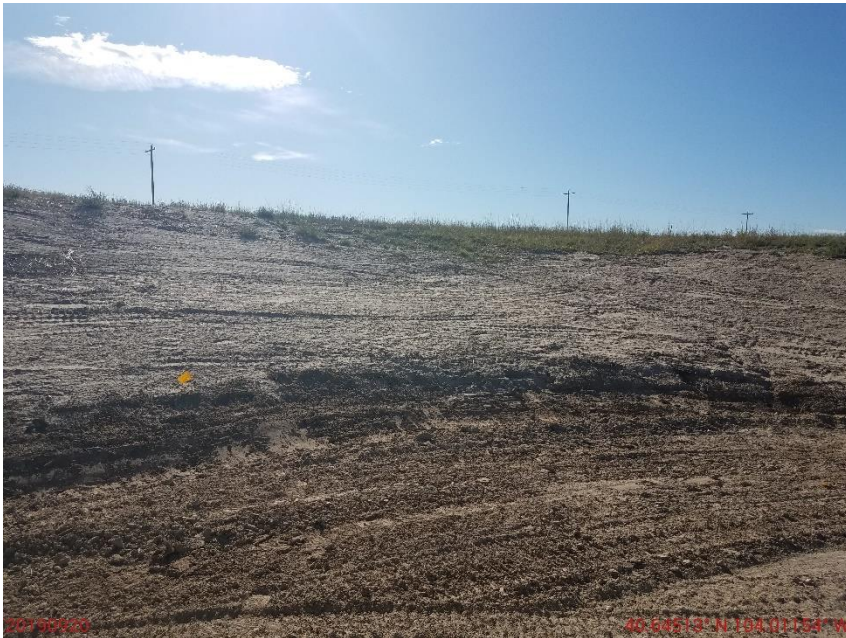
**Photo 1:** Photo taken from the southeast end of the location, facing southeast. Photo shows erosion degradation appears to have been repaired on the cut slopes, however, no BMPs have been installed to stabilize the slopes. Rill erosion is beginning to re-form.

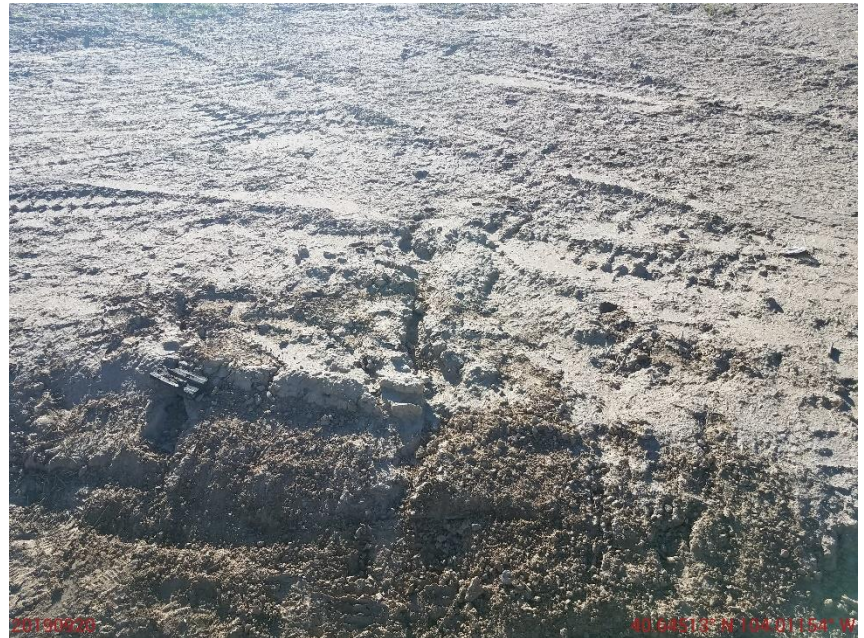
**Photo 2:** Continued from photo 1. Photo shows erosion degradation is beginning to recur on the cut slopes.

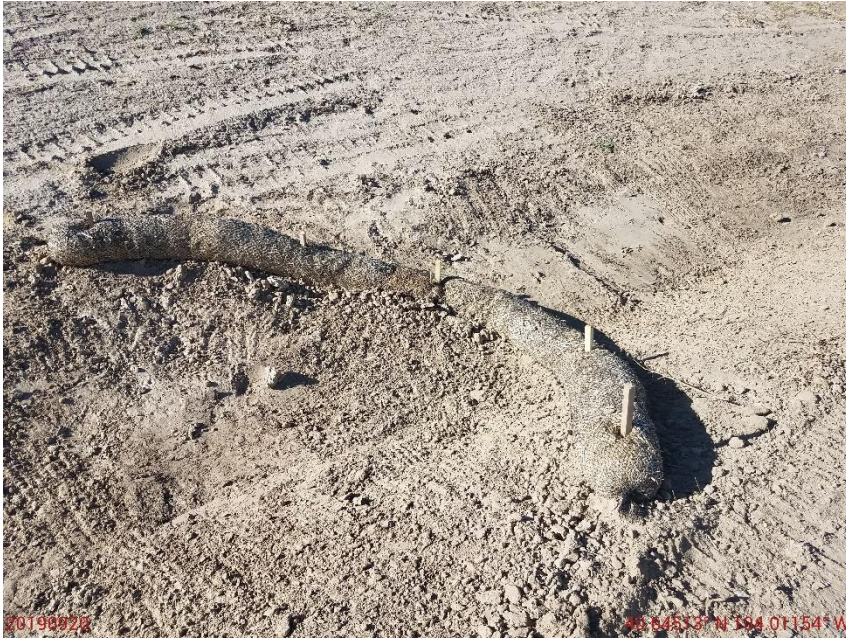
**Photo 3:** Photo taken from the perimeter stormwater diversion ditch. Photo shows wattles within ditch appear to have been installed in accordance with good engineering practices.

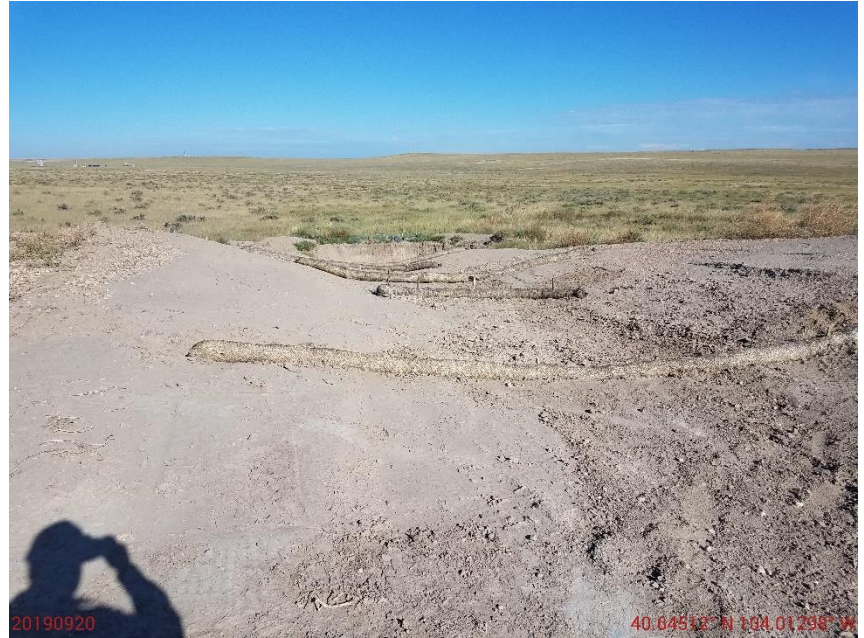
**Photo 4:** Photo taken from the sediment trap on the northwest end of the location, facing north. Photo shows erosion degradation appears to have been repaired. Operator appears to have re-installed wattles as inlet protection.

Insufficient inlet protections at sediment traps.

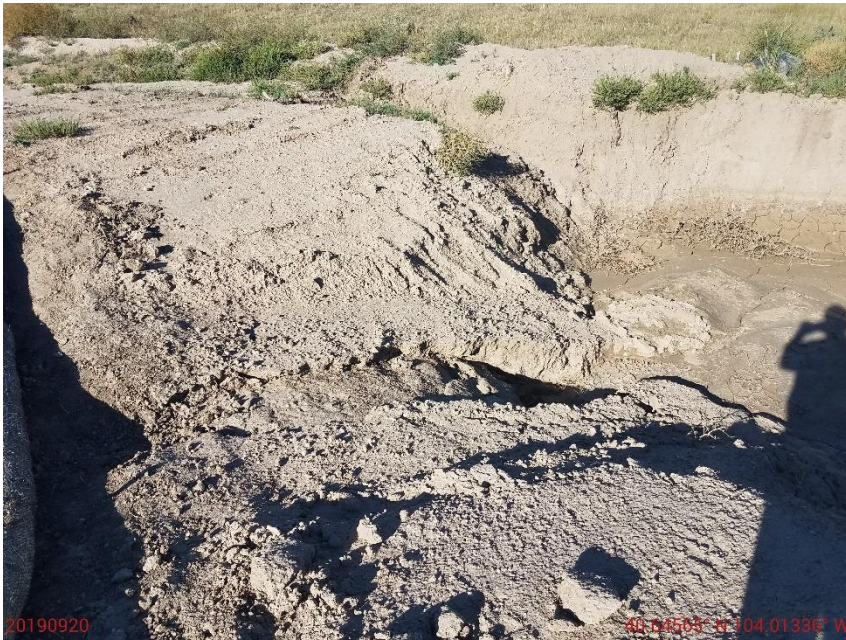
**Photo 5:** Continued from photo 4. Photo shows stormwater erosion degradation is beginning to recur within the trap inlet. Operator has failed to construct BMP in accordance with good engineering practices.

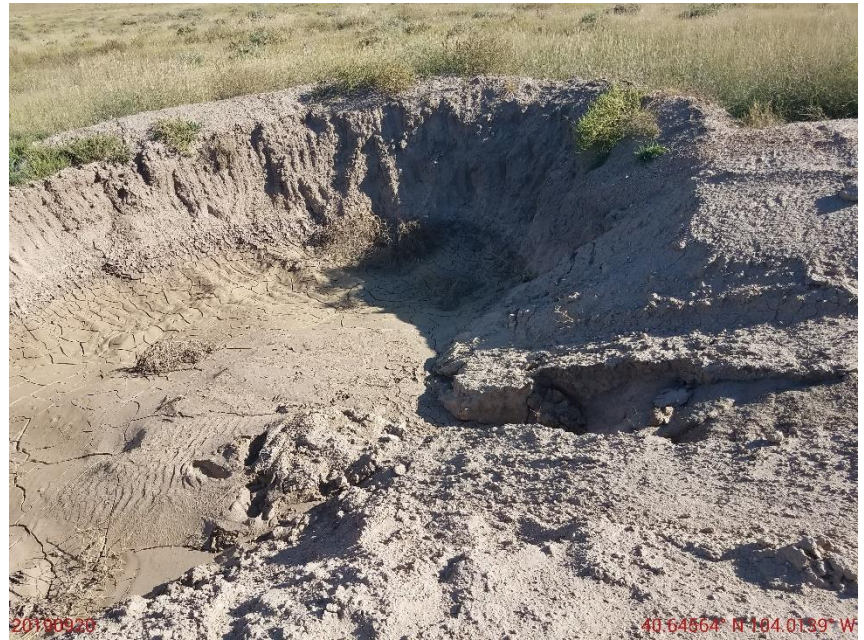
**Photo 6:** See comments under photo 5.

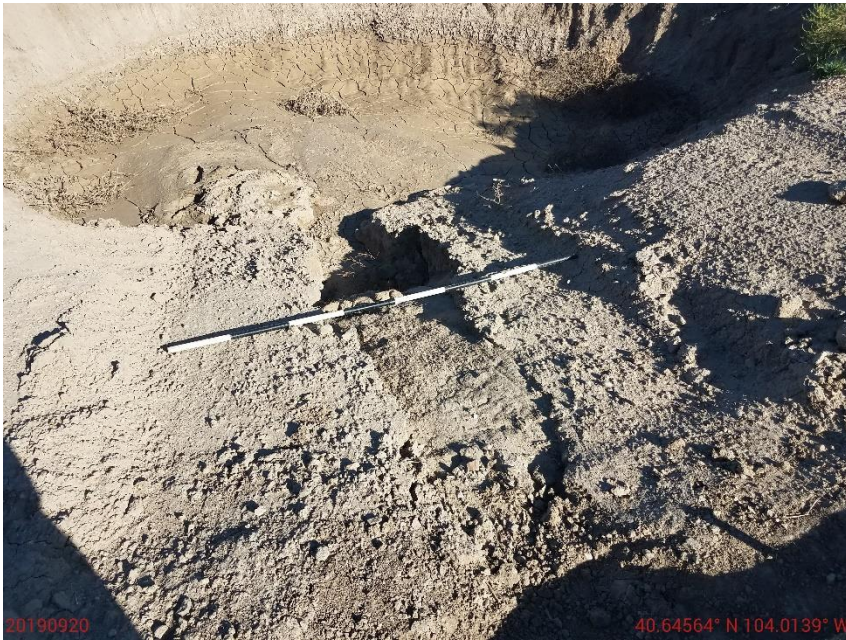
**Photo 7:** See comments under photo 5. Two (2) meter robel pole for reference.

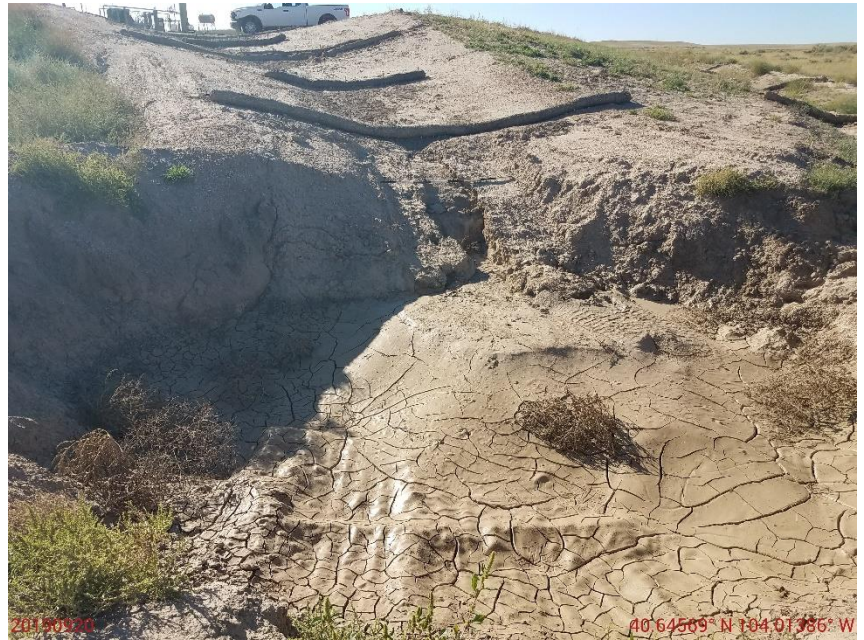
**Photo 8:** See comments under photo 5. Two (2) meter robel pole for reference.

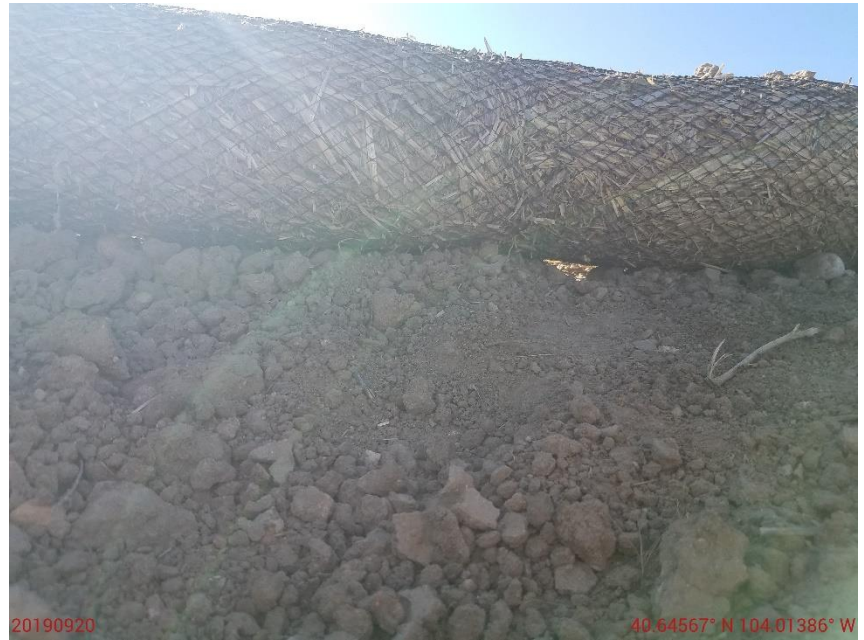
**Photo 10:** Photo taken from the wattle within the sediment trap inlet. Photo shows day light beneath wattle. Insufficient inlet protections at sediment traps.

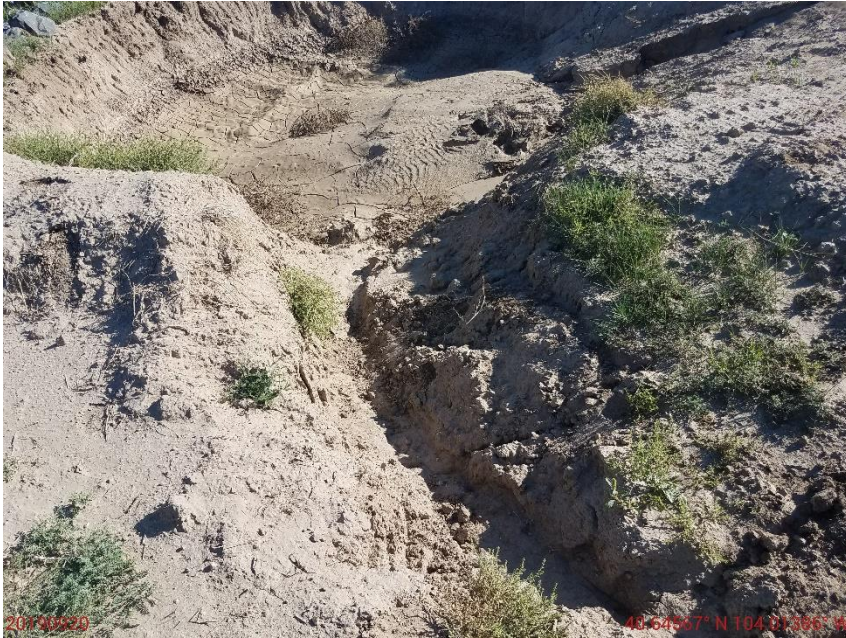
**Photo 11:** See comments under photo 5.

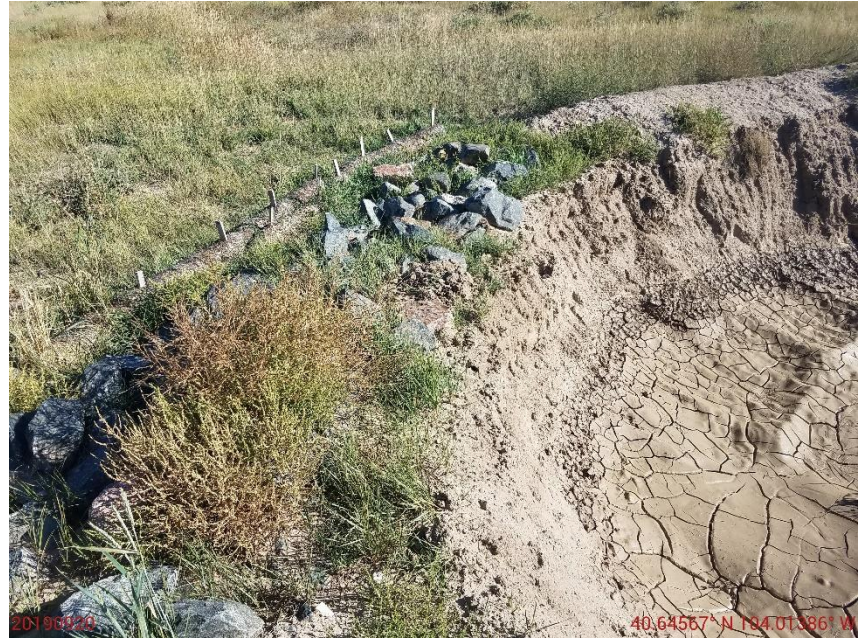
**Photo 12:** Photo shows outlet of the sediment trap. Outlet has not been constructed in accordance with good engineering practices.

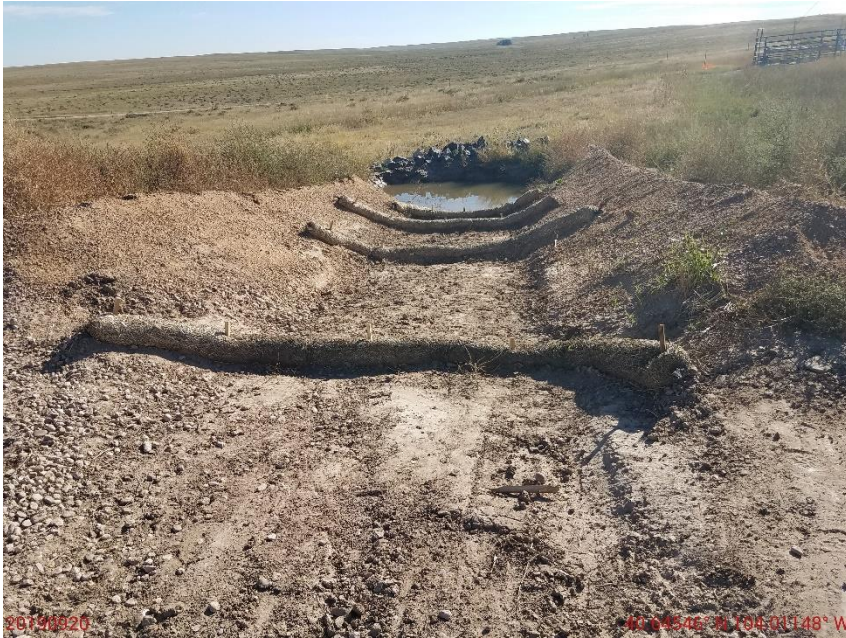
**Photo 13:** Photo taken from the sediment trap on the northeast end of the location, facing east. Photo shows erosion degradation appears to have been repaired at inlet. Operator appears to have re-installed wattles as inlet protection.

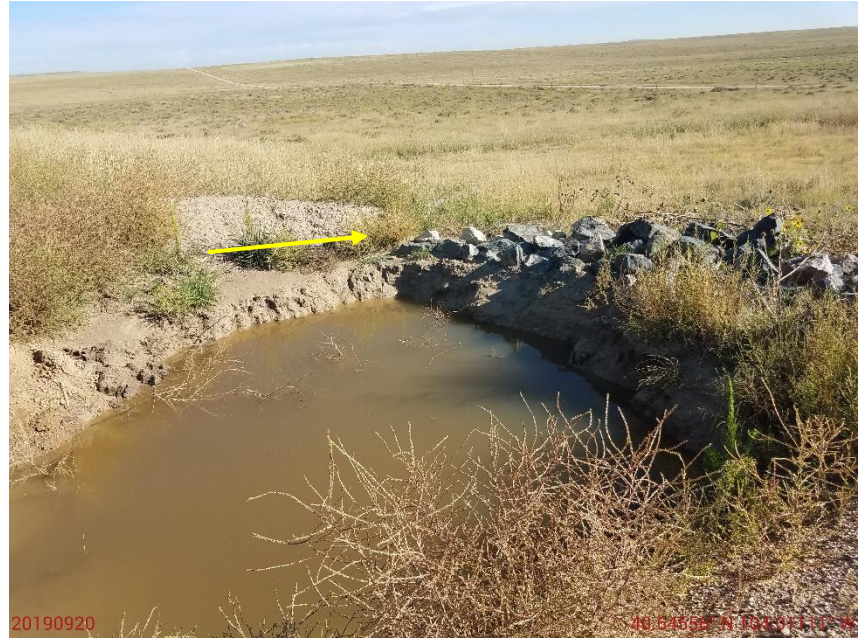
**Photo 14:** Continued from photo 13. Photo shows outlet at sediment trap. Outlet has not been constructed in accordance with good engineering practices.

Insufficient inlet protections at sediment traps.

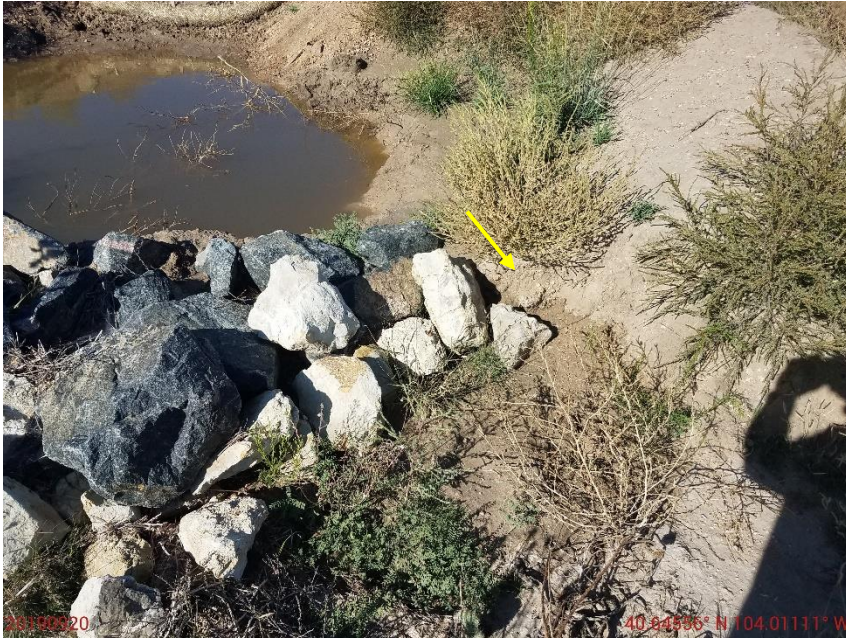
**Photo 15:** Continued from photo 14. Photo shows outlet has not been constructed in accordance with good engineering practices. Stormwater movement around outlet and degradation evident

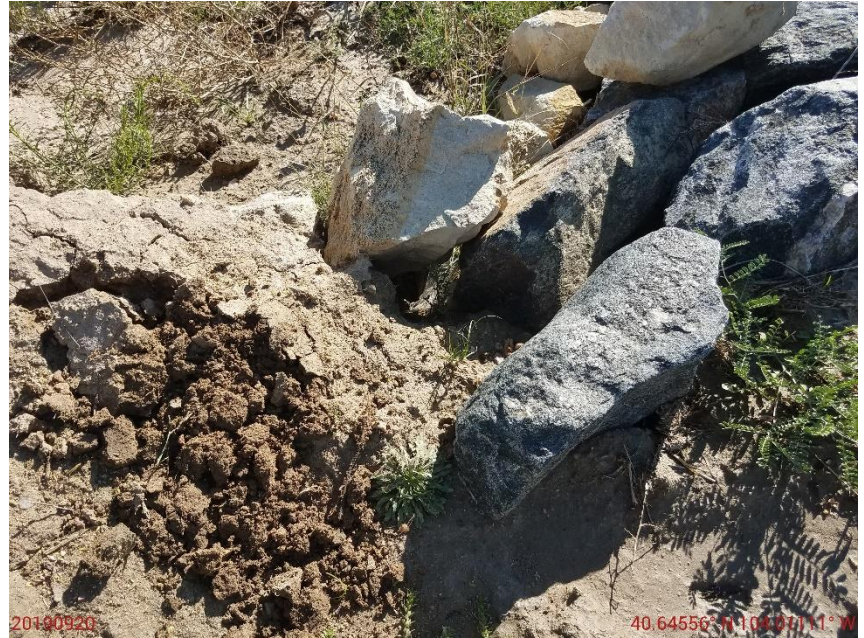
**Photo 16:** See comments under photo 15.

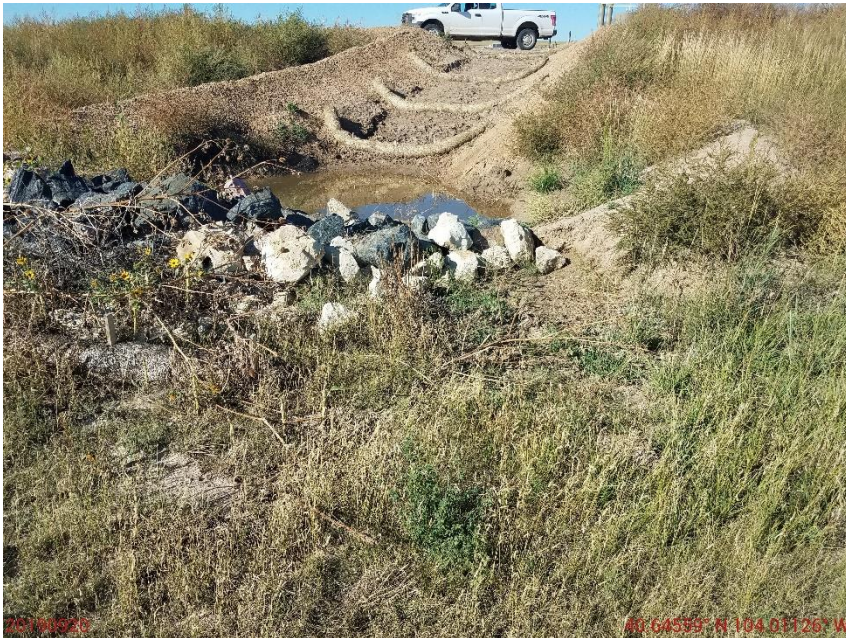
**Photo 17:** See comments under photo 15.

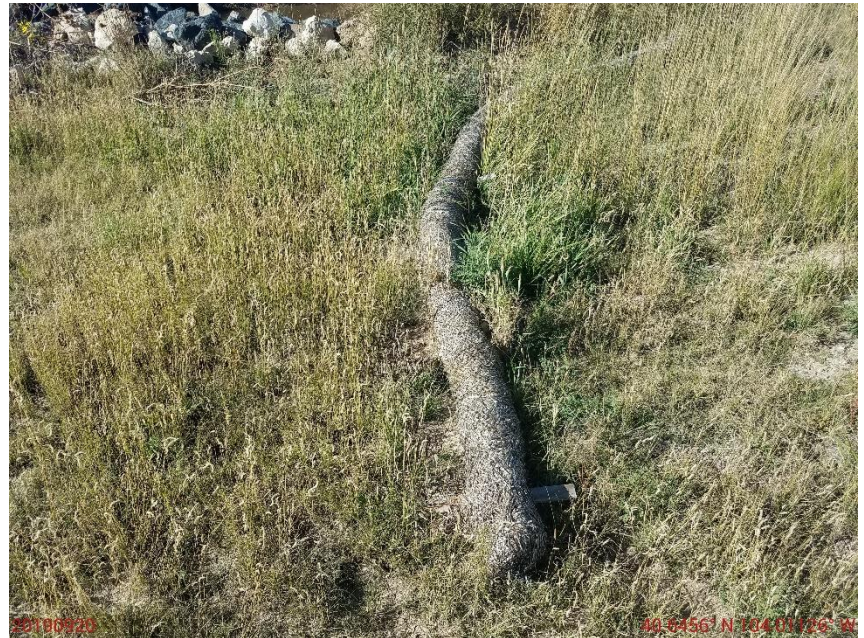
**Photo 18:** Photo shows straw wattle at outlet not in proper functioning condition.

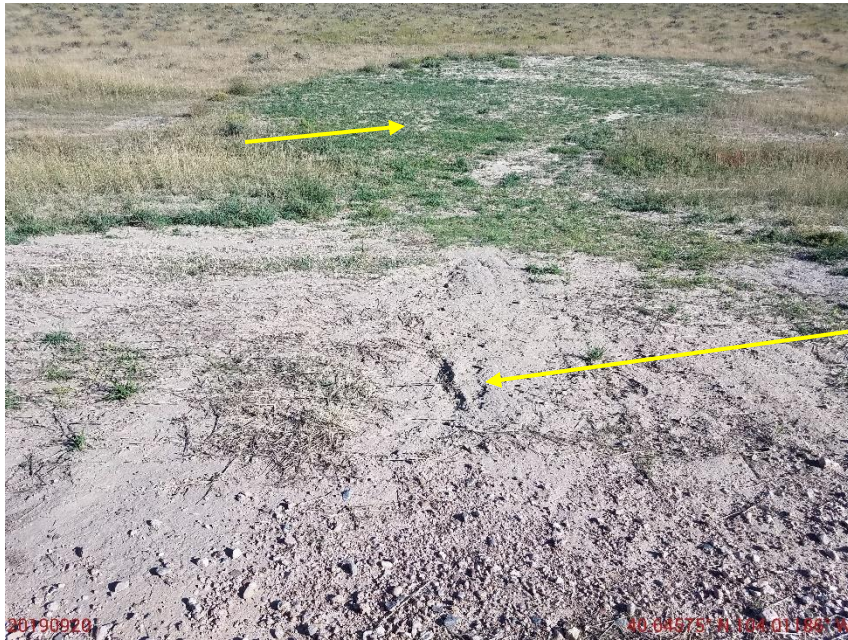
**Photo 19:** Photo taken from the fill slopes on the south end of the location. Photo show area where stormwater previously degraded the slope and transported sediment off location (yellow arrow). Photo also shows erosion degradation is beginning to recur along slopes. Insufficient BMPs in place to stabilize slopes.

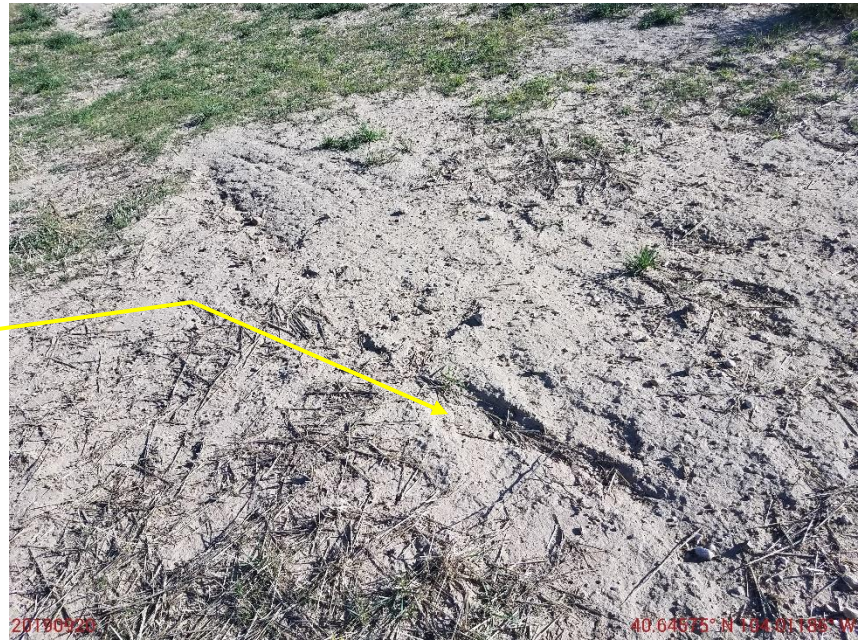
**Photo 20:** Continued from photo 19. Photo shows rill erosion beginning on slope.
