Inspection Photos

09/20/2019

Operator: BISON OIL & GAS II LLC # 10661

Location ID: 454591

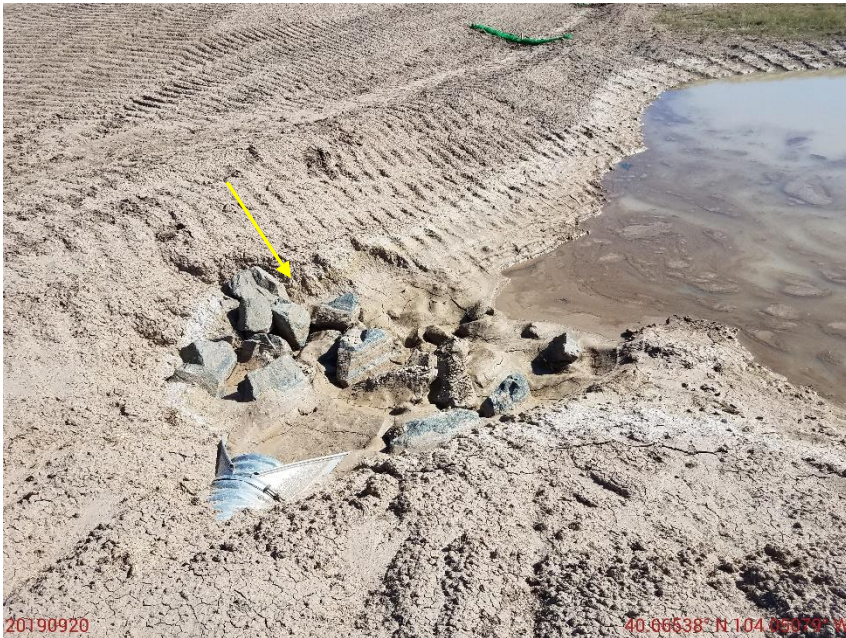
Photo 1: Photo taken from the culvert/sediment trap on the south end of the location. Photo shows sufficient outlet protection has not been installed above culvert outlet. Culvert outlet/sediment trap inlet has filled with sediment

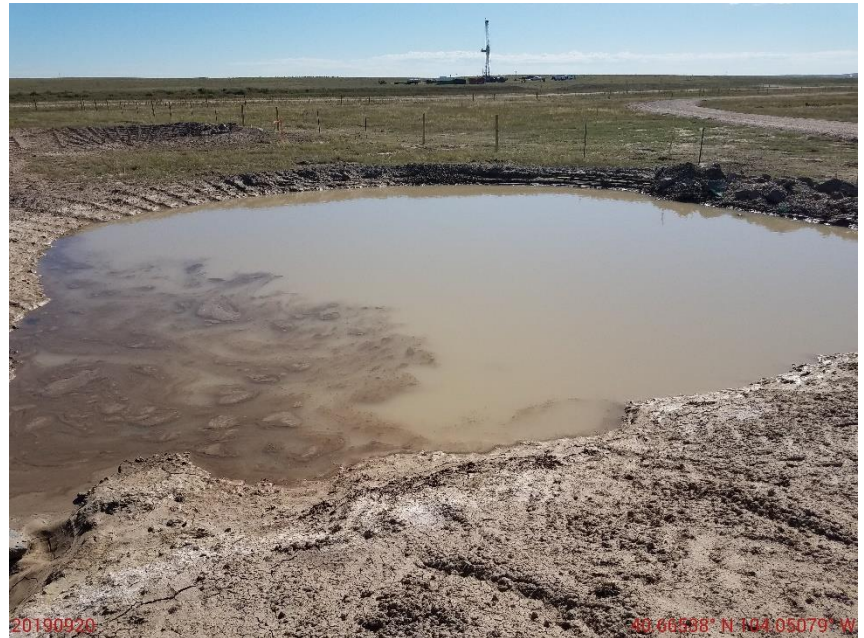
Photo 2: Photo of sediment trap on the south end of the location. It appears BMP is sufficient in size to mitigate runoff on the location. However (though repaired) it appears that areas of the trap had failed resulting in sediment laden stormwater discharge. See photos 4-6.

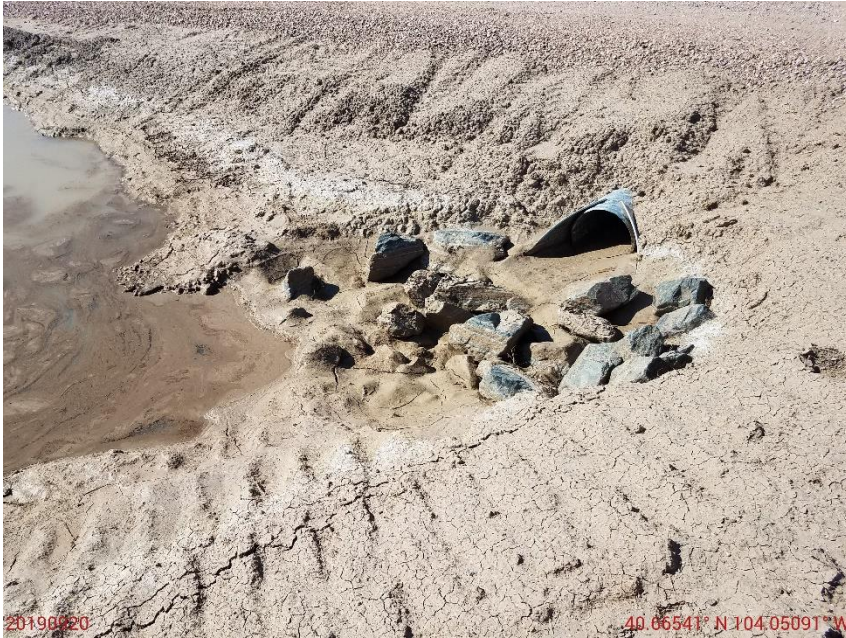
Photo 3: See comments under photo 1.

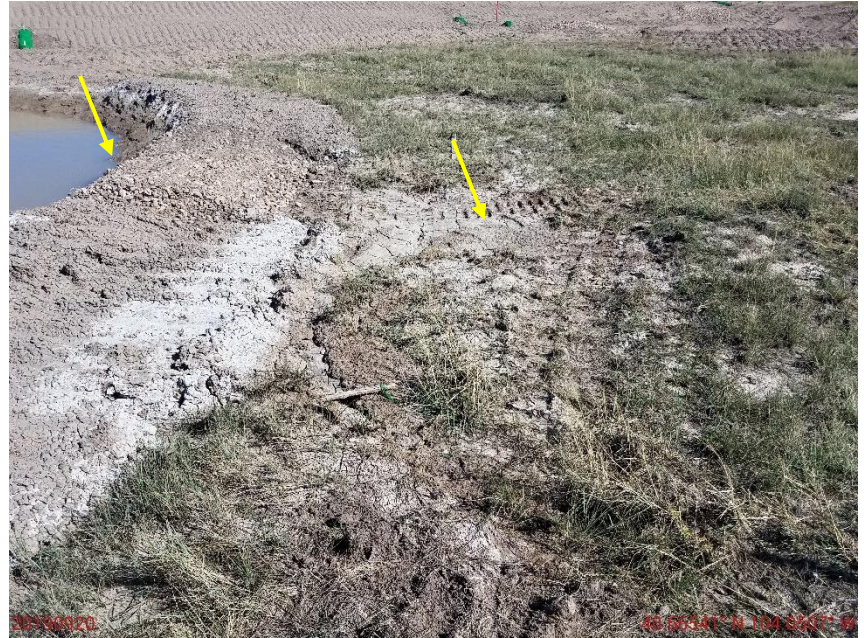
Photo 4: Photo shows area of the sediment trap BMP that appears to have failed resulting in sediment laden stormwater discharge

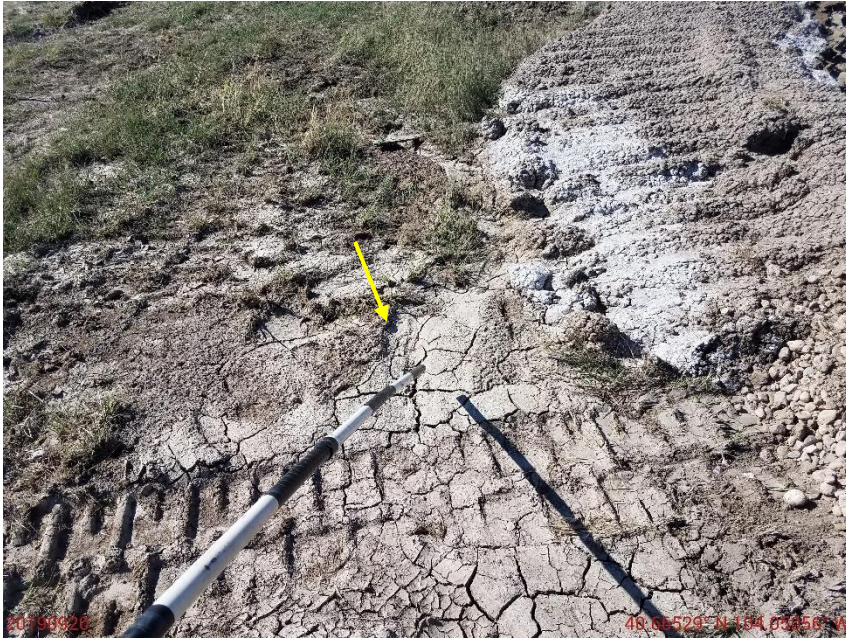
Photo 5: See comments under photo 4.

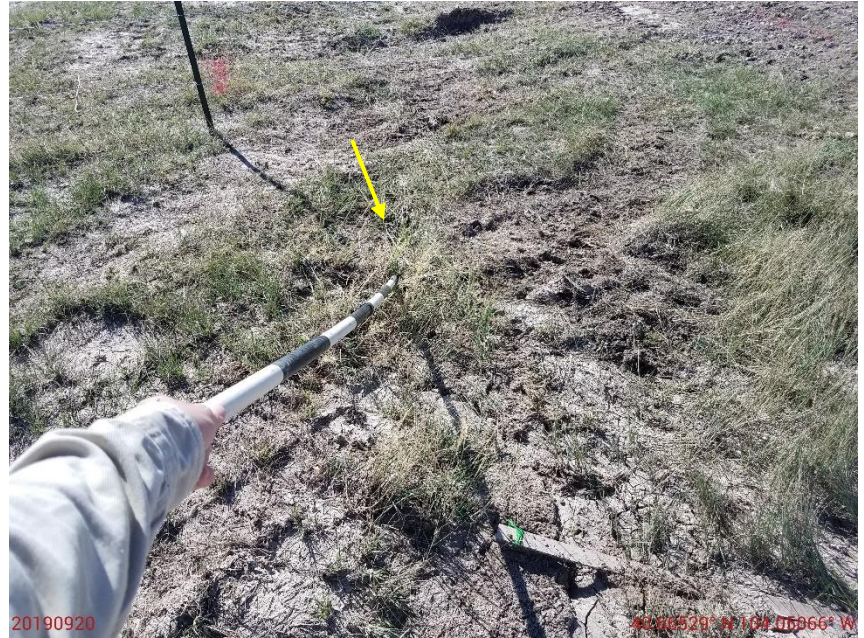
Photo 6: See comments under photo 4.

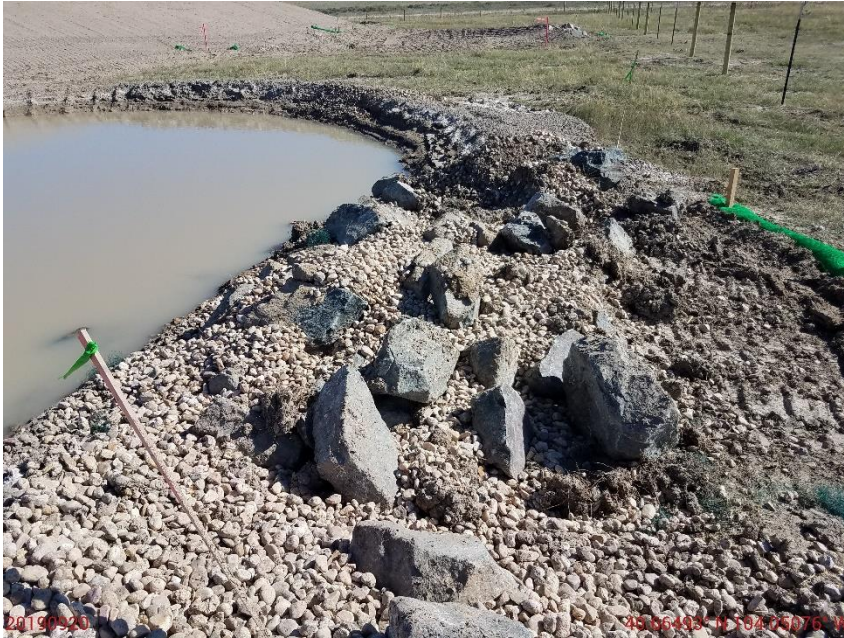
Photo 7: Photo taken from the outlet at the sediment trap. Operator appears to have installed the outlet at the same elevation as the adjacent berms, and constructed in such a manner to dam stormwater rather than reducing velocity, trapping excess sediment and allow for sediment laden-free stormwater discharge from the trap. BMP has not been constructed with good engineering practices.

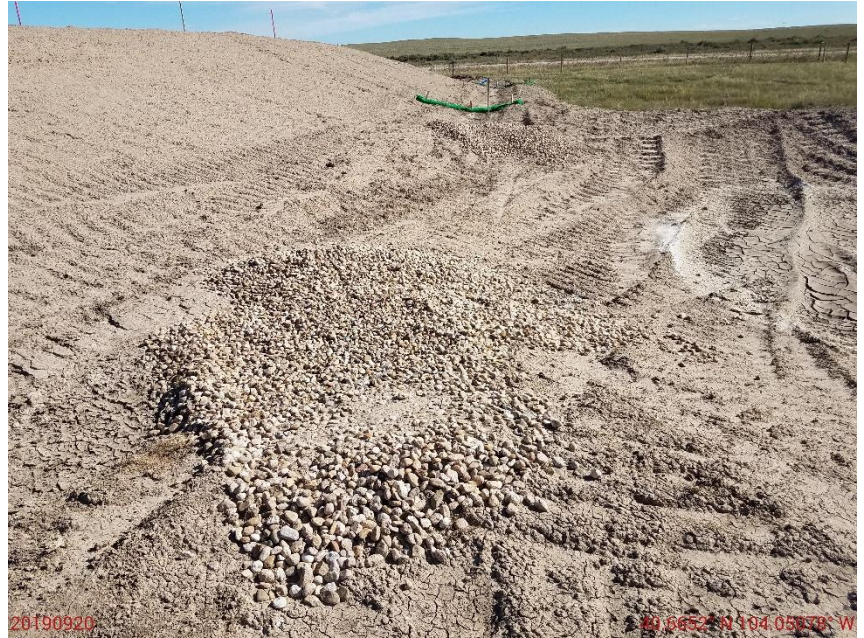
Photo 8: Photo taken from the sediment trap on the southeast end of the location. Photo shows operator appears to have installed rock aggregate as inlet protection.

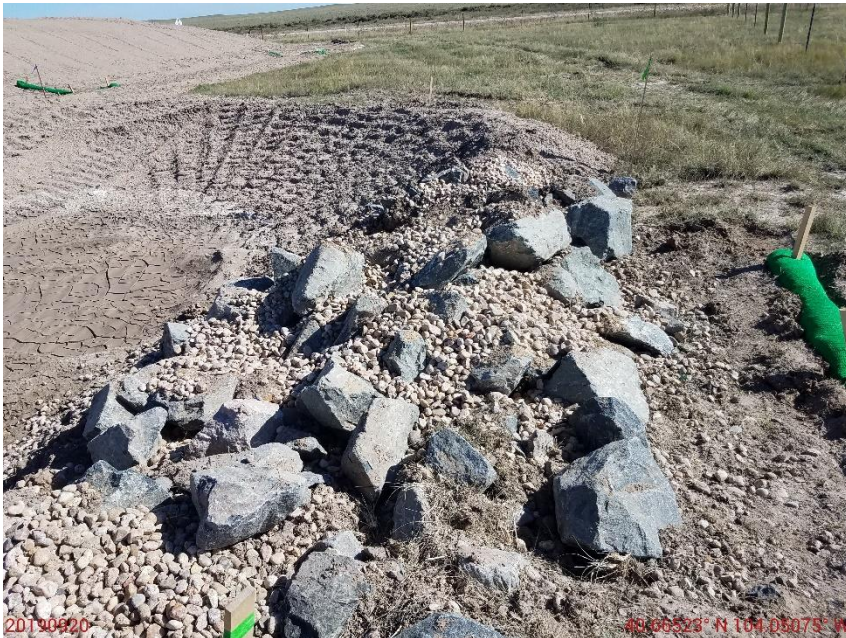
Photo 9: Photo of outlet at the sediment trap on the northeast end of the location. See comments under photo 7

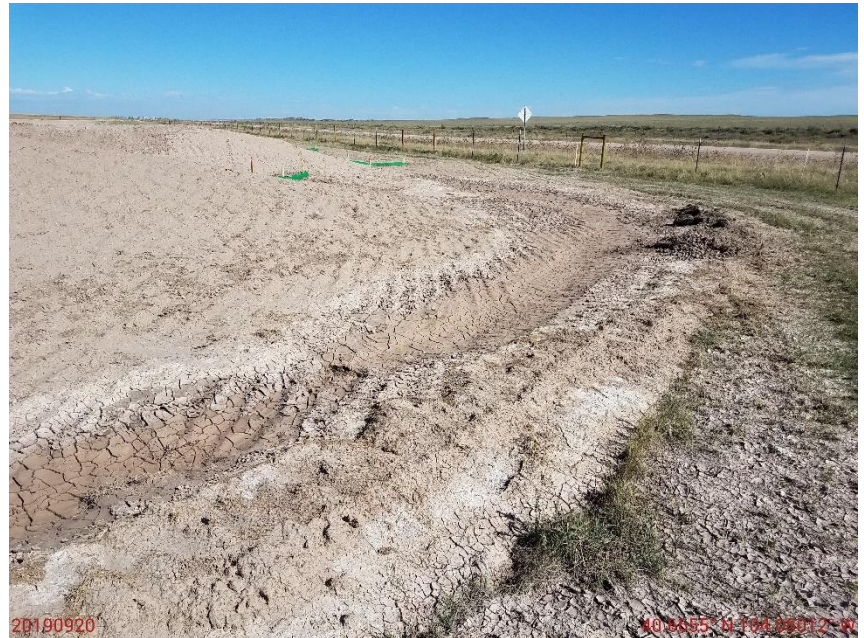
Photo 10: Photo of diversion ditch on the southeast end of the location. Erosion degradation on the slopes have resulted in sediment deposition within ditch. Maintenance required.

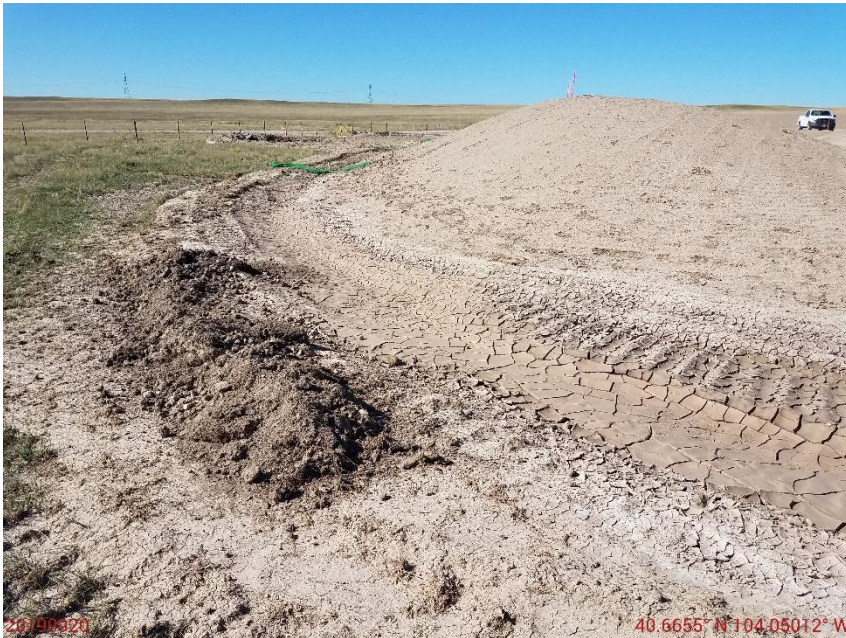
Photo 11: See comments under photo 10.

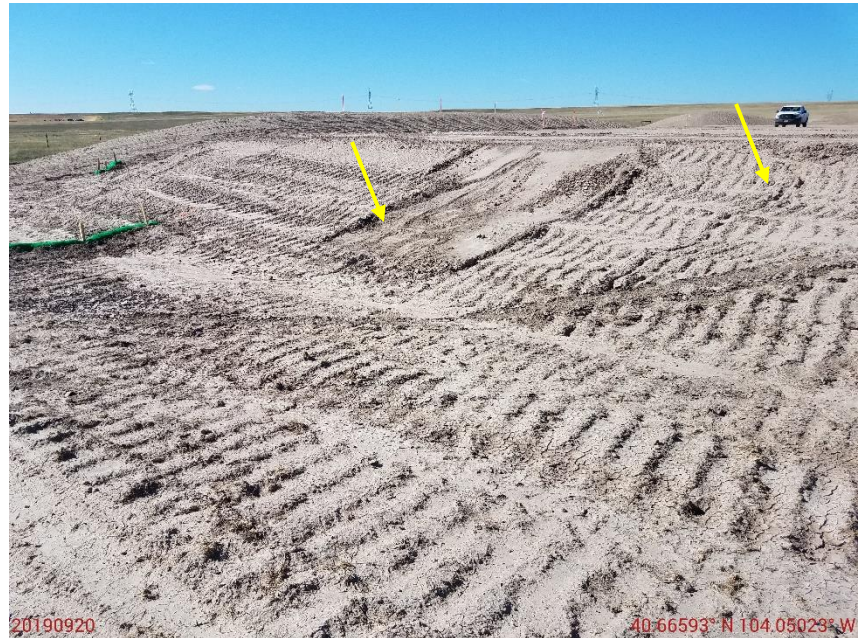
Photo 12: Photo taken from the southeast end of the location, facing west. Photo shows area where stormwater erosion appears to have degraded the slopes. Operator appears to have repaired the erosion. However, photo also shows operator has not installed stabilization controls on slopes in accordance with good engineering practices. Operator has installed tracking along the contour of the slopes rather than up and down. This has resulted in the facilitation of rill erosion on the slopes.

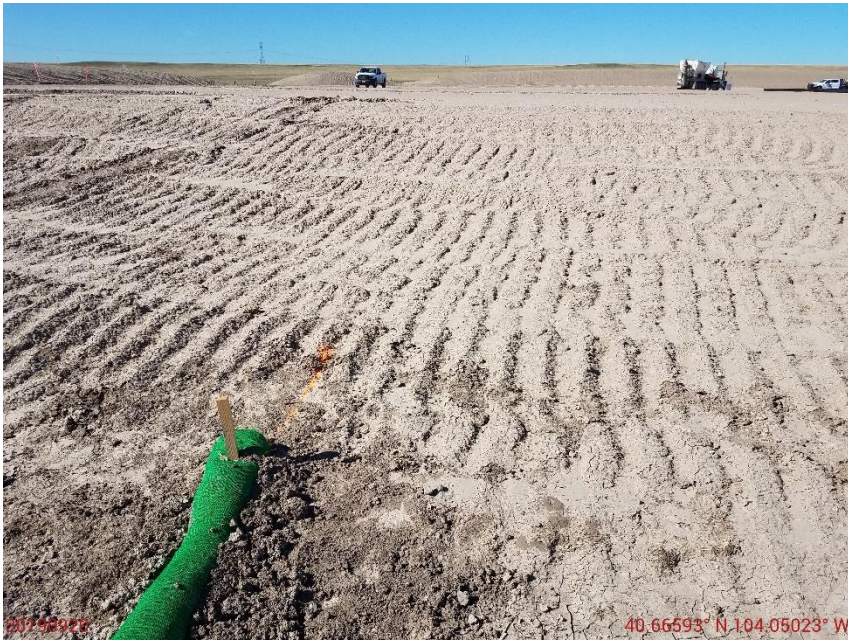
Photo 13: See comments under photo 12.

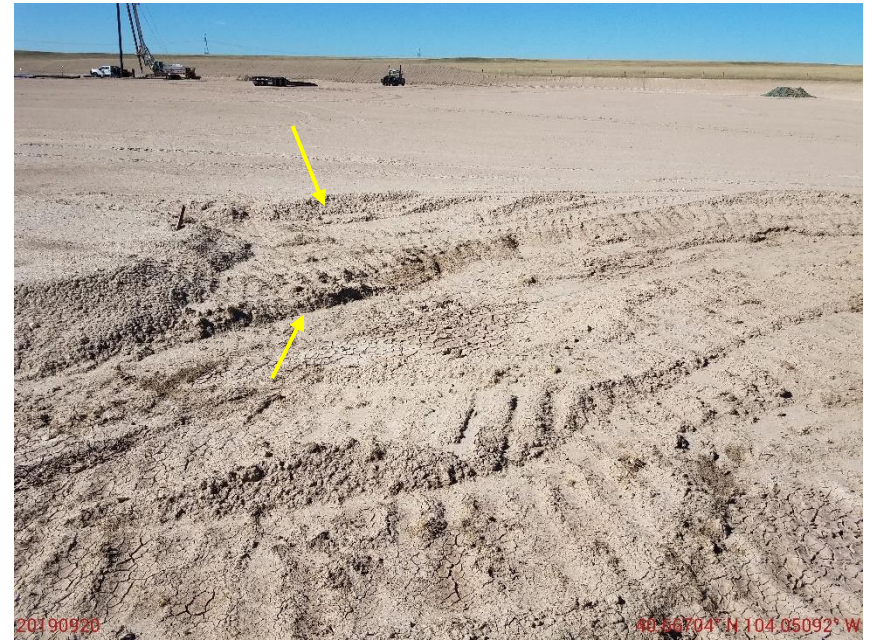
Photo 14: Photo taken from the east end of the location. Photo shows area where pad meets the perimeter diversion ditch. Photo shows insufficient BMPs in place to stabilize soils and location.

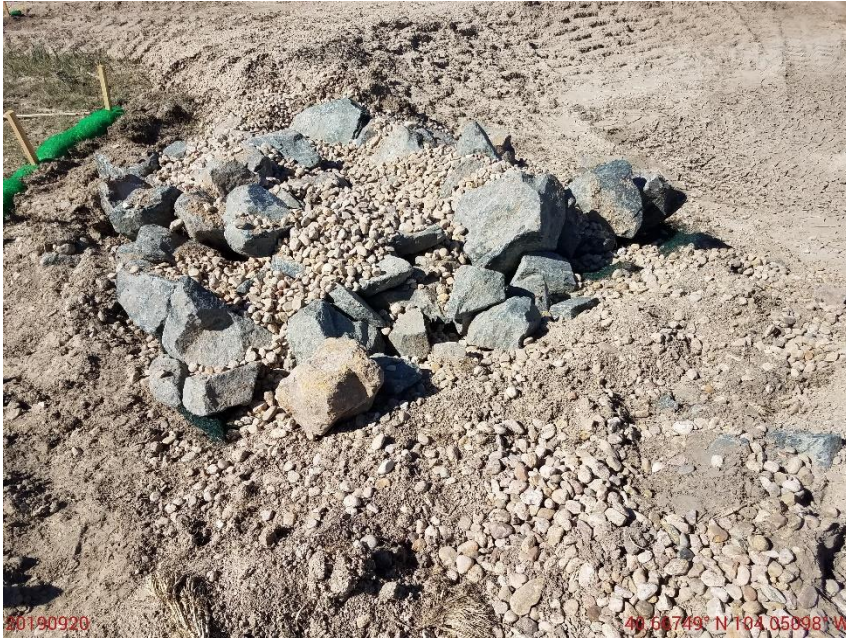
Photo 15: Photo taken from the sediment trap on the northeast end of the location. See comments under photo 7.

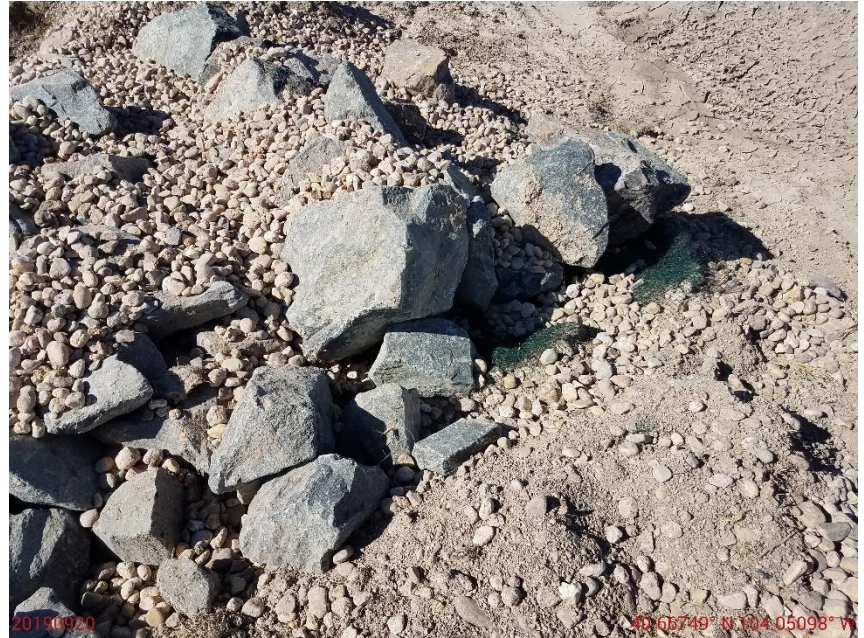
Photo 16: Continued from photo 15.

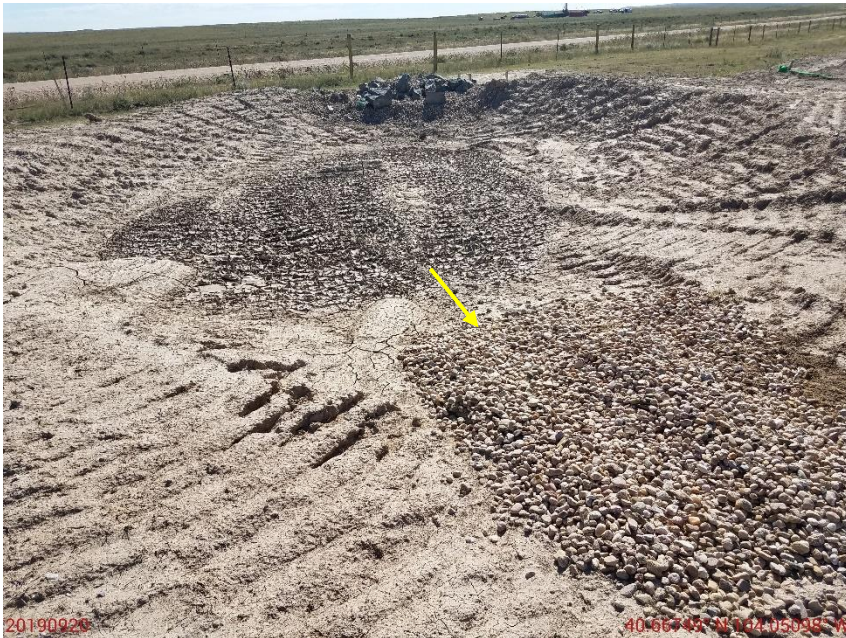
Photo 17: See comments under photo 15. Photo also shows operator has installed rock aggregate along inlet.

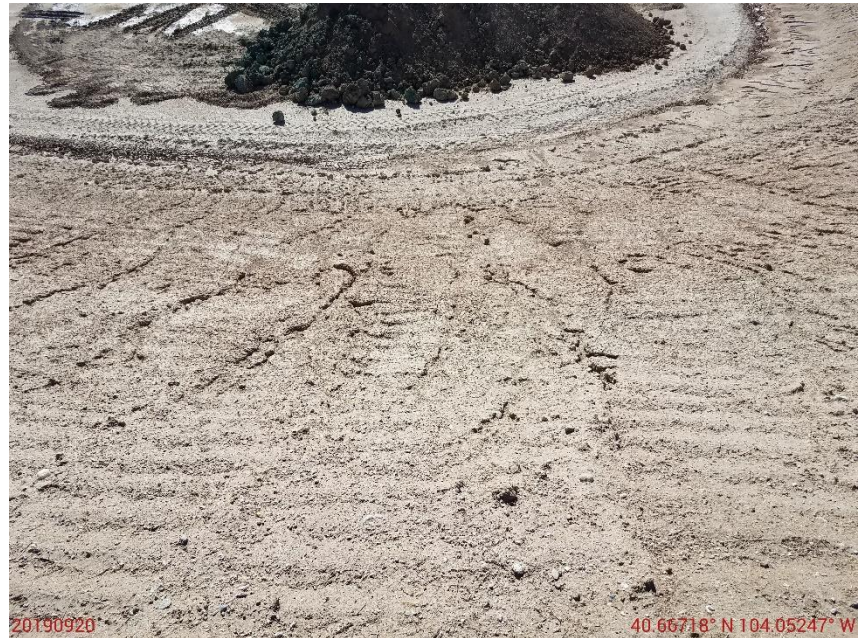
Photo 18: Photo taken from the northwest end of the location. Photo shows erosion degradation on slopes due to insufficient stormwater and erosion control BMPs.

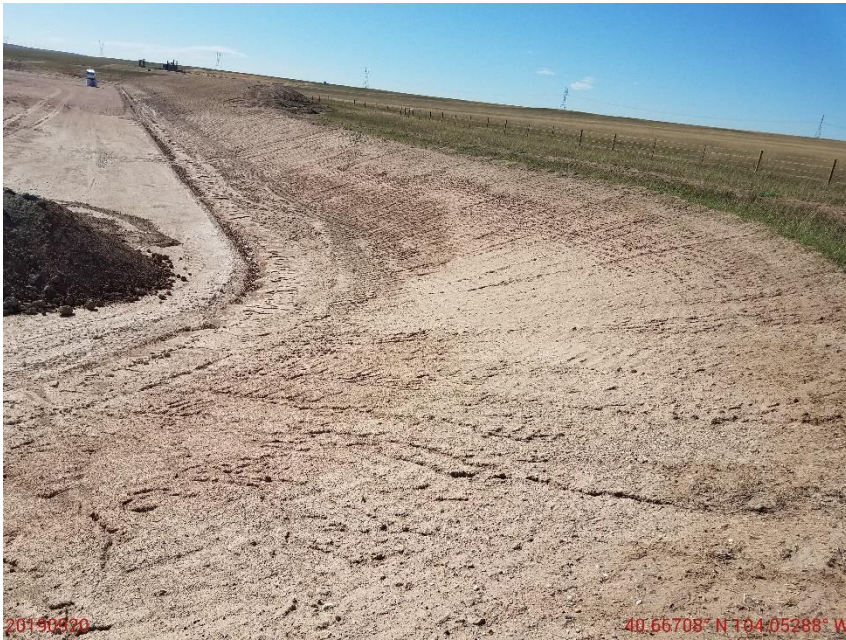
Photo 19: See comments under photo 18.

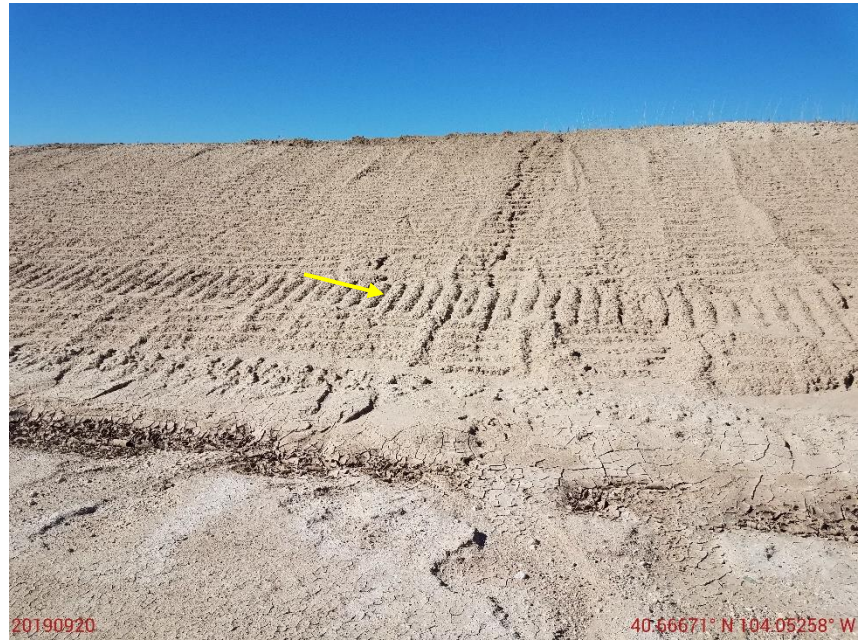
Photo 20: Photo taken from the northwest end of the location, facing west. Photo shows operator has not installed stabilization controls on slopes in accordance with good engineering practices. Operator has installed tracking along the contour of the slopes rather than up and down. This has resulted in the facilitation of rill erosion on the slopes.

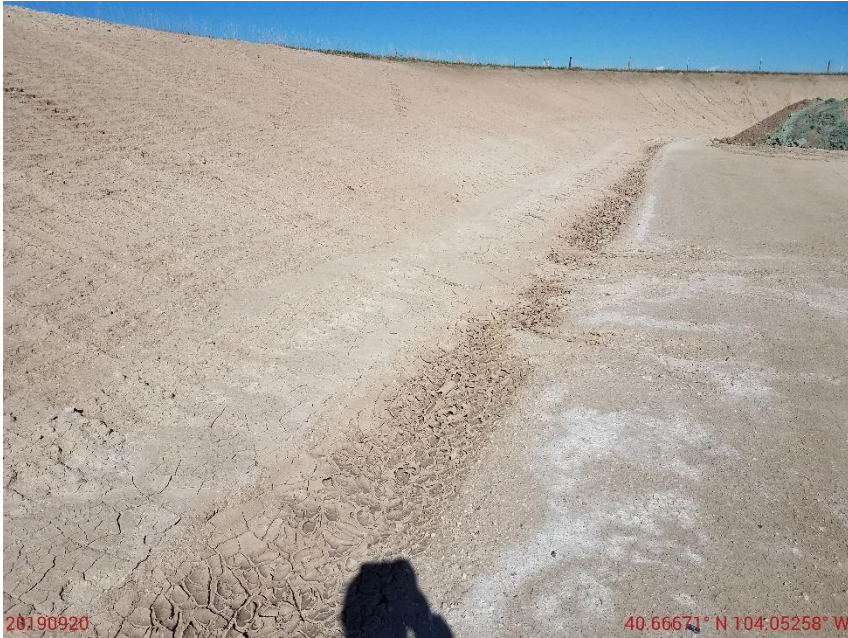
Photo 21: Continued from photo 20. Photo shows sediment deposition due to stormwater erosion on slopes.

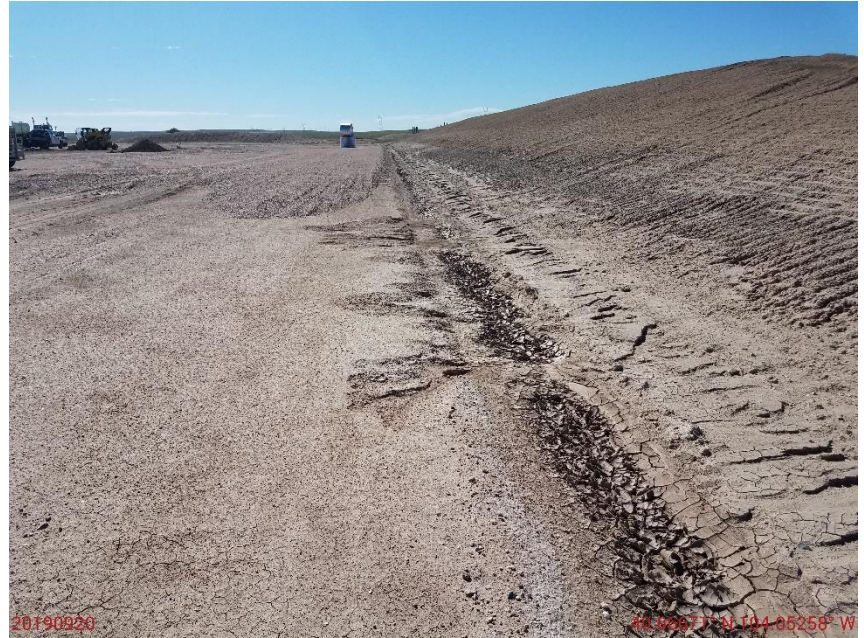
Photo 22: Continued from photo 20. Photo shows sediment deposition due to stormwater erosion on slopes.

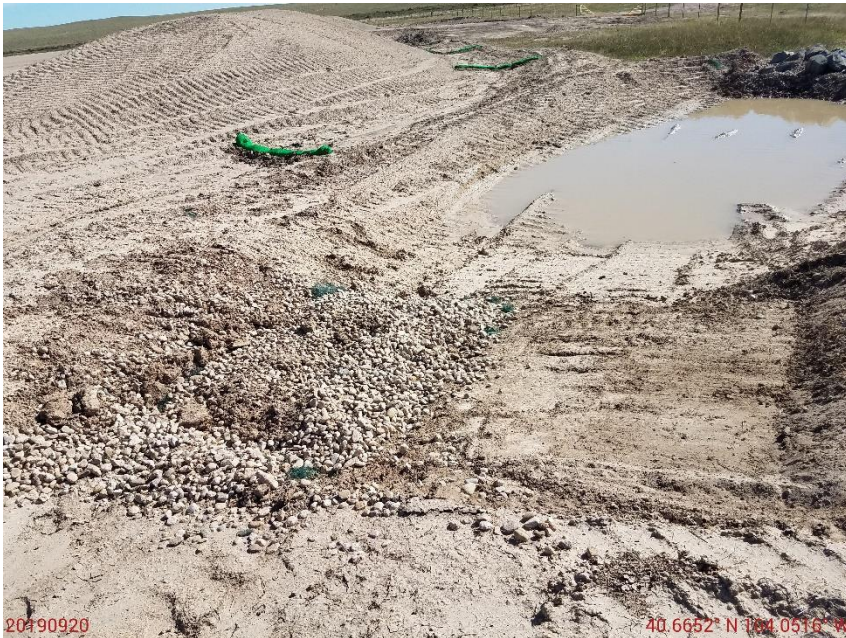
Photo 23: Photo taken from the sediment trap on the southwest end of the location. Photo shows operator has installed inlet protection on a portion of the inlet. BMP does not appear to be sufficient as erosion degradation is evident.

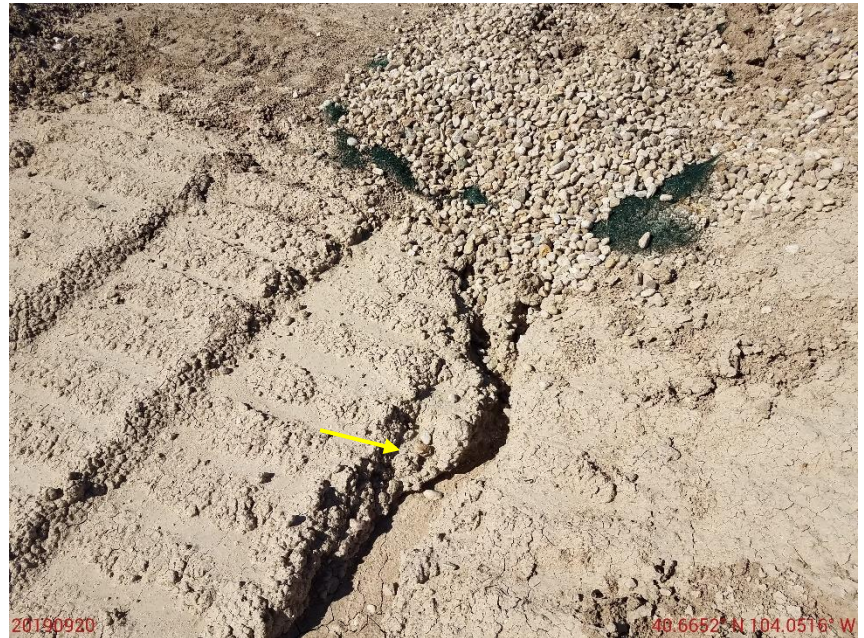
Photo 24: Continued from photo 22.

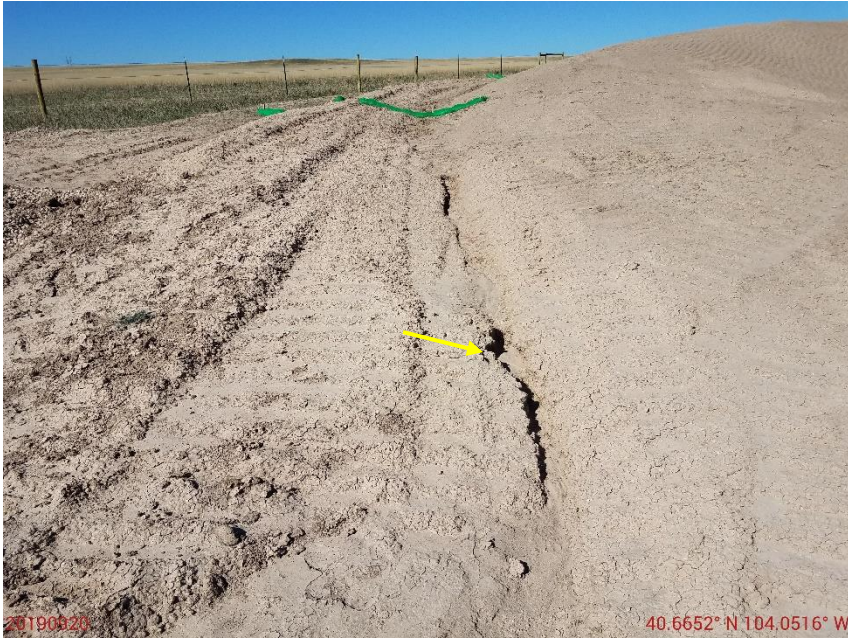
Photo 25: Photo taken from the stormwater ditch on the south end of the location. Photo shows erosion degradation within ditch.

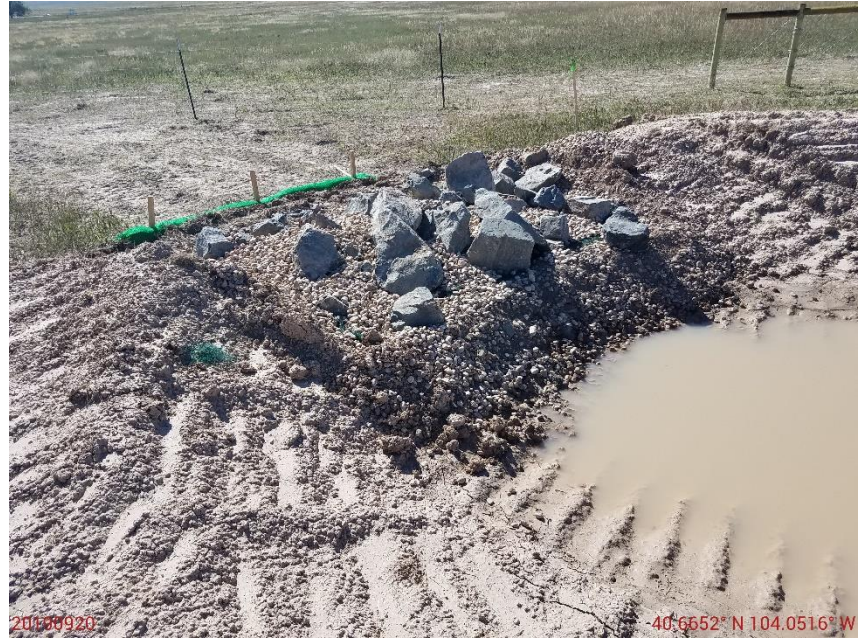
Photo 26: Photo taken from the sediment trap on the southwest end of the location. See comments under photo 7.

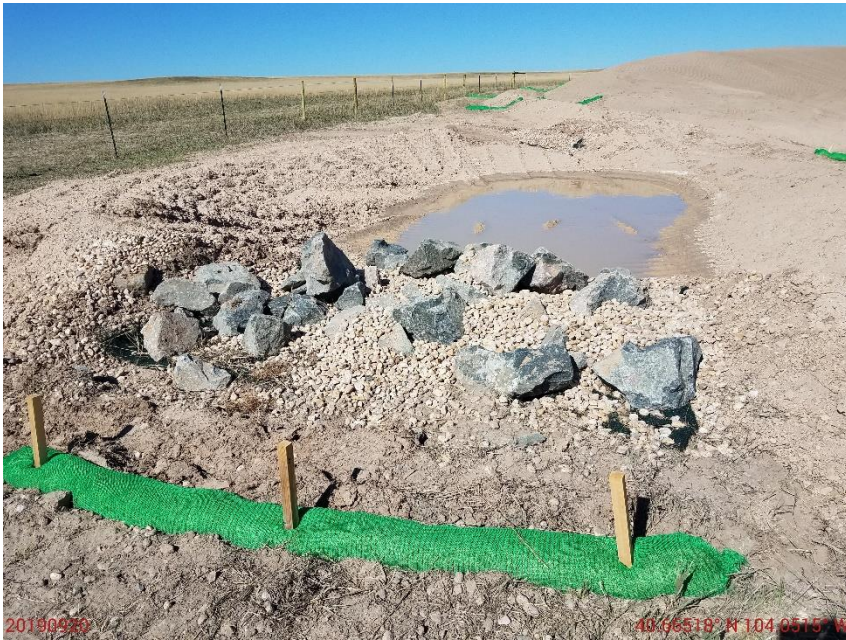
Photo 27: Continued from photo 26.

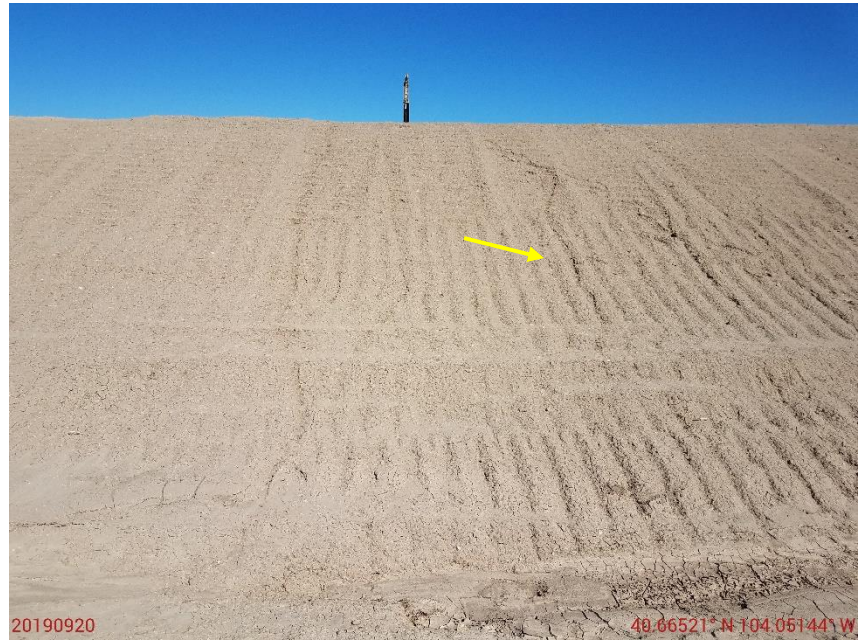
Photo 28: Photo taken from the topsoil stockpile on the southwest end of the location. Photo shows operator has not installed stabilization controls on slopes in accordance with good engineering practices. Operator has installed tracking along the contour of the slopes rather than up and down. This has resulted in the facilitation of rill erosion on the slopes.

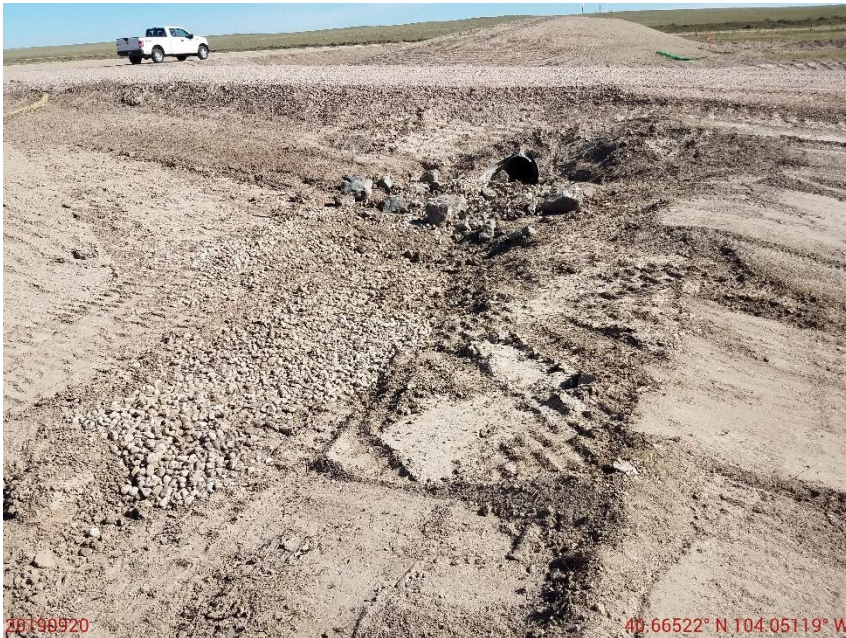
Photo 29: Photo taken from the culvert on the south end of the location. Photo shows sufficient outlet protection has not been installed above culvert outlet. Sediment is also beginning to fill culvert and rip-rap; maintenance advised.

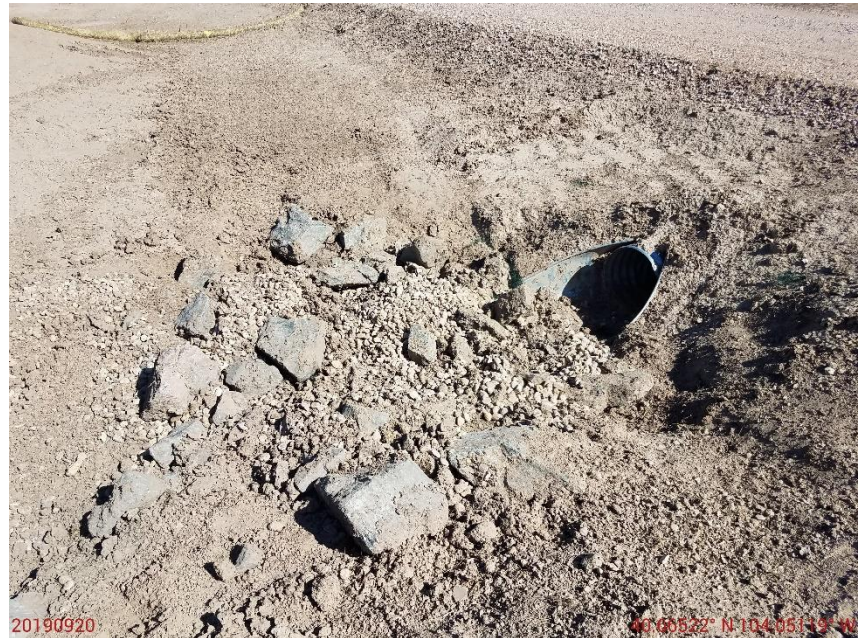
Photo 30: Continued from photo 29

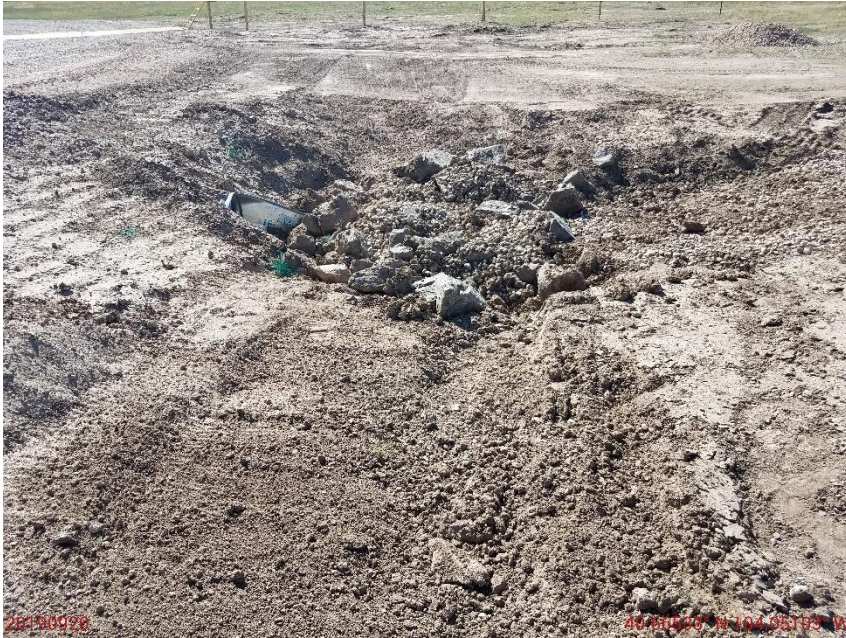
Photo 31: Continued from photo 29

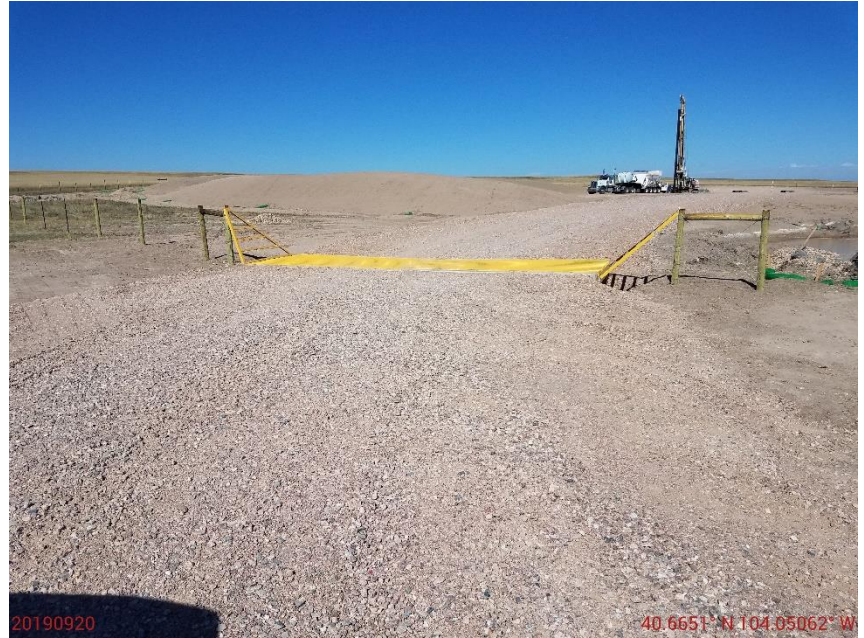
Photo 32: Photo taken from the access road south of the location, facing north. Photo of cattle guard. Insufficient tracking BMPs on location and/or access road.

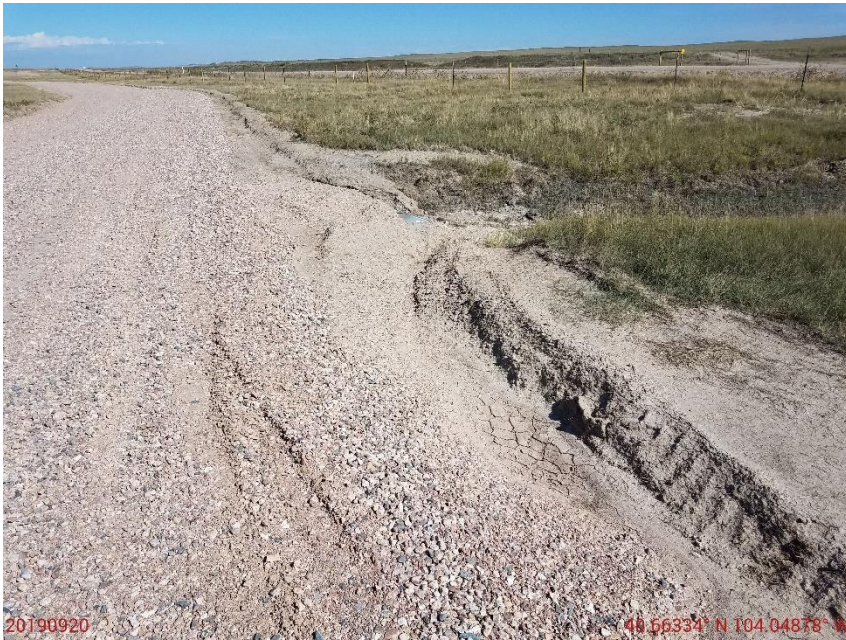
Photo 33: Photo taken from cattle guard along access road. Photo shows insufficient outlet protection at culvert. Erosion degradation evident.

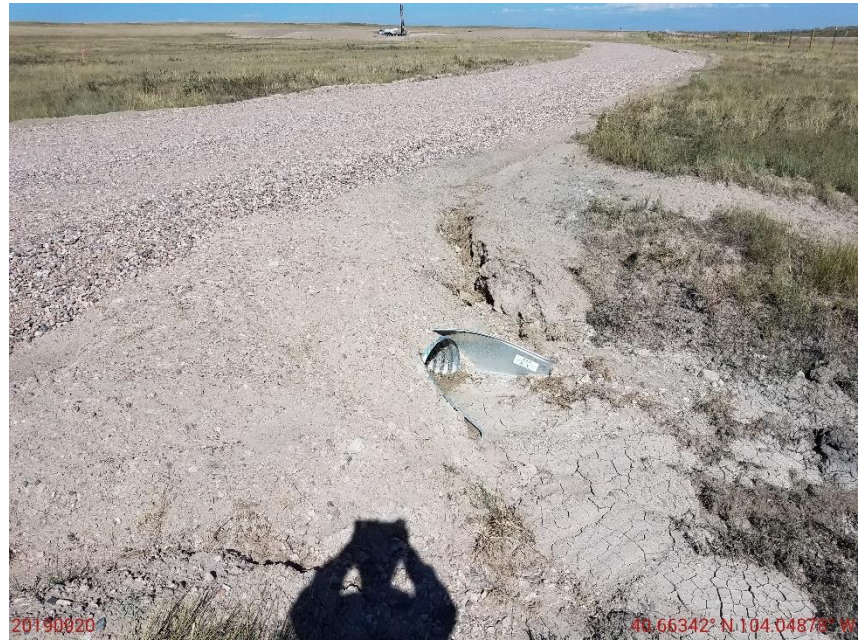
Photo 34: See comments under photo 33.

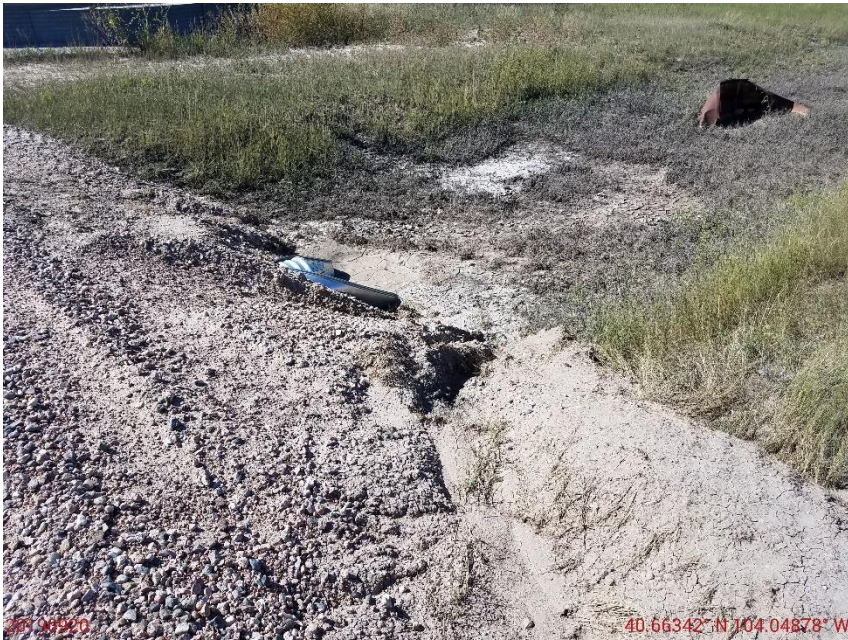
Photo 35: See comments under photo 33.

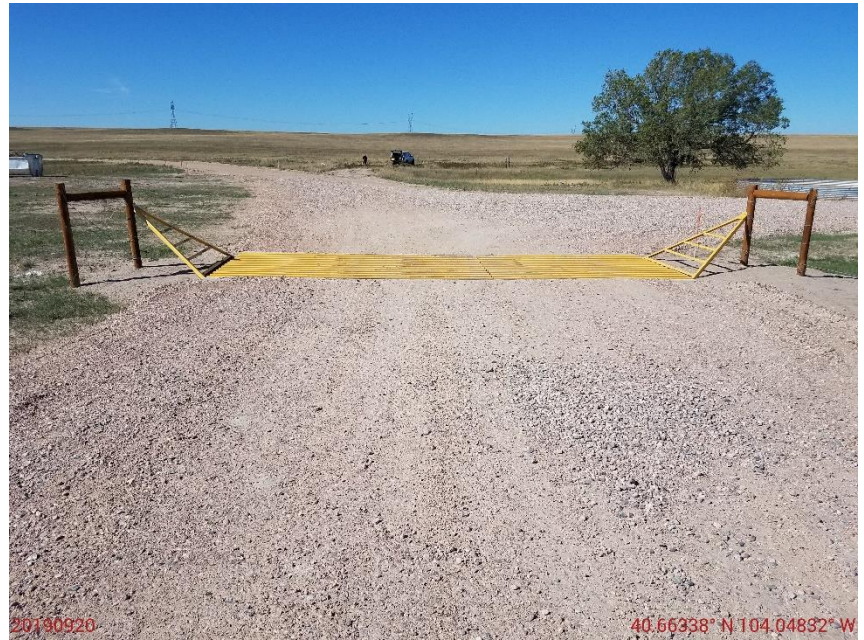
Photo 36: Photo taken from the access road south of the location, facing west. Photo of cattle guard. Insufficient tracking BMPs on location and/or access road.
