Inspection Photos
Operator: Hilcorp Energy
Location/API #: 067-08737
Date: 9-16-2019

Germination Transect
067-08737
9/16/2019

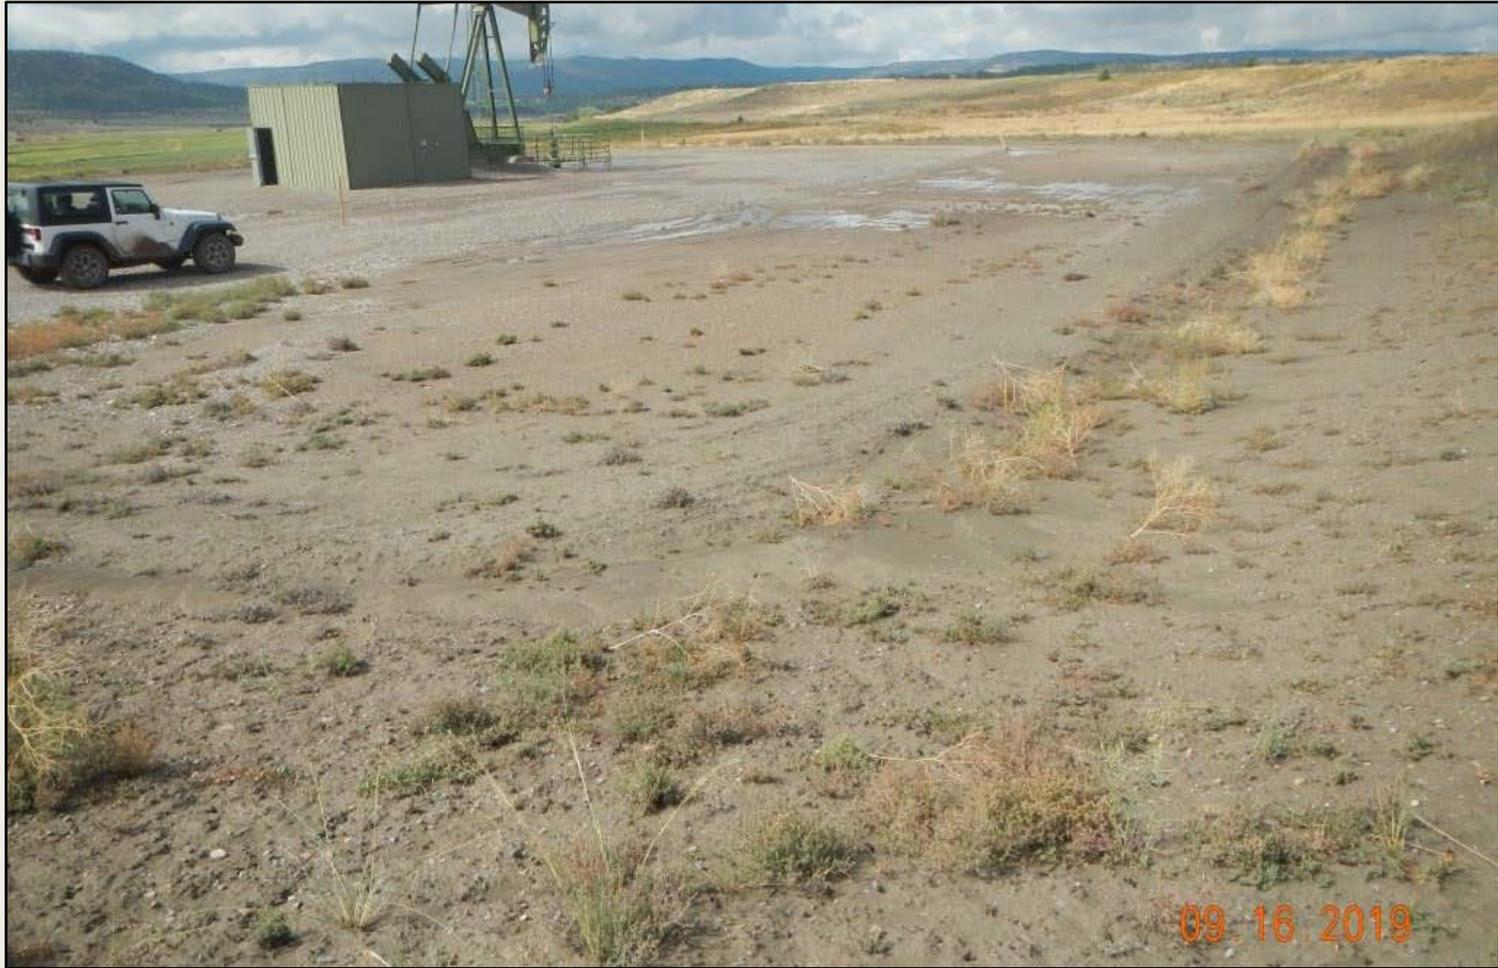
Photo 1. View of the project area from the northeastern edge facing center.

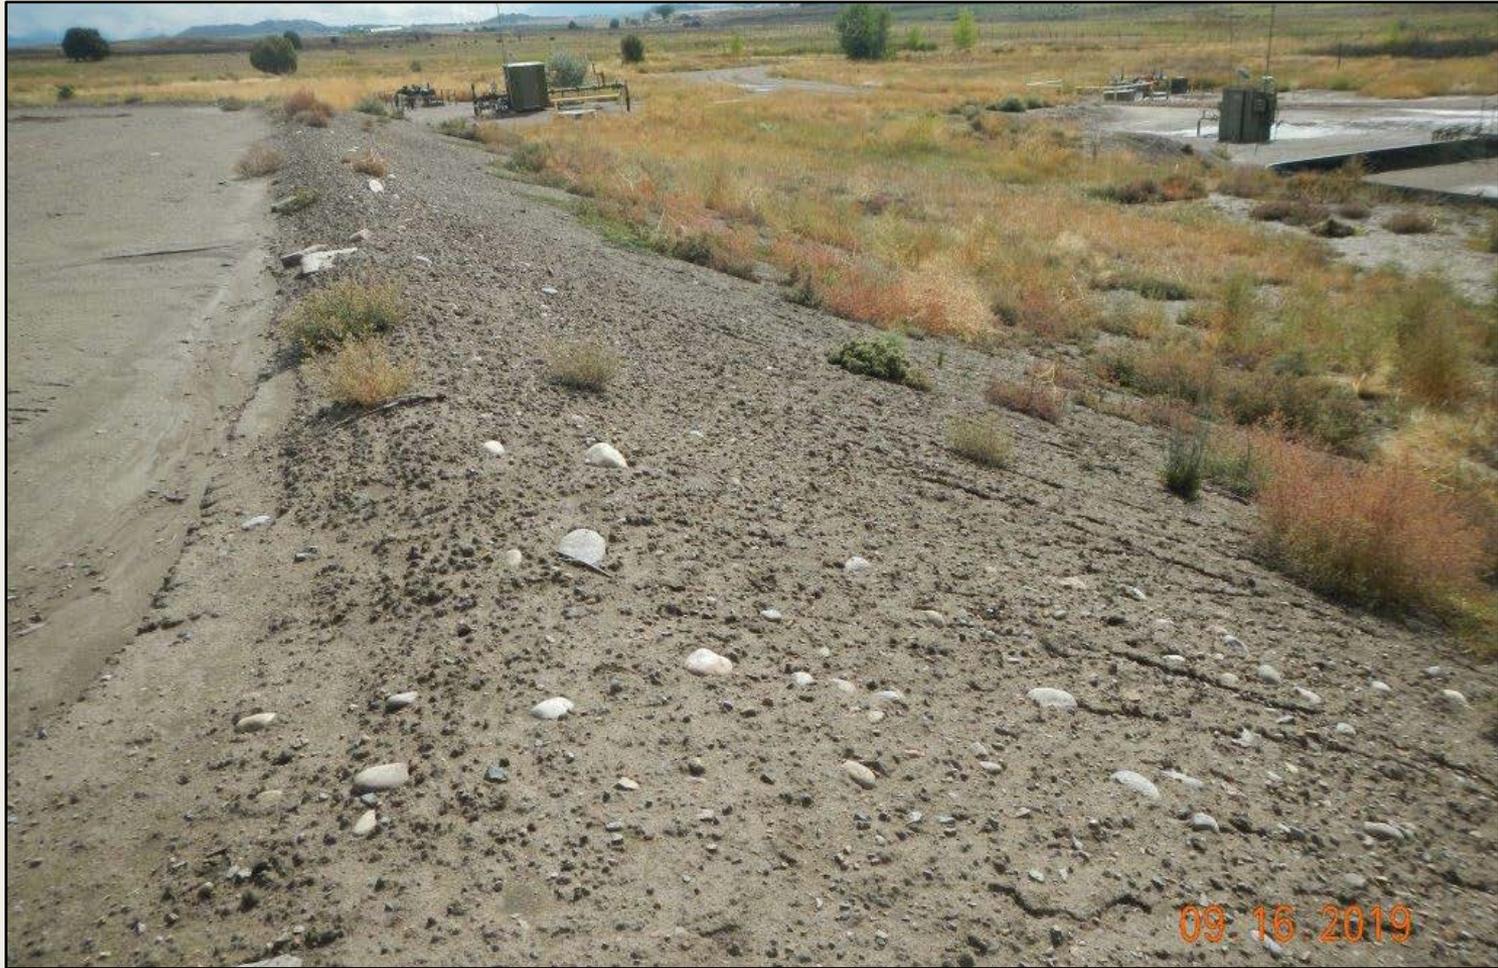
Photo 2. View of the southern fill slope. Little desirable vegetation observed on the fill slope.

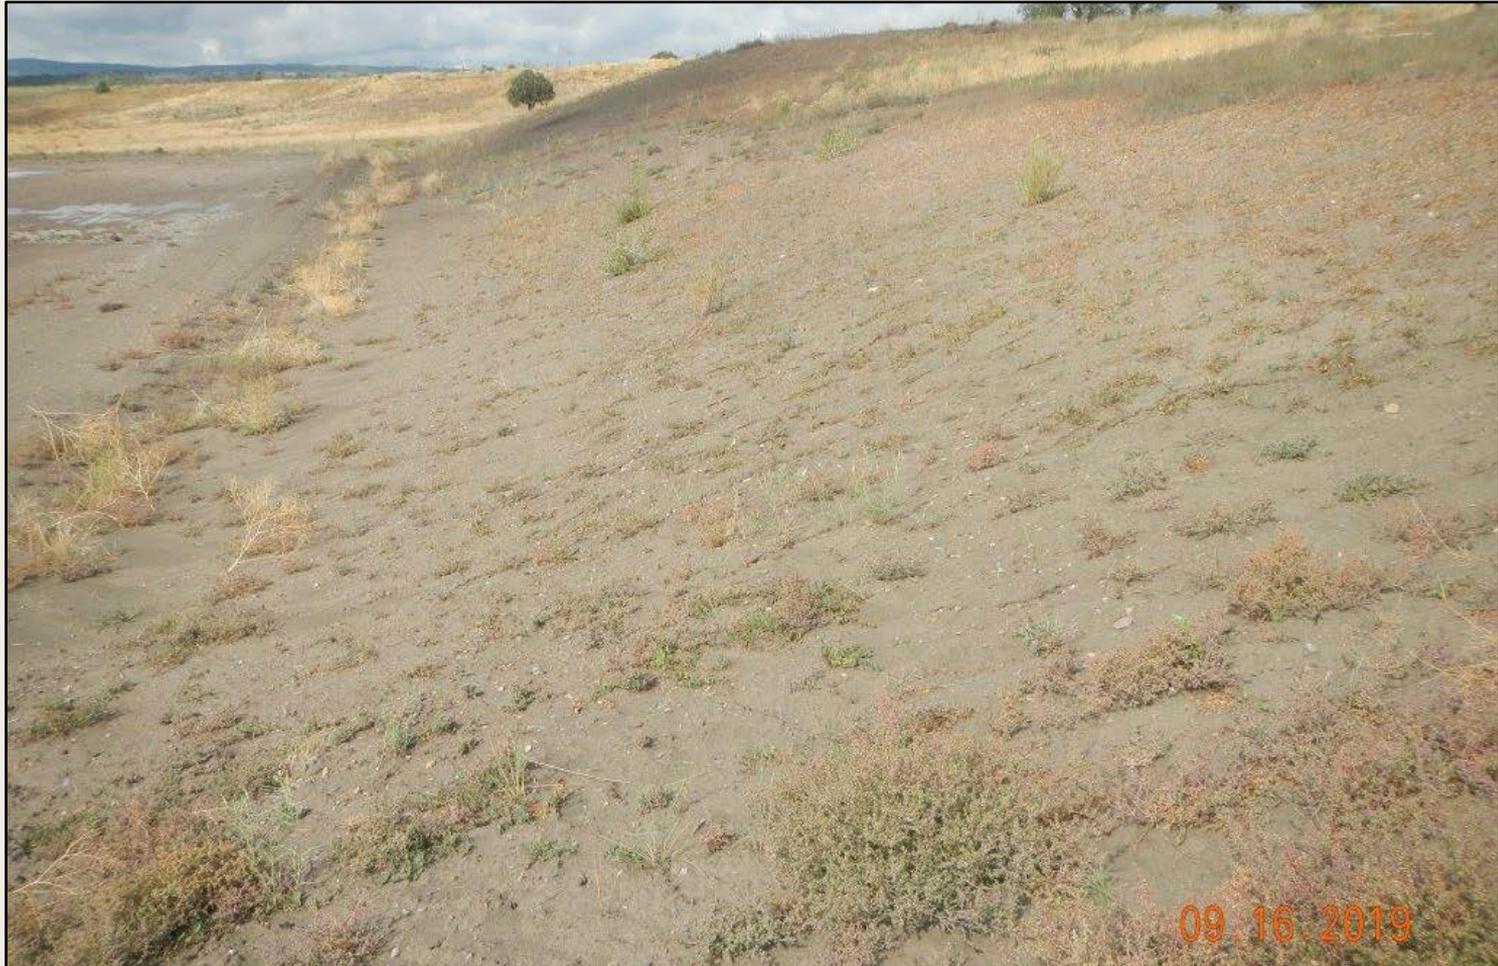
Photo 3. View of northern cut-slope from the northeastern edge facing westward. Little desirable vegetation observed here. Observable vegetation is largely comprised of Russian thistle (*Salsola tragus*). Slope appears to be recently seeded, although no mulch or erosion control practices observed.

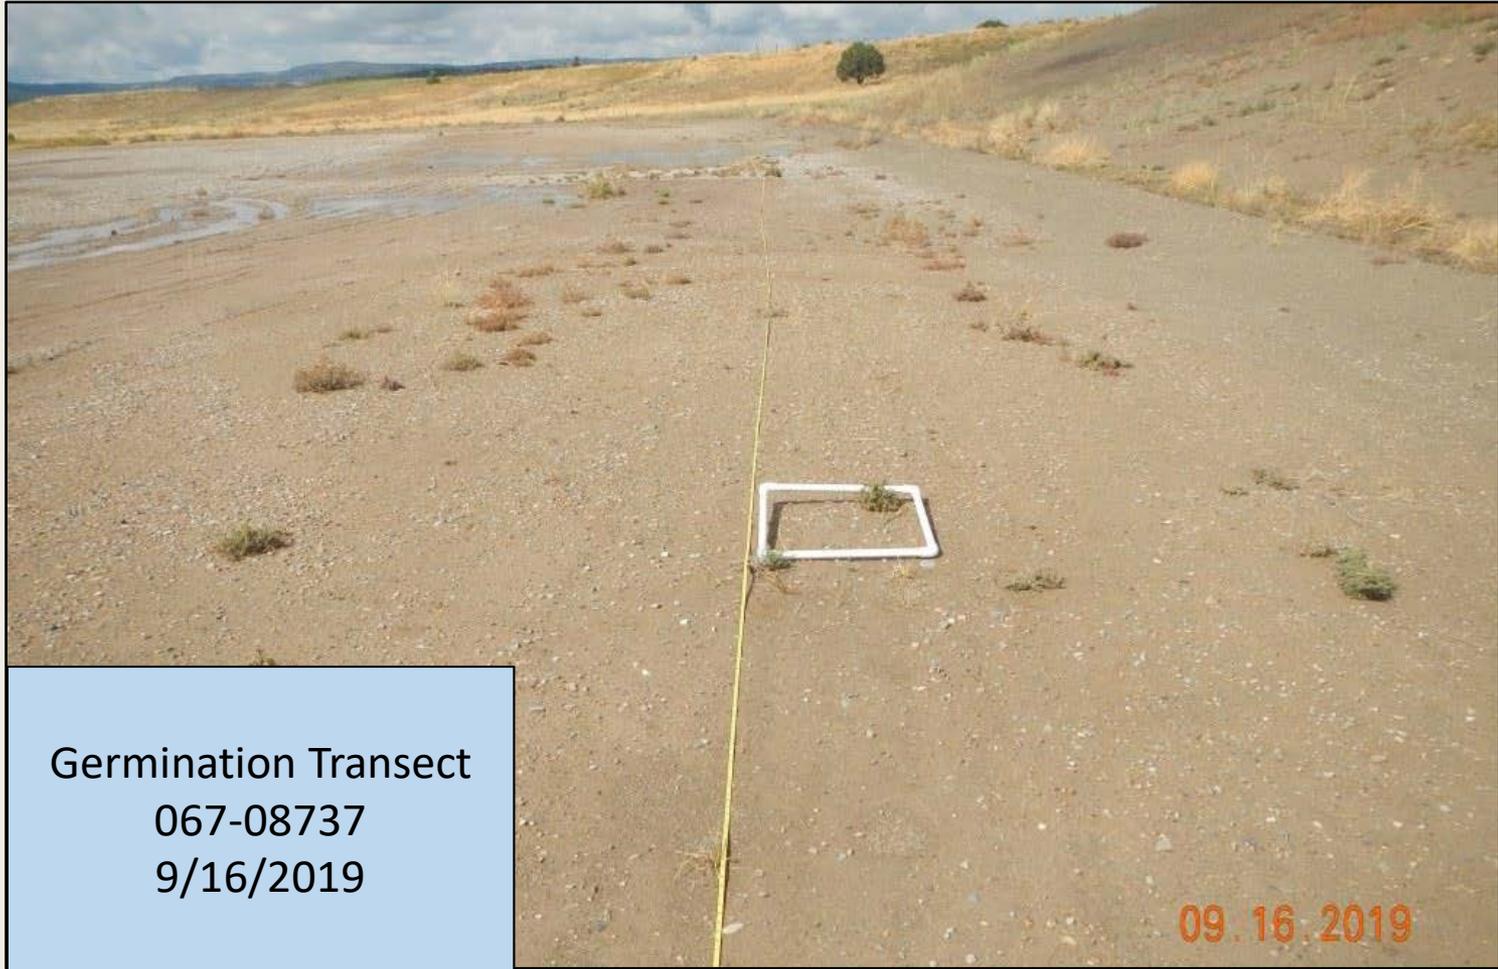
Photo 4. View of the beginning of germination transect facing westward.

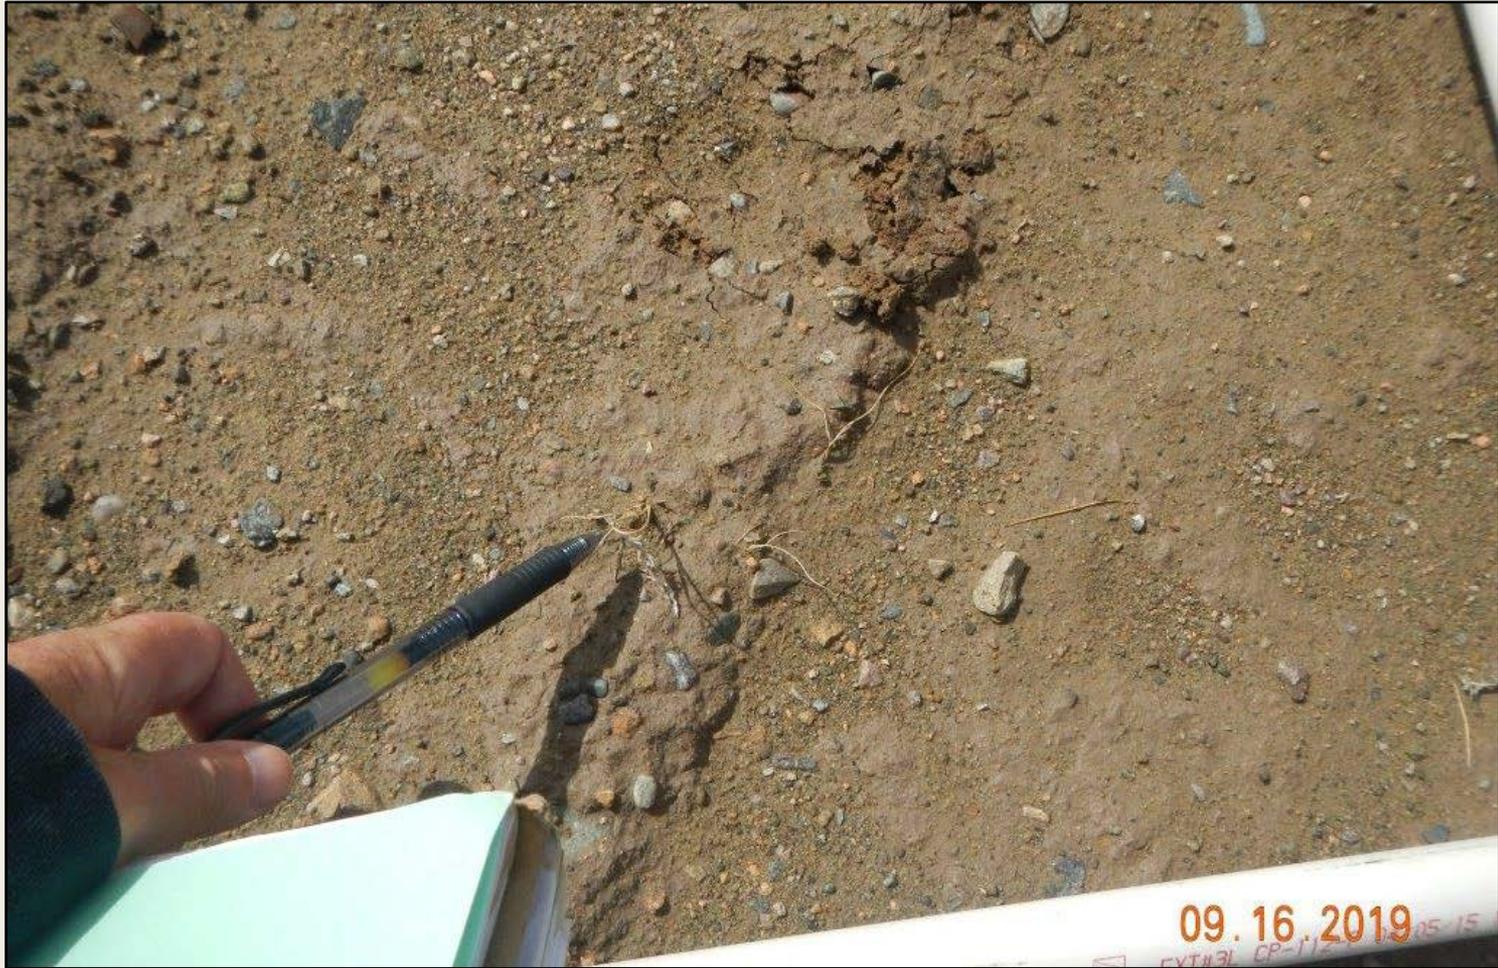
Photo 5. Birdseye view of typical seedling within germination quadrat. It is not apparent whether seedling is alive.

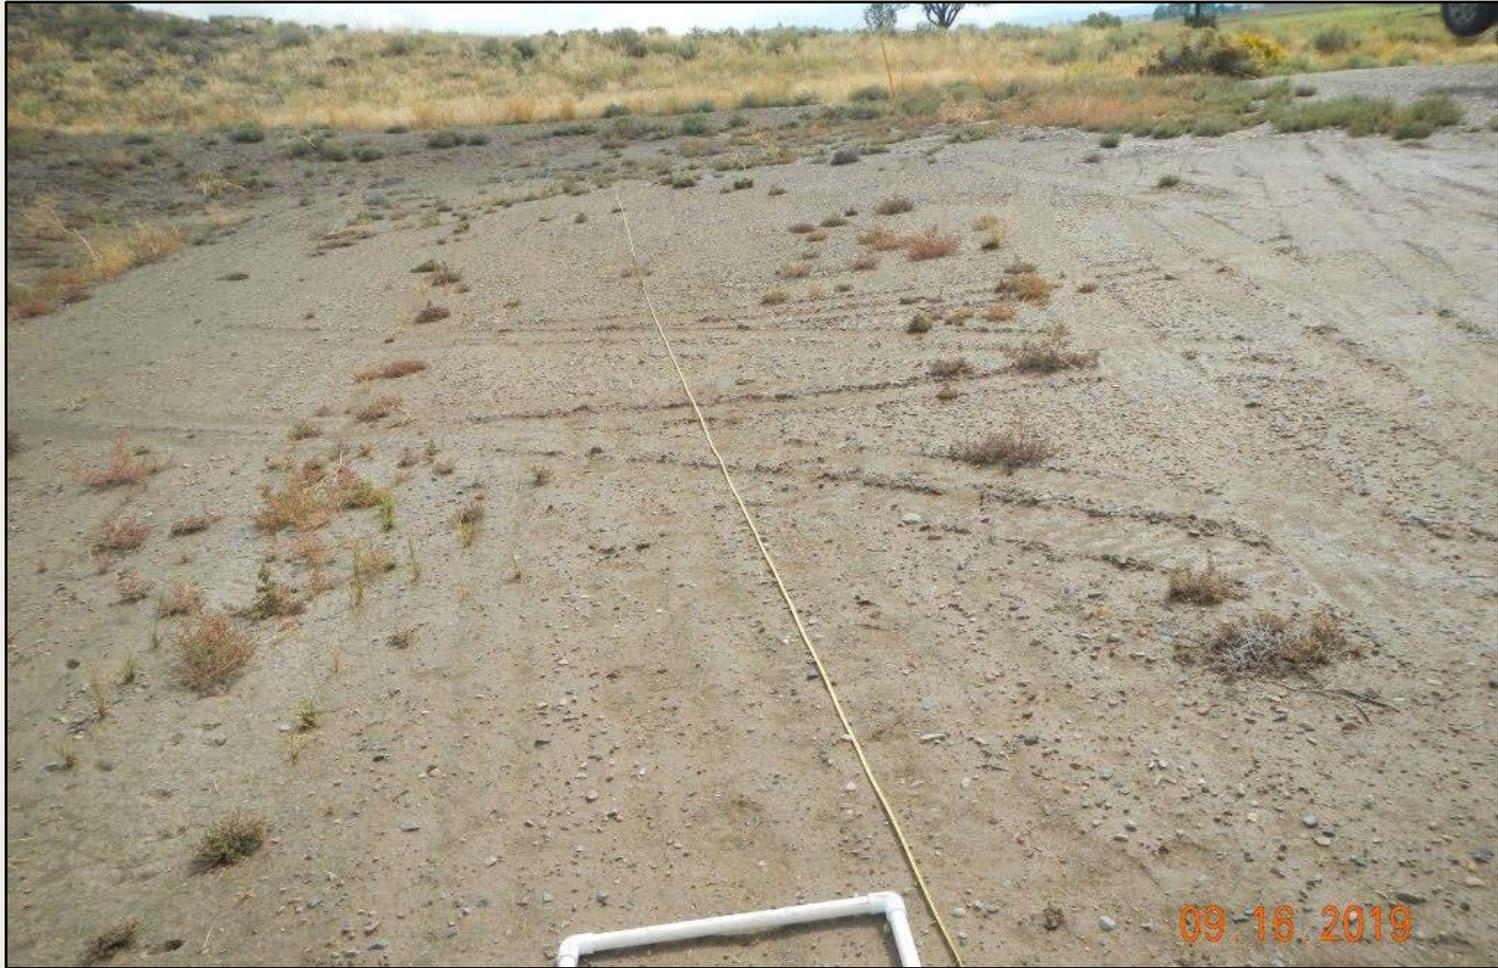
Photo 6 View from the end of germination transect facing eastward.

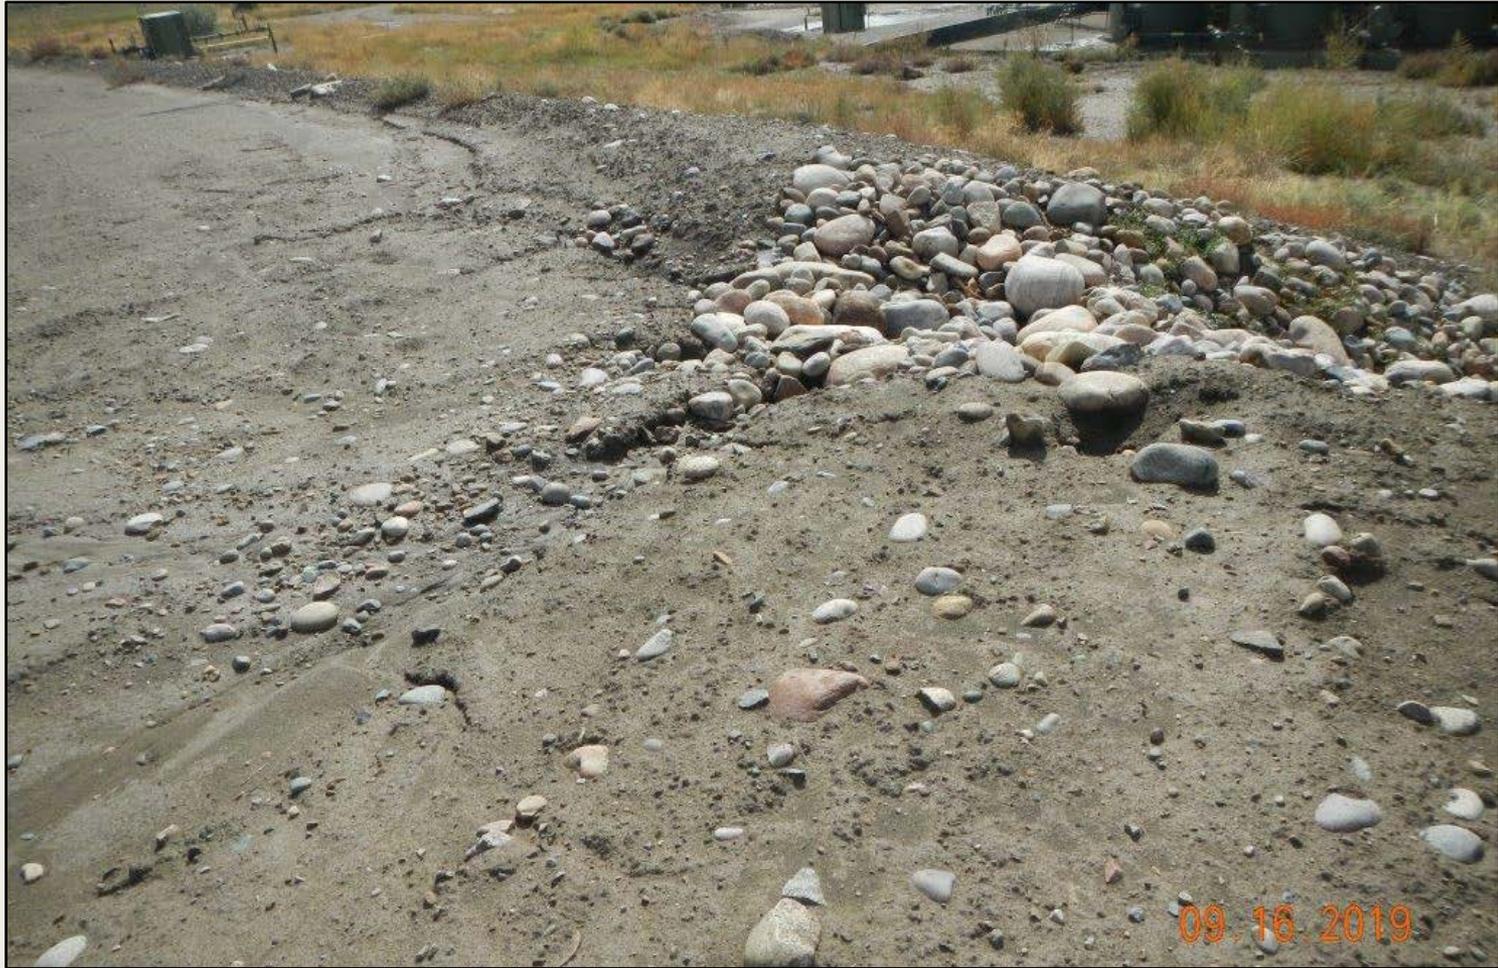
Photo 7. View of are in the southwestern well pad where cobble BMP is not sufficient and erosion continues. Surrounding soils are not stabilized.

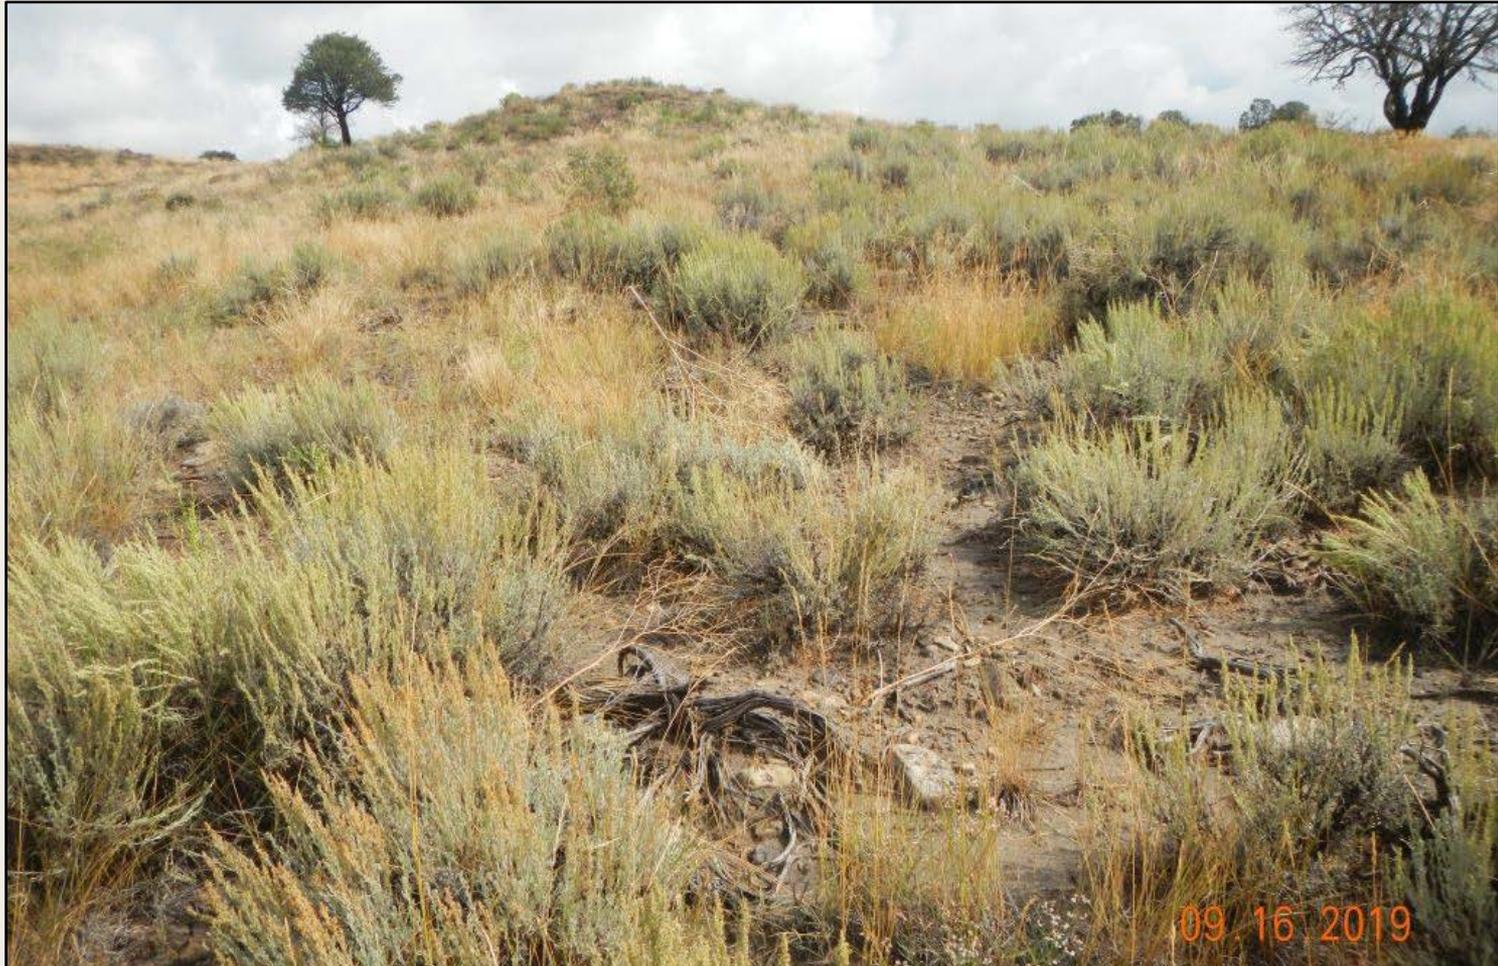
Photo 8. View of reference area vegetation facing northward, east of well pad.
