Inspection Photos

Operator: Hilcorp Energy
Location/API #: 067-06512
Date: 9-16-2019

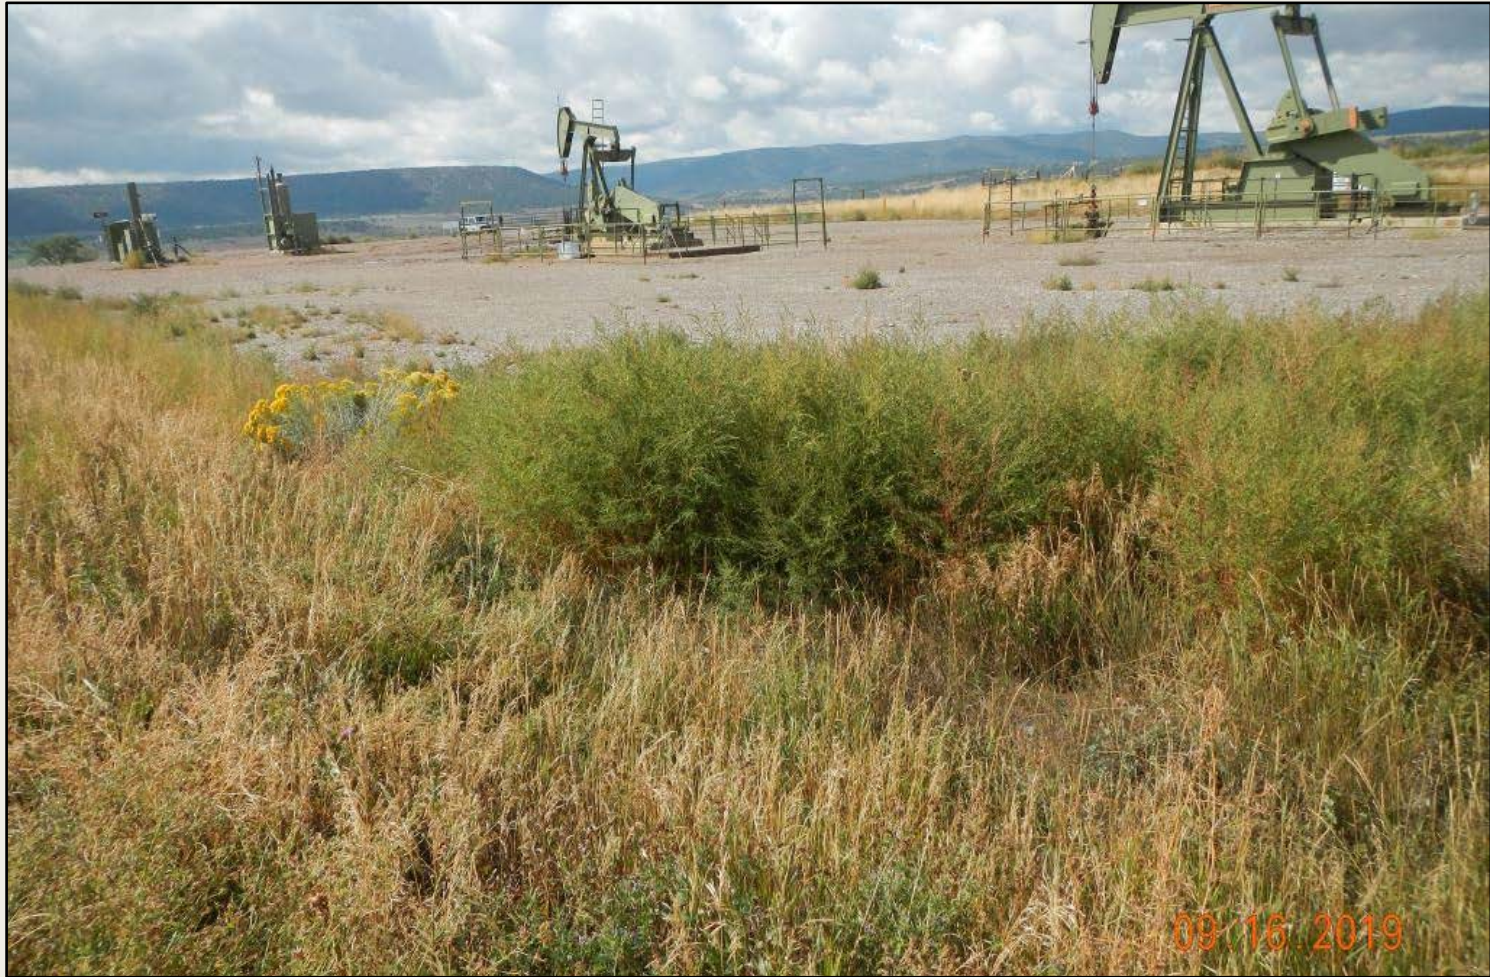
Photo 1. View of the project area from the northeastern corner facing center.

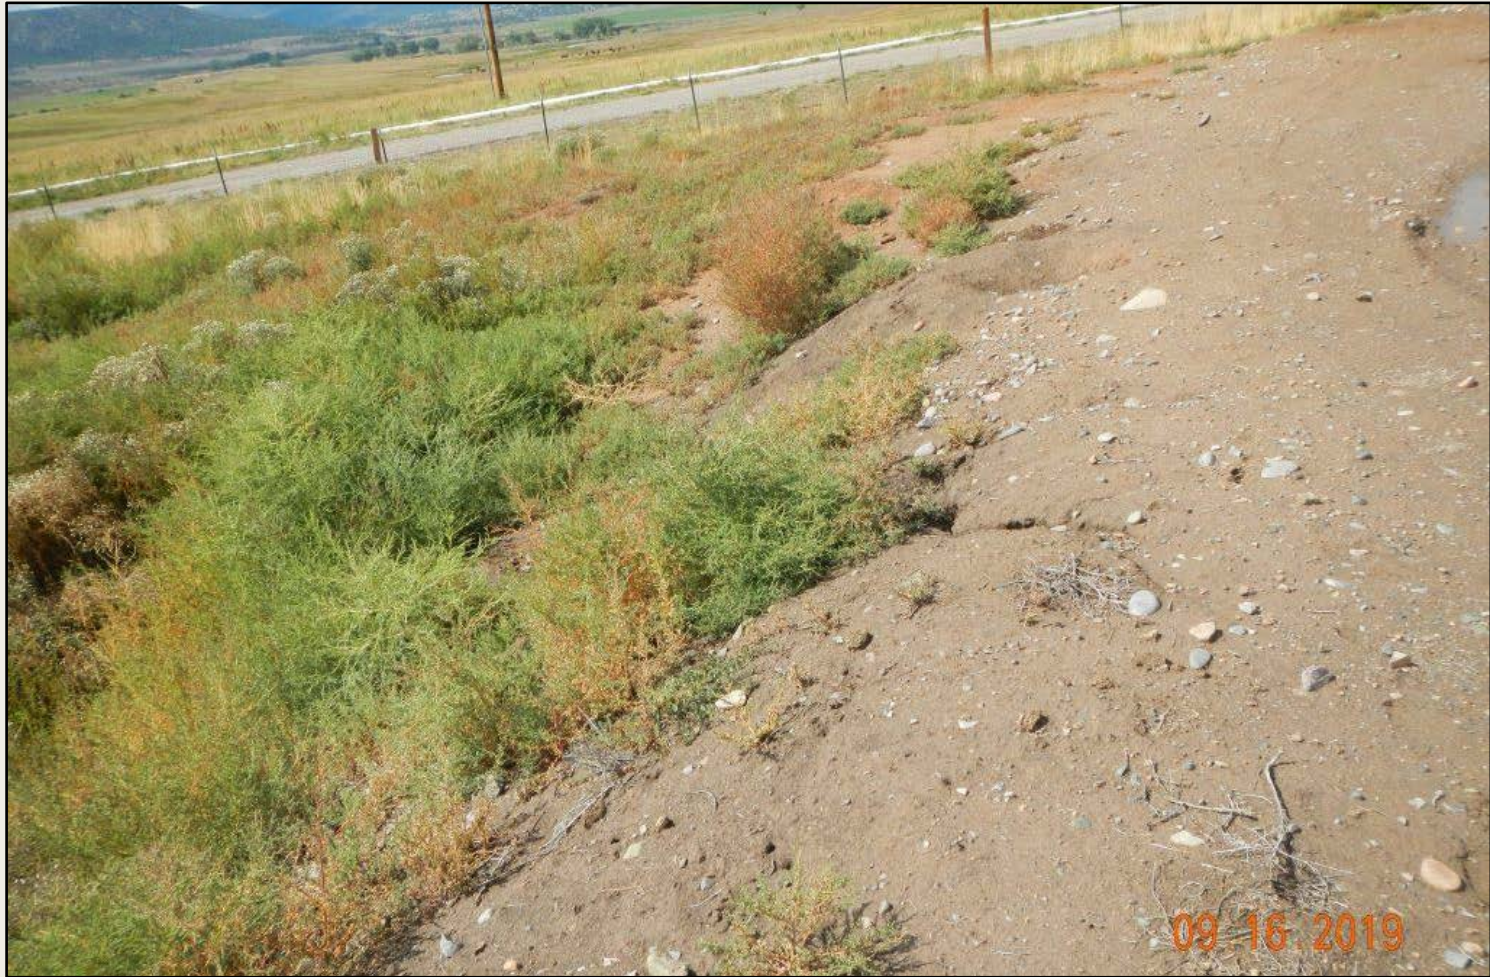
Photo 2. View of the southern fill slope facing westward. Slope is not stabilized as weedy kochia is preventing desirable vegetation establishment and bare soils are eroding.

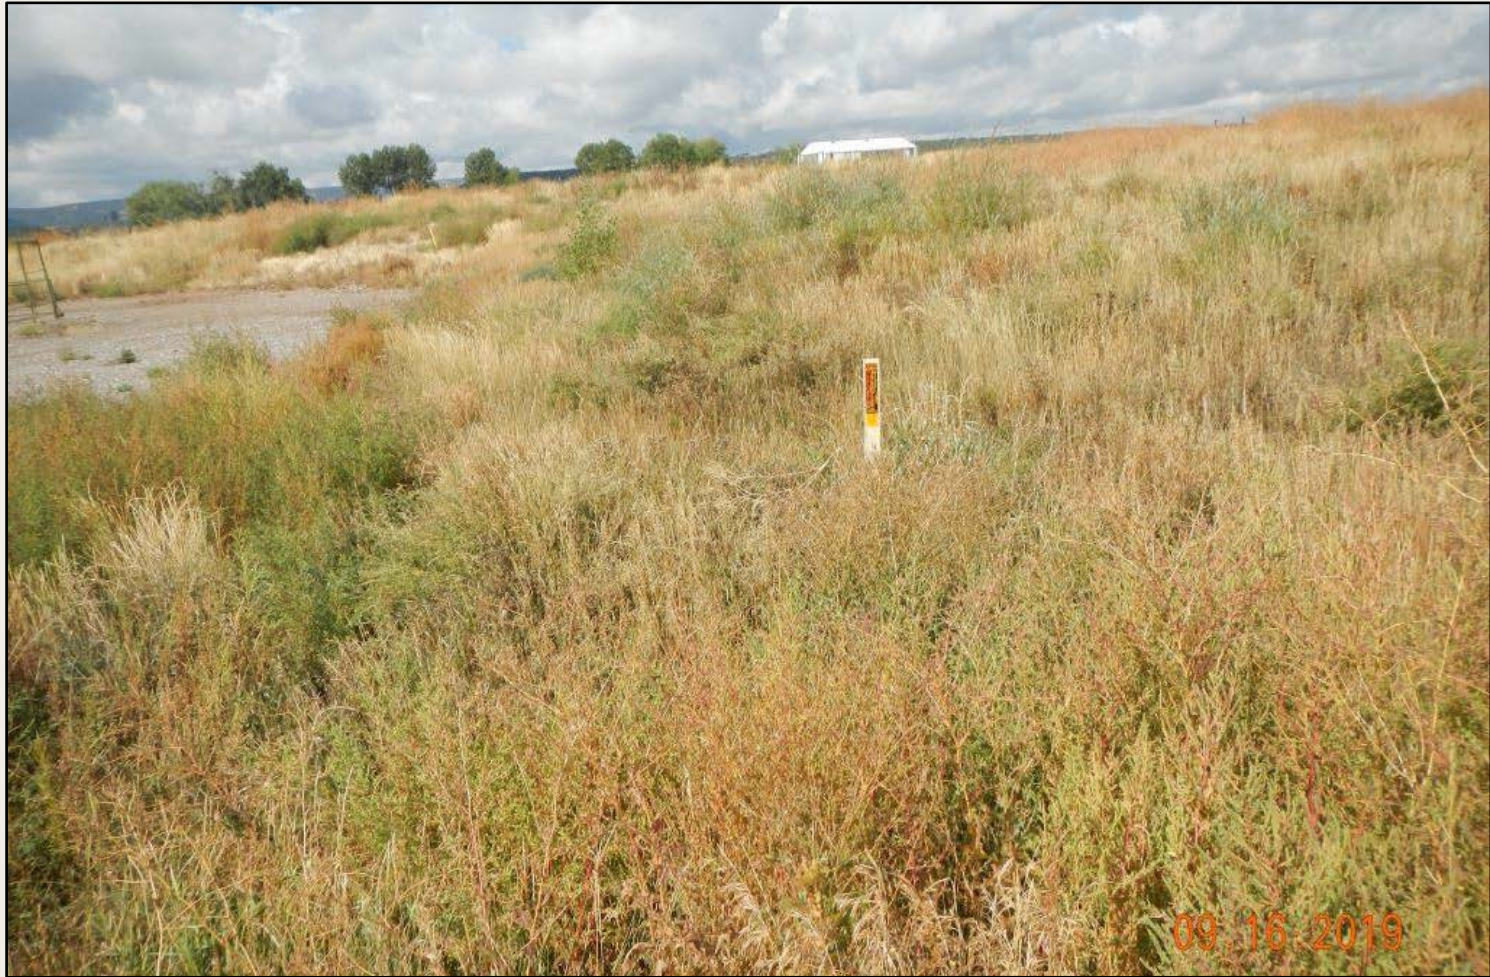
Photo 3. View of northern project area from the northeastern corner facing westward. Revegetation of perennial grasses such as smooth brome, is progressing within portions of the interim reclamation area; although dense kochia is threatening successful revegetation.

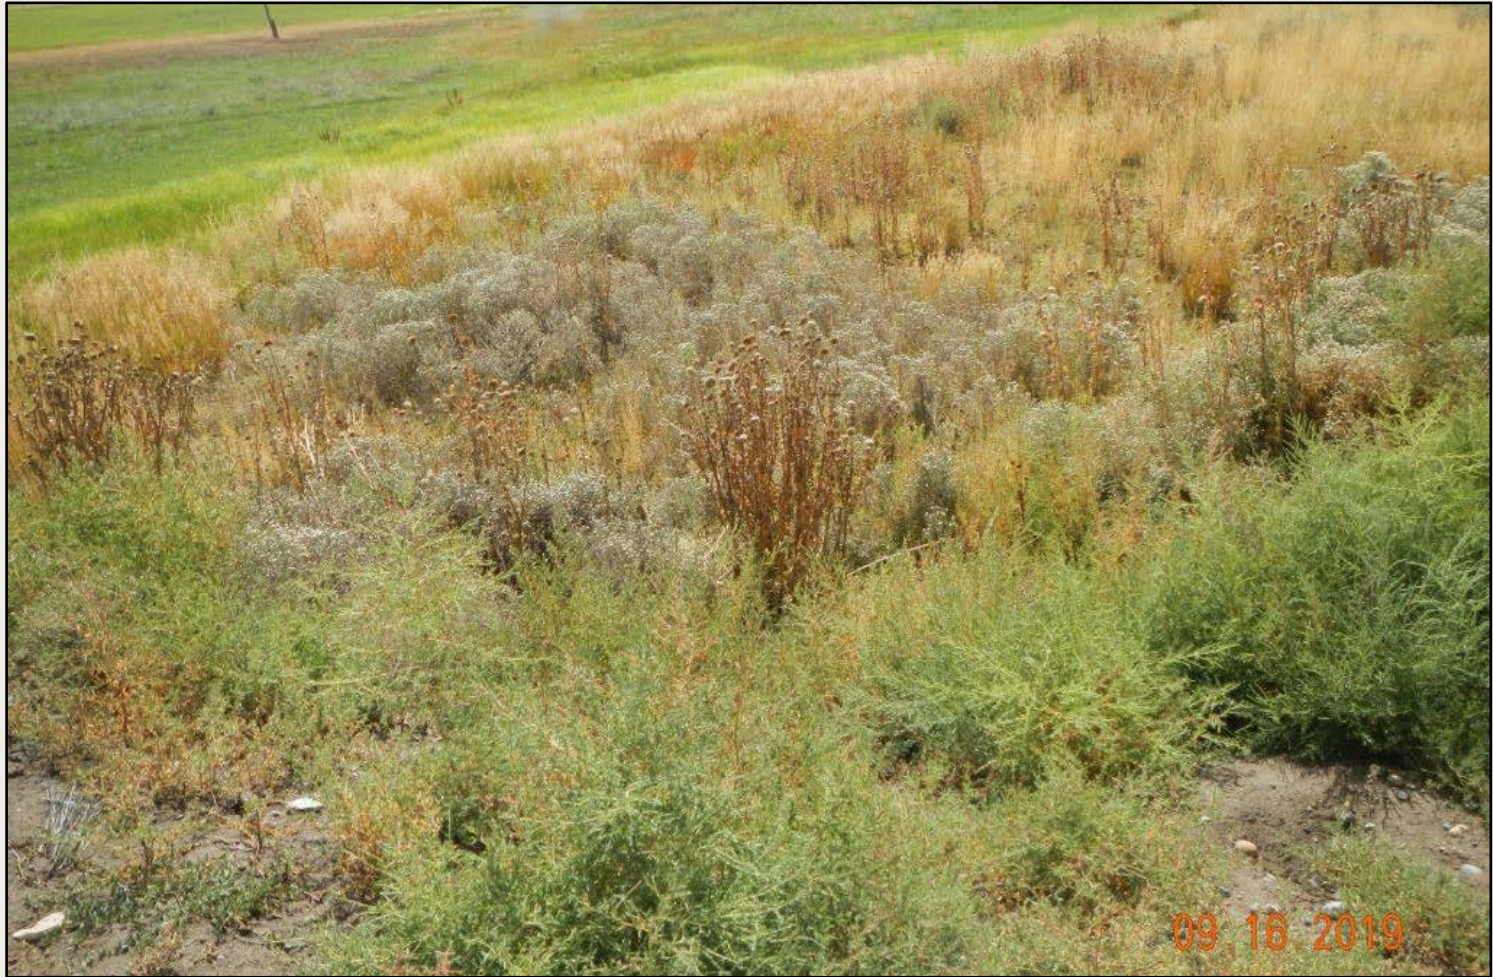
Photo 4. View of dense Canada and musk thistles within the southeastern project area.

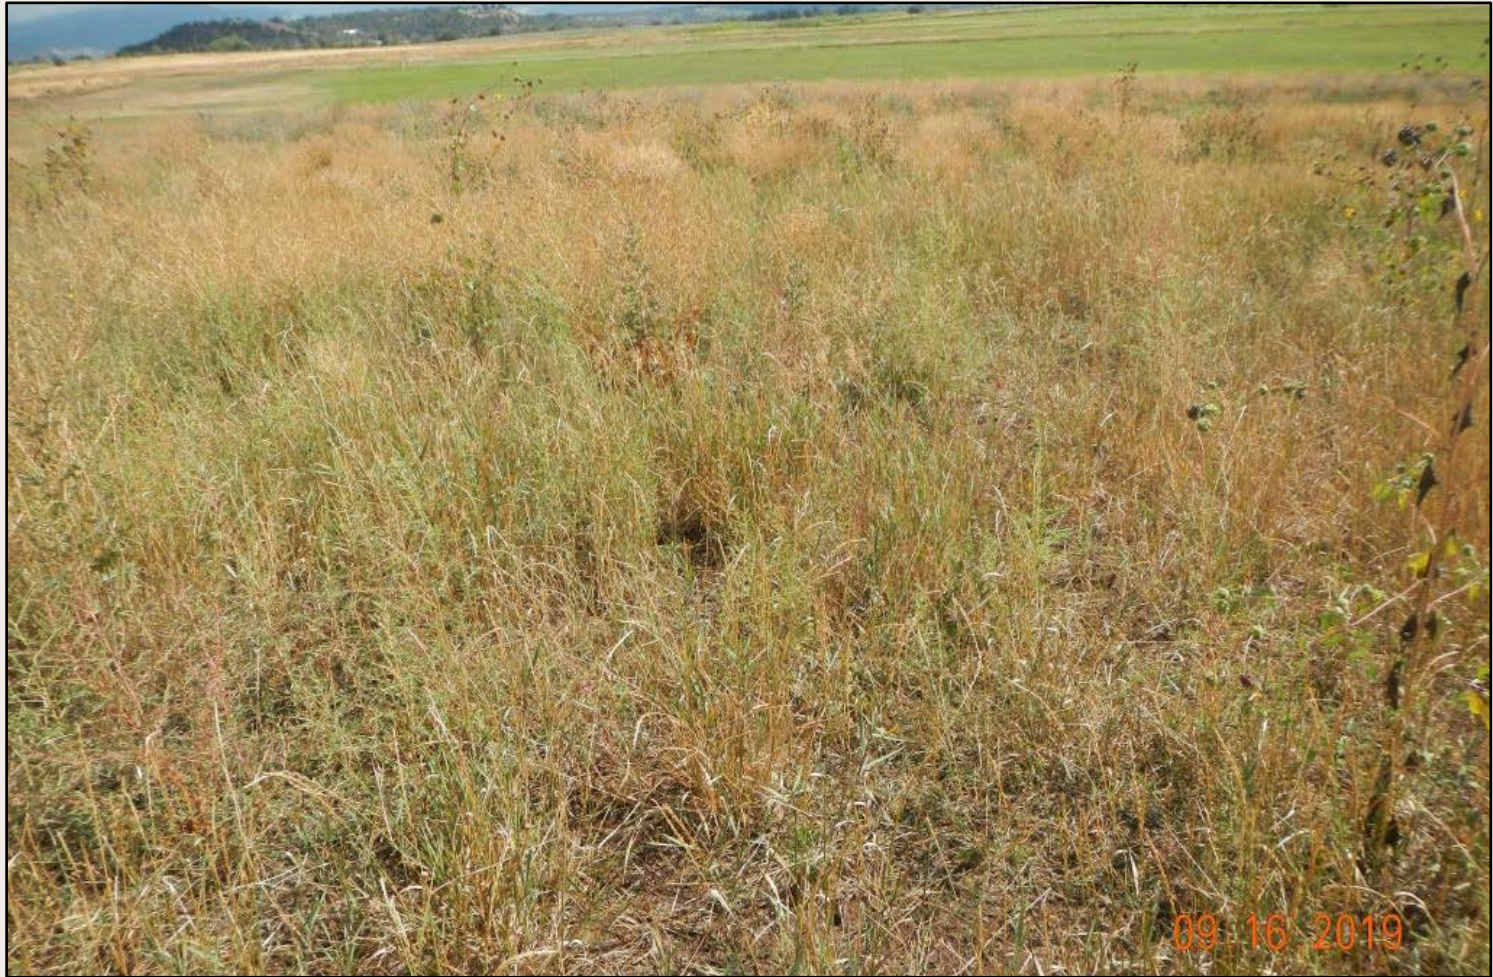
Photo 5. View of reference area vegetation, east of the project area, facing northward.
