Stormwater Inspection Report

Operator:	Laramie Energy, LLC
Project:	Horseshoe Canyon Project Area
Location:	Mesa 18-10E Pad
Date:	Monday, August 12, 2019
Weather:	Mostly Sunny, Light Wind, Hi 92°, Lo 55°

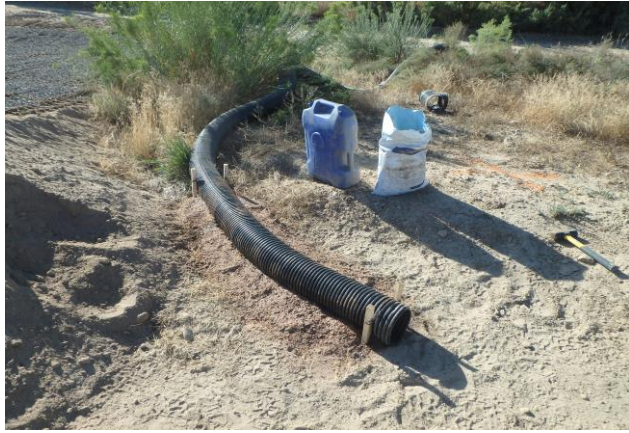
Photo 1

*Installing Flex Pipe Outlet***Photo 2**

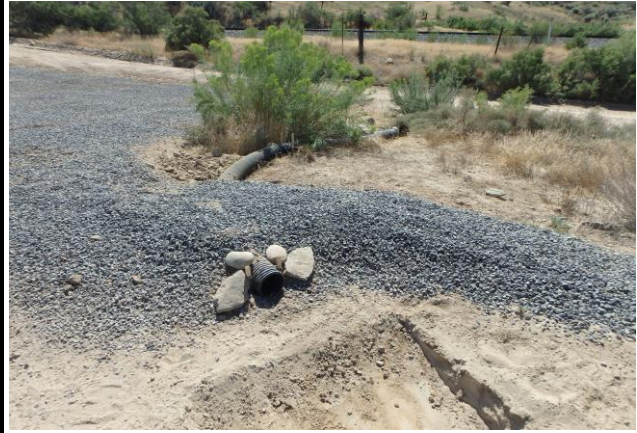
*Flex Pipe Outlet Installed***Photo 3**

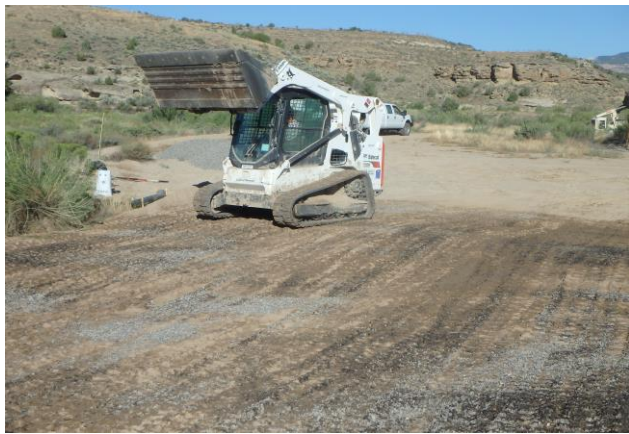
*Compacting Earthen Berm and Pad Entrance***Photo 4**

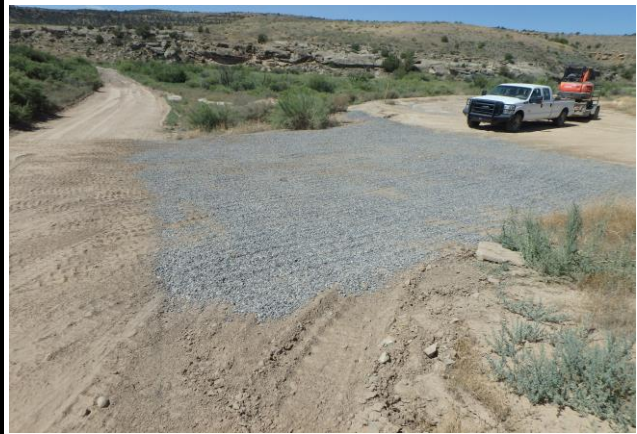
*Mesa 18-10E Pad Entrance Installed*
