Stormwater Inspection Report

Operator:	Laramie Energy, LLC
Project:	Horseshoe Canyon Project Area
Location:	Mesa 18-10E Pad
Date:	Tuesday, August 13, 2019
Weather:	Mostly Sunny, Light Wind, Hi 90°, Lo 53°

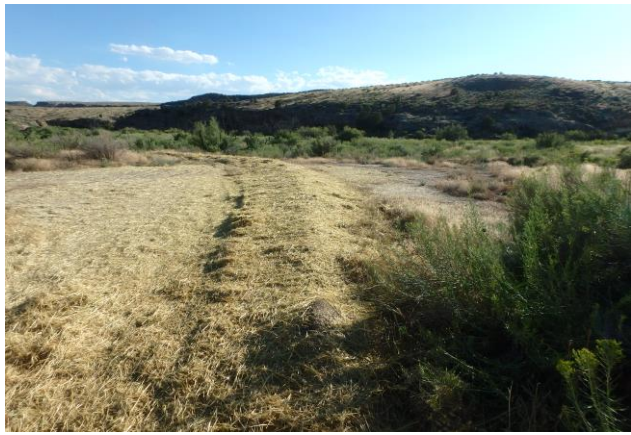
Photo 1

*West Side of Location***Photo 2**

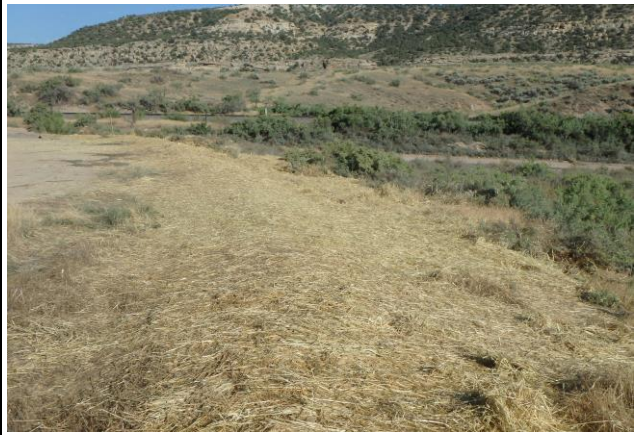
*South Side of Location***Photo 3**

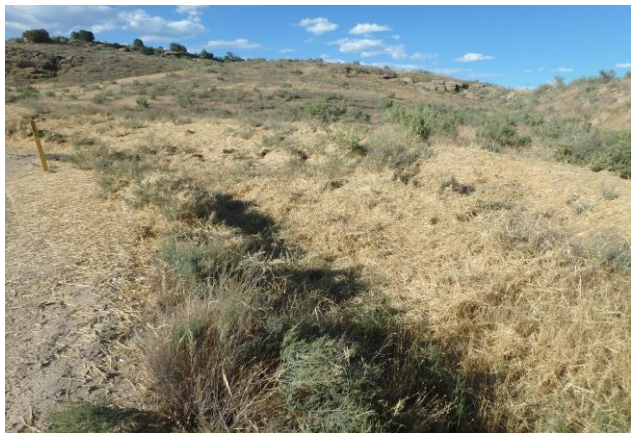
*East Side of Location***Photo 4**

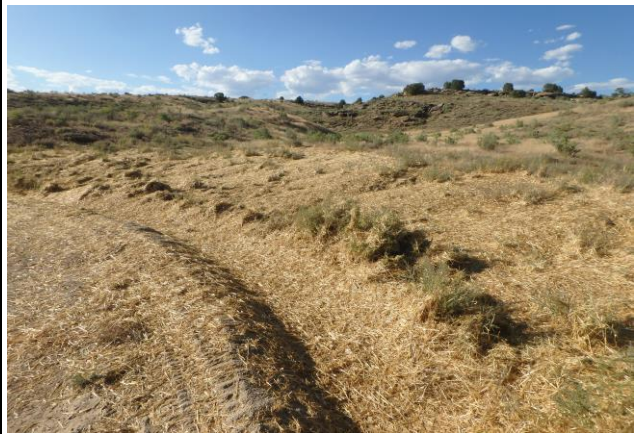
*North Side of Location*
