Inspection Photos

API: 05-071-09838

Operator: ARP PRODUCTION COMPANY
WAPITI OPERATING LLC

Inspection Date: 9/23/2019

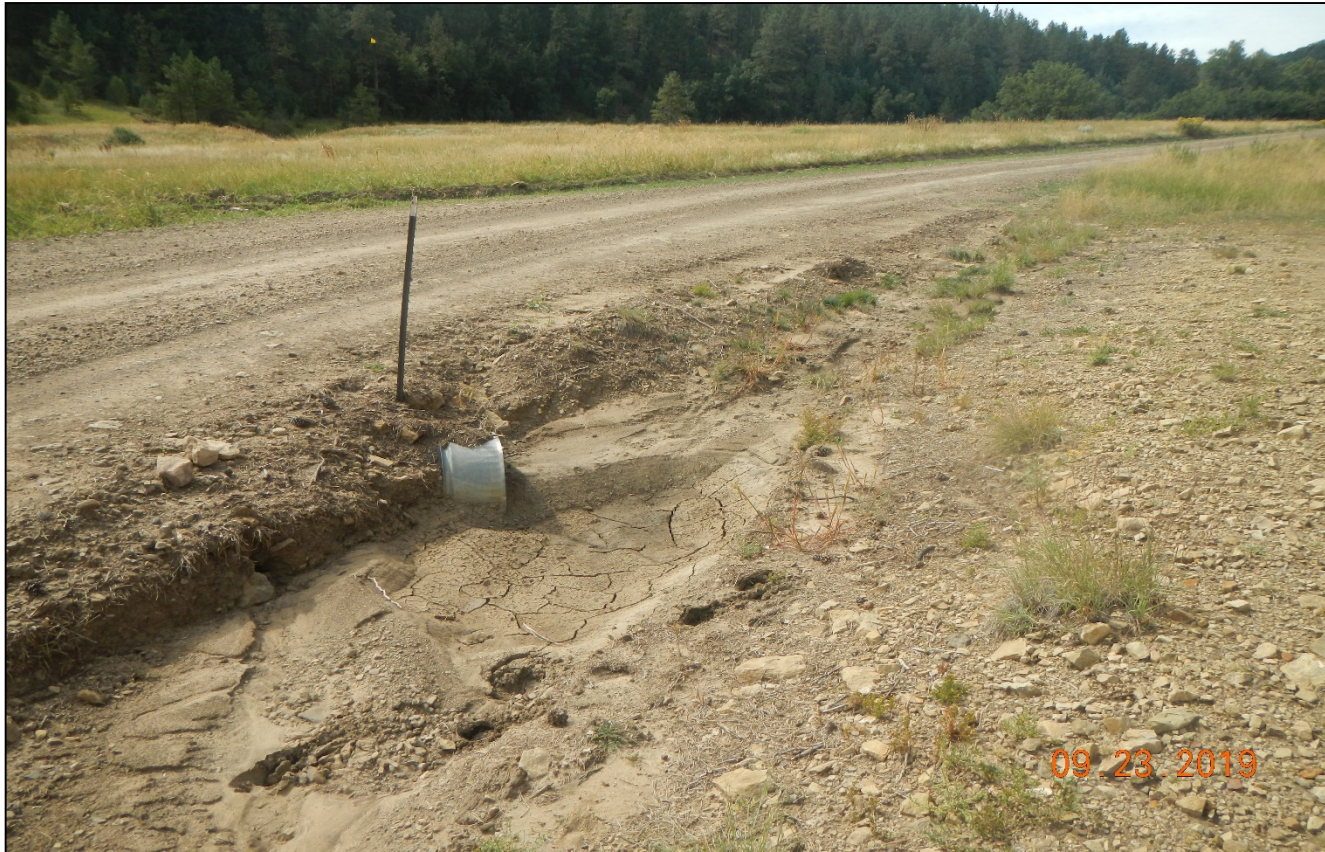
Photo 1. The culvert along the main road has partially filled in with sediment. It appears to have been cleaned out since the previous inspection but requires ongoing maintenance.

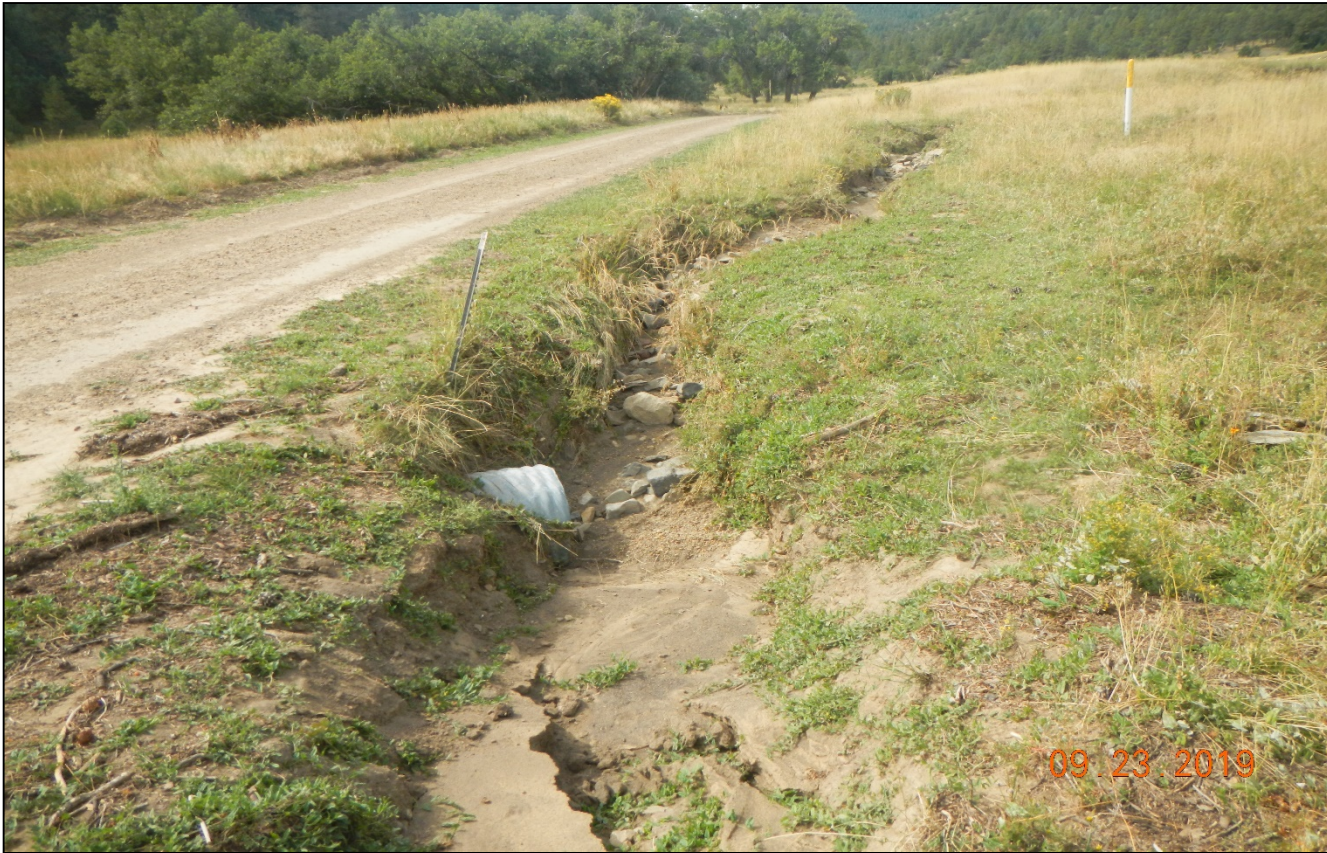
Photo 2. The culvert has been cleaned out from sediment buildup.
Lat/Long:37.02425,-104.82919

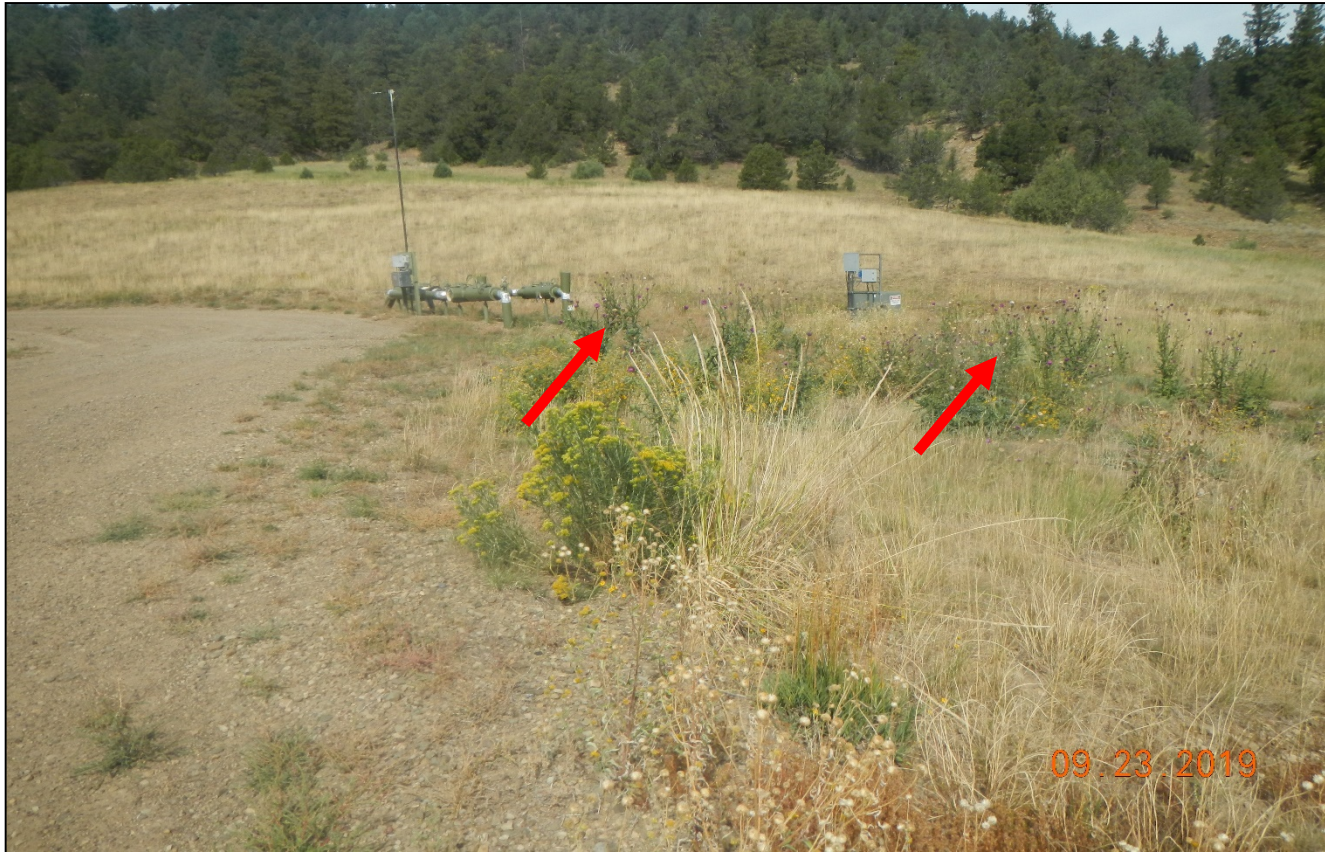
Photo 3. There is List B noxious weeds growing at the location. (Musk thistle shown in photo). Corrective action was not completed since previous inspection.

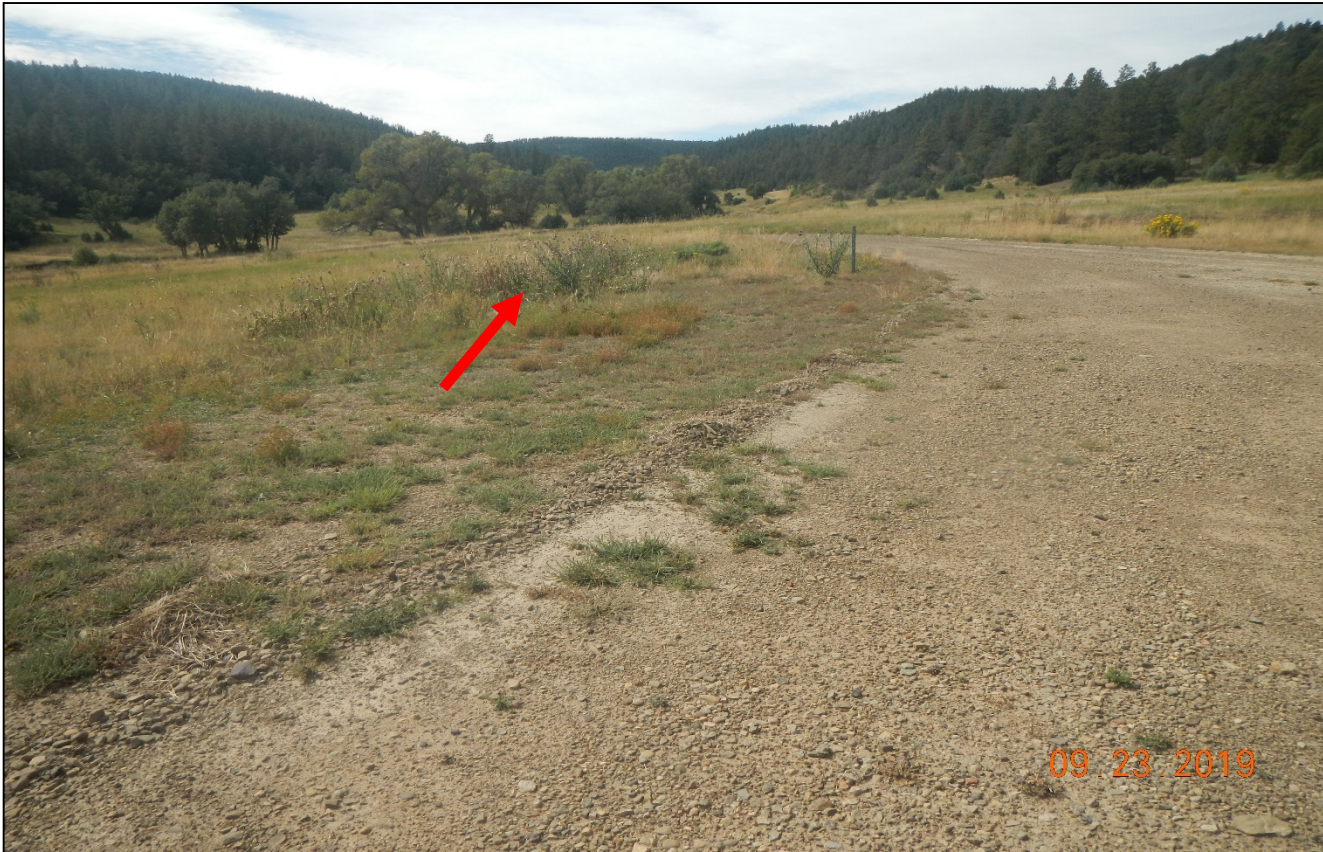
Photo 4. Noxious weeds have not been controlled at the location and have developed seed heads

Corrective action was not performed since previous inspection.

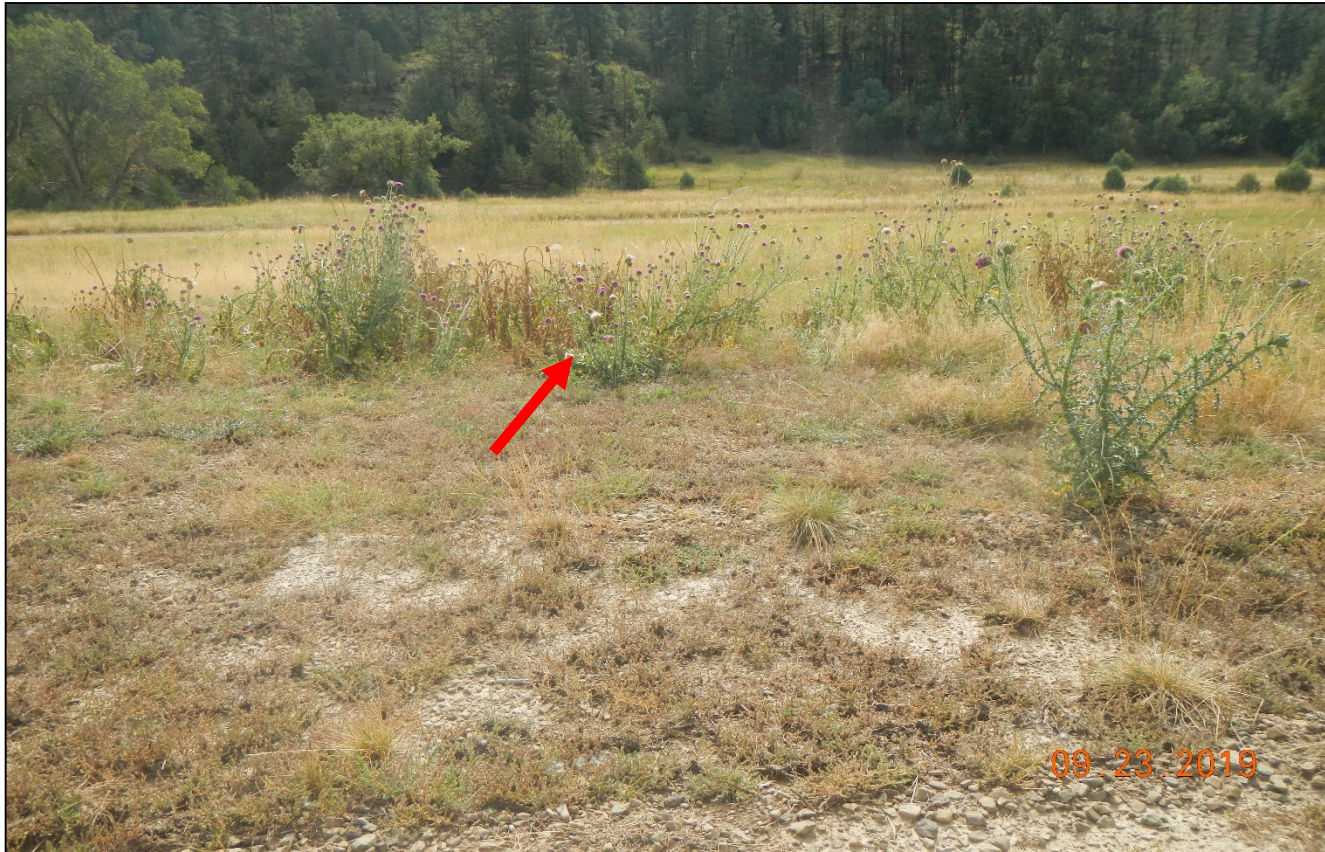
Photo 5. Noxious weeds have not been controlled at the location and have developed seed heads which are dispersing seed.
