# Inspection Photos

API: 05-071-09061

Operator: ARP PRODUCTION COMPANY

Inspection Date: 9/23/2019

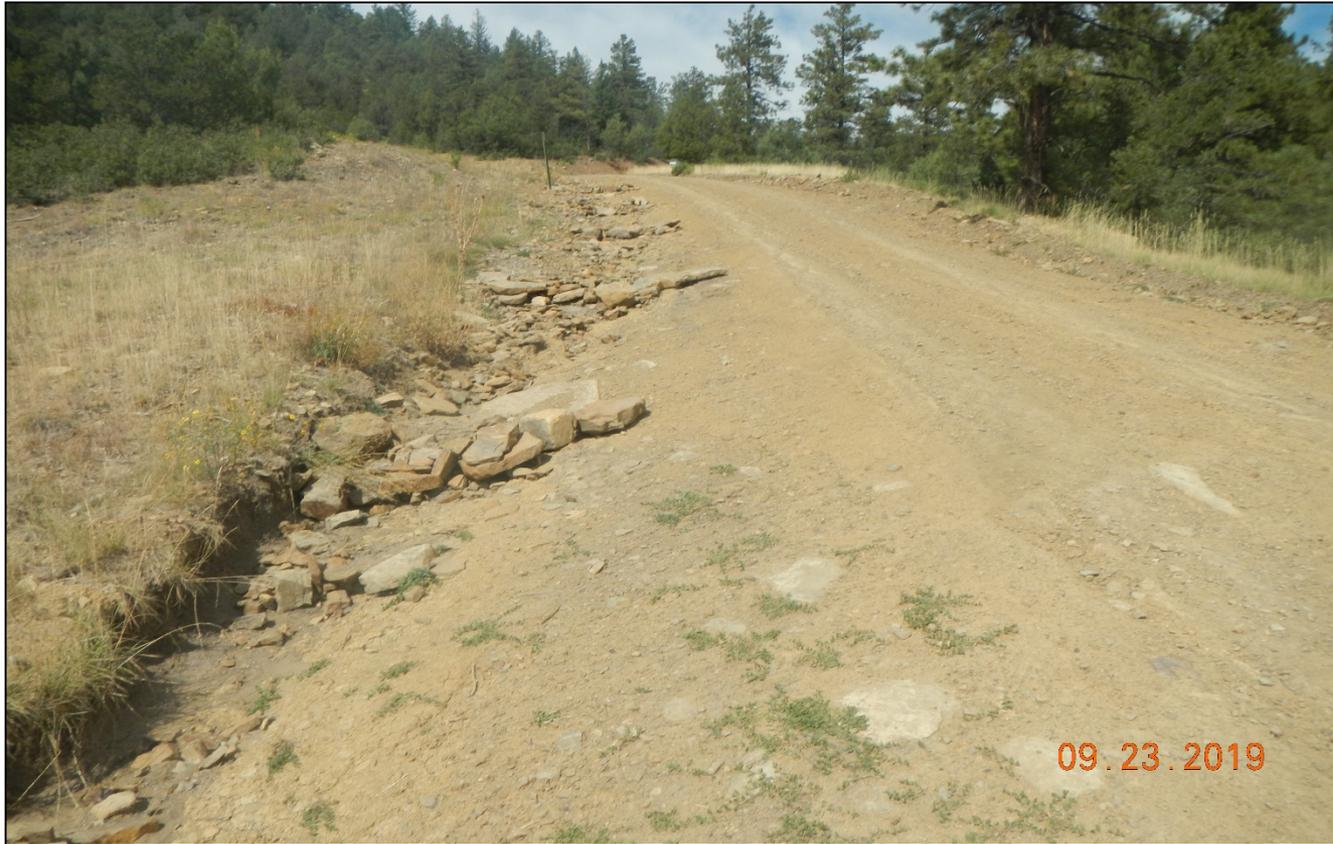
**Photo 1.** Facing toward the location. Red arrow points to erosion issues that have not been repaired.

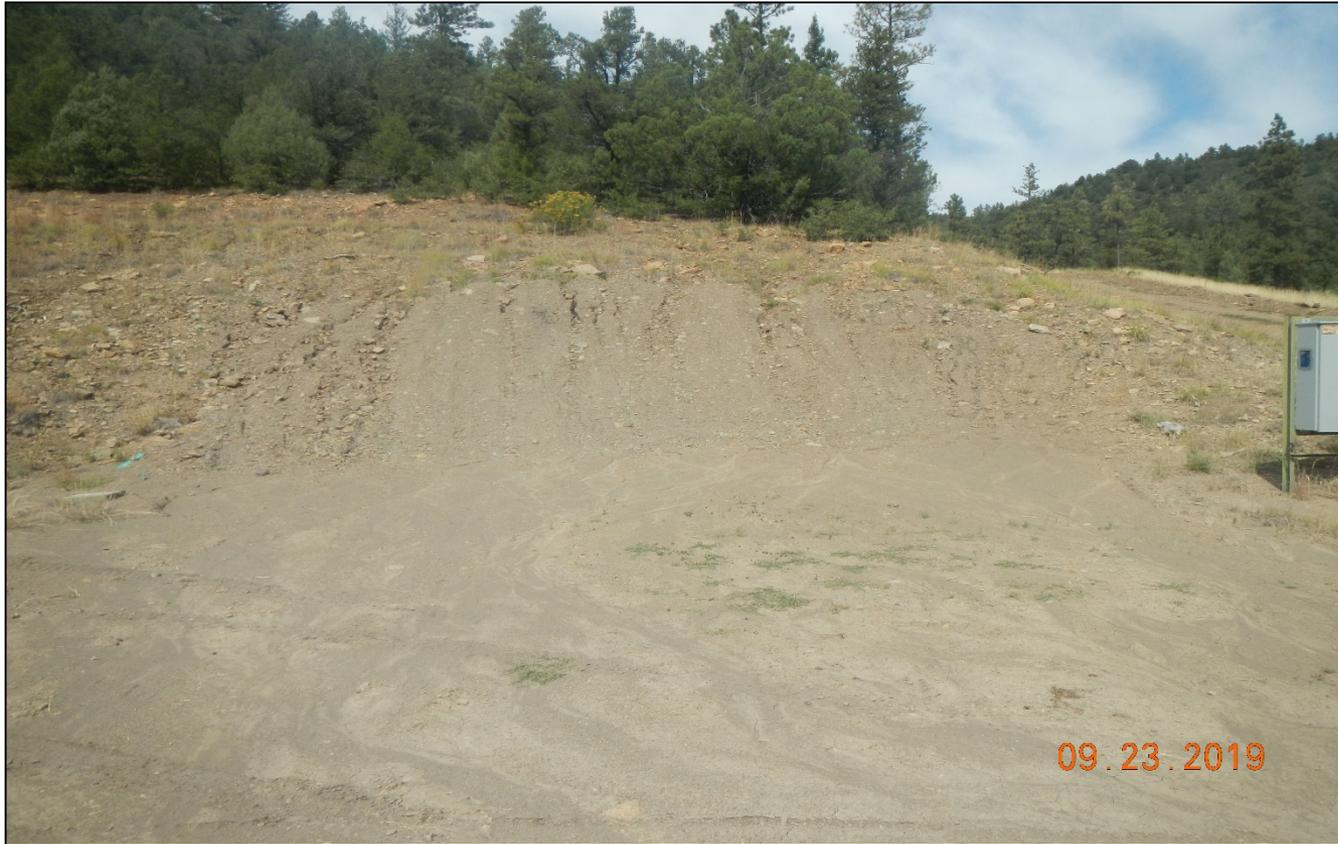
**Photo 2.** Facing toward the location. Red arrow points to erosion issues that have not been repaired.

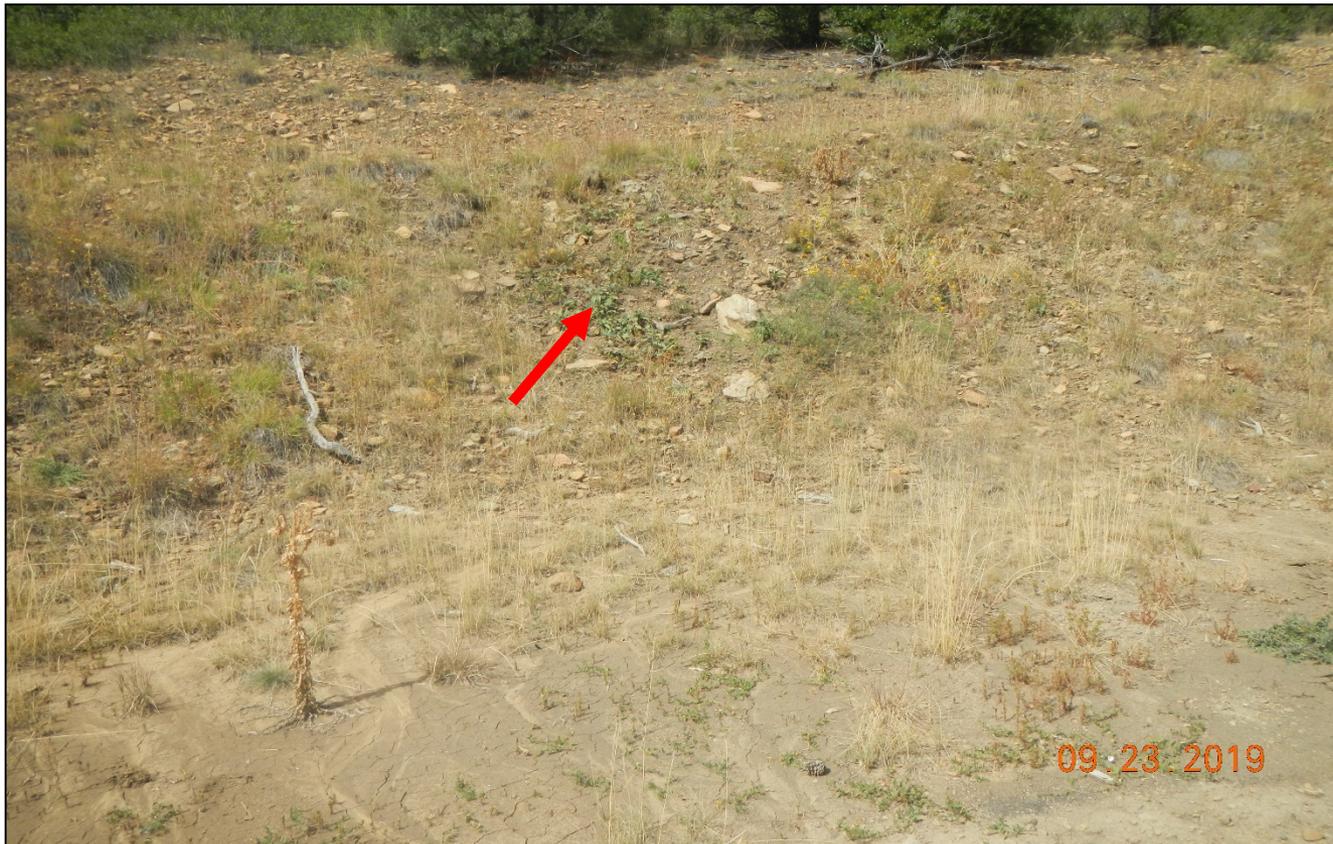
**Photo 3.** There is List B noxious weeds growing along the cut slope. (Hounds tongue shown in photo)

Corrective action was not completed since previous inspection.

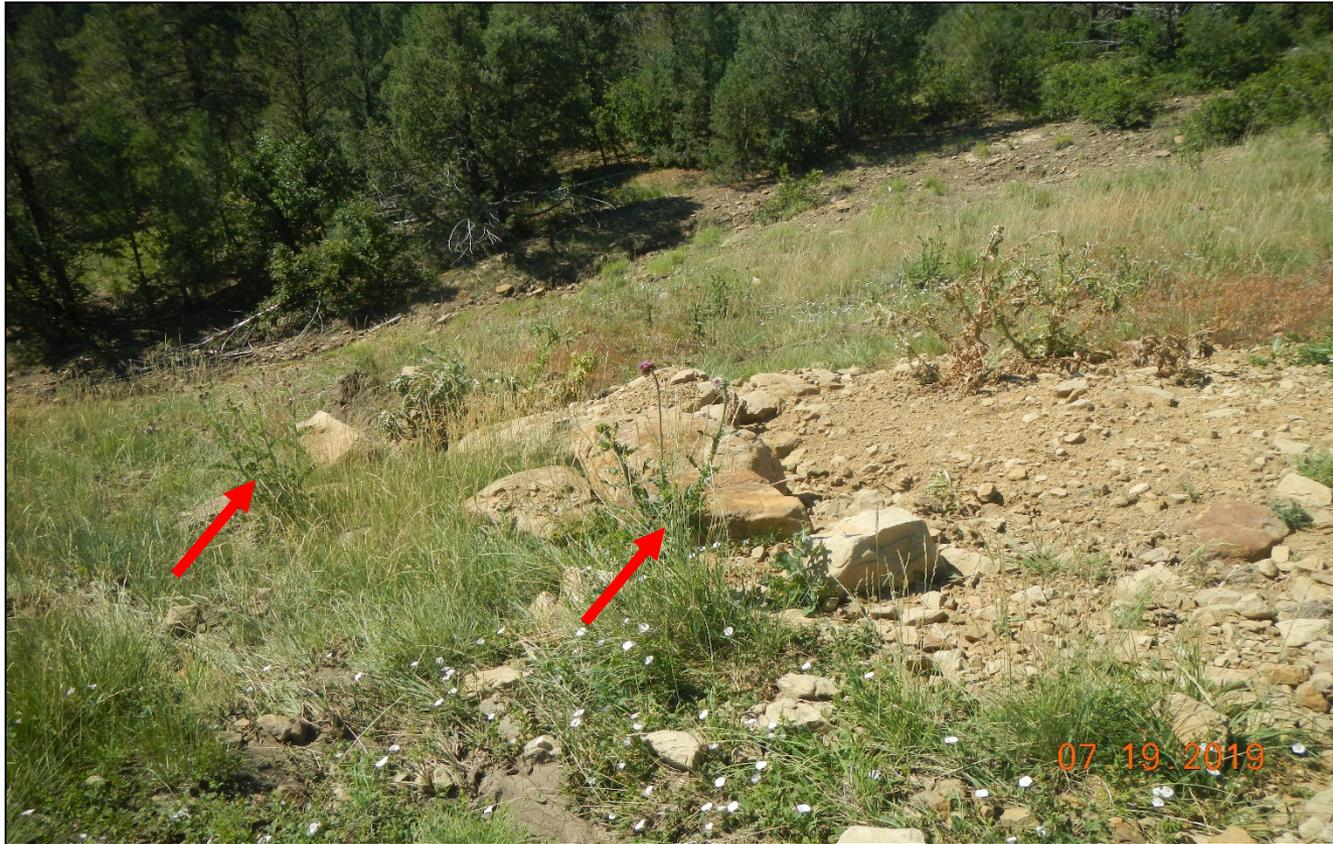
**Photo 4.** There is List B noxious weeds growing along the cut slope. (Musk thistle shown in photo)

Corrective action was not completed since previous inspection.
