## Stormwater Inspection Report

<b>Operator:</b>	Laramie Energy, LLC
<b>Project:</b>	Collbran Project Area
<b>Location:</b>	Gunderson 18-5 / Gipp 13-9
<b>Date:</b>	Tuesday, July 30, 2019
<b>Weather:</b>	Thunderstorms, Moderate Winds, High 84° Lo 56°

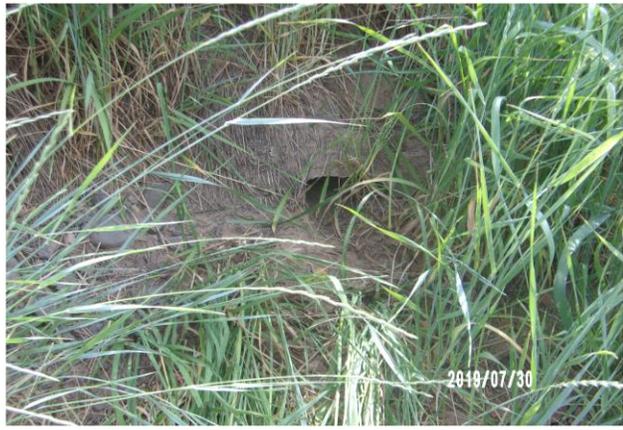
**Photo 1**

*Culvert Outlet on the Gunderson 18-5 Access Road*

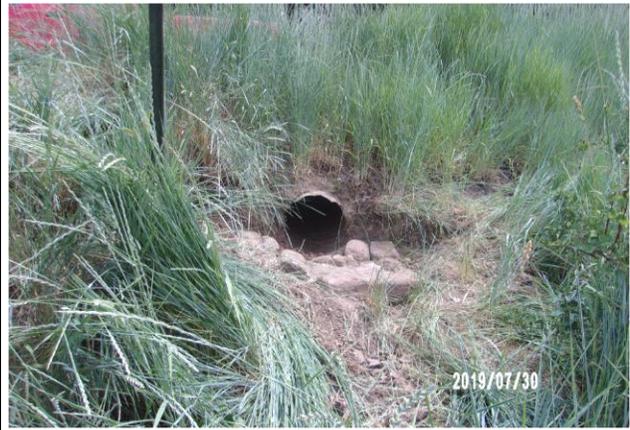
**Photo 2**

*Culvert Outlet Maintained on the Gunderson 18-5 Access Road*

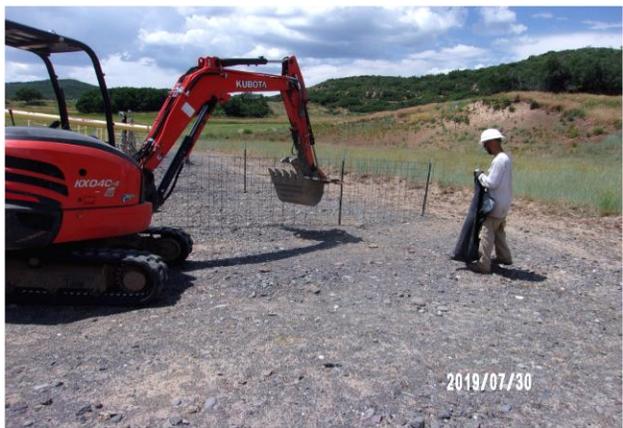
**Photo 3**

*Corrective Actions on the Gipp 13-9 Pad*

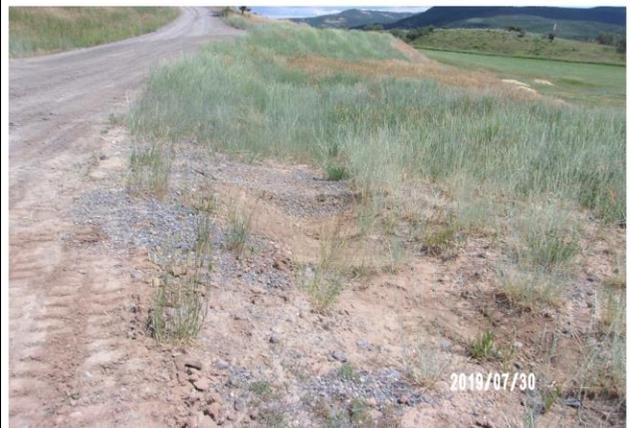
**Photo 4**

*Corrective Actions on the Gipp 13-9 Pad*
