Inspection Photos  
Location Name: IRELAND 14-32 TR  
API#: 05-071-09384  
INSP. #: 695101418

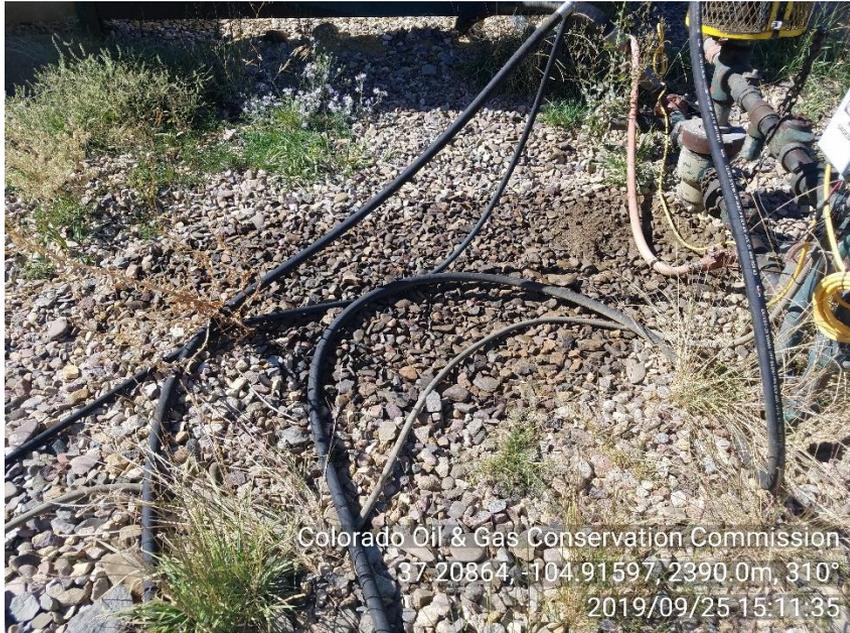
**PHOTO 3: AREA OF STAINED SOIL APPEARS TO BE FROM HYDRAULIC HOSES OR DRIVEHEAD FITTING. "Properly treat or dispose of oily waste in accordance with 907.e." CA DATE 10-25-19**
