**Inspection Photos**  
**Location Name: Champlin 117 AMOCO 1#2**  
**Location ID: 320151**

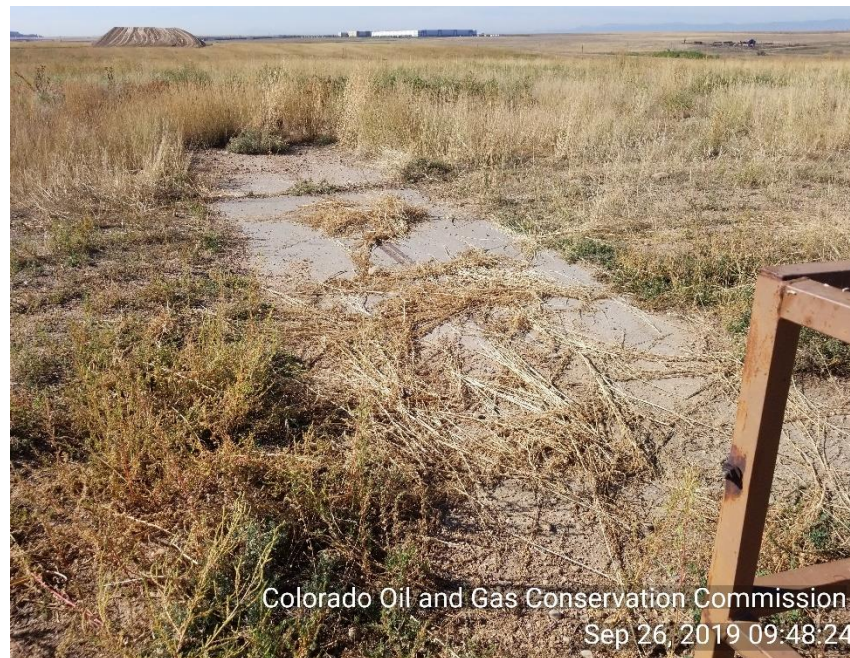
**Photo 2 Unused equipment PU base and weeds on locatin**

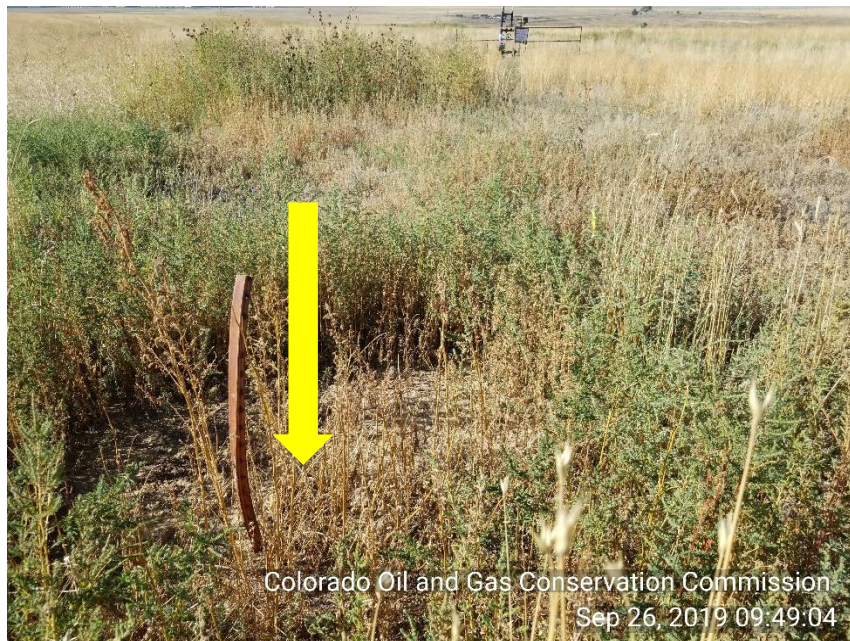
**Photo 3 Guy line anchor not properly marked and weeds on location**

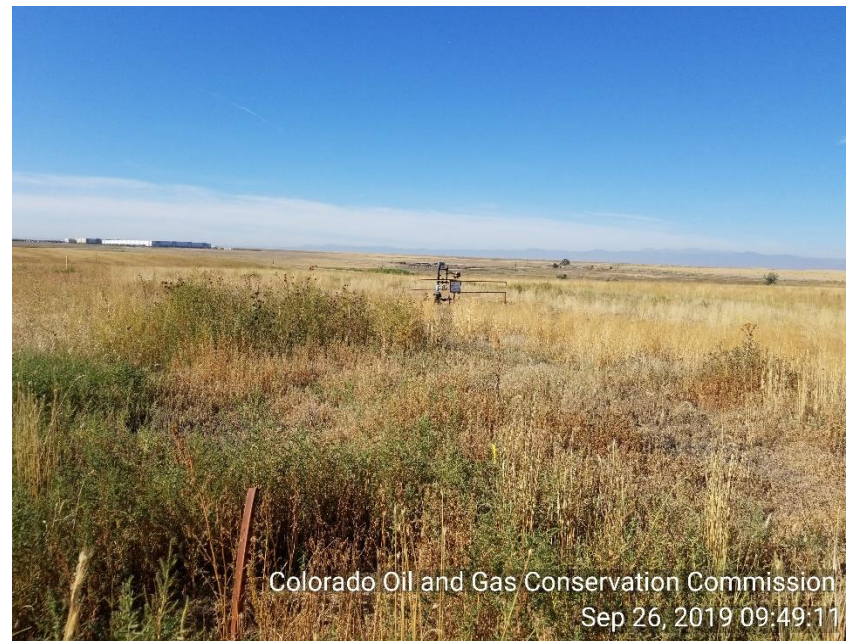
**Photo 4 Weeds on entire location.**
