Inspection Photos

09/27/2019

Operator: OILFIELD SALVAGE & SERVICE CO -
65550

Location ID: 311709
Adams County, CO

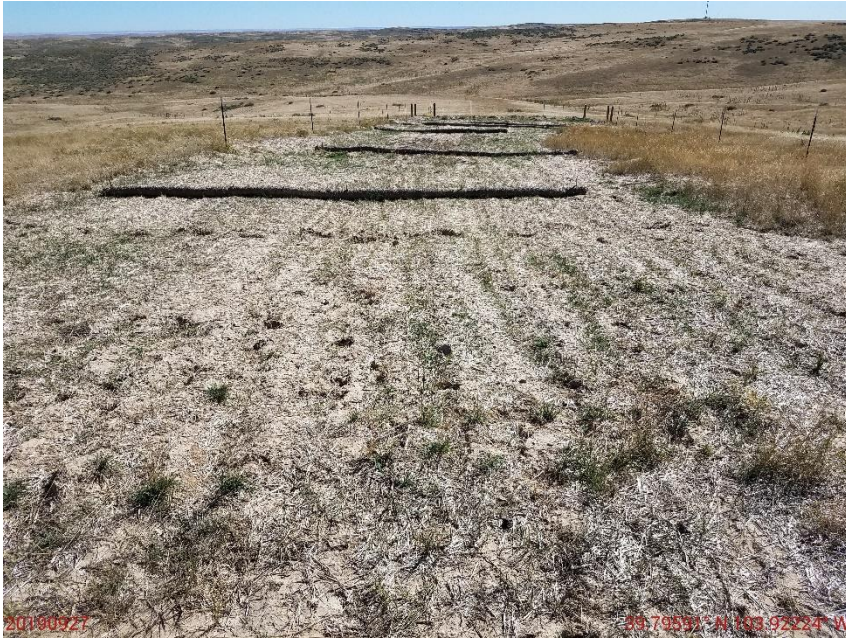
Photo 1: Photo taken from the north end of the location, facing south. Photo shows additional reclamation appears to have been conducted, however, operator has seeded up the slope rather than along the contour. Seeding actives have not been conducted in accordance with good engineering practices and will likely facilitate erosion degradation.

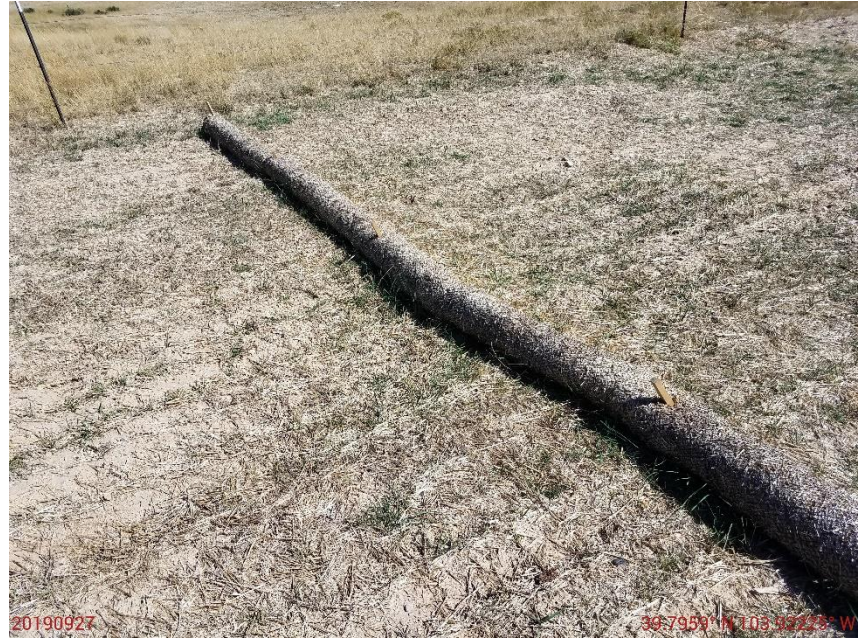
Photo 2: Photo shows wattles on location have not been properly staked/trenched/backfilled in accordance with good engineering practices. BMP is not in proper functioning condition.

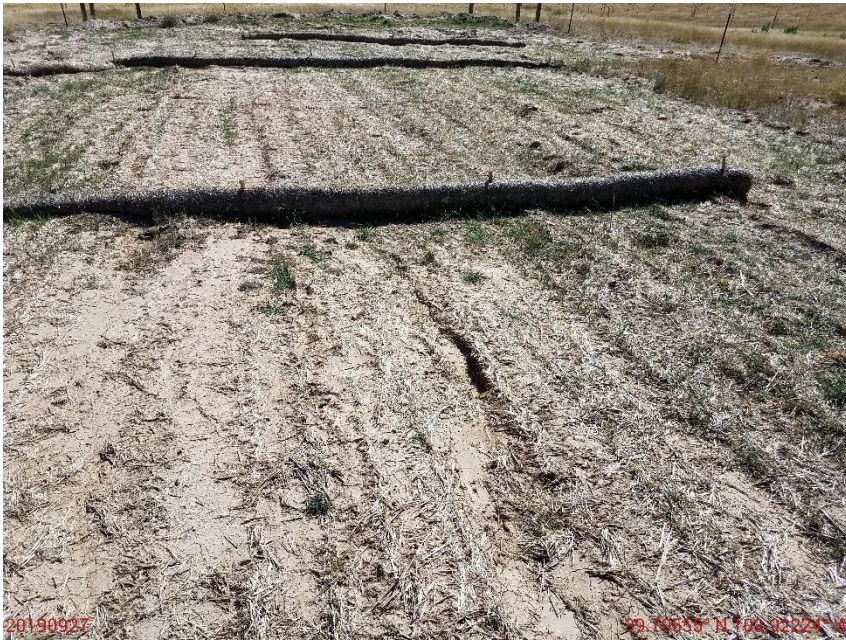
Photo 3: See comments under photo 2.

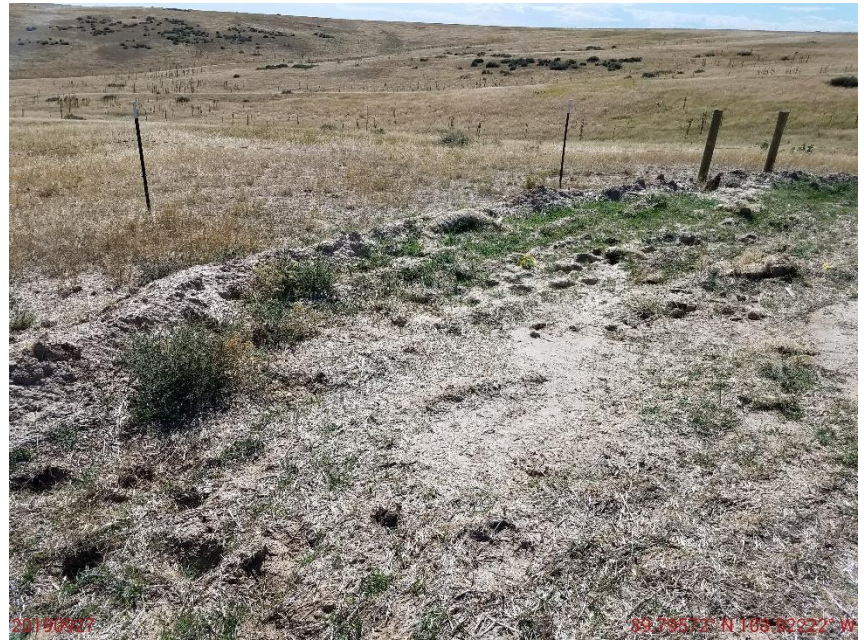
Photo 4: Photo taken from the south end of the location. Photo shows operator has installed a berm. Berm remains loose and unconsolidated material. BMP has not been installed in accordance with good engineering practices.

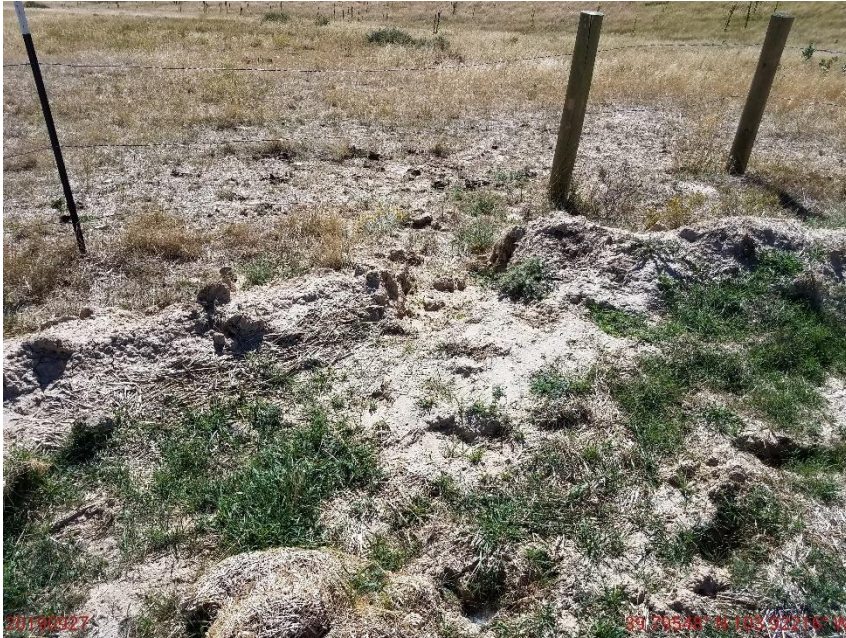
Photo 5: Contined from photo 4. Photo shows area of the berm that has been “blown-out”. BMP is not in proper functioning condition.

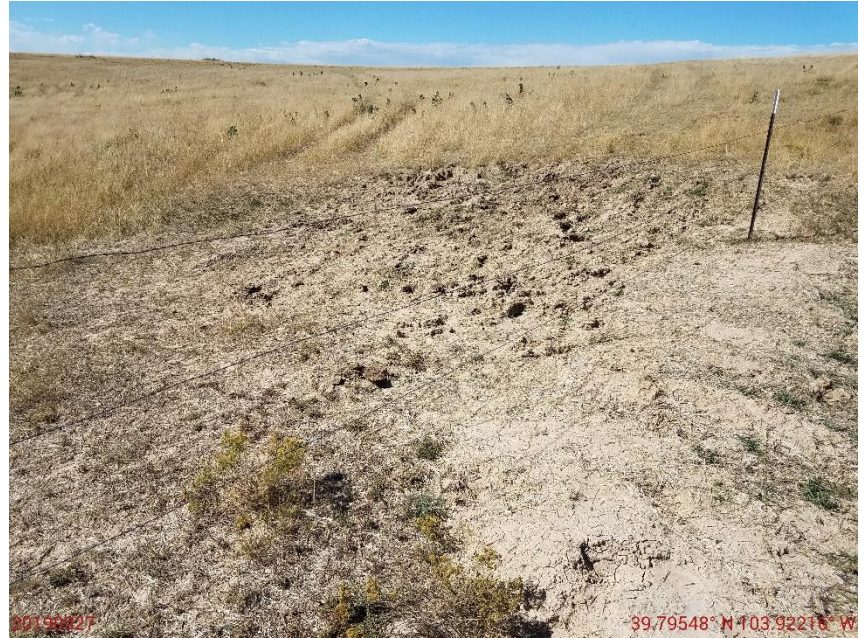
Photo 6: Photo taken from the south end of the location, facing west. Photo shows areas to the west of the location where stormwater runoff from location deposited sediment. It does not appear as though these areas have had additional reclamation activities conducted, or BMPs installed.
