# *Inspection Photos*

*Loc#430698*

*Operator: Maralex*

*Inspection: #692401383*

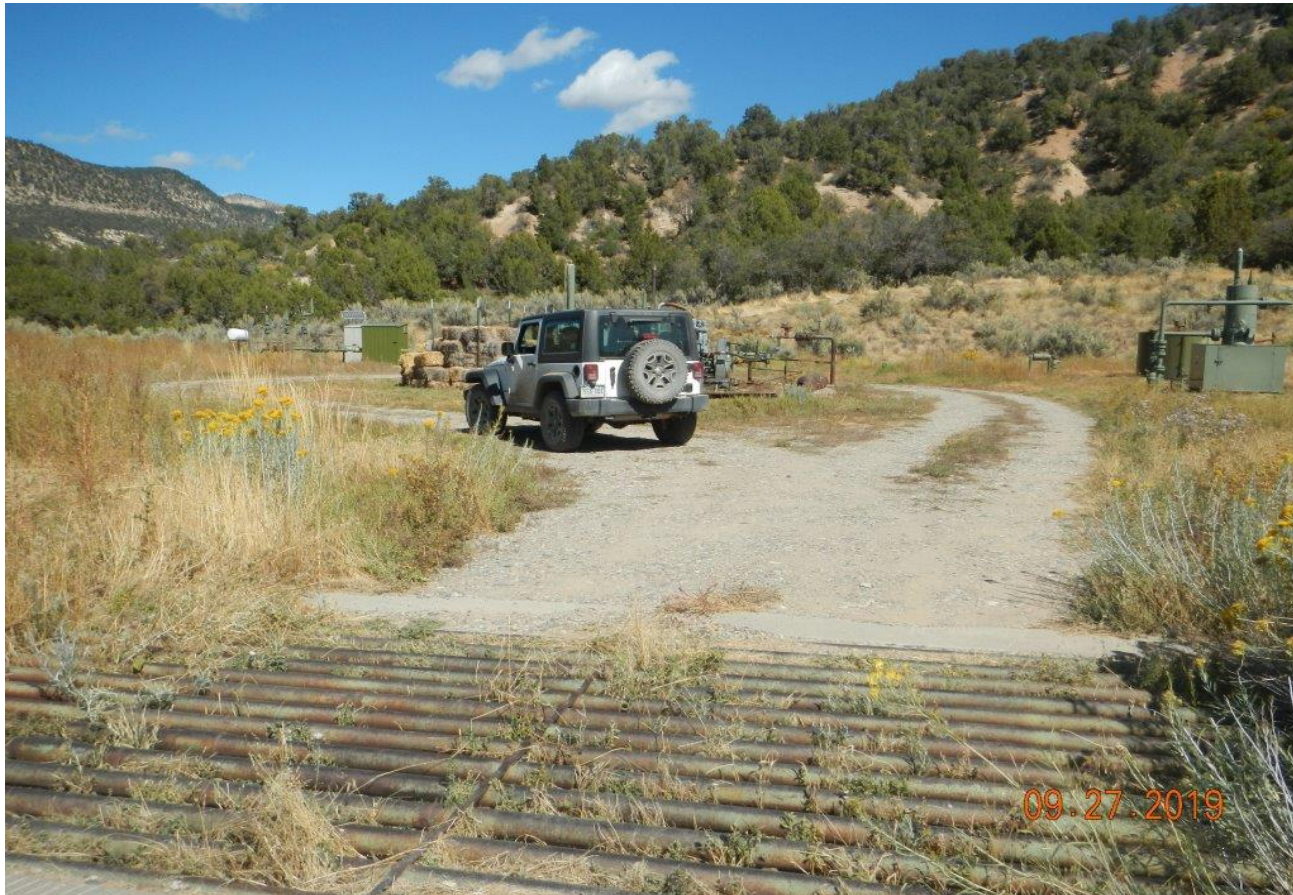
Photo#1:  
Overview of Location from entry to North.

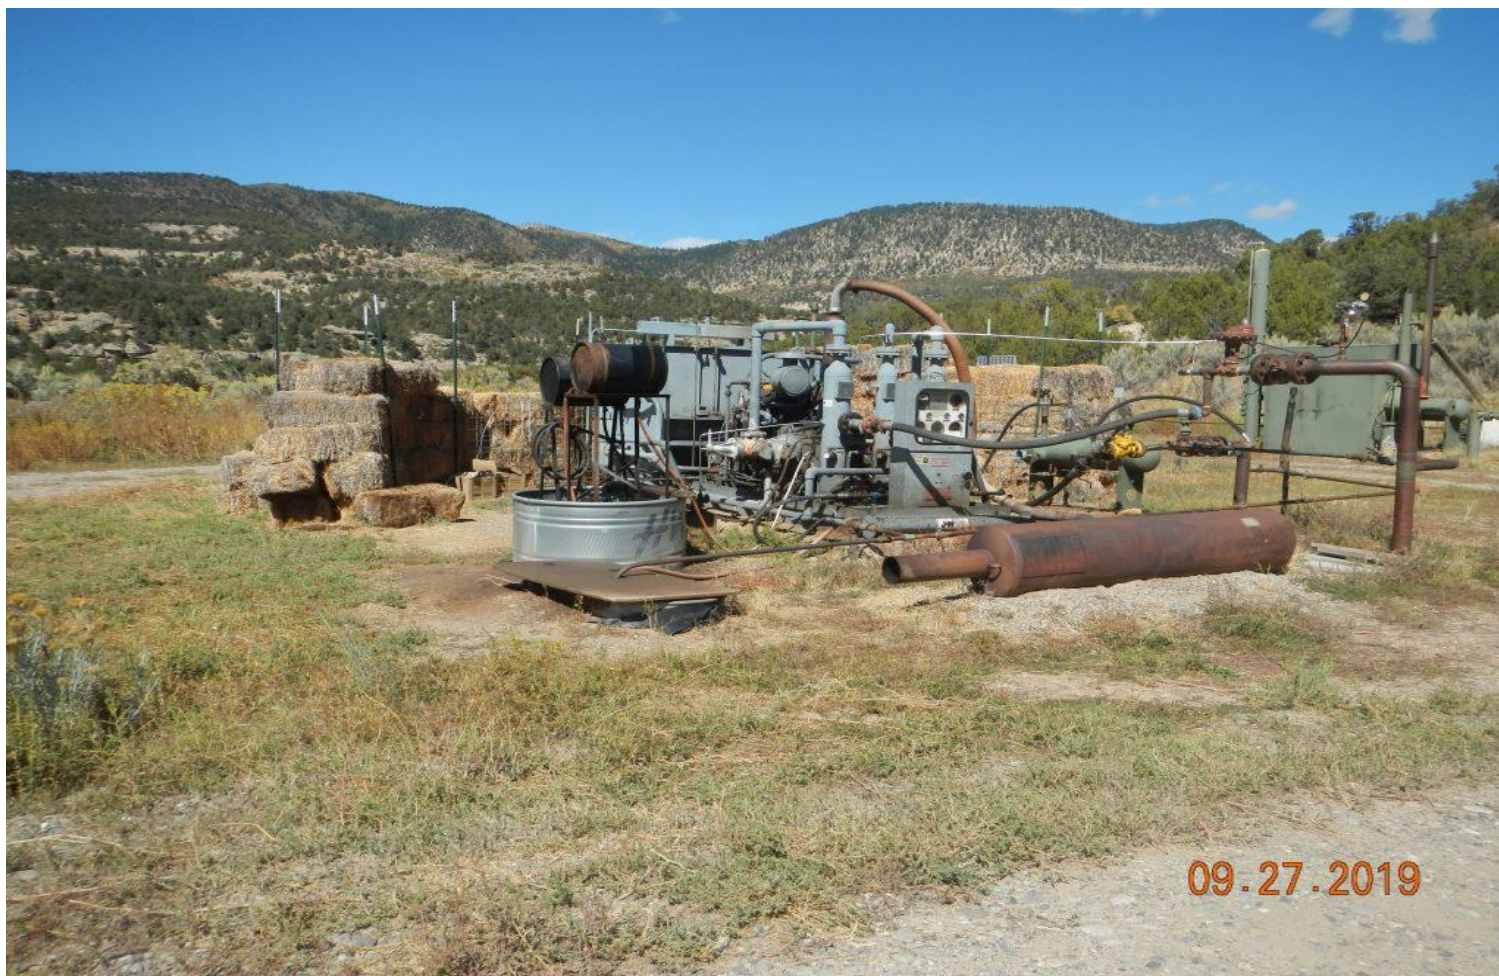
Photo#2:  
View of Compressor & Sound Wall area.

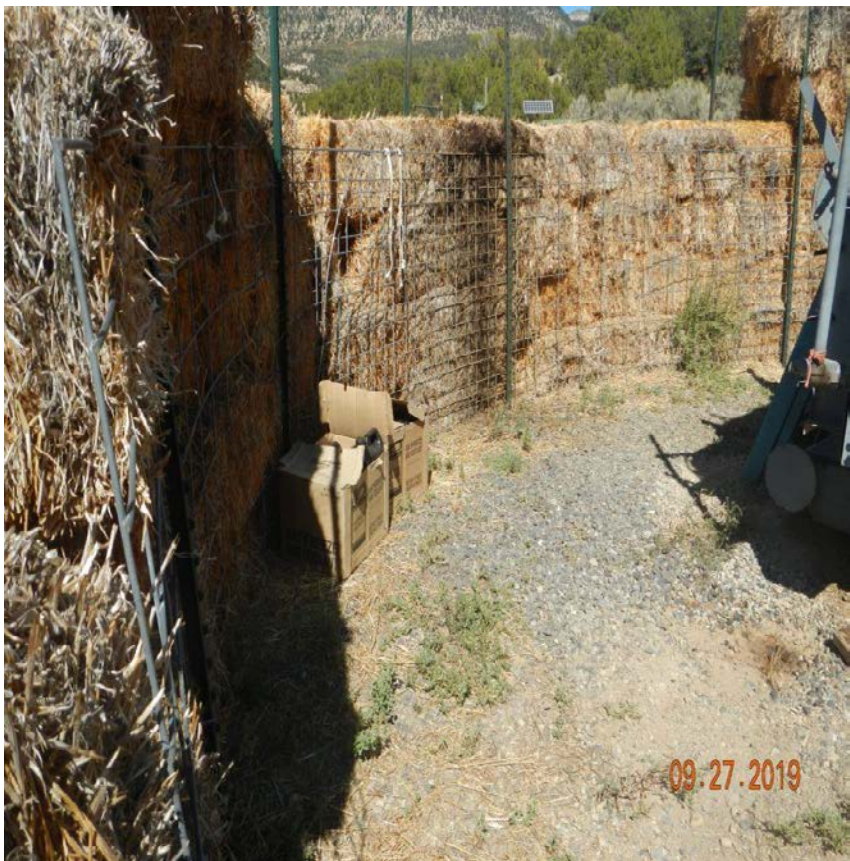
Photo#3:  
View inside sound wall in back of compressor.

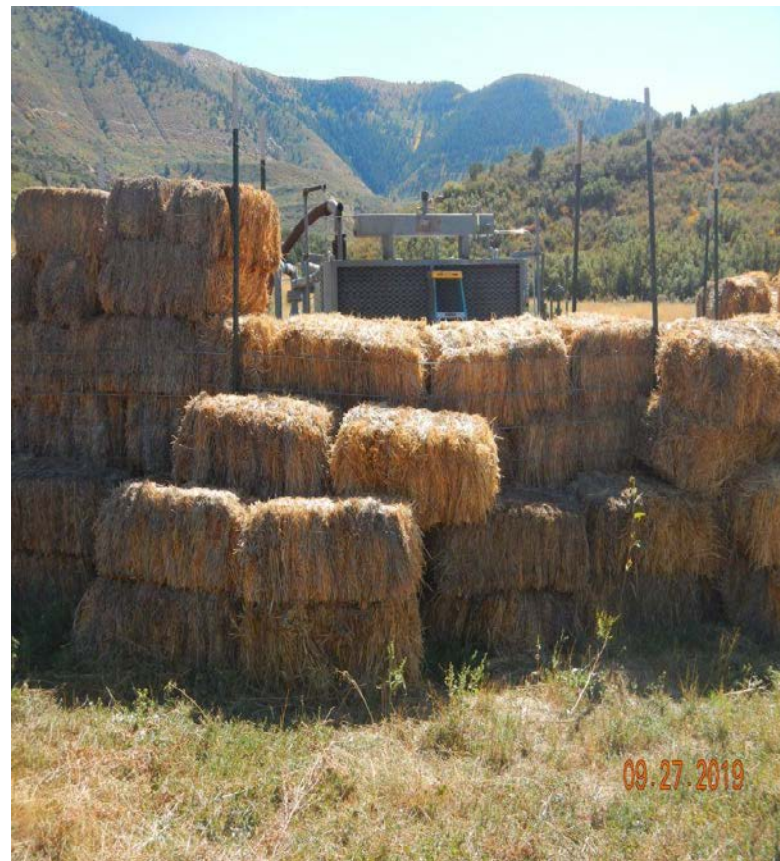
Photo#4:  
View outside of sound wall; top layer of bales not in place.

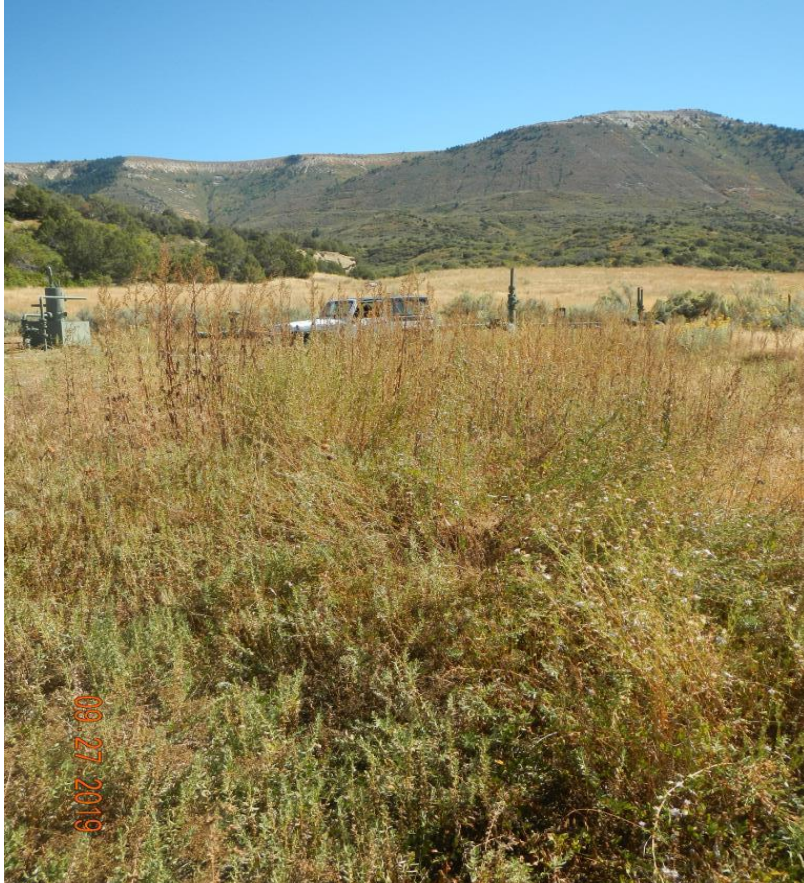
**Photo#5:**  
Majority of Vegetation within Interim Reclamation areas are weedy species

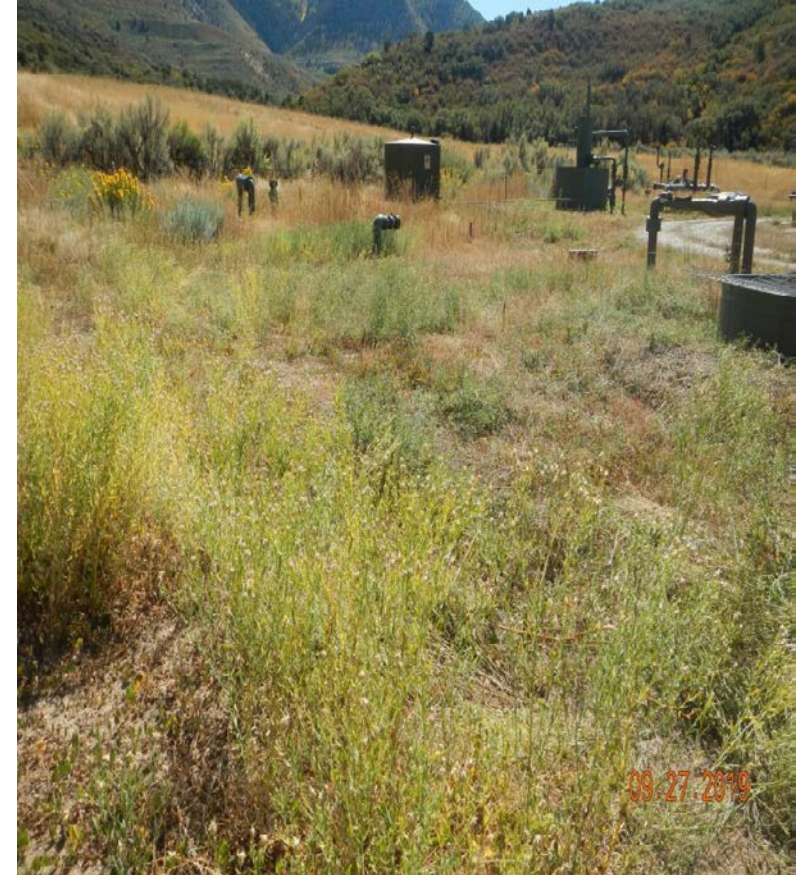
**Photo#6:**  
Majority of Vegetation within Interim Reclamation areas are weedy species

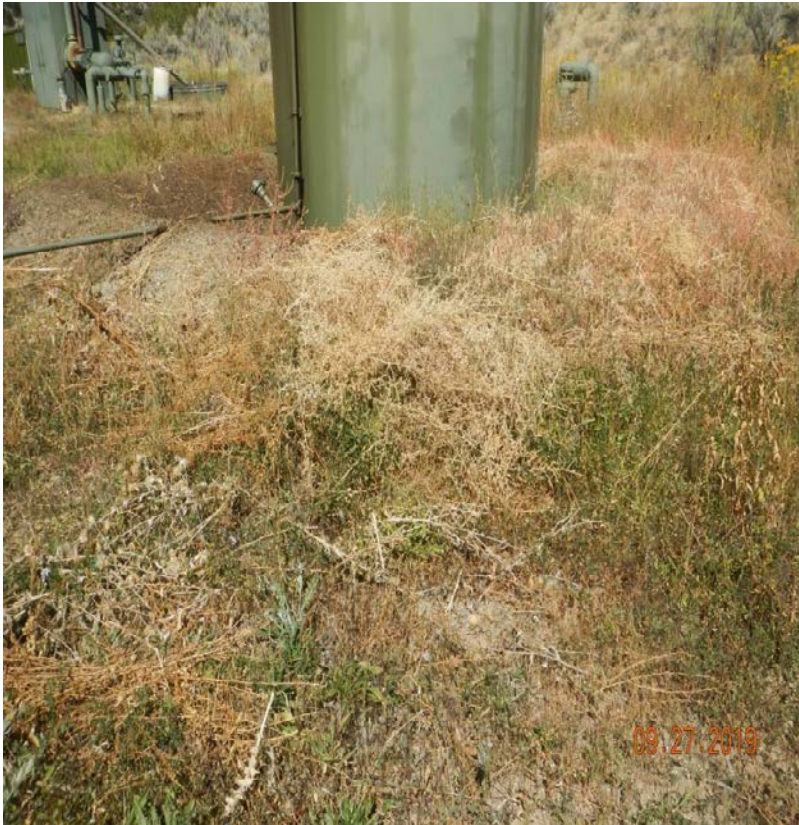
Photo#7:  
Mature weeds have been cut off, left on site & become Debris.

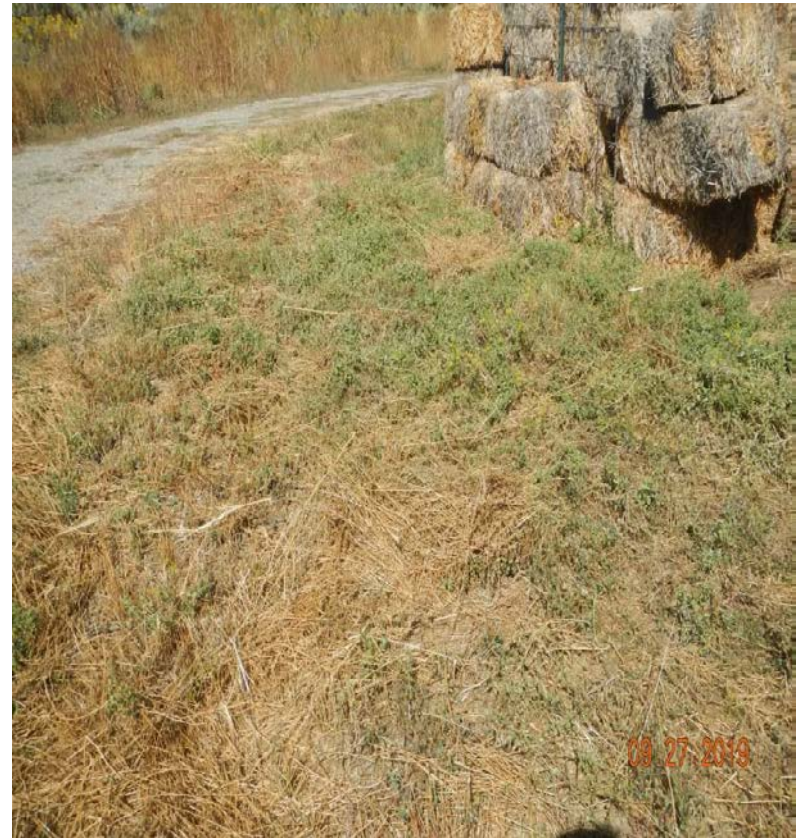
Photo#8:  
Mature weeds have been cut off, left on site & become Debris.

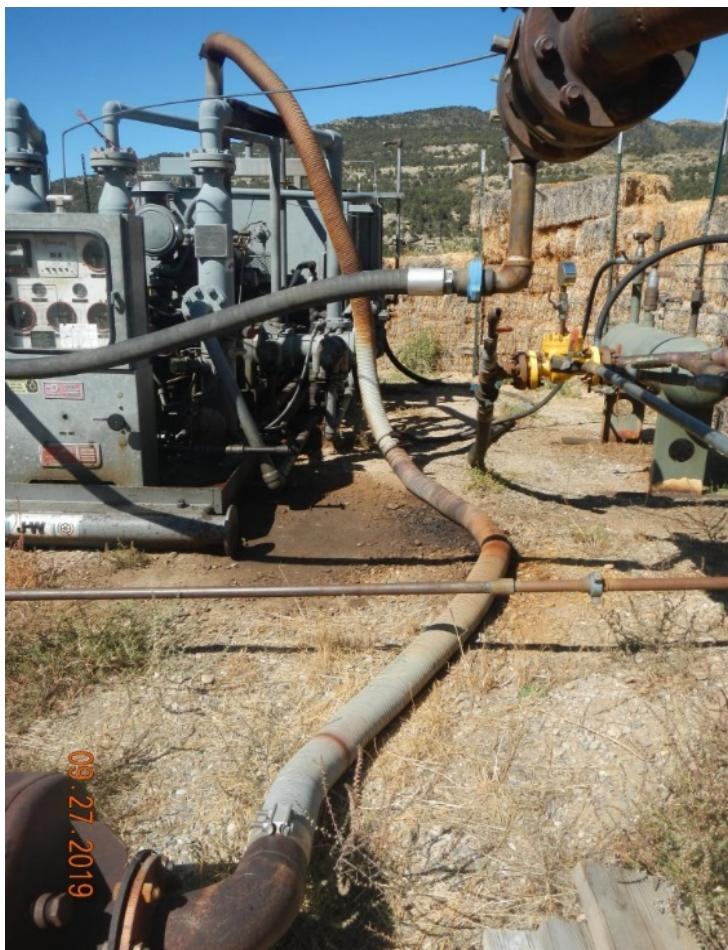
Photo#9:  
Staining, impacted soil observed around multiple pieces of equipment.

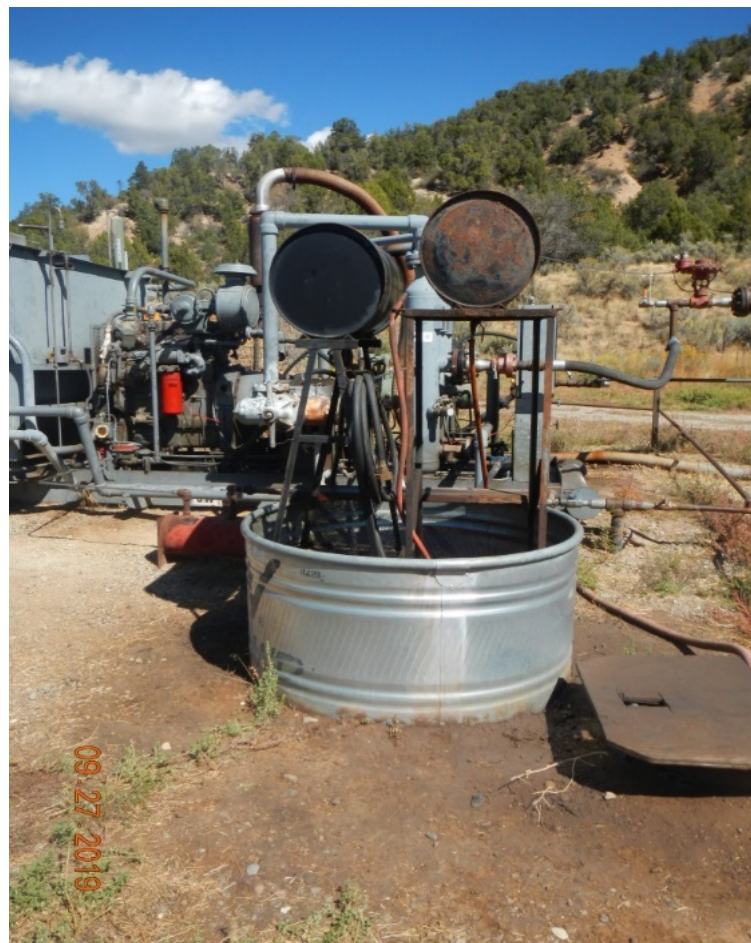
Photo#10:  
Staining, impacted soil observed around multiple pieces of equipment.

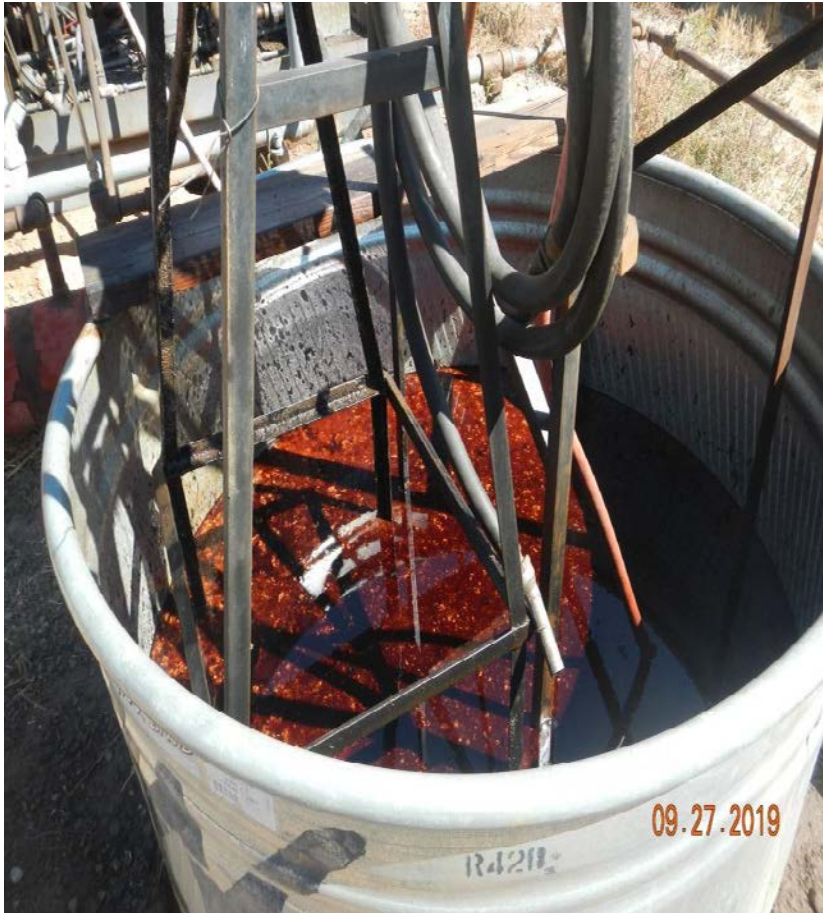
Photo#11:  
Stock tank used for containment of day tanks.

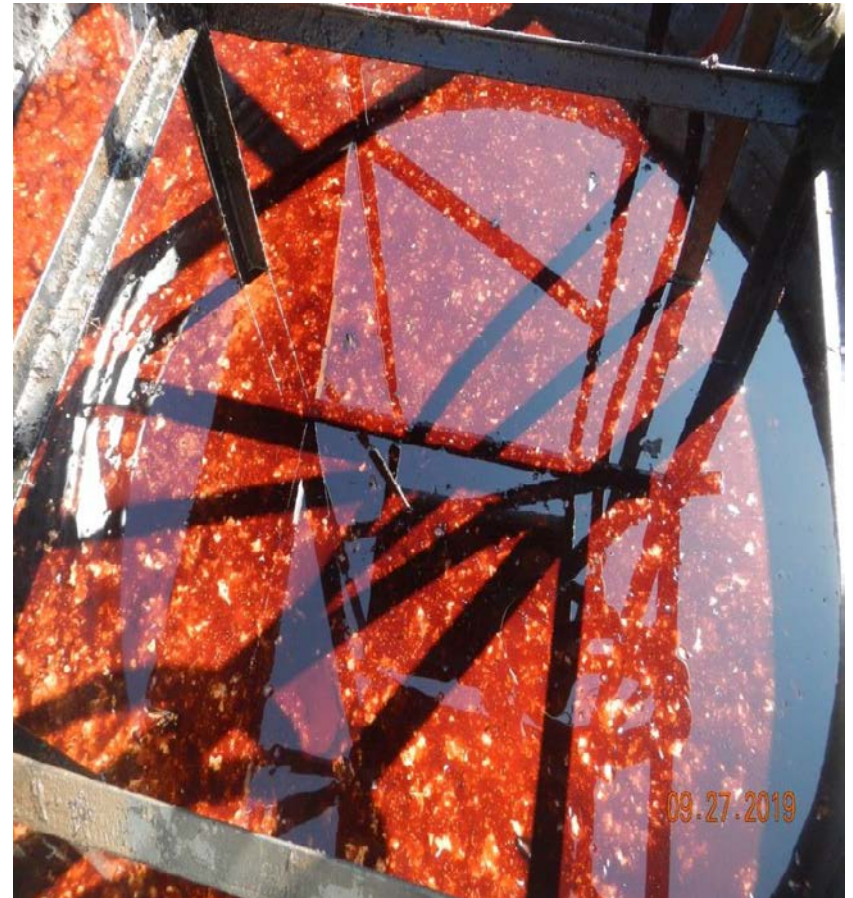
Photo#12:  
Close up view of liquid in stock tank used  
for containment of day tanks.

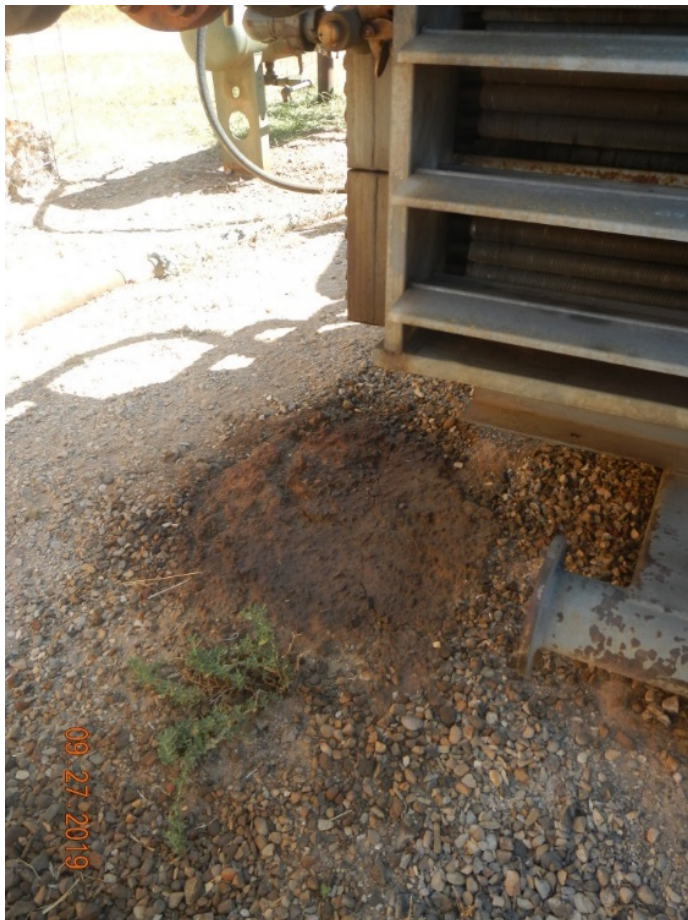
**Photo#13:**

Staining, impacted soil observed around multiple pieces of equipment.

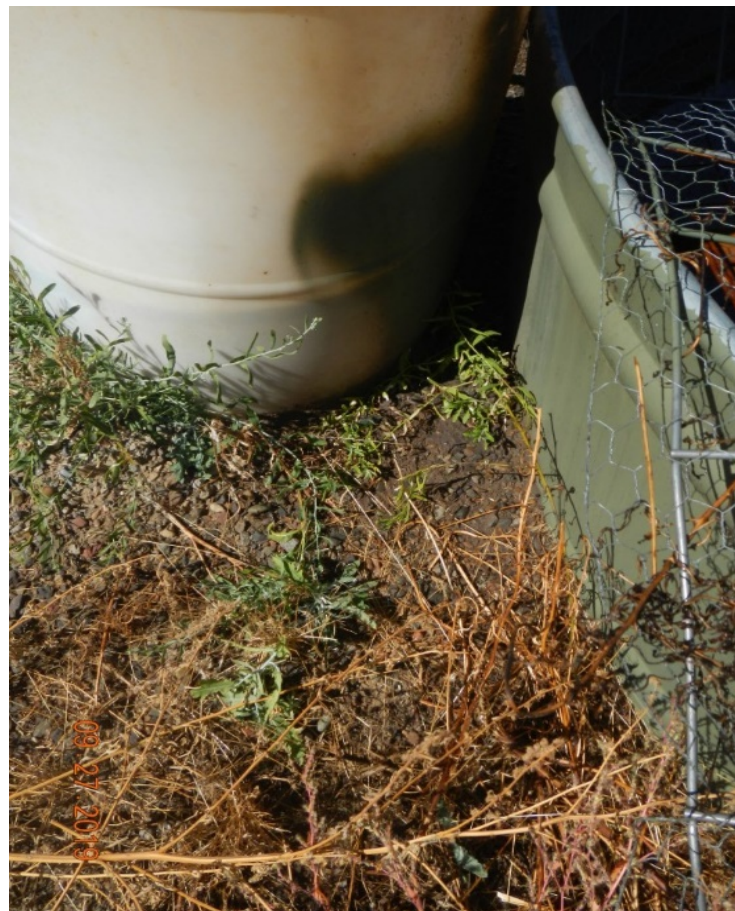
**Photo#14:**

Staining, impacted soil observed around multiple pieces of equipment.

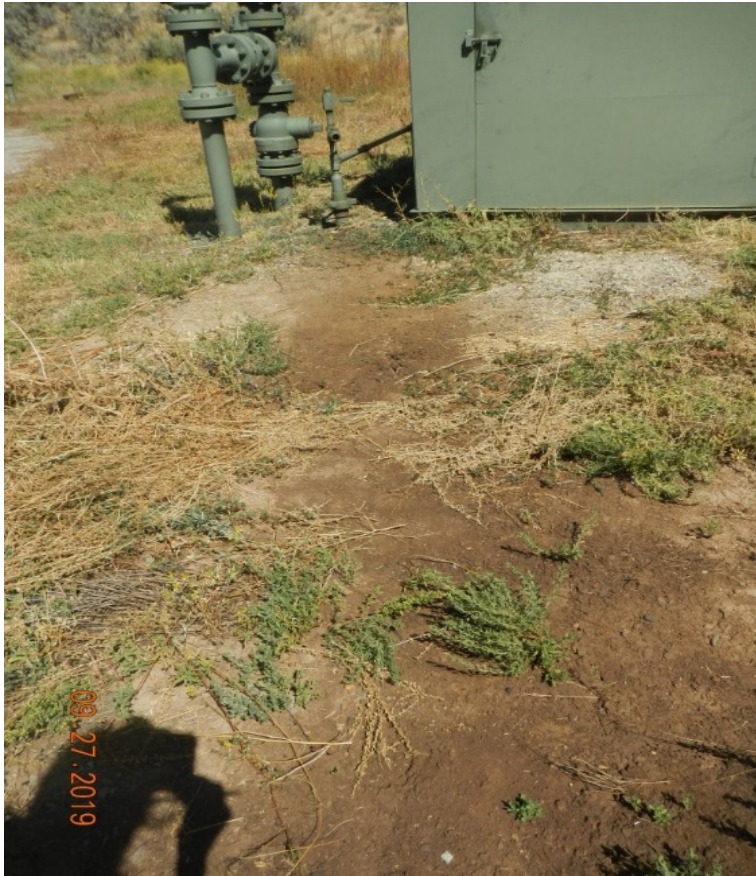
Photo#15:  
Staining, impacted soil observed around multiple pieces of equipment.

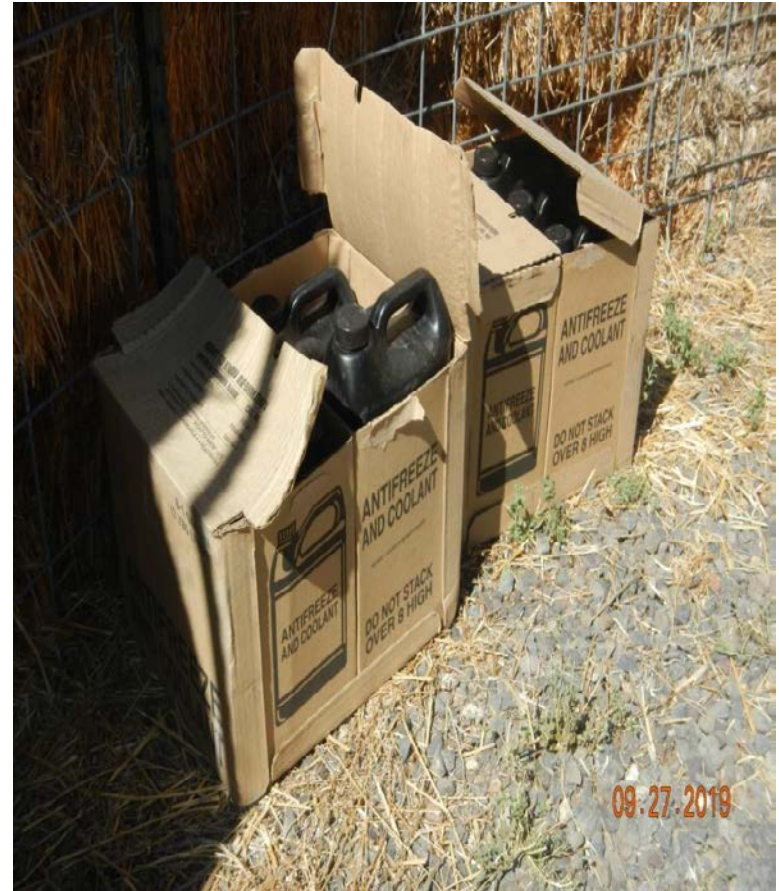
Photo#16:  
Improperly stored supplies.

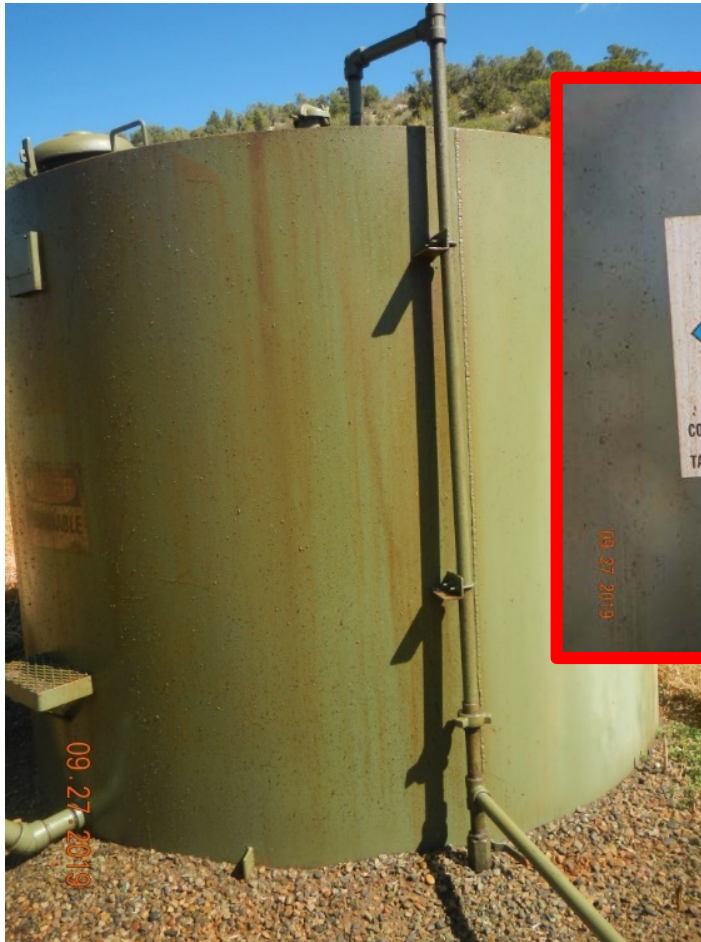
Photo#17:  
Tank appears stained with overflow; insert of tank label missing Capacity and contents.

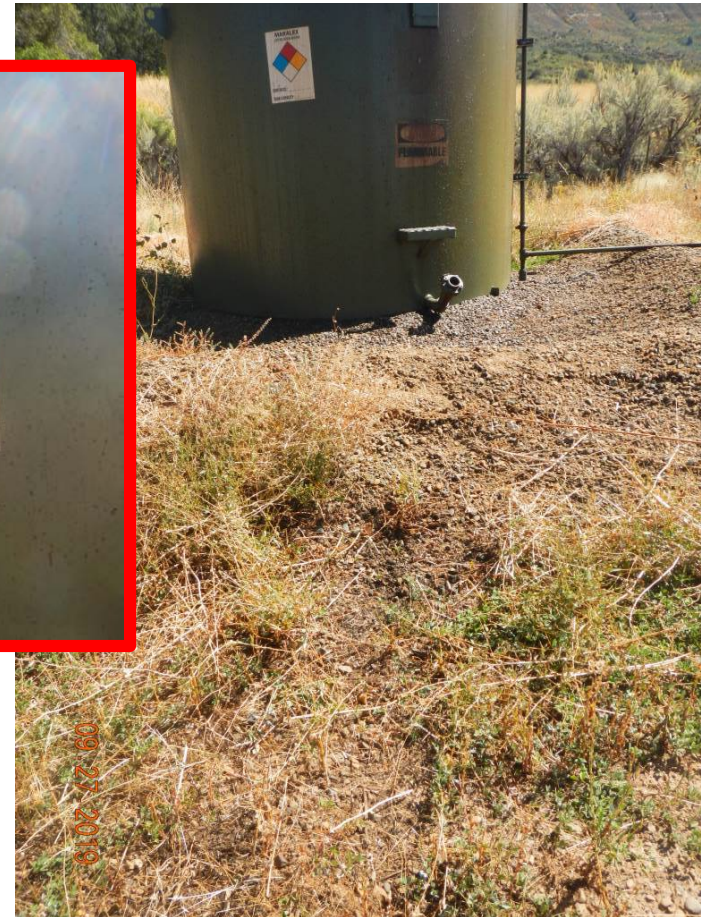
Photo#18:  
Staining observed outside of tank berm.

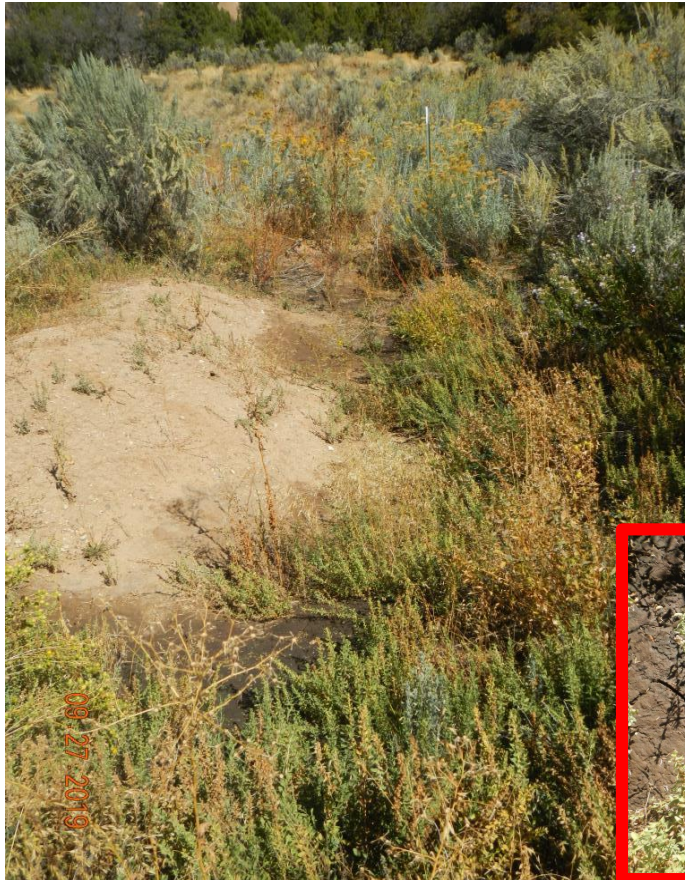
Photo#19:  
Shallow pit hidden in weeds at East side of site.  
Insert is close up of impacted soil.

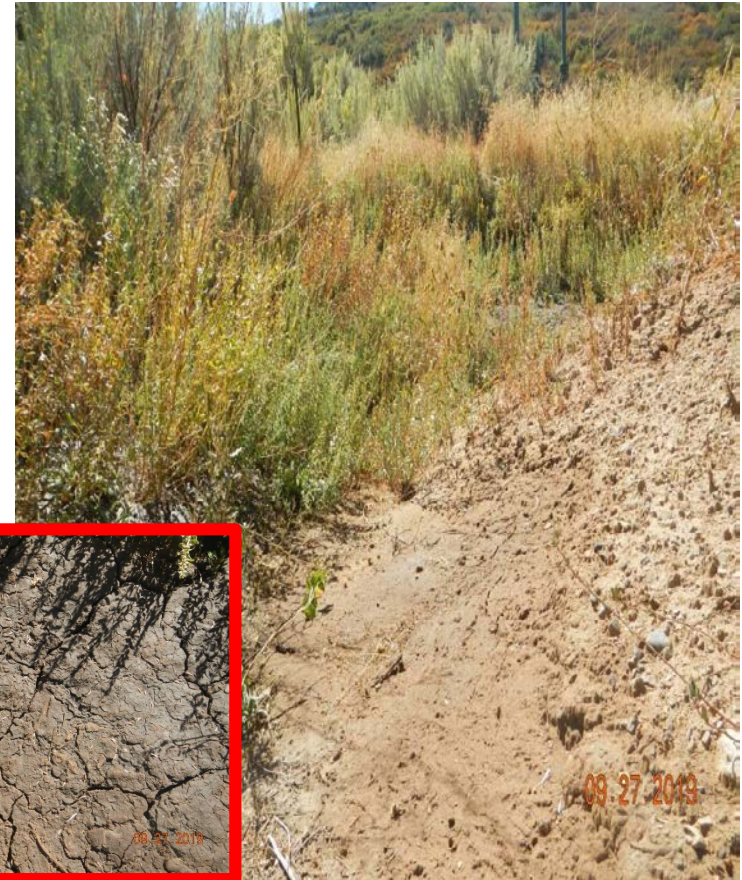
Photo#20:  
Shallow pit hidden in weeds at East side of site.  
Insert is close up of impacted soil.

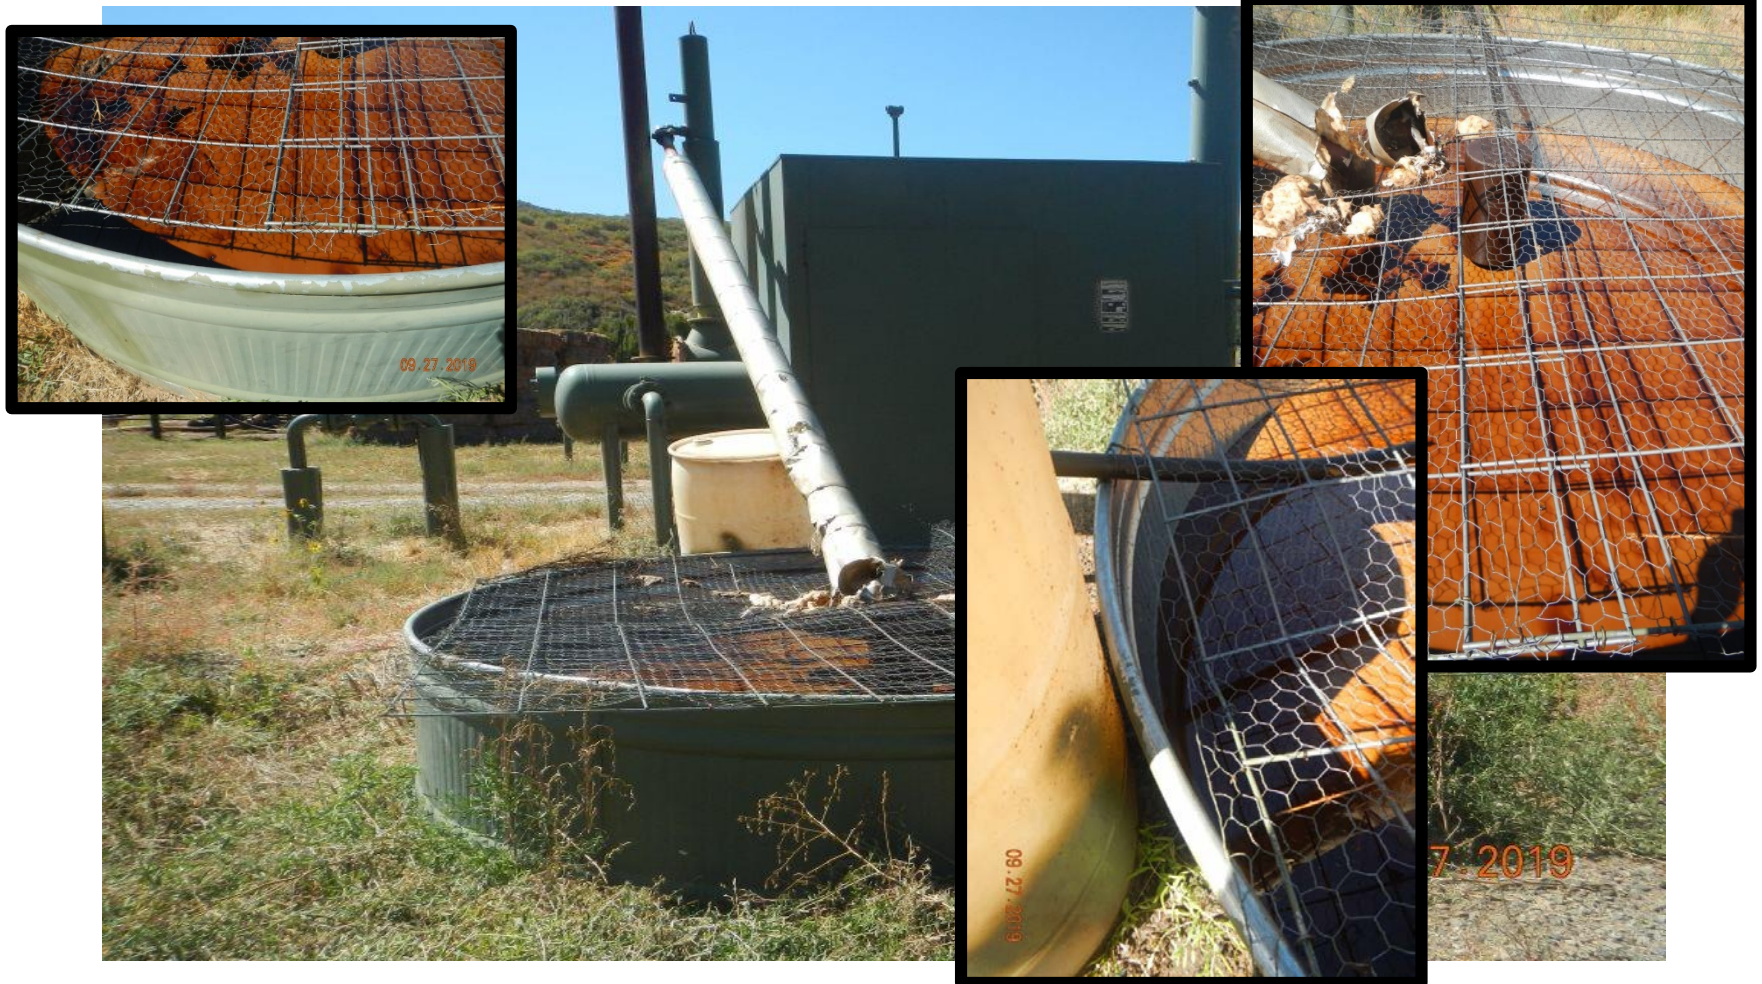
Photo#21:

Gaps in netted panel that covers stock tank used for fluid storage from separator unit, allows ingress of smaller Wildlife.
