Inspection Photos

Operator: Hilcorp Energy
Location/API #: 067-08295
Date: 9-24-2019

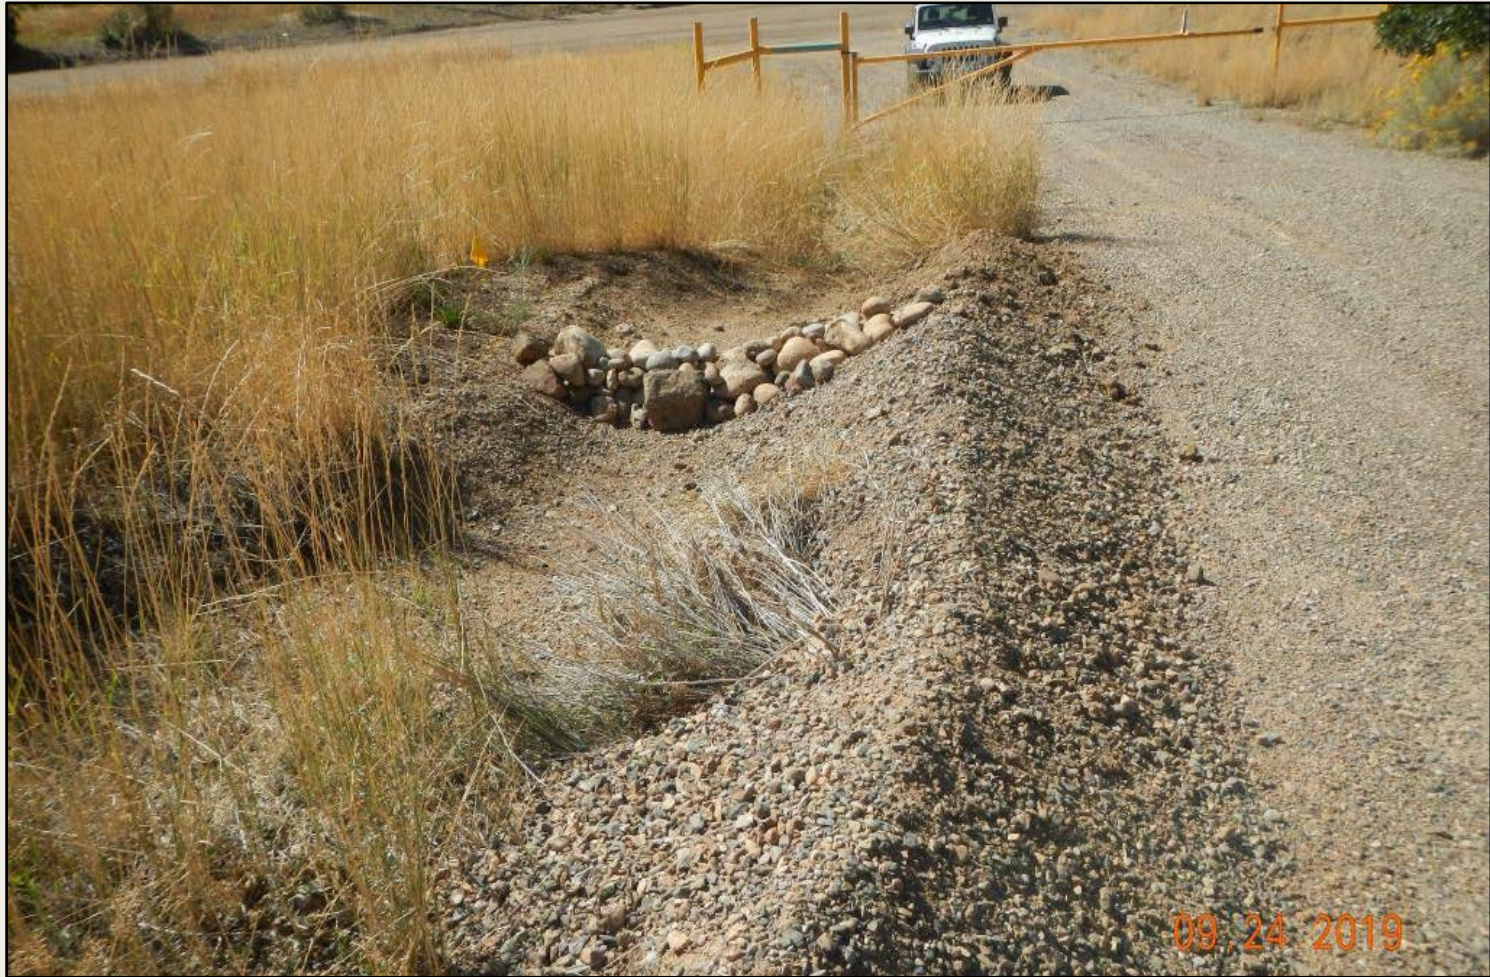
Photo 1. View of repaired ditch and berm along the access road entrance.

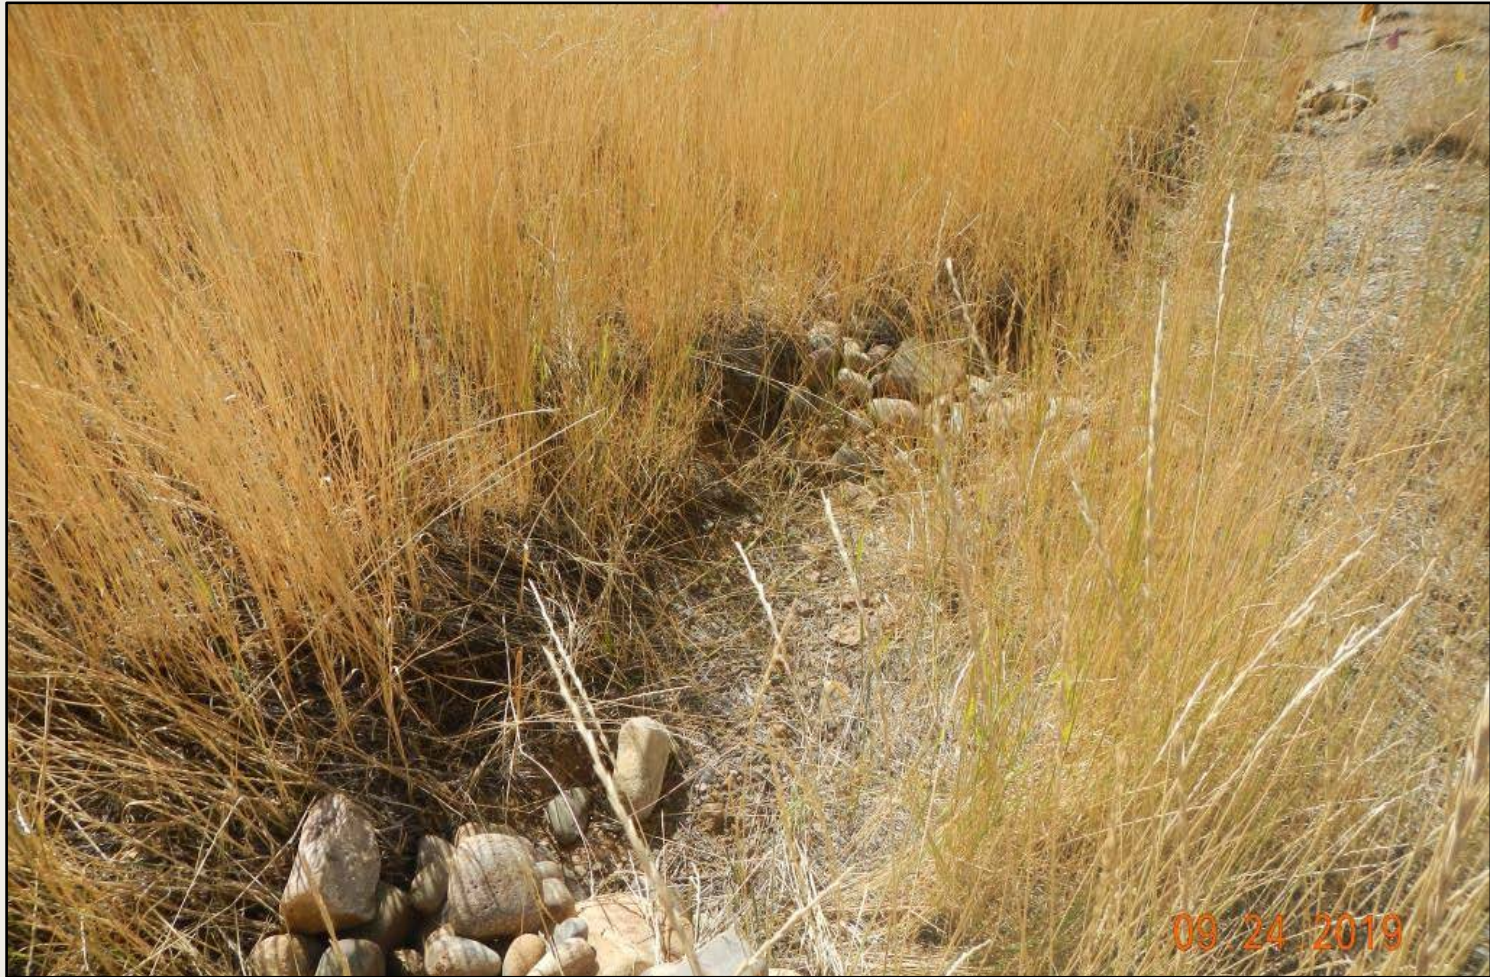
Photo 2. View of cobble in ditch along access road. Cobble placed in this manner is not a BMP installed in accordance with good engineering practices. See CDOT erosion control and stormwater quality field guide for examples. This will need to be carefully monitored and if erosion continues here additional BMPs will need to be installed using good engineering practices.
