Inspection Photos
Operator: BP America
Location/API #: 067-07161
Date: 9-24-2019

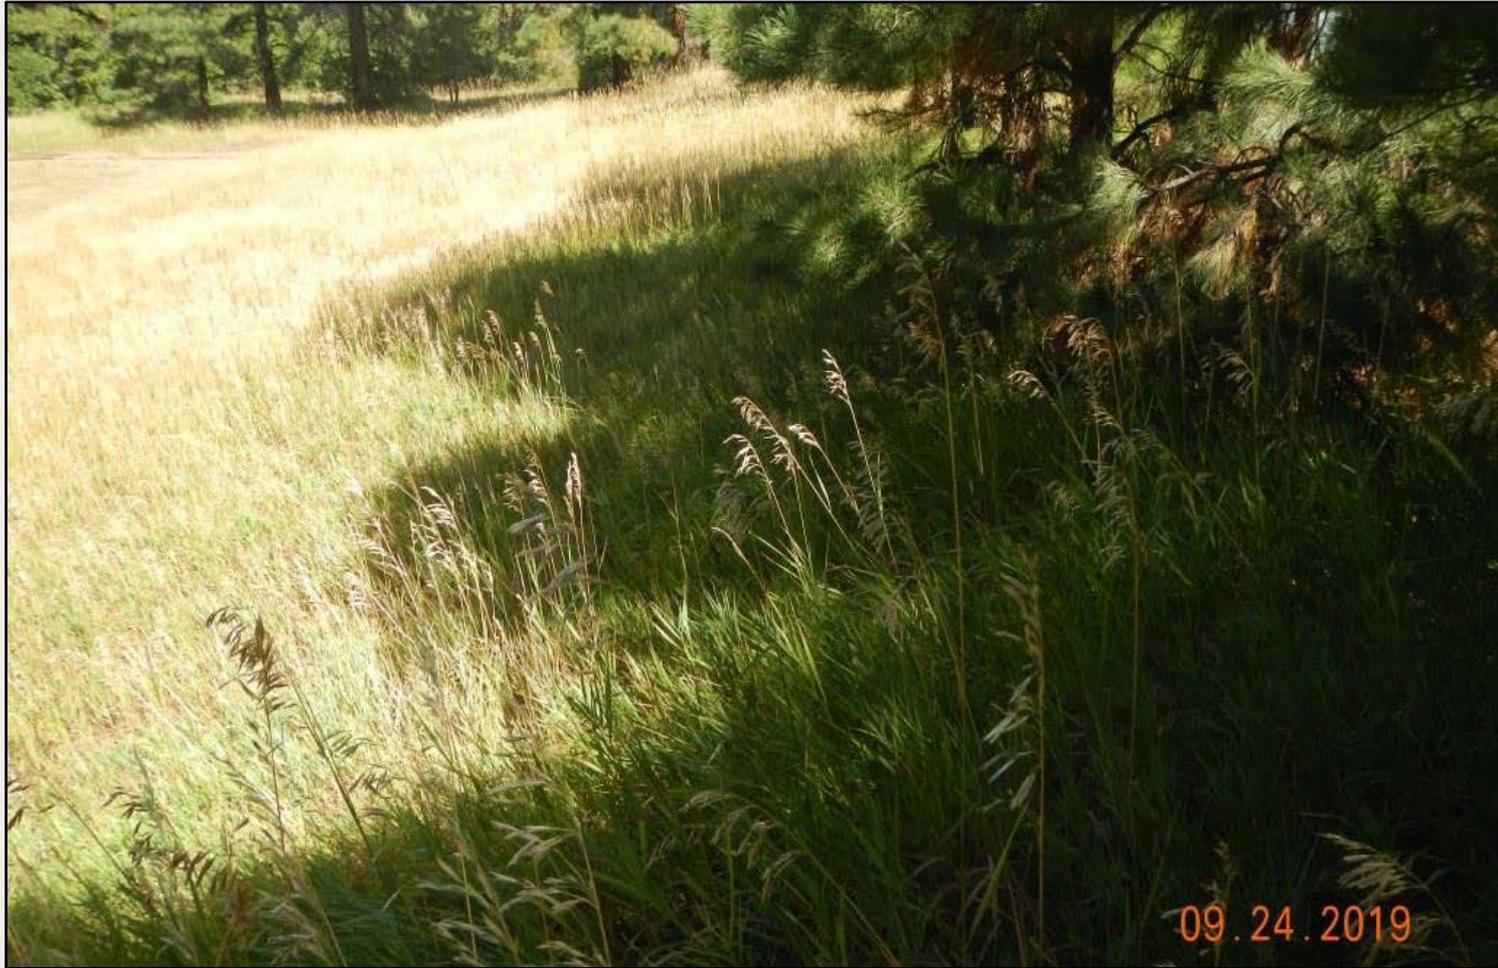
Photo 1. View of western fill slope from the southwestern edge facing northward. Revegetation is largely comprised of smooth brome and ponderosa pine trees.

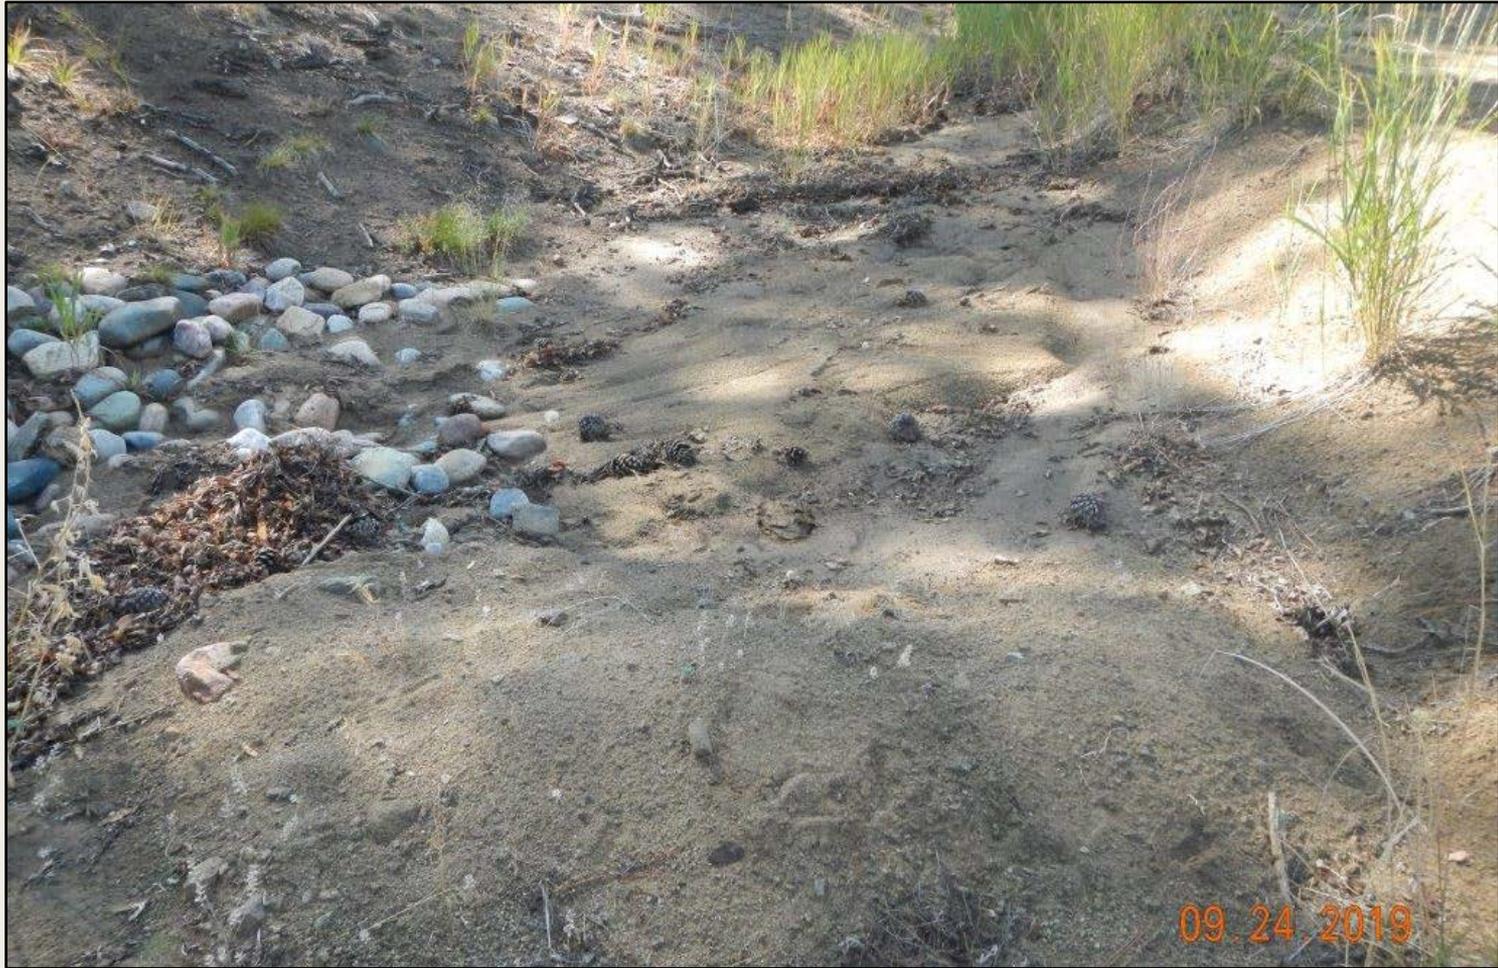
Photo 2. View of sediment catchment within the eastern project area needing maintenance. Additional BMPs to prevent sediment run-on are recommended.

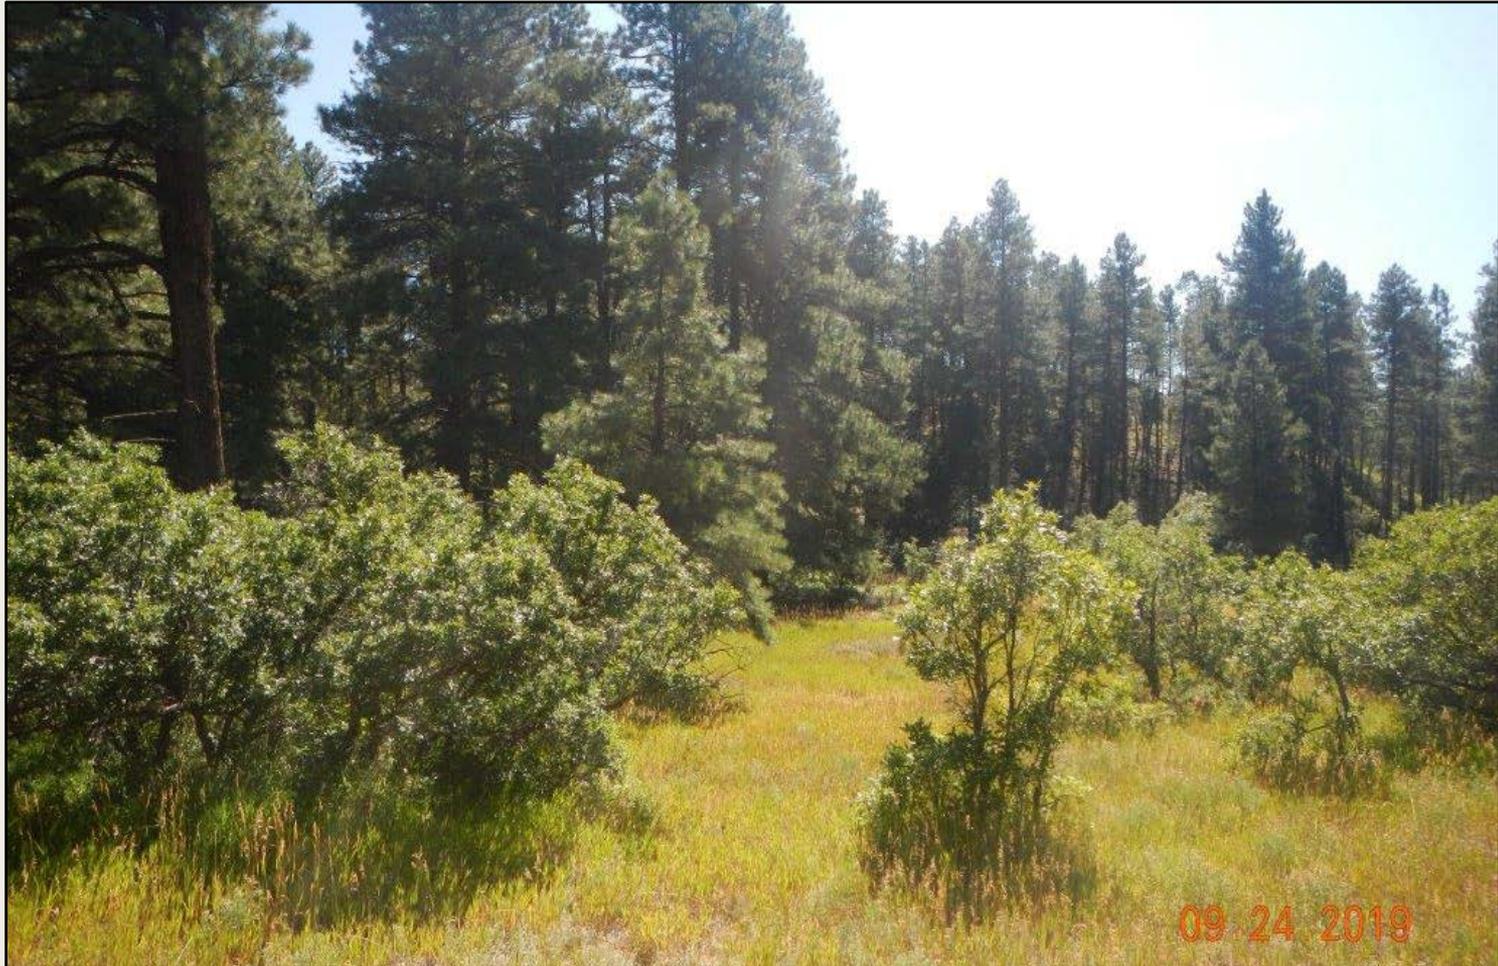
Photo 3. View of reference area vegetation, comprised of mixed ponderosa pine and gambel oak woodland with grass field.
