Inspection Photos
Operator: BP America
Location/API #: 067-09080
Date: 9-30-2019

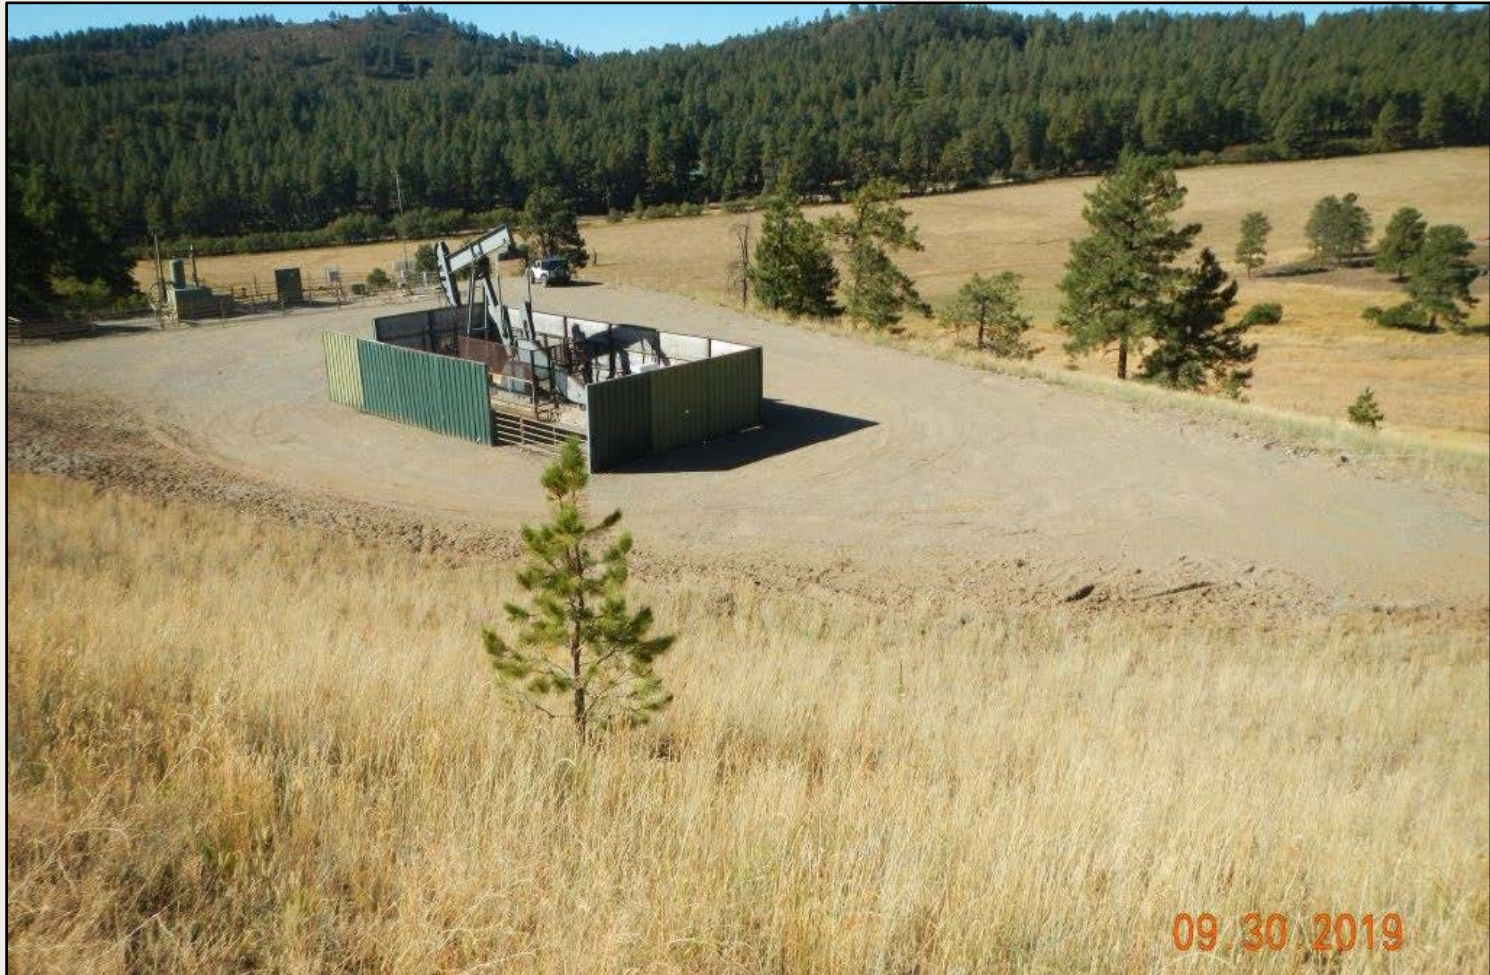
Photo 1. View of the project area from the northeastern corner facing center. Revegetation is largely comprised of a mixture of grasses such as intermediate wheatgrass, crested wheatgrass, and smooth brome.

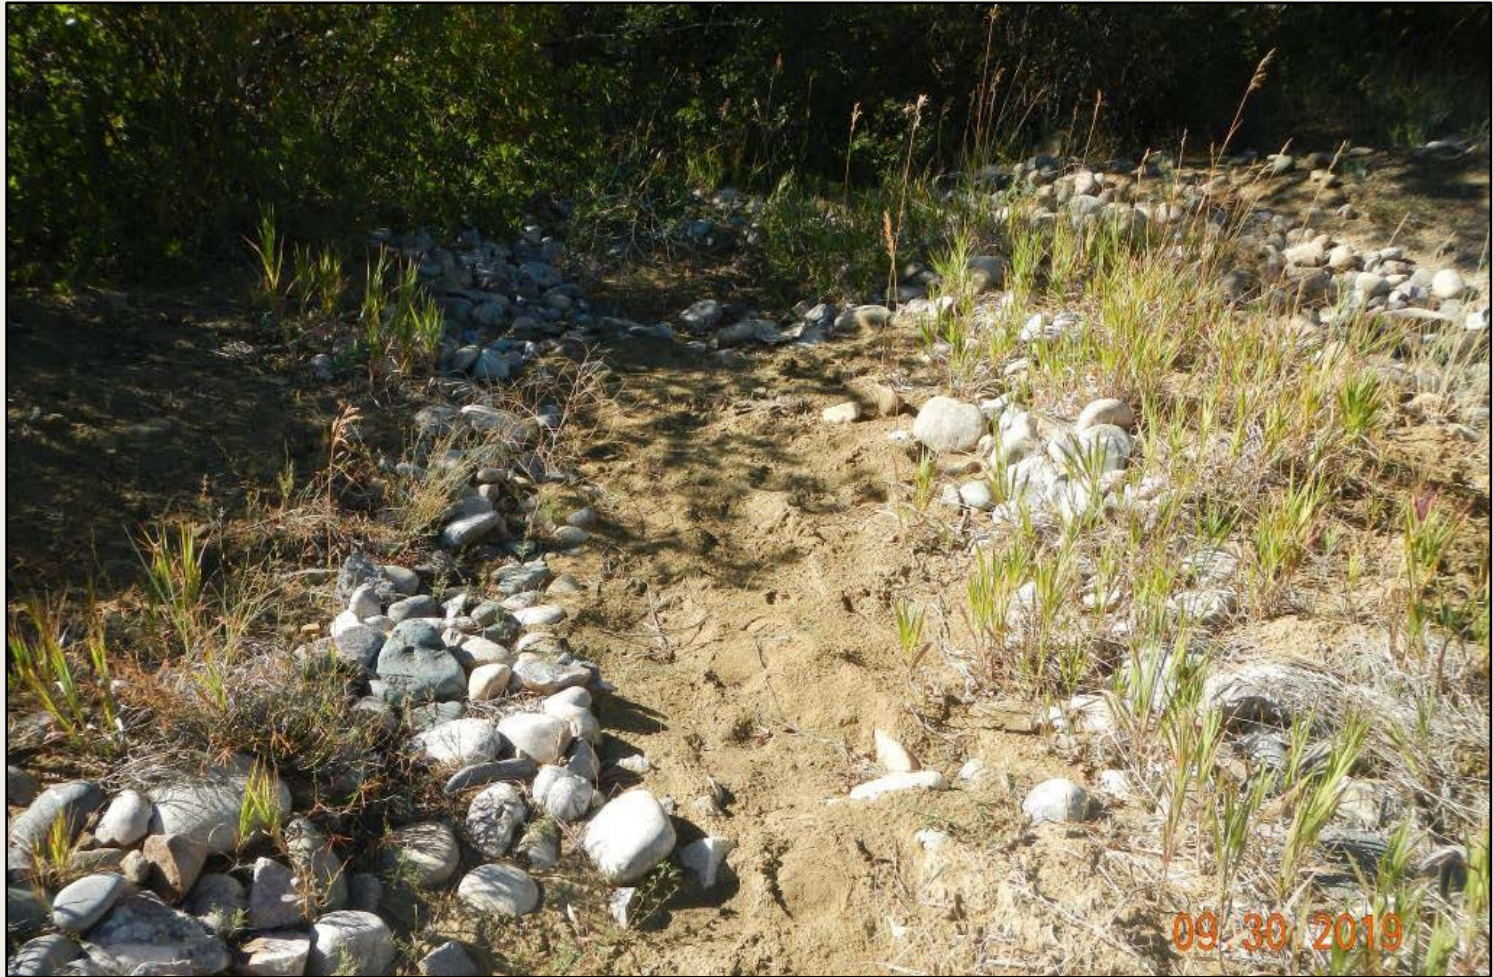
Photo 2. View of sediment accumulation within cobble lined silt trap, needing maintenance.

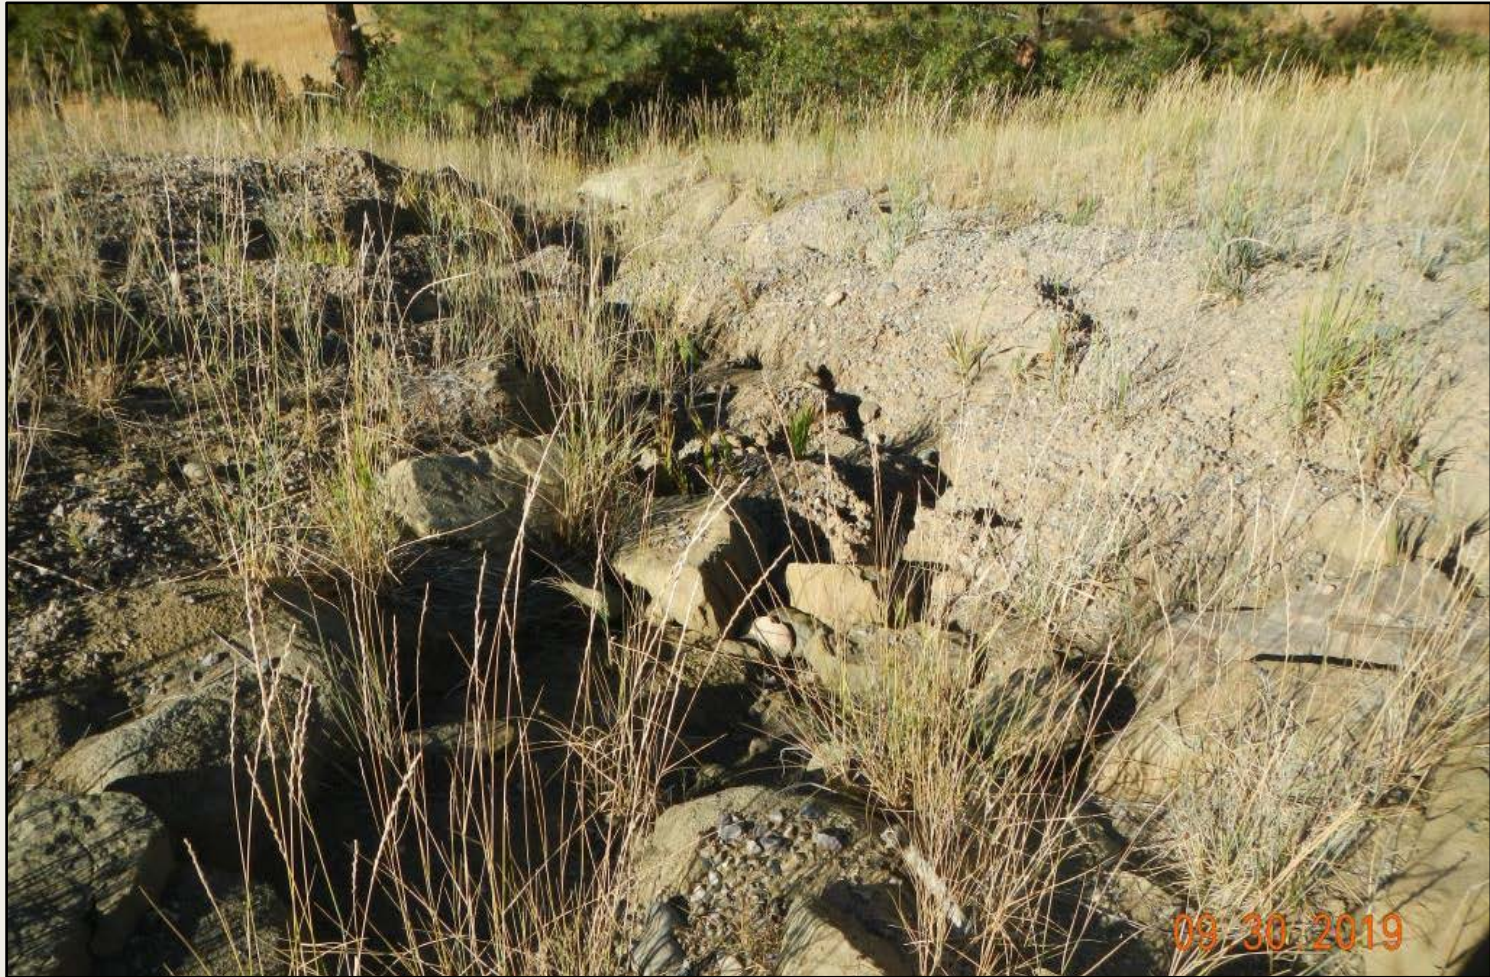
Photo 3. View of erosion occurring around rock BMP within the western project area.

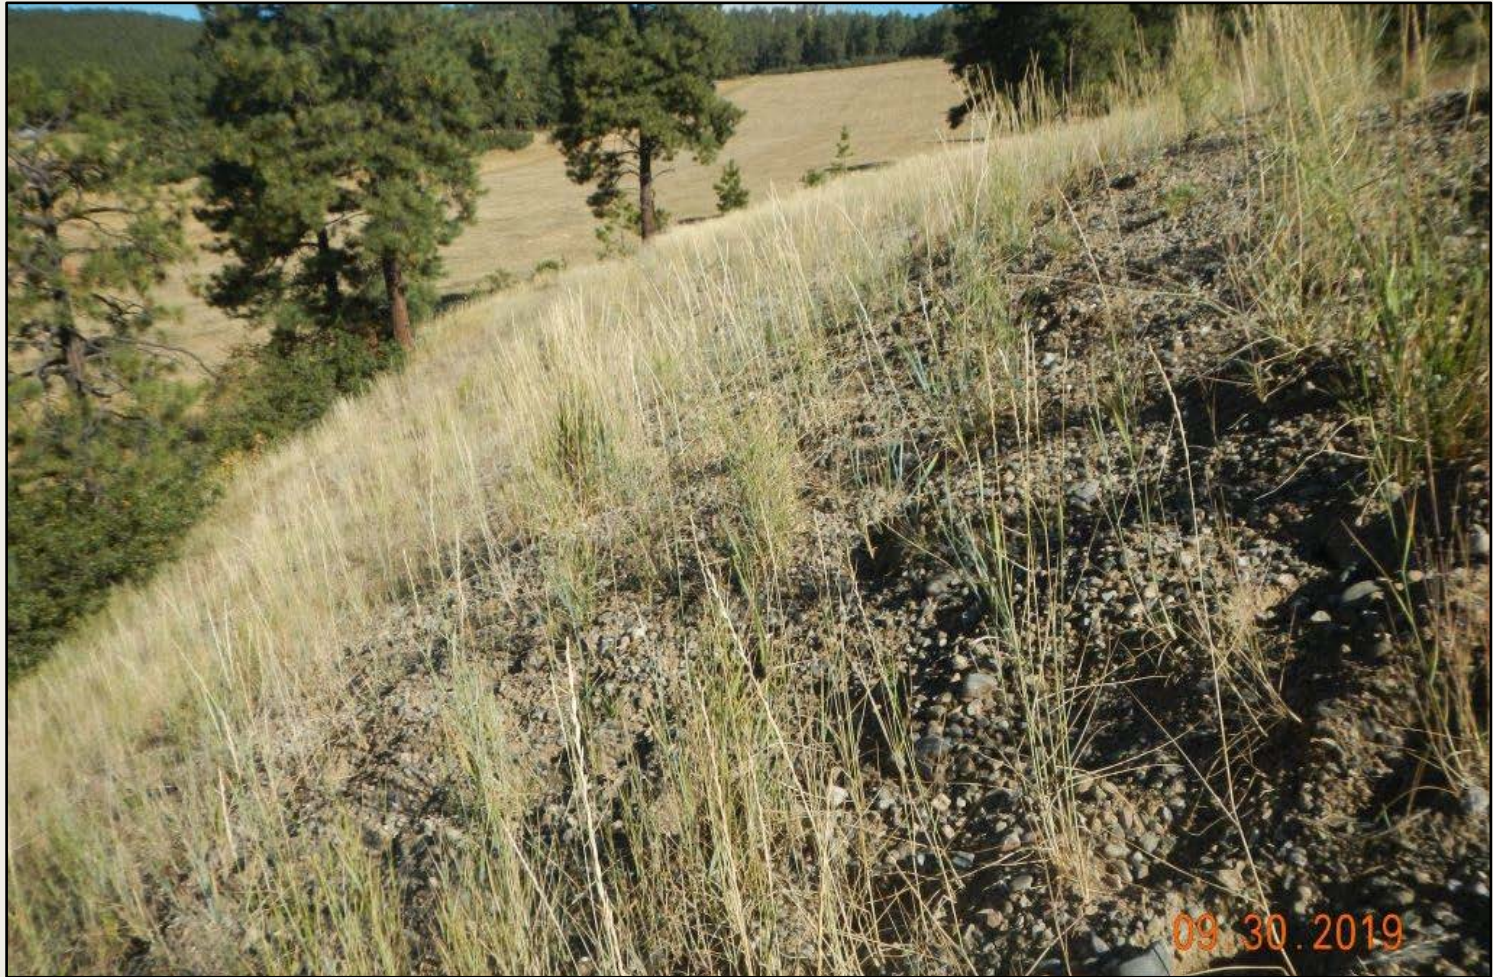
Photo 4. View of the western fill slope from the southwestern edge facing northward.

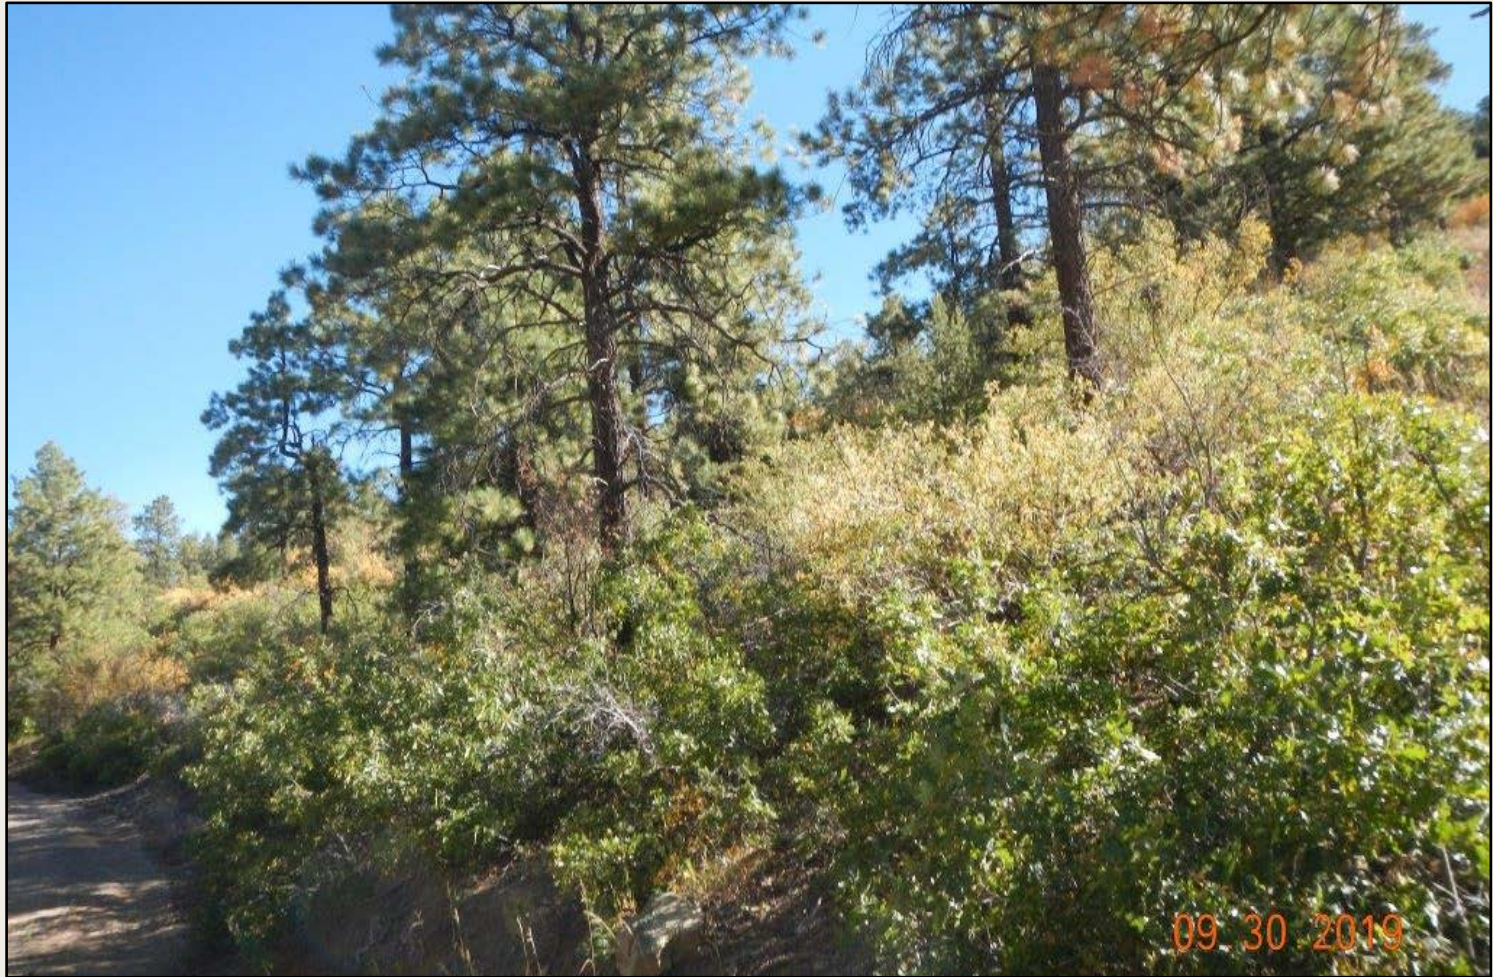
Photo 5. View of reference area vegetation, comprised of open ponderosa pine woodland and dense shrub understory dominated by gambel oak.
