Inspection Photos

Operator: Kinder Morgan
Location/API #: 083-06715
Date: 10-3-2019

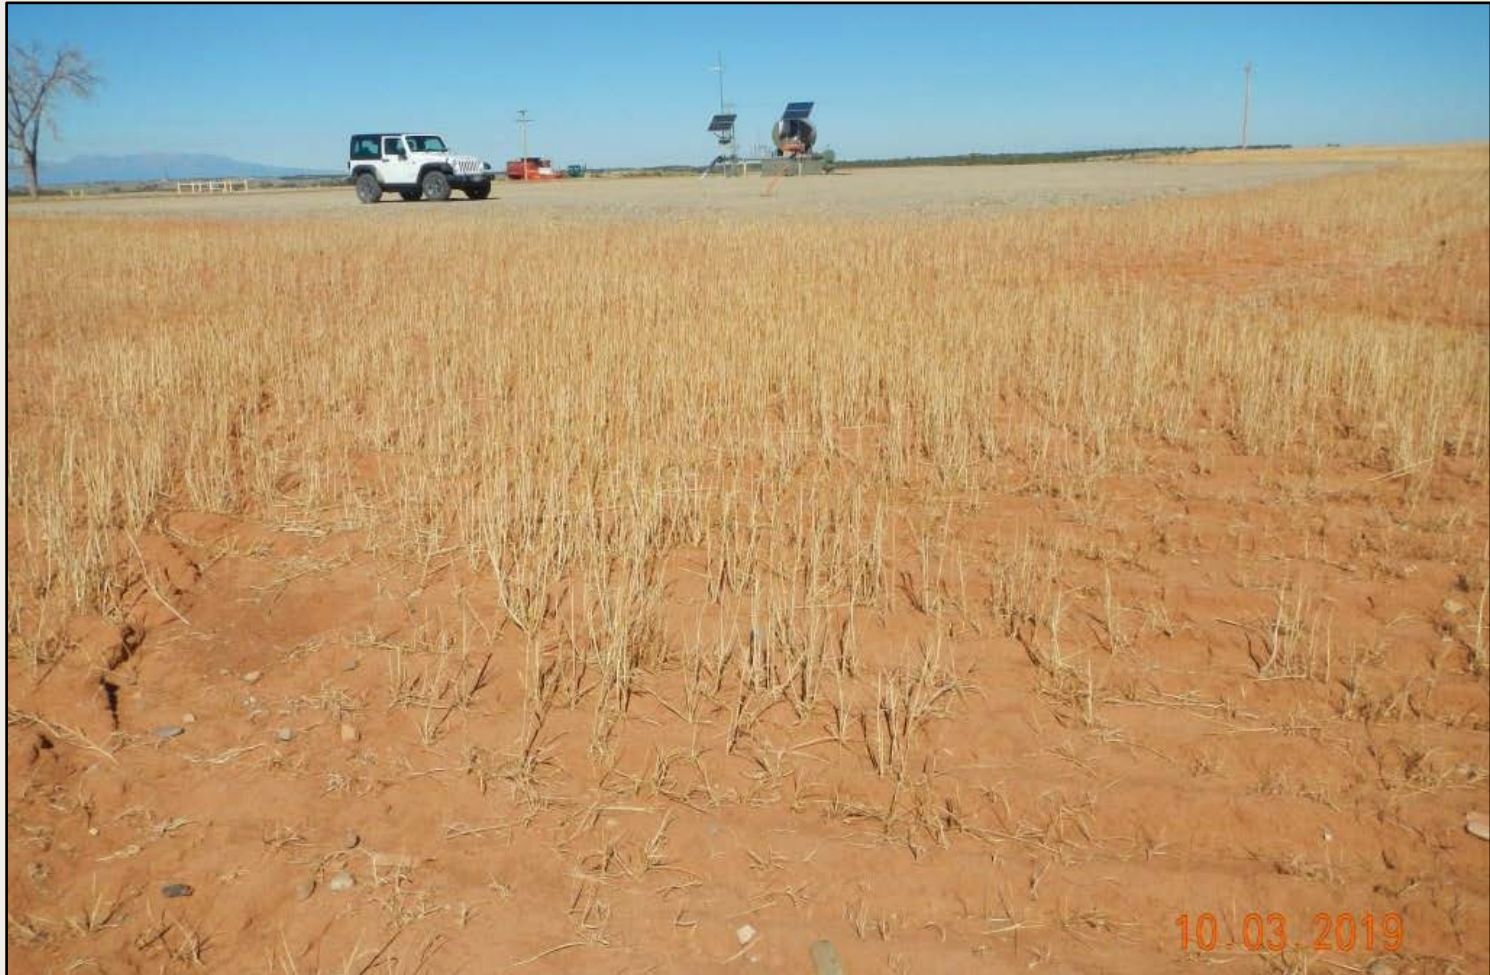
Photo 1. View of the project area from the southeastern edge facing center.

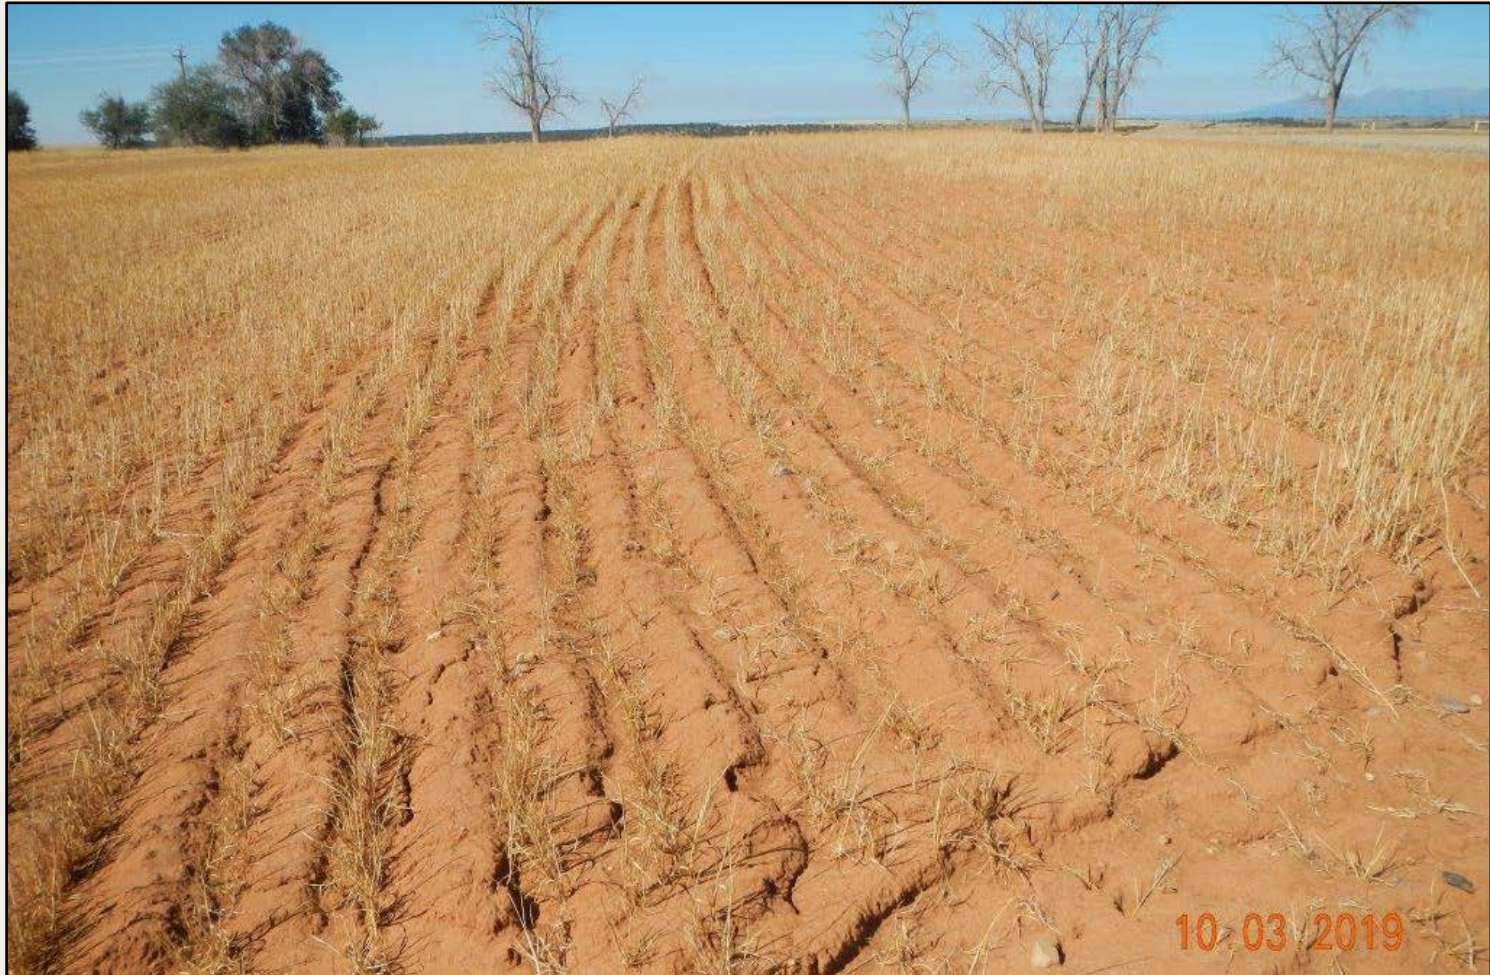
Photo 2. View of the southern portion of the interim reclamation area, returned to cultivation.

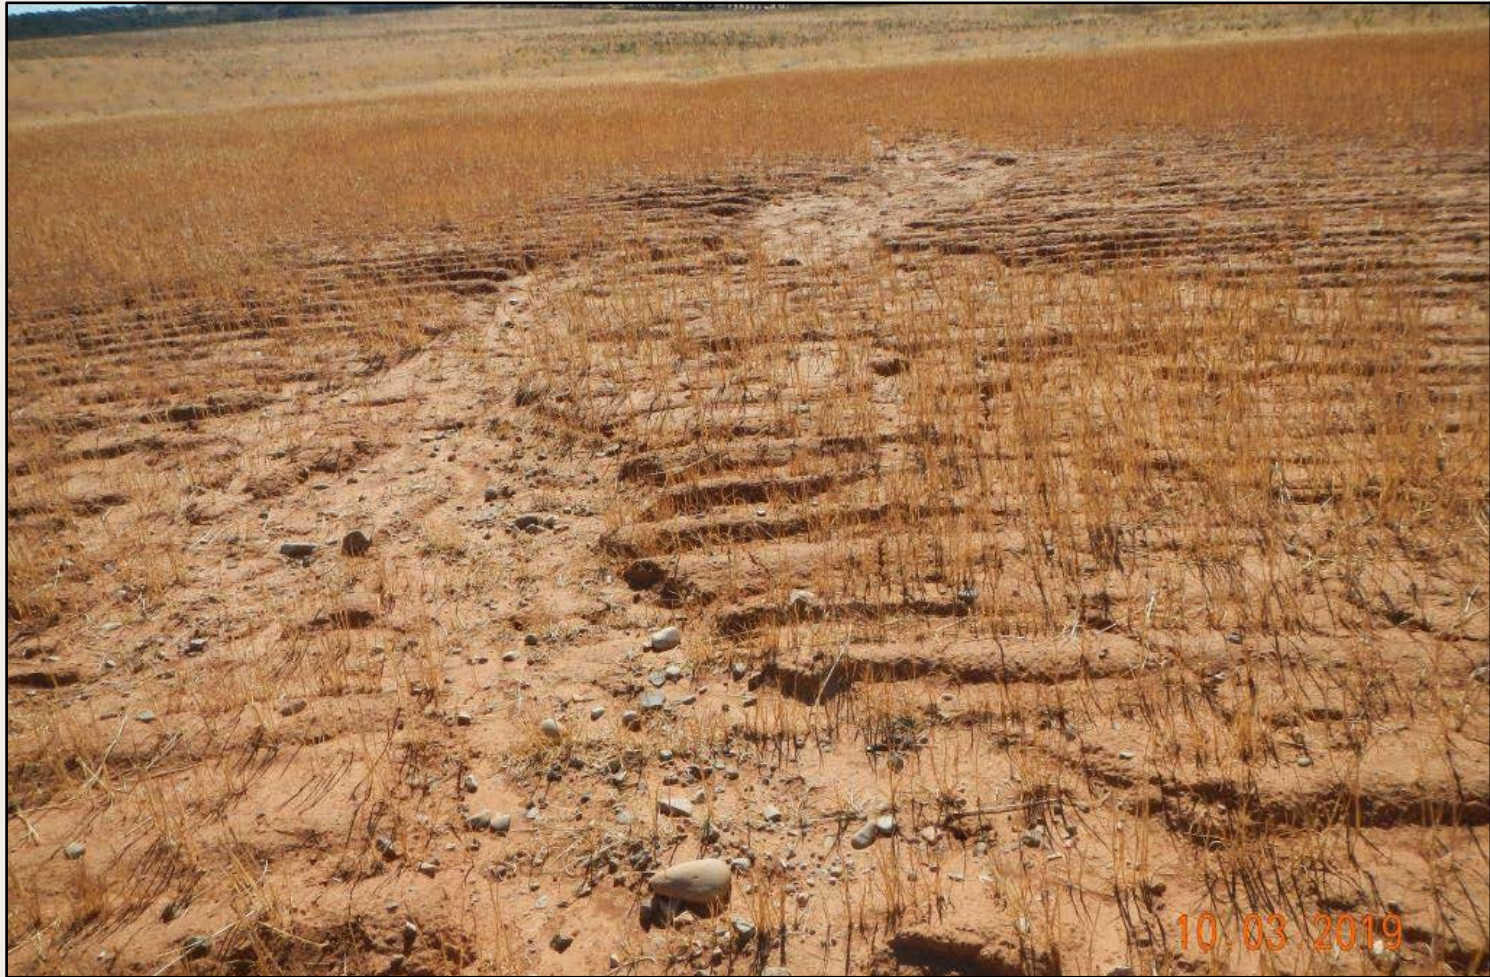
Photo 3. View of erosional channeling (approx. 2 feet wide and 4 inches deep) in eastern and southeastern interim reclamation area, from concentrated stormwater flows exiting the eastern edge of the well pad.

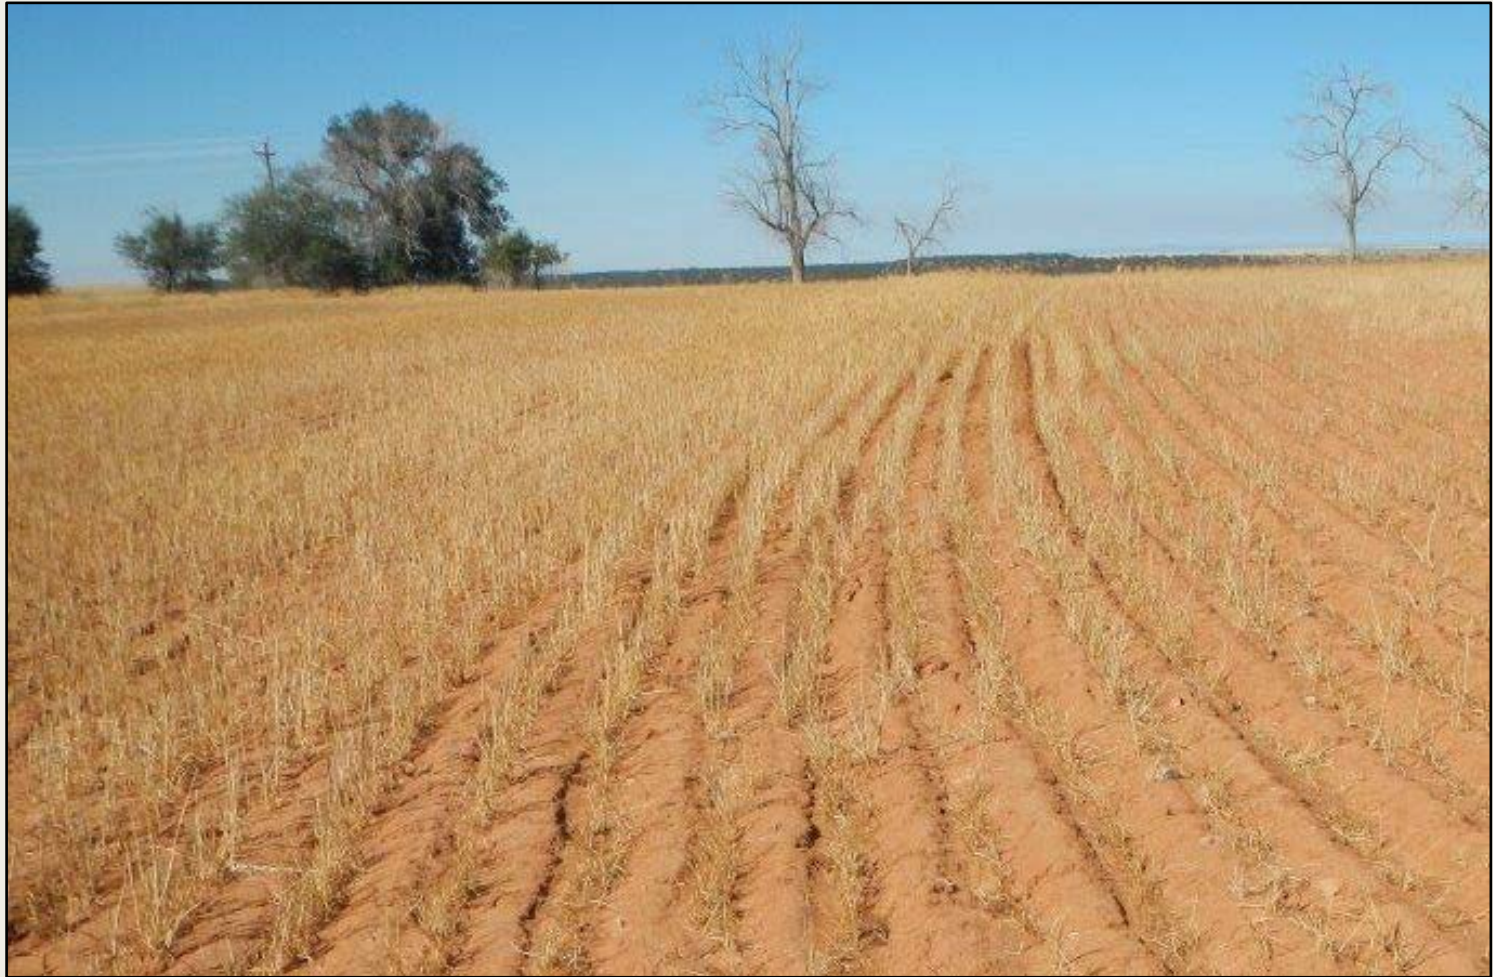
Photo 4. View of reference area comprised of dryland wheat cropfield, in mowed condition at this time.
