Inspection Photos

10/09/2019

Operator: FOUNDATION ENERGY
MANAGEMENT LLC # 10112

Location ID: 303599
Yuma County, CO

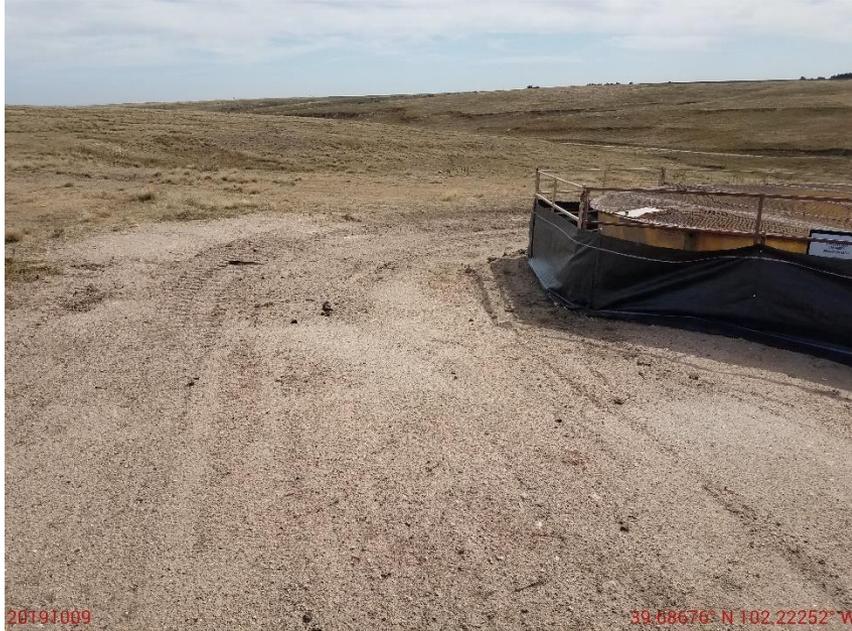
Photo 1: Photo taken from the north end of the location, facing southeast. Photos 1-3 provide an overview of the location from southeast, south to southwest. Photo shows erosion on the pad has been repaired. However, site remains unstabilized and soils loose; location remains at risk to erosion degradation. Photos also show no erosion control BMPs have been installed per CAS

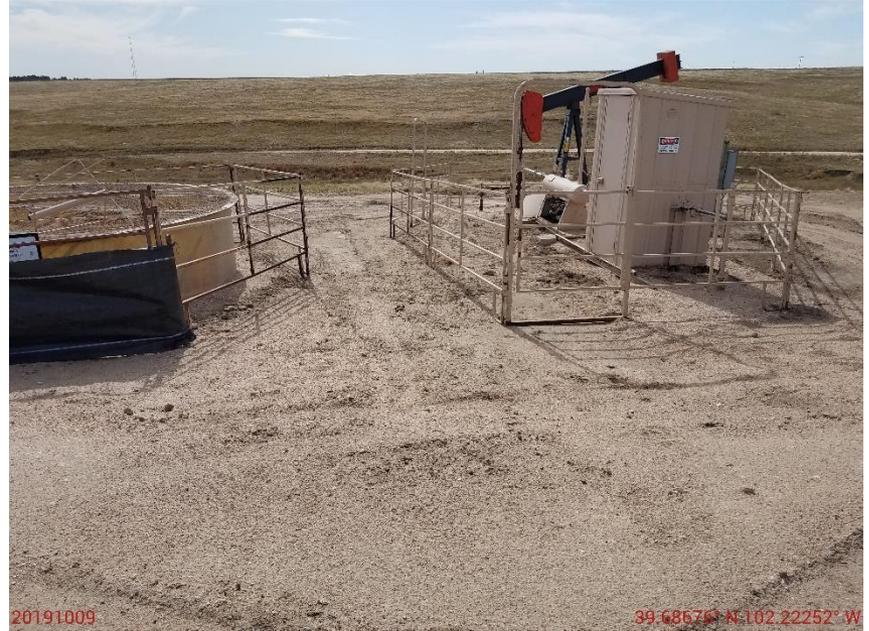
Photo 2: See comments under photo 1.

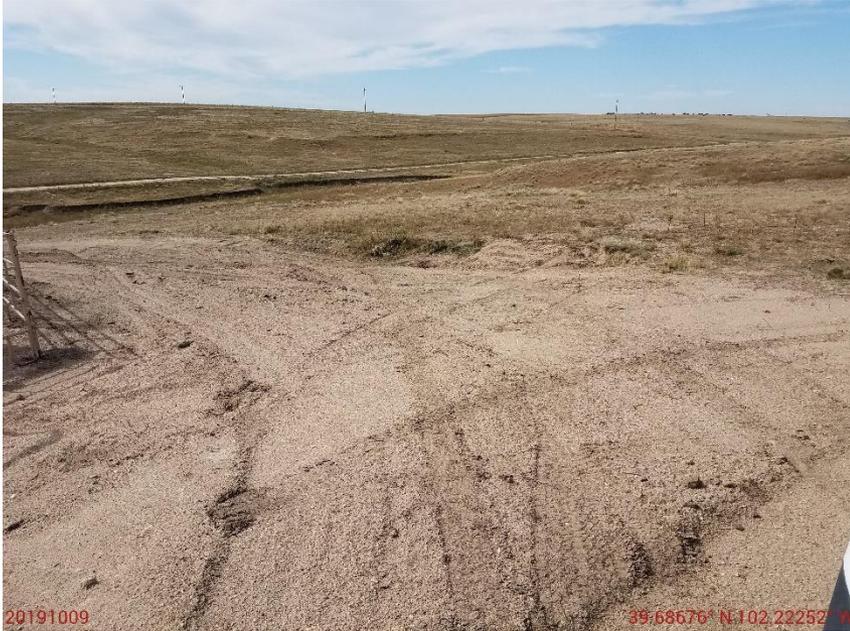
Photo 3: See comments under photo 1.

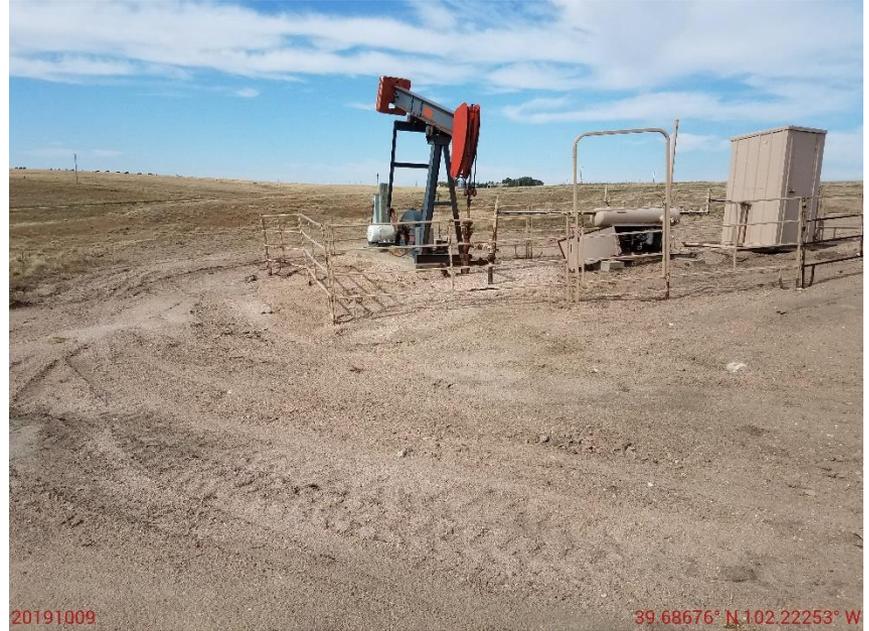
Photo 4: Photo taken from the location, facing west. See comments under photo 1.

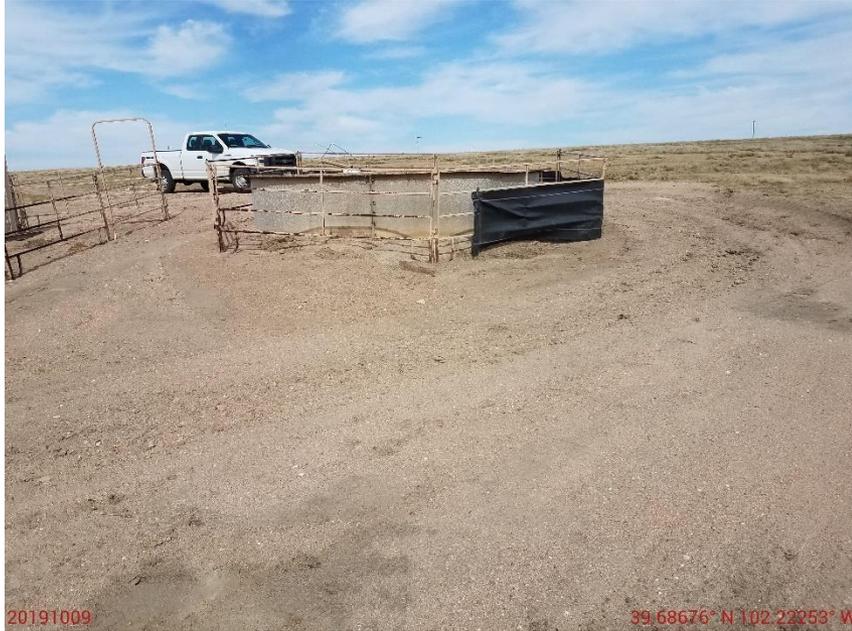
Photo 5: Photo taken from the location, facing north. See comments under photo 1.

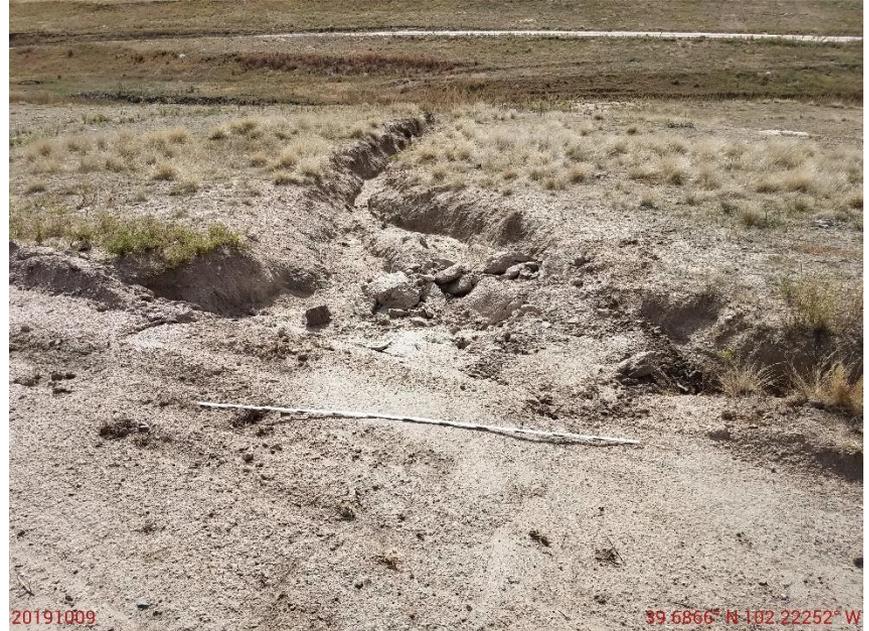
Photo 6: Photo from the south end of the location, facing south. Photo shows Operator has failed to repair/reclaim adjacent lands degraded due to stormwater runoff from the location. 6 foot measuring stick for reference.

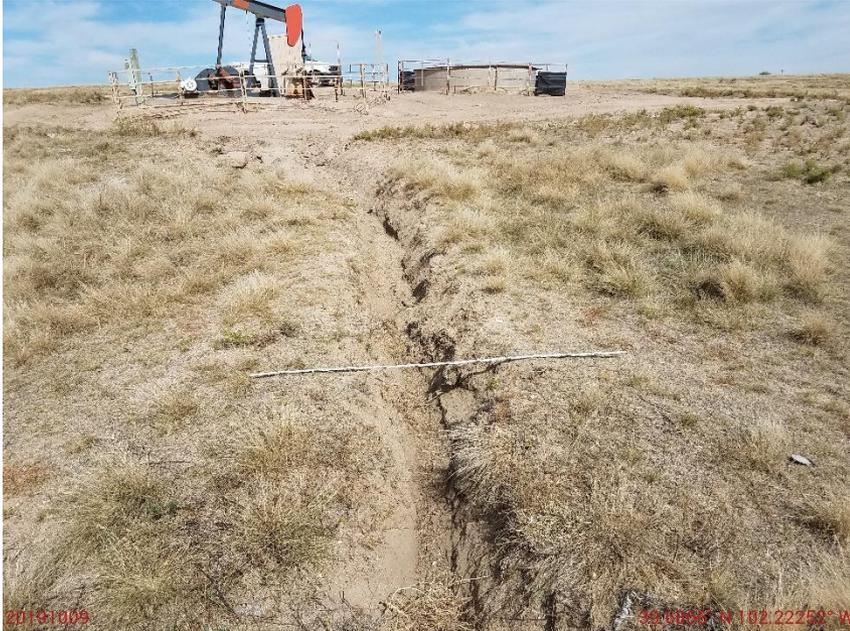
Photo 7: See comments under photo 6.

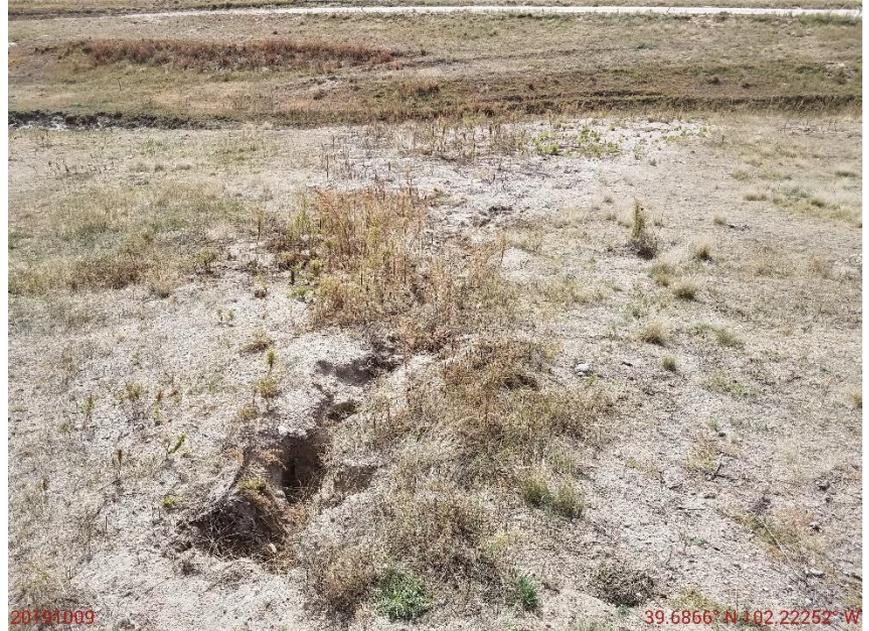
Photo 8: See comments under photo 6. Photo also shows sediment deposition into and intermittent stream.

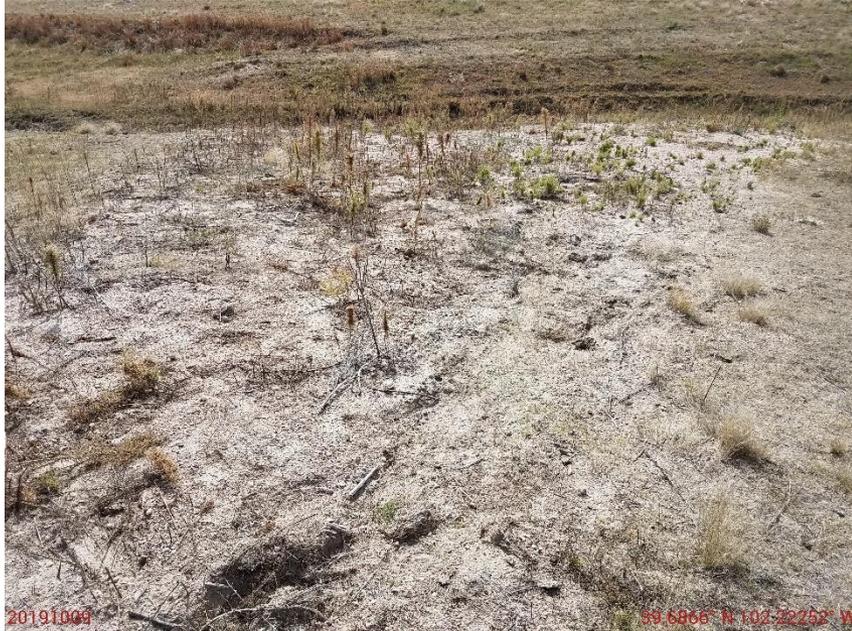
Photo 9: See comments under photo 8.

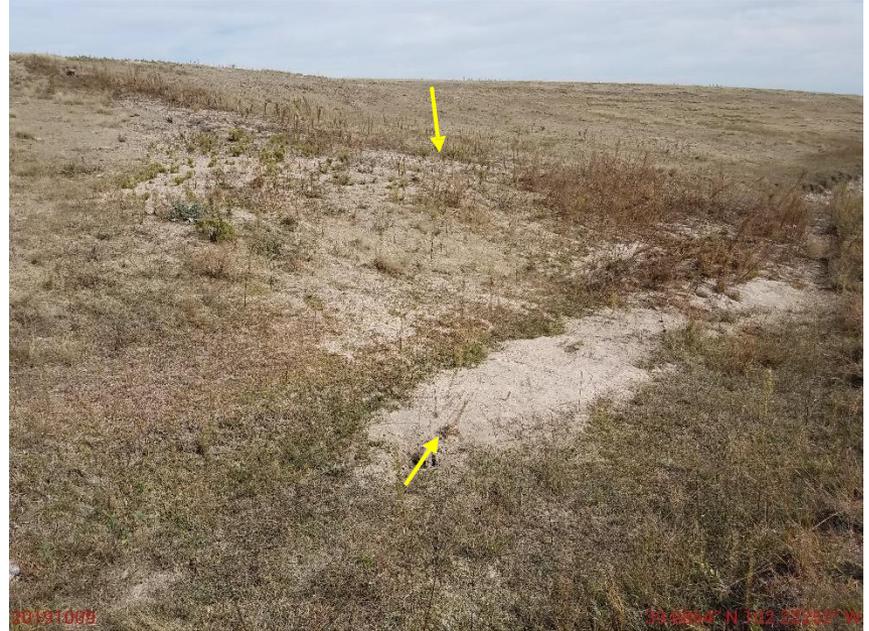
Photo 10: See comments under photo 8.

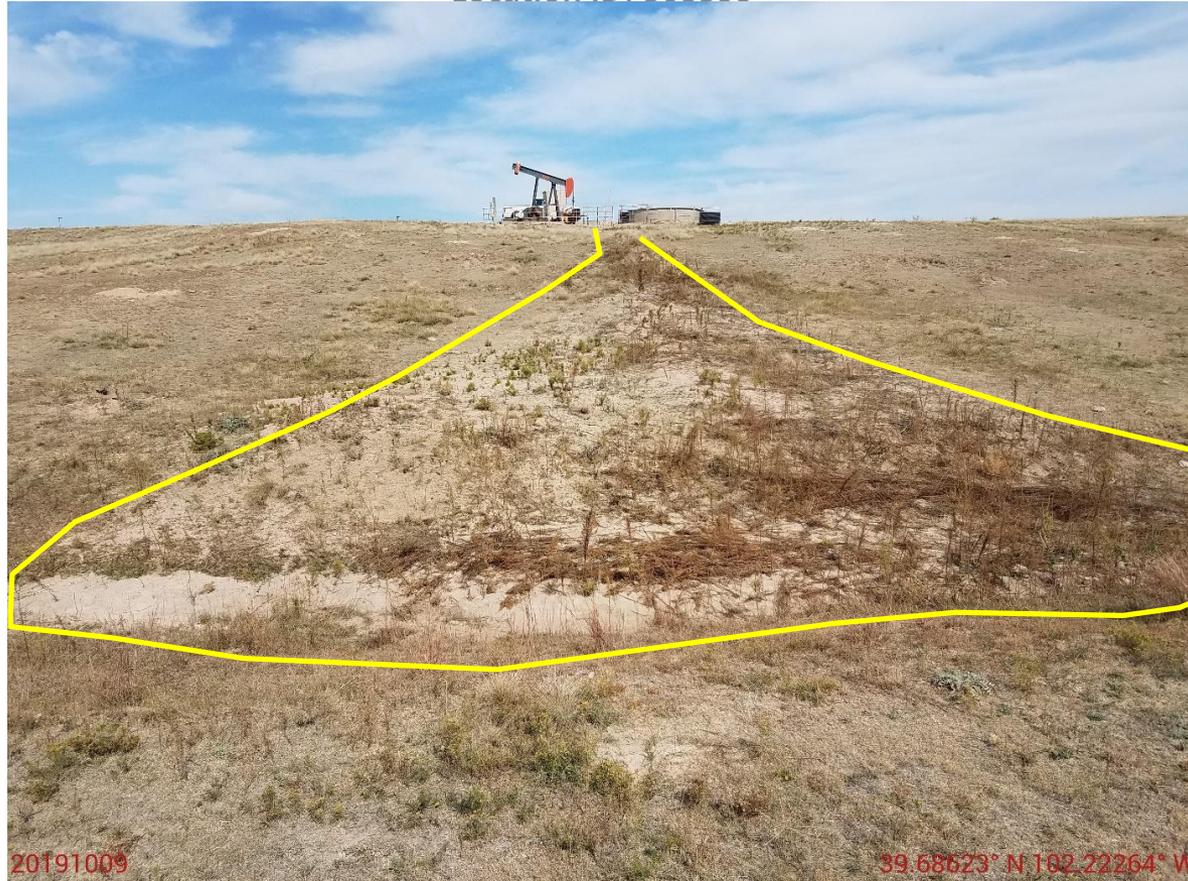
Photo 11: Photo taken from an intermittent drainage south of the location, facing north. Photo shows stormwater runoff from the location has caused degradation to the adjacent lands, as well as sediment deposition in an intermittent drainage/stream. Photo also shows that operator has not conducted reclamation activities to repair the degradation, or installed stormwater and erosion control BMPs.
