# Inspection Photos

API: 05-061-06076

Operator: CHEMCO INC

Inspection Date: 10/7/2019

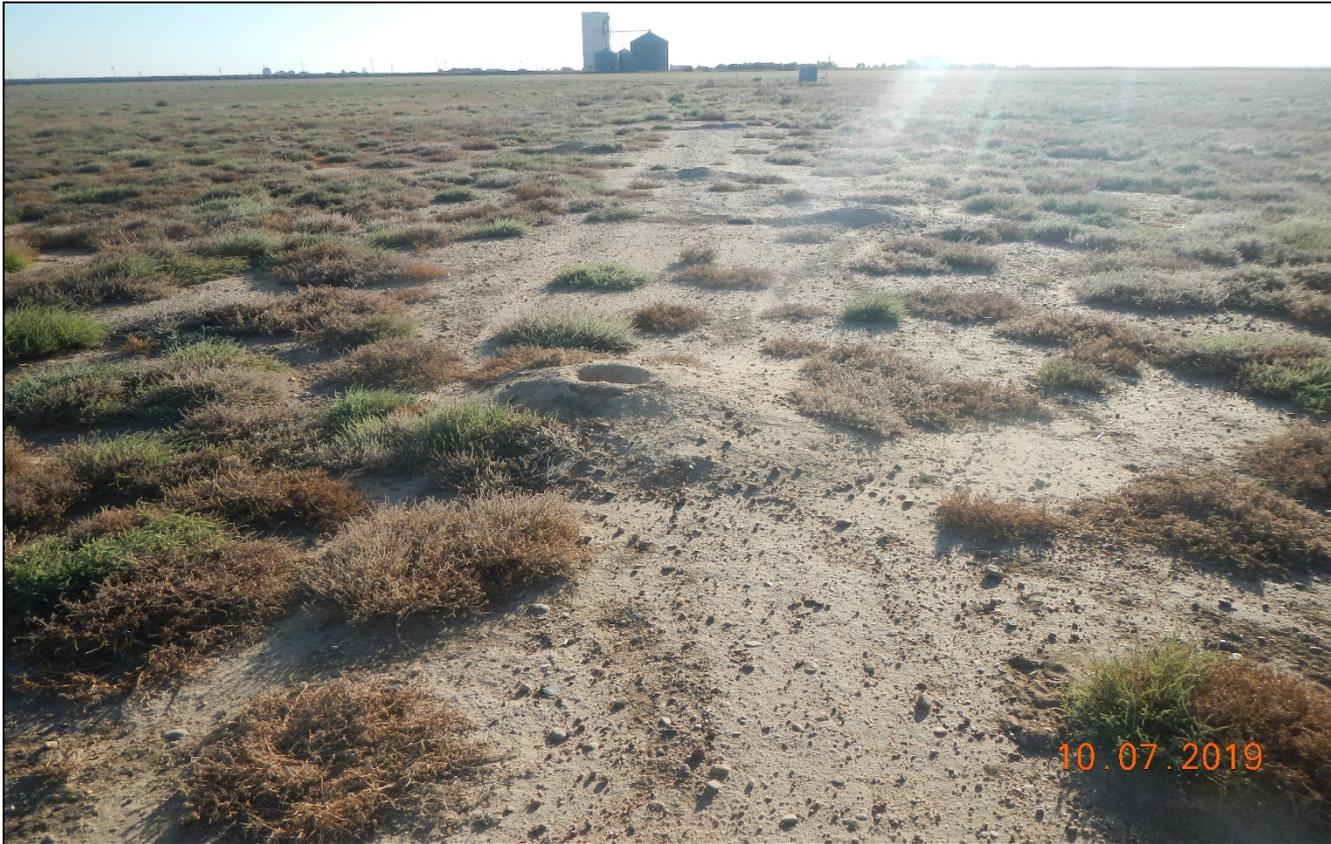
**Photo 1.** Facing southwest along the access road which has not been reclaimed. The crop has not re-established and there are undesirable weeds.

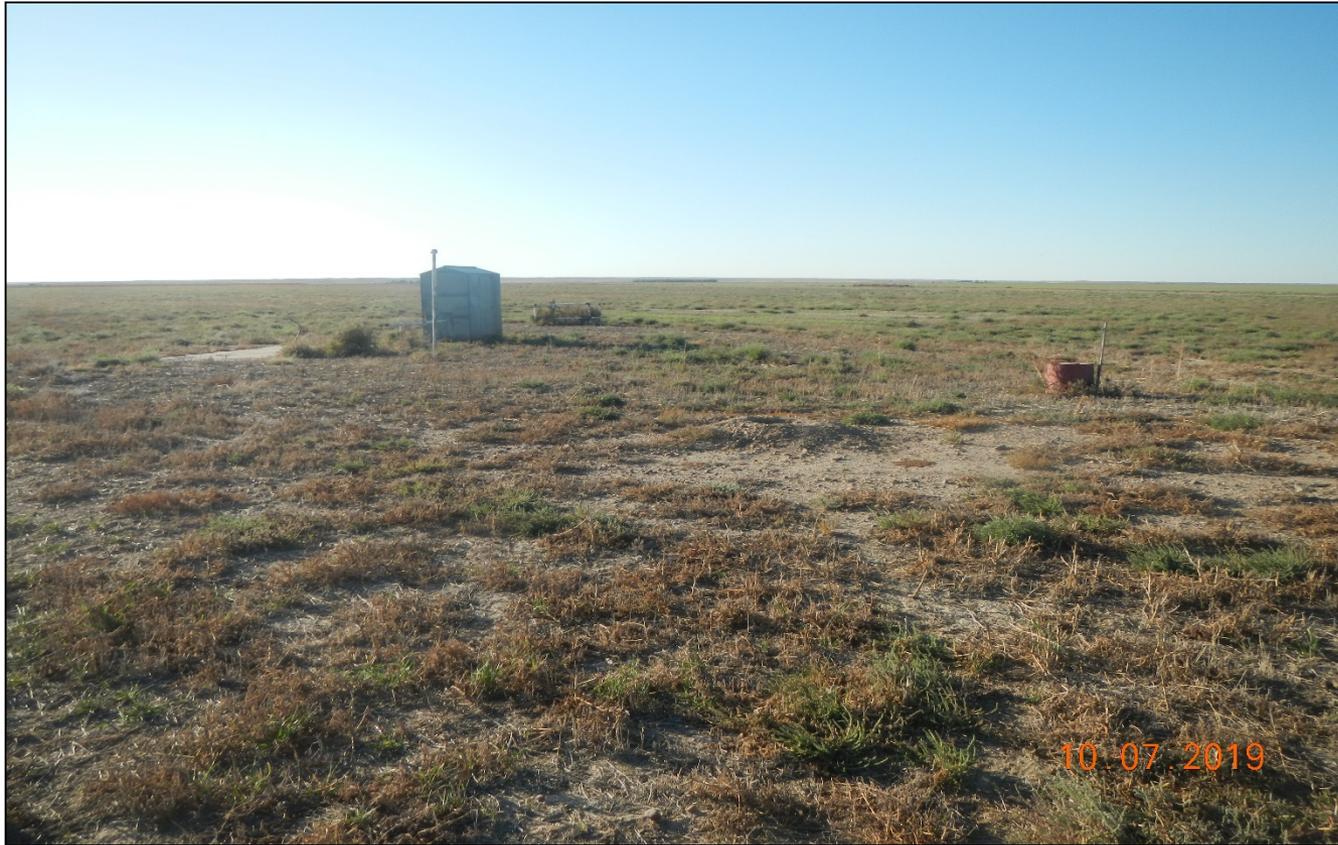
**Photo 2.** Facing west toward the location. There is equipment that still remains at the location.

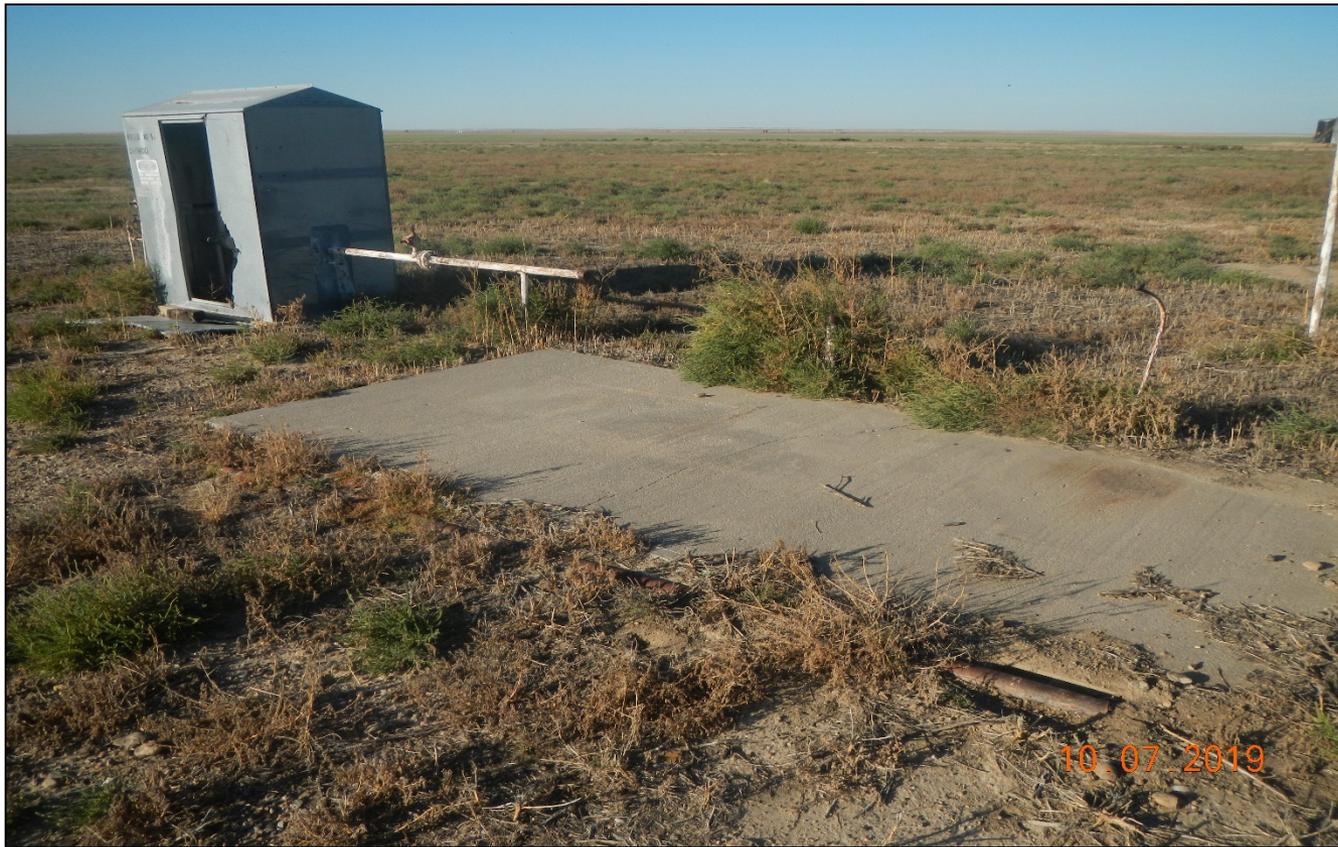
**Photo 3.** There is a cement pad, shed, and pipe risers that remain.

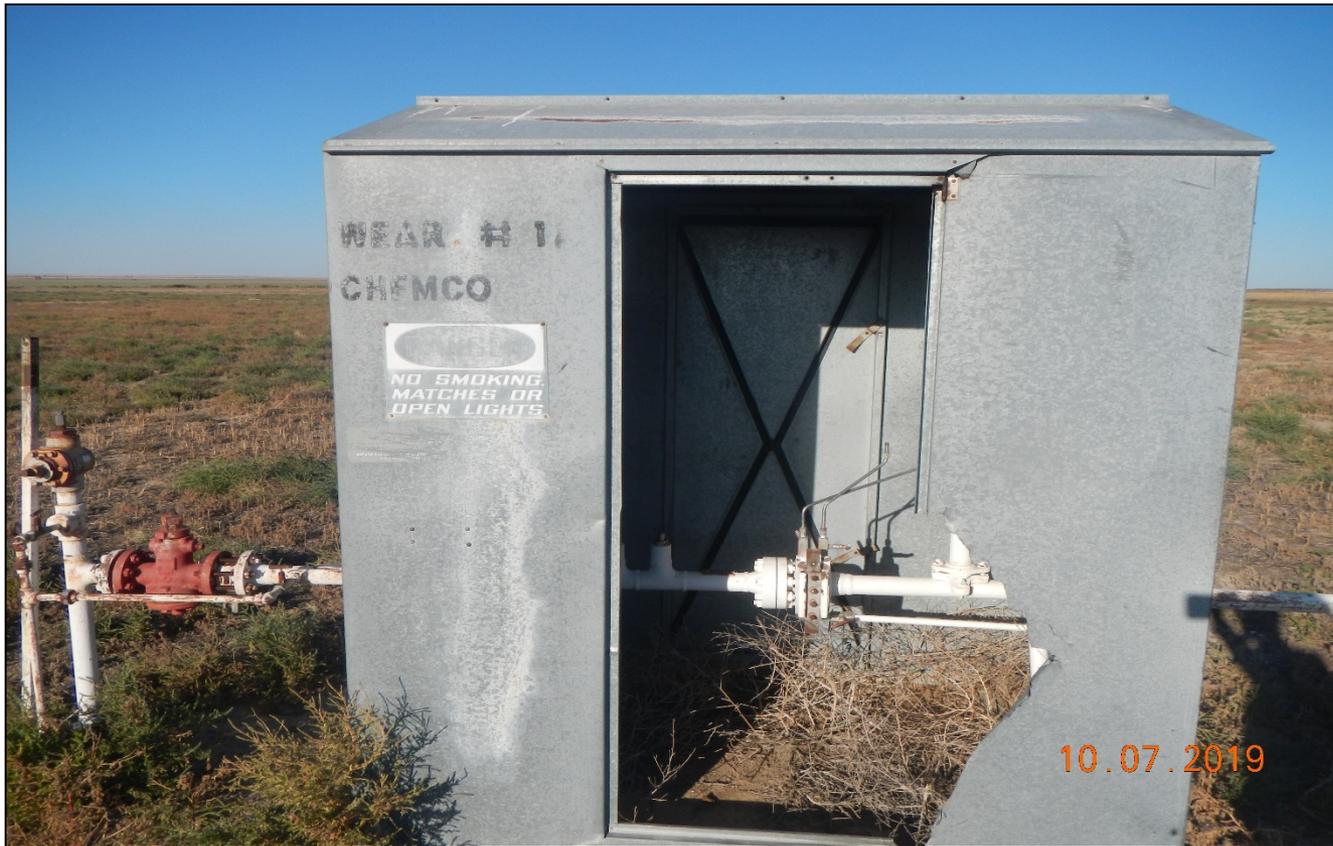
**Photo 4.** The shed Has location name Wear #1, and the Operator name CHEMCO.

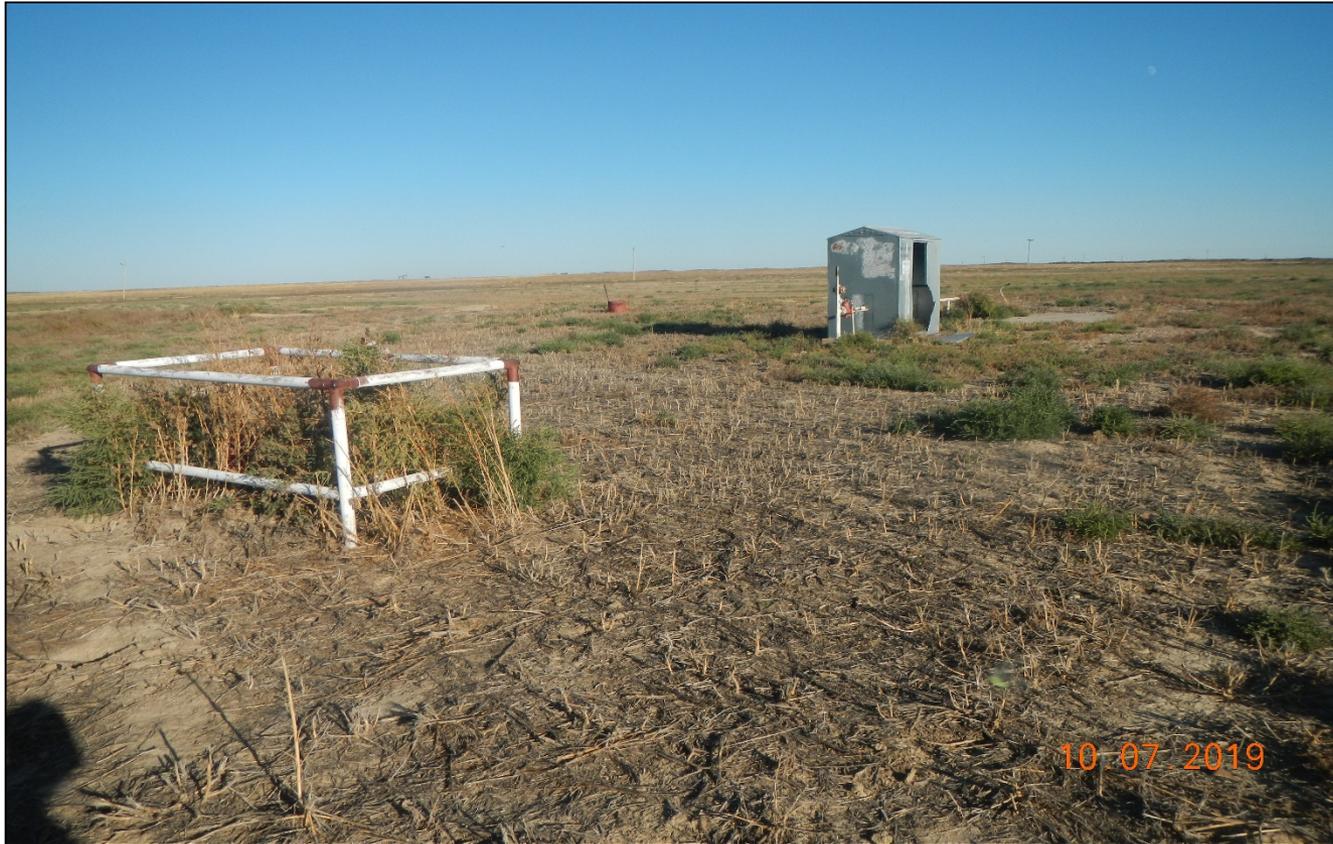
**Photo 5.** Facing east at the location.

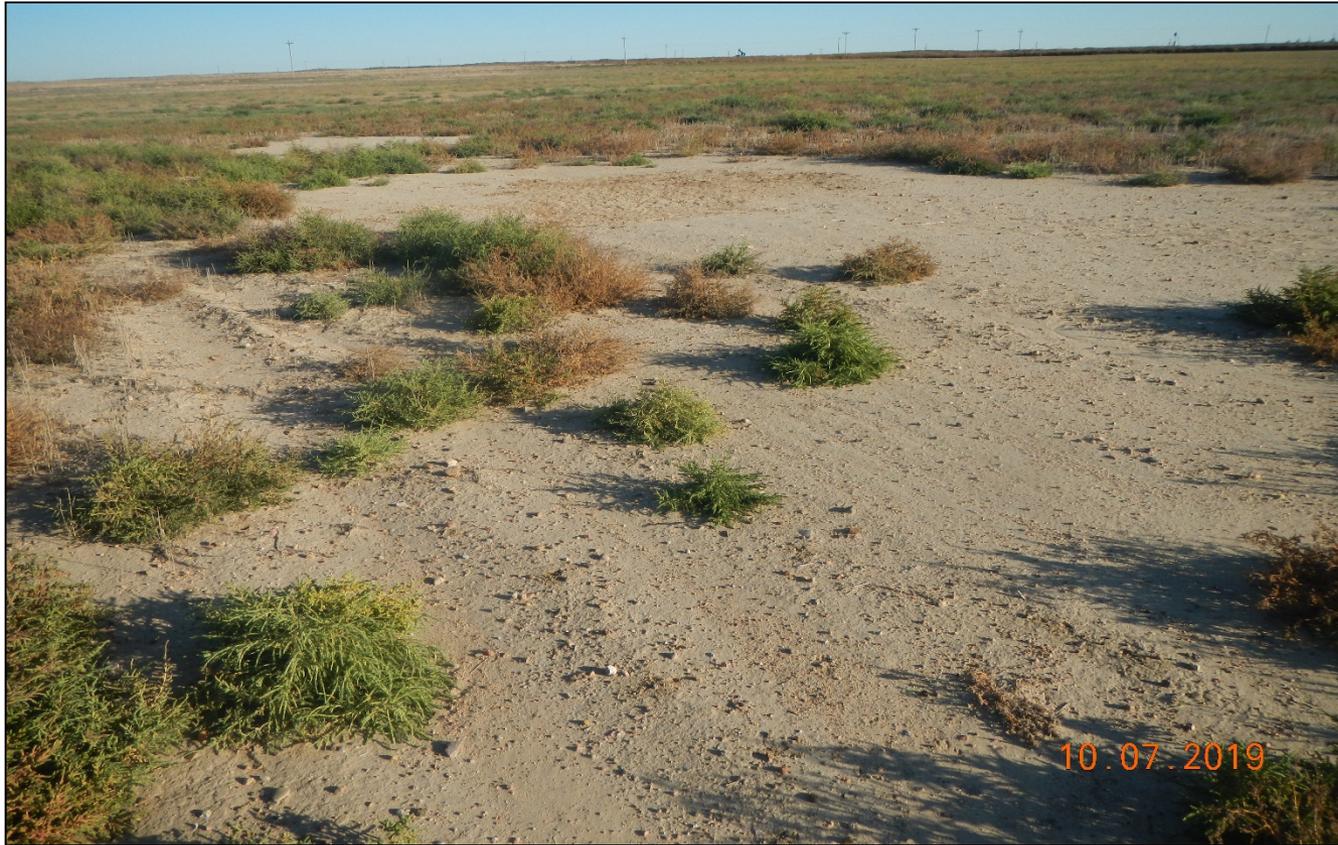
**Photo 6.** Facing toward the south side of the location. This area is bare of vegetation with no crop growth.

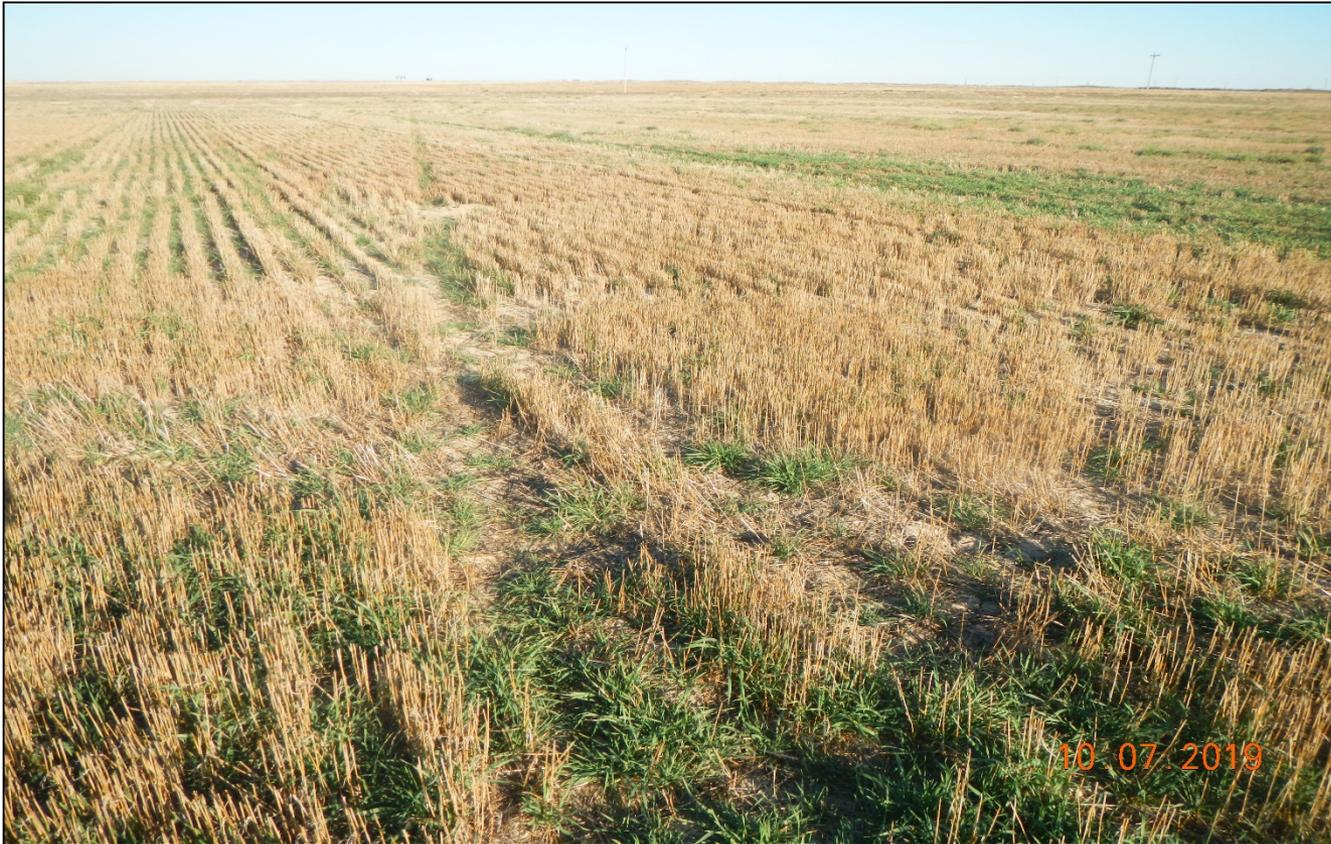
**Photo 7.** Facing southeast toward the surrounding undisturbed crop field. Wheat stubble is shown to be uniformly established.
