Inspection Photos

API: 05-017-07453

Operator: RESOURCE DEVELOPMENT

Inspection Date: 10/7/2019

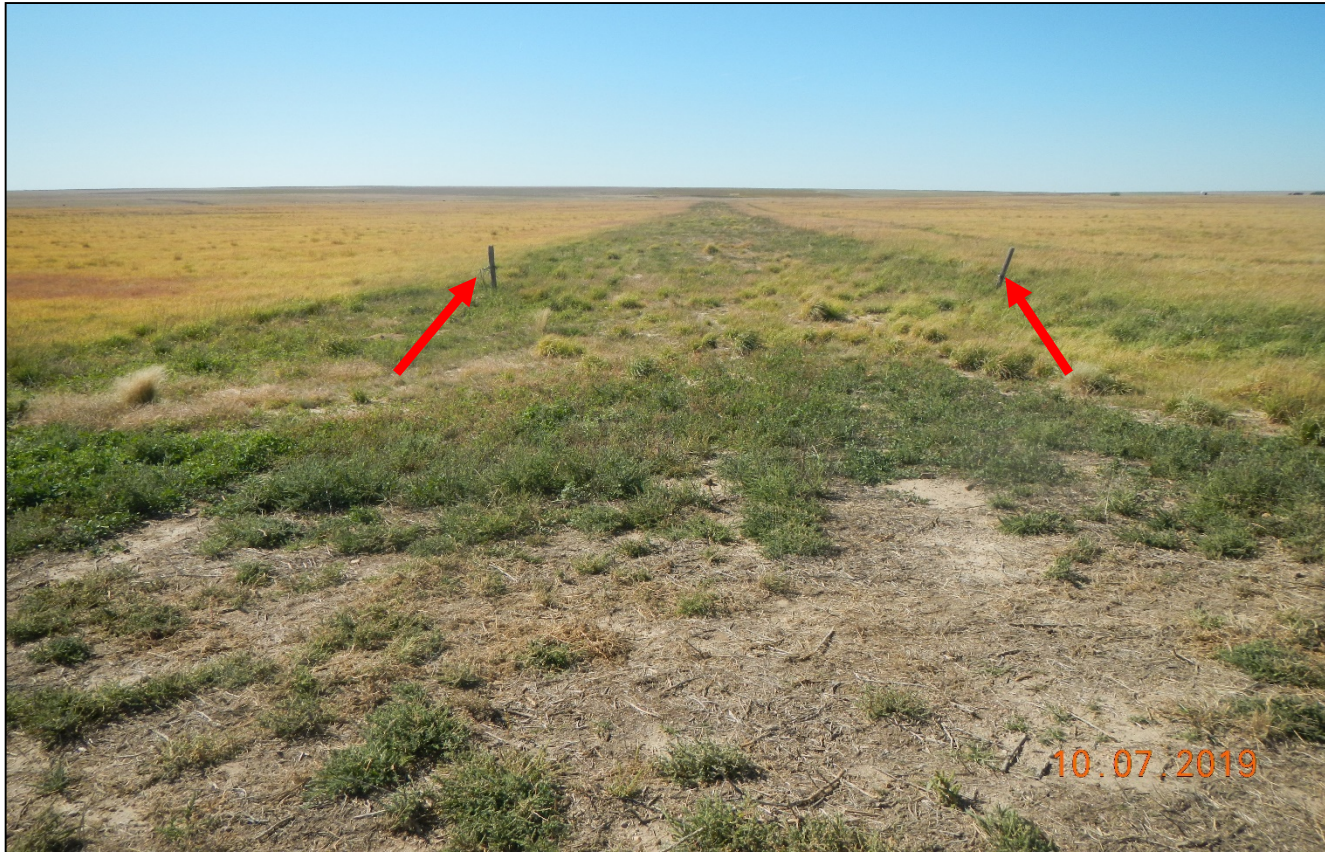
Photo 1. Facing west at the beginning of the reclaimed access road. There are two wood posts that remain.

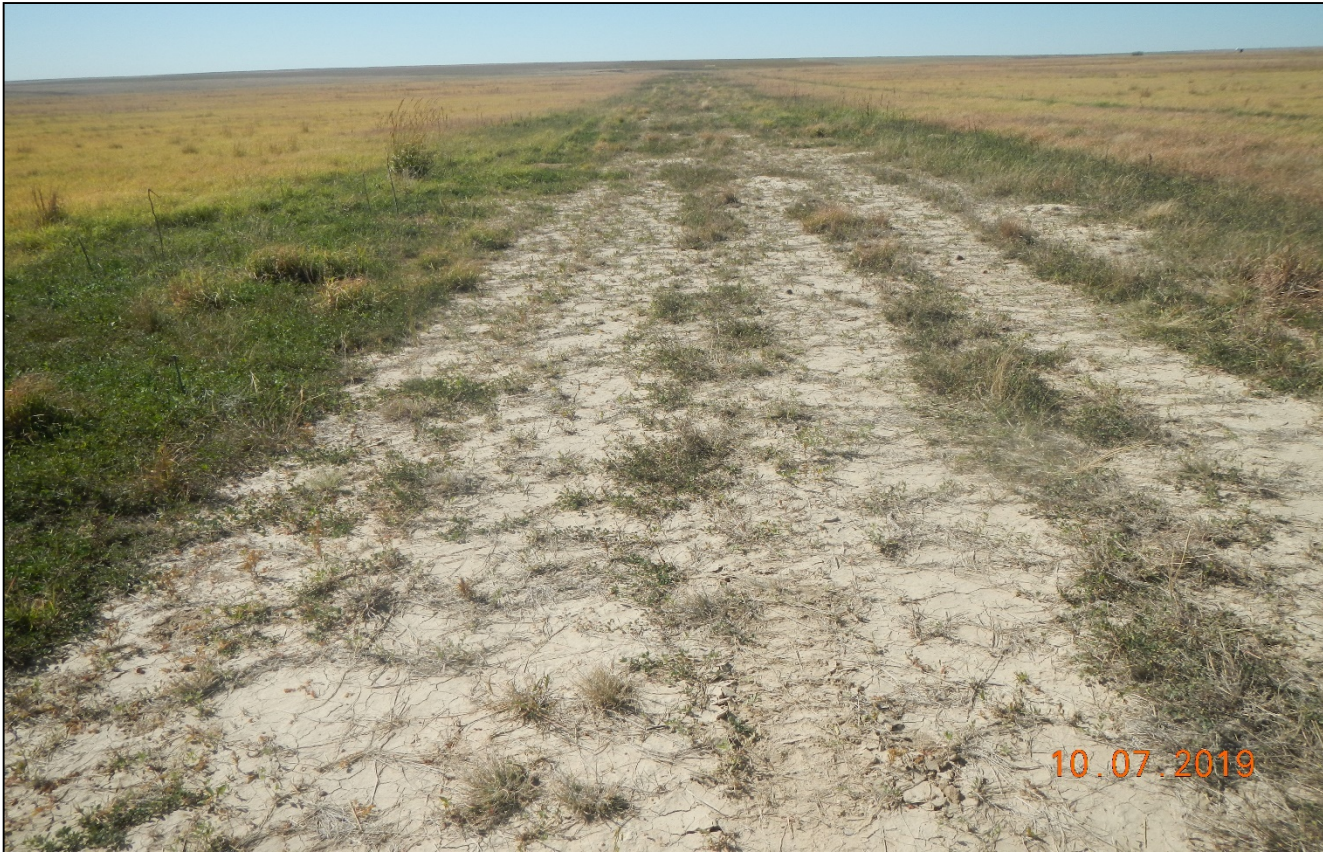
Photo 2. Facing west along the former access road. There are areas along the road where vegetation is not established and soils appear to be compacted.

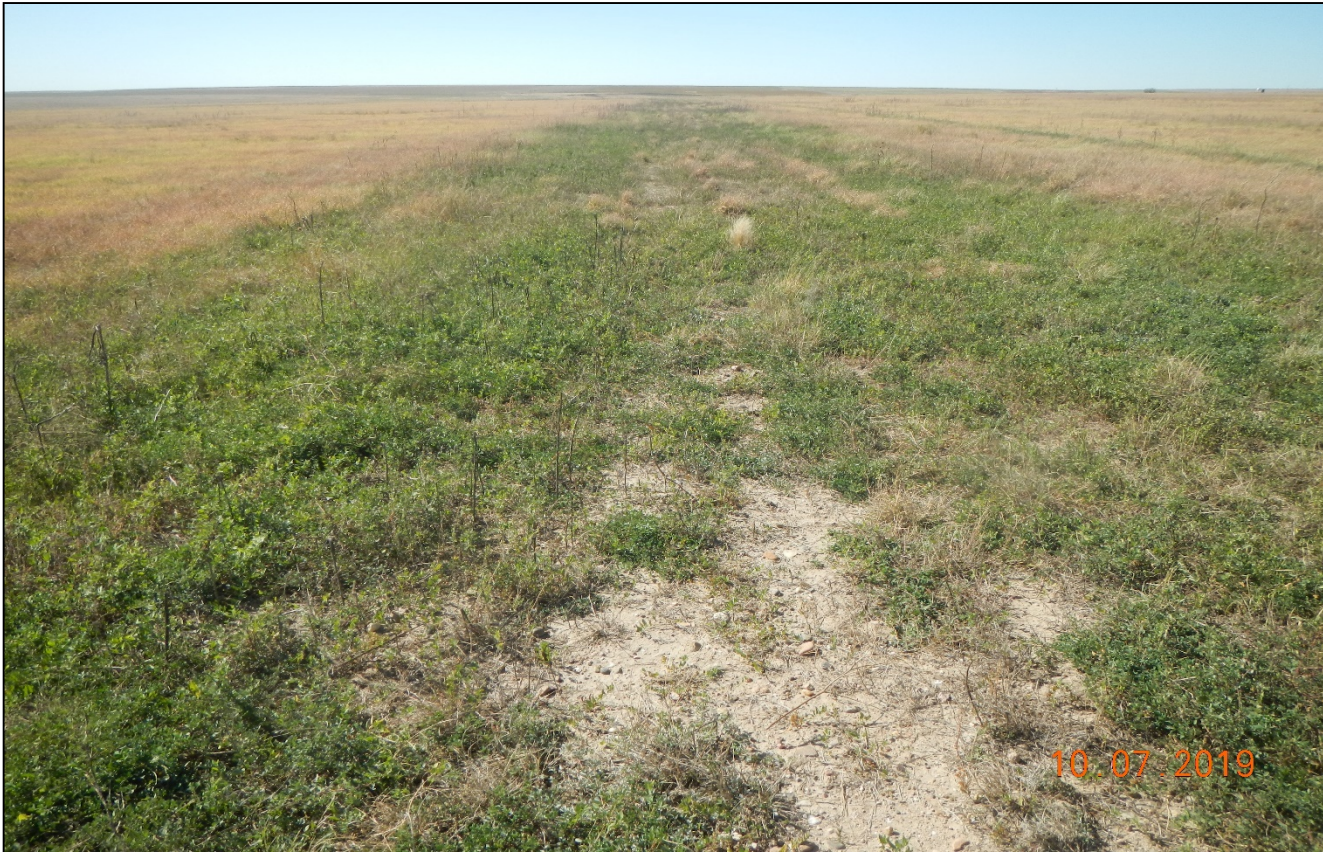
Photo 3. Facing west further along the access road. There is weedy vegetation along the road.

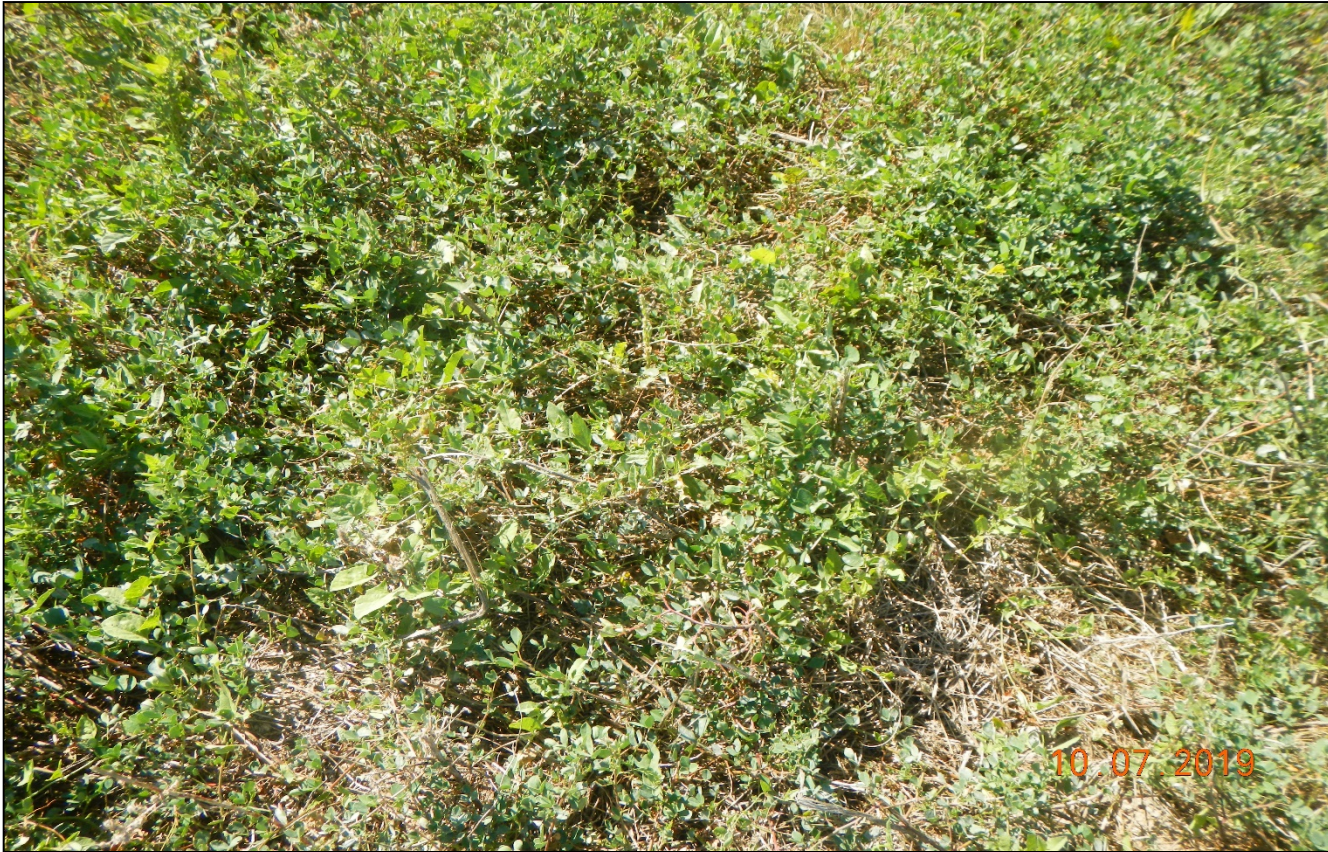
Photo 4. View of vegetation along the road is comprised mostly with *Medicago* sp. and Field bindweed which is a List C noxious weed. These species were not observed in the undisturbed reference area.

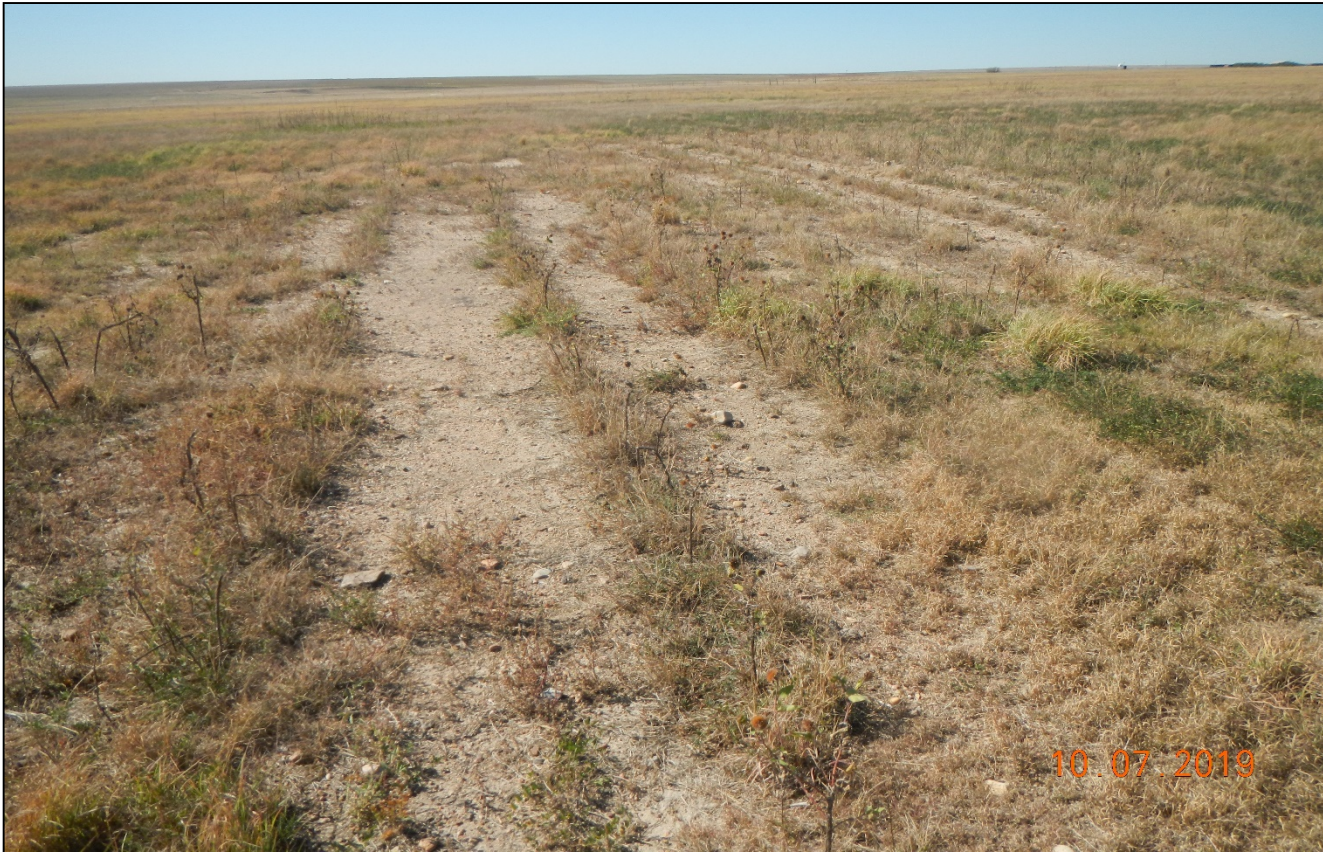
Photo 5. Facing west toward the location. Vegetation has not adequately established and bare areas have compacted soils. It appears the soils were not cross ripped as required.

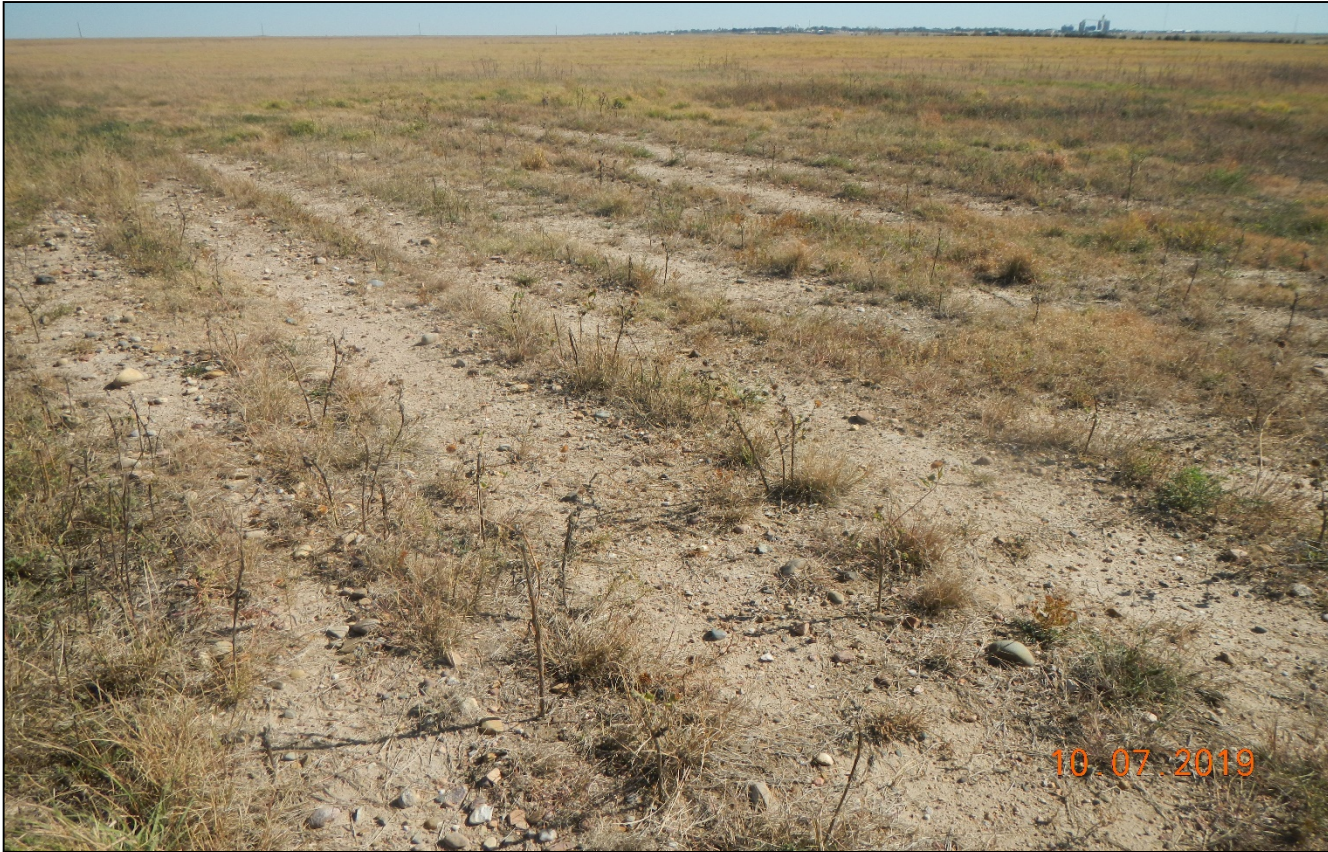
Photo 6. Facing southeast. There are rows of compacted soil where vegetation is not growing.

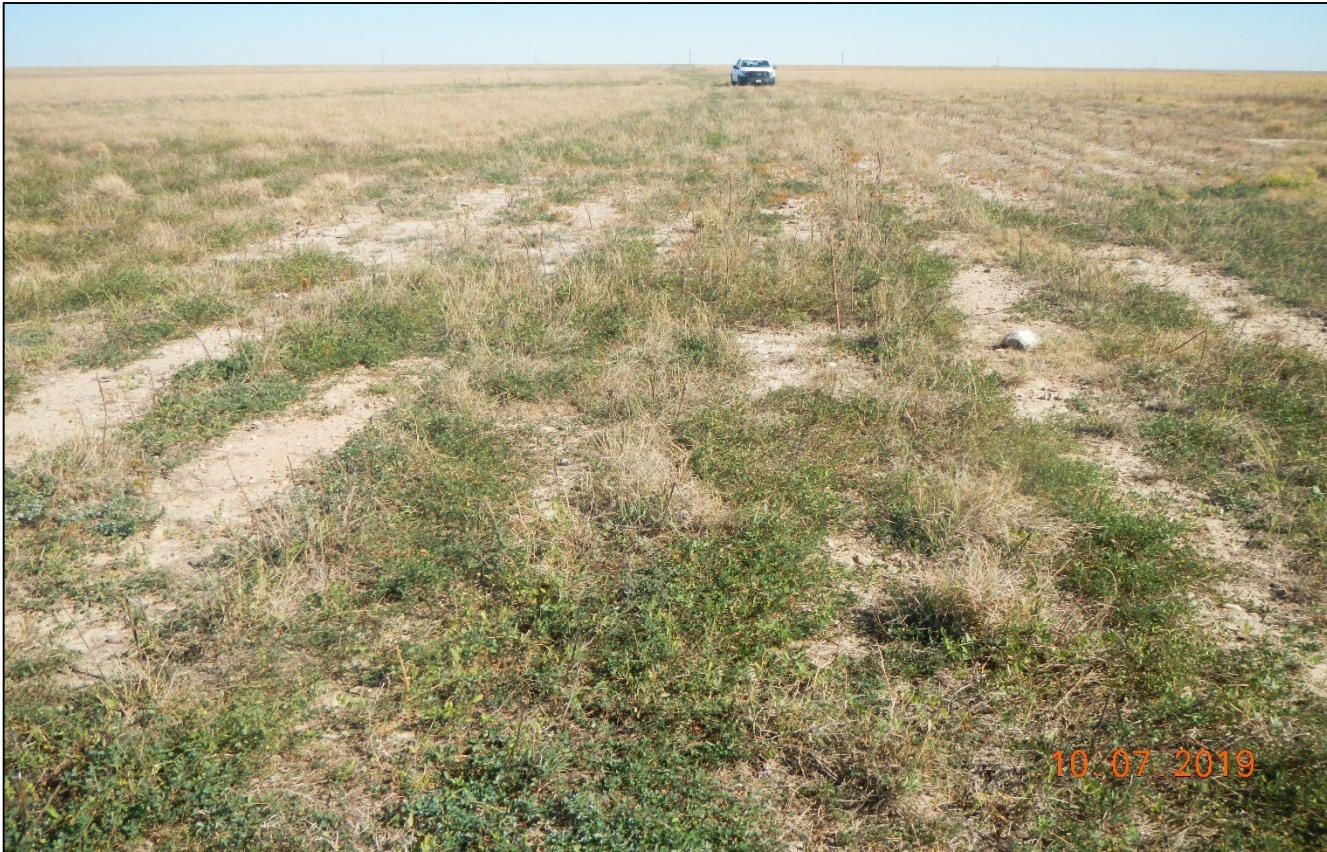
Photo 7. West side of the location facing east. There are rows of compacted soil where vegetation is not growing.

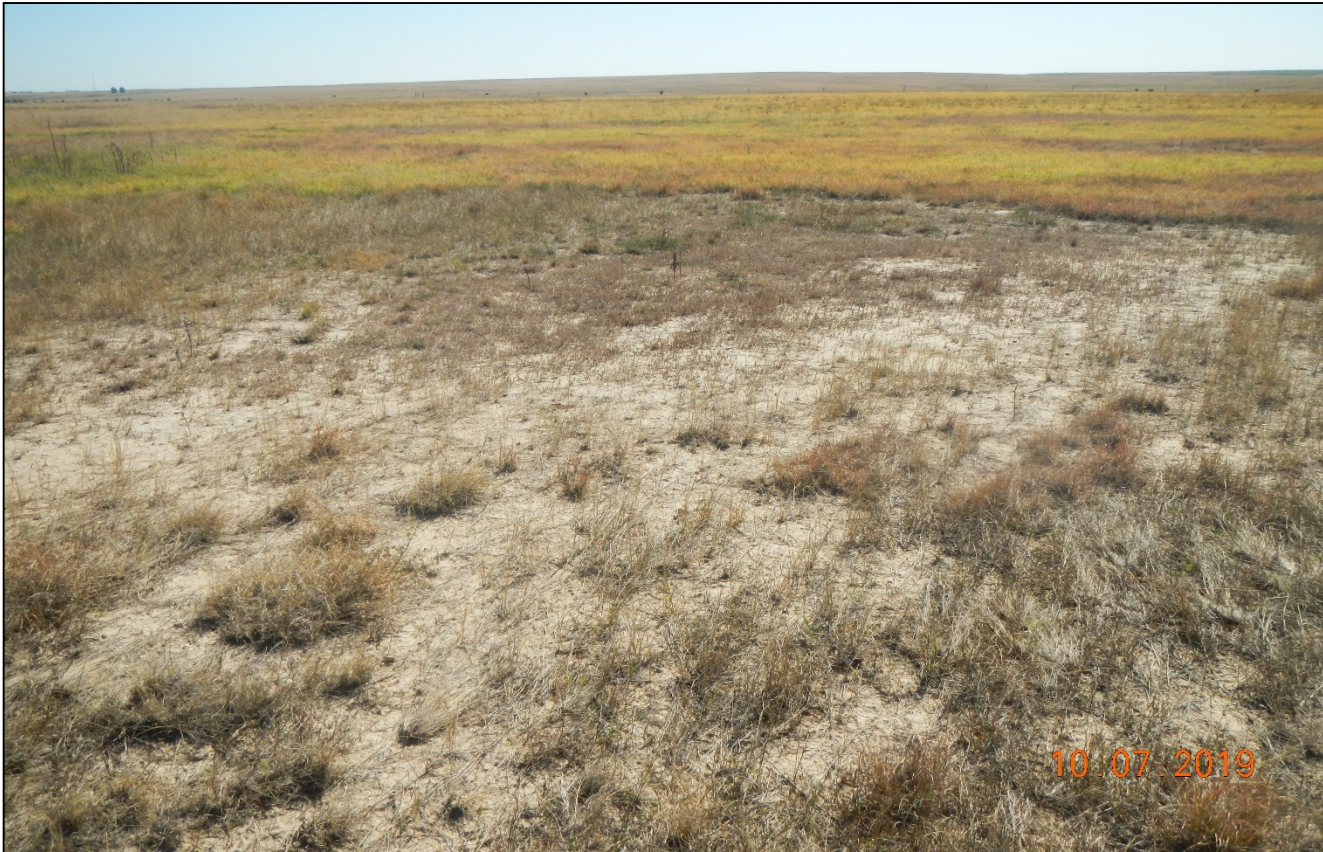
Photo 8. West side of the location facing south. Vegetation has not adequately established in this area. Possible soil compaction.

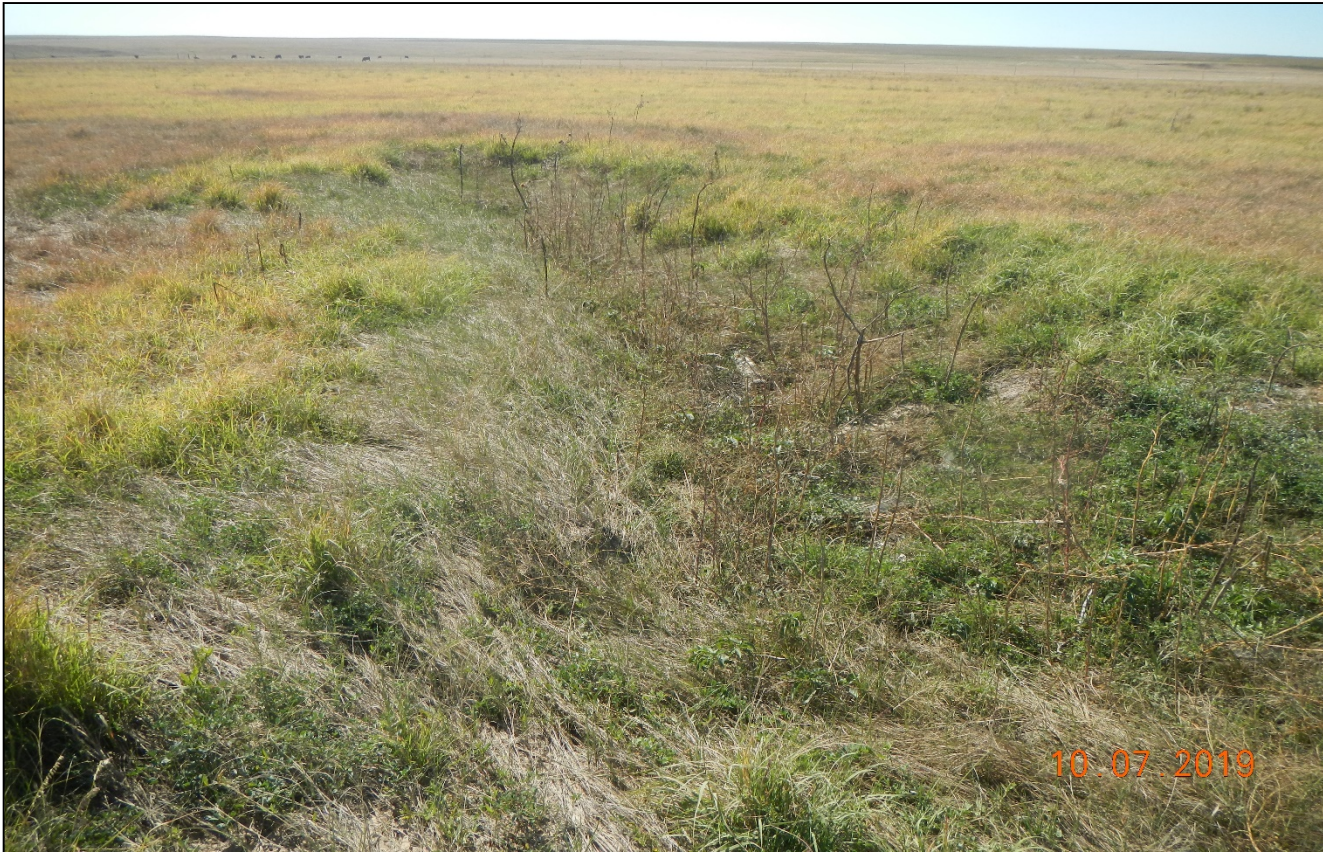
Photo 9. There is an area of subsidence at the west side of the location which is approximately 80 ft. long x 10 ft. wide x 2ft. deep.

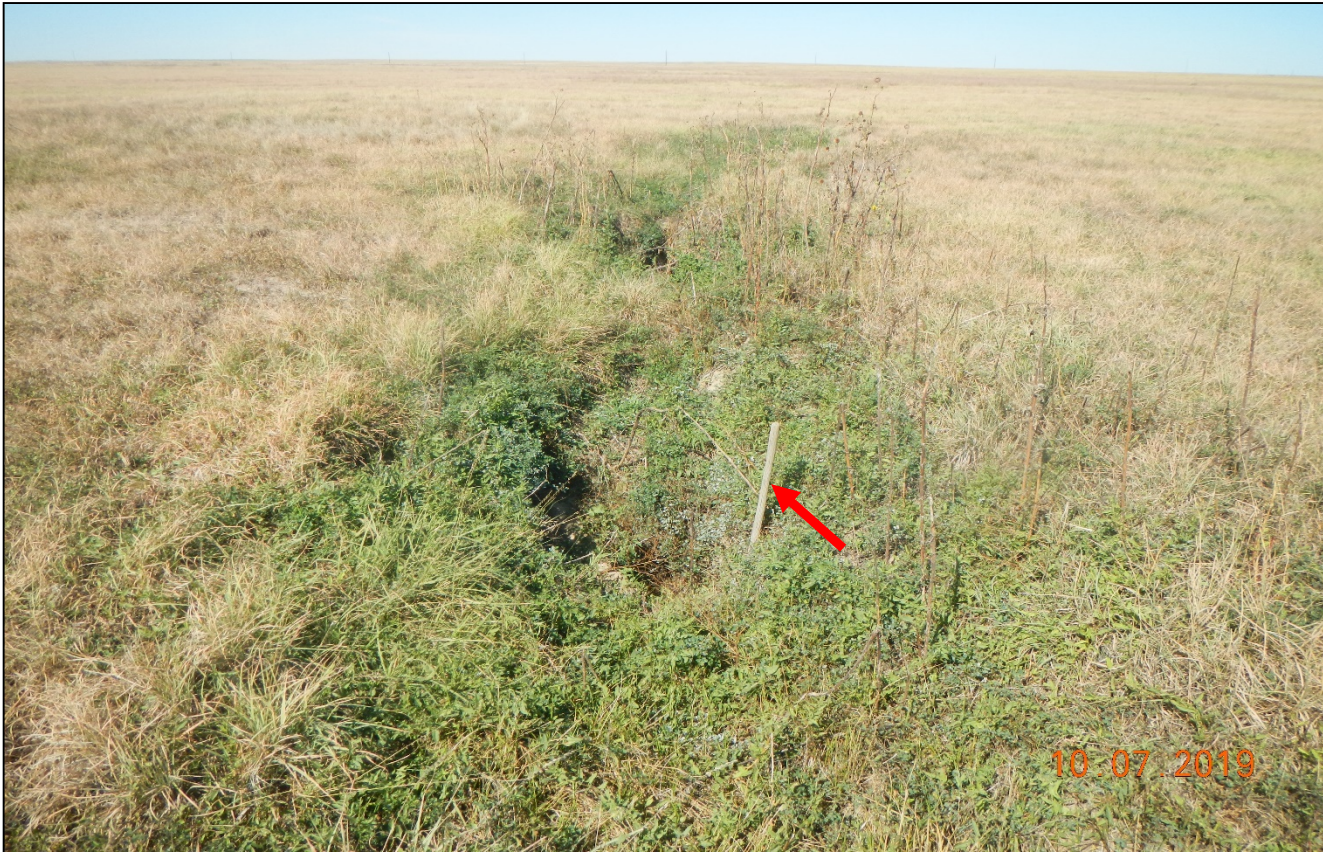
Photo 10. There is another area of subsidence at the north side of the location which is approximately 3-4ft. deep. Red arrow points to 5 ft. shovel placed in the area.

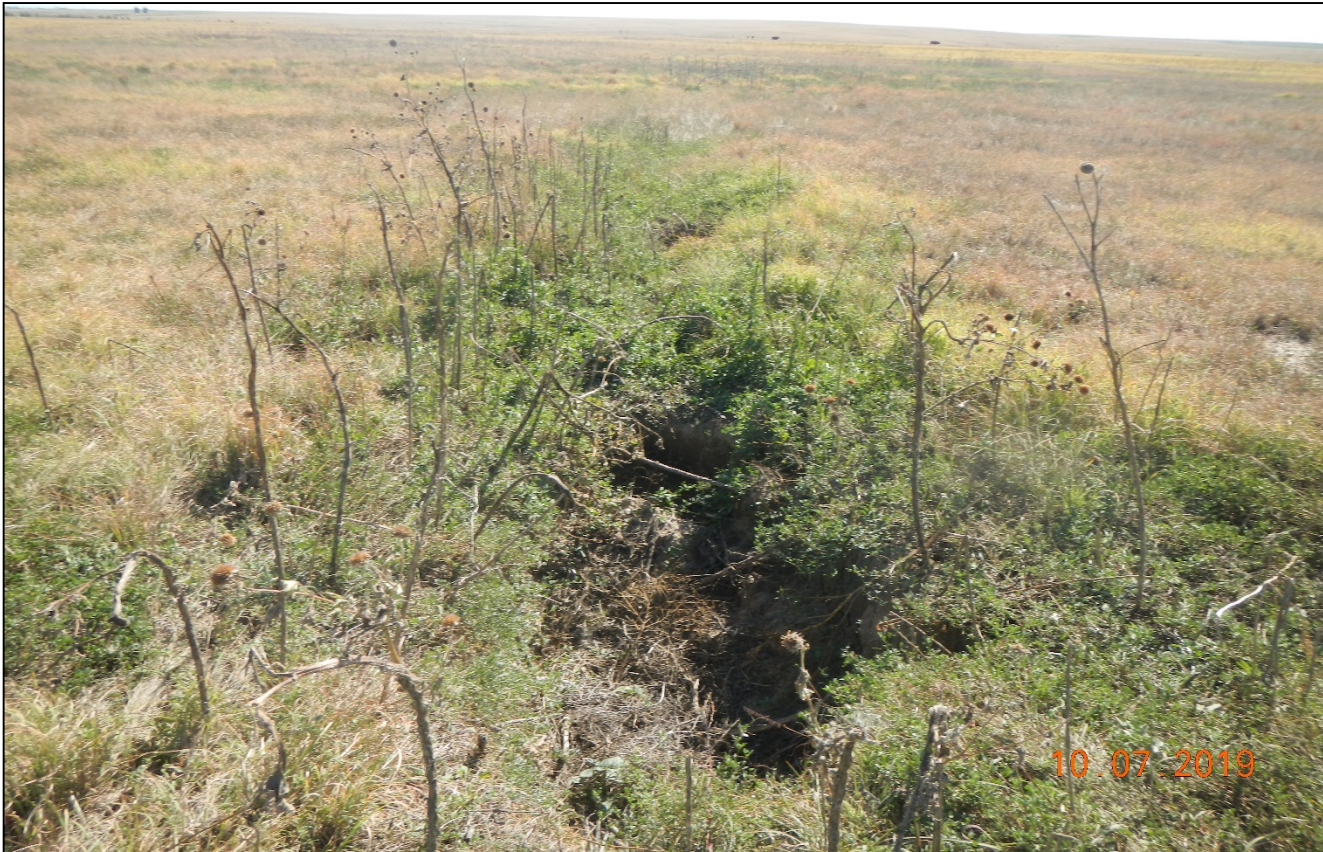
Photo 11. Facing south at the north side of the location where subsidence occurred. Deep hole is a safety concern.

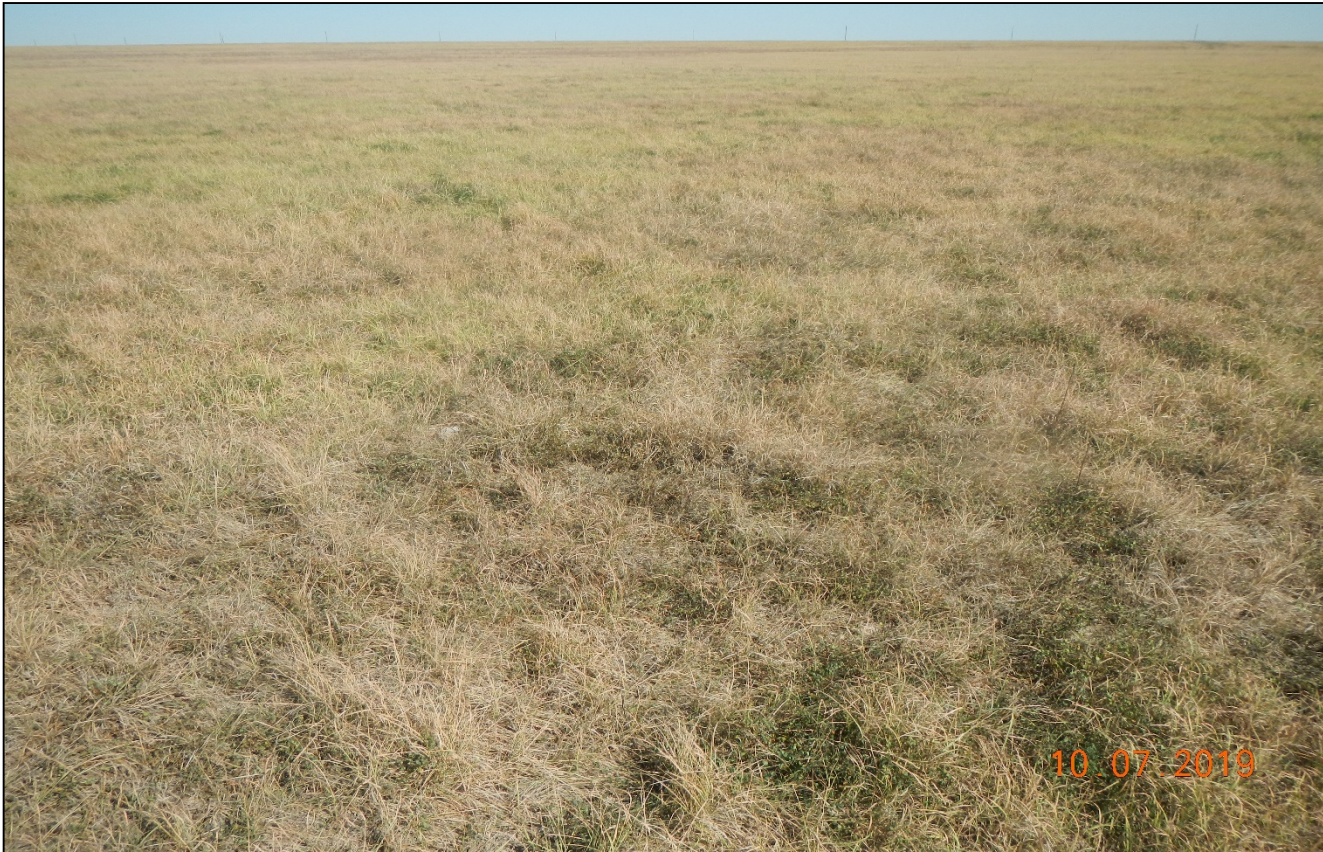
Photo 12. Facing north toward the undisturbed reference area which is mostly composed of Sideoats grama, Blue grama, and Sand dropseed.
