# Inspection Photos

API: 05-009-05182

Operator: TROJAN OIL & GAS COMPANY

Inspection Date: 10/8/2019

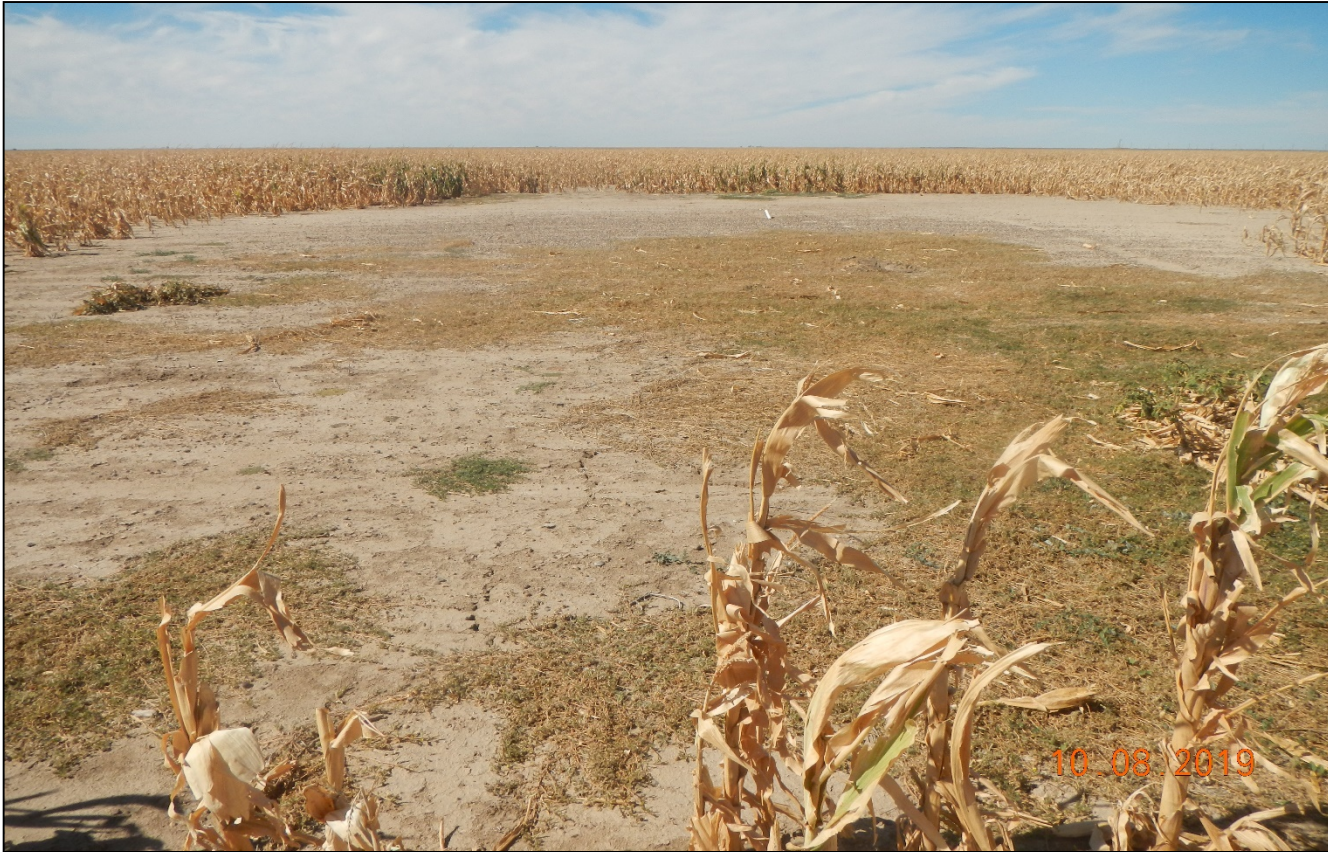
**Photo 1.** Facing west toward the location. The area which does not have crop growth was stepped out to be approximately 130' x 60'.

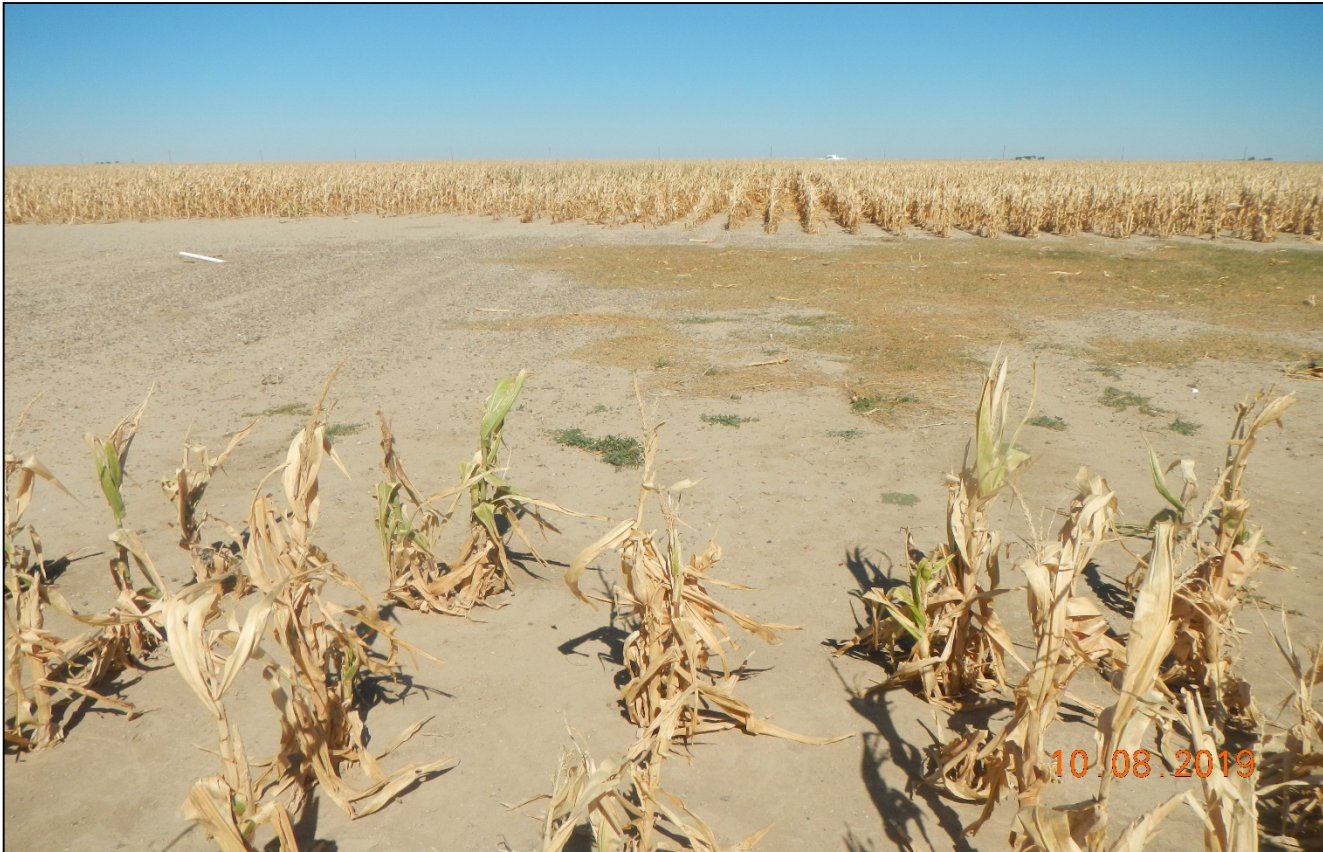
**Photo 2.** Facing north toward the location. The area which does not have crop growth was stepped out to be approximately 130' x 60'.

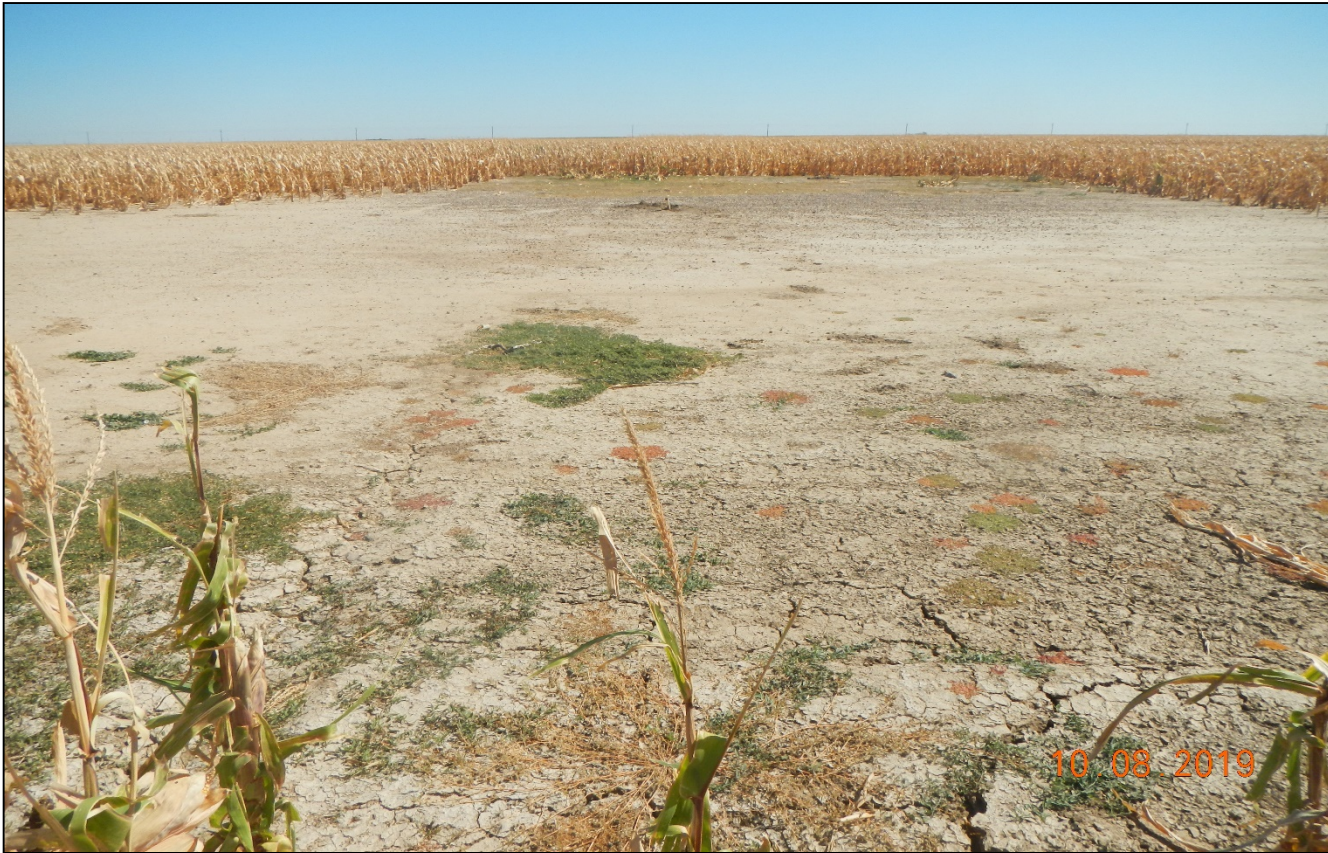
**Photo 3.** Facing east toward the location. The area which does not have crop growth was stepped out to be approximately 130' x 60'.

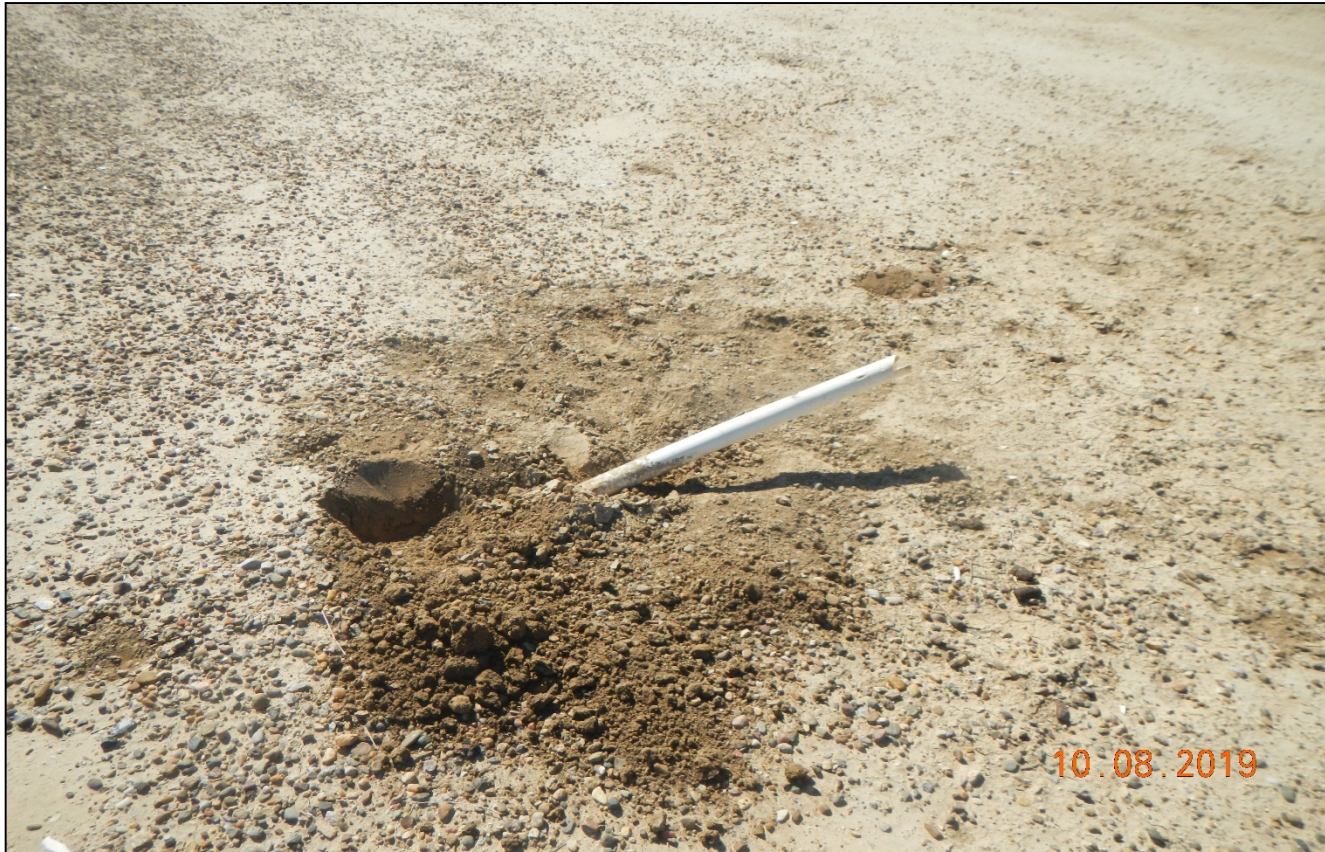
**Photo 5.** Plastic pipe remains at center of the location. Dug around the pipe but it is buried deep into the ground. Will need to be cut and capped 3 ft. below grade.

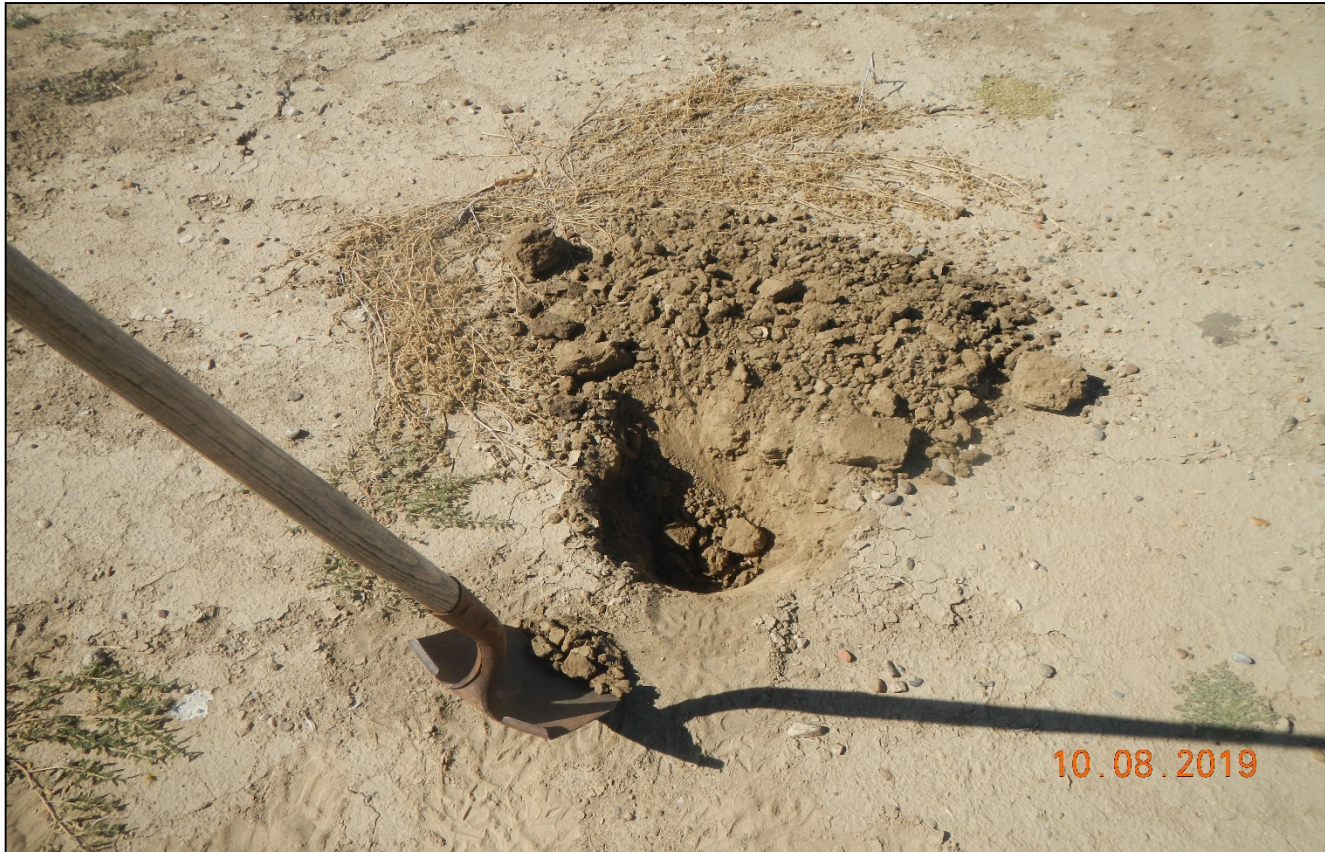
**Photo 6.** The top six inches did not seem to be compacted but it was much more compacted past 6 inch depth.
