# Inspection Photos

API: 05-009-06189

Operator: DOVER ATWOOD CORPORATION

Inspection Date: 10/8/2019

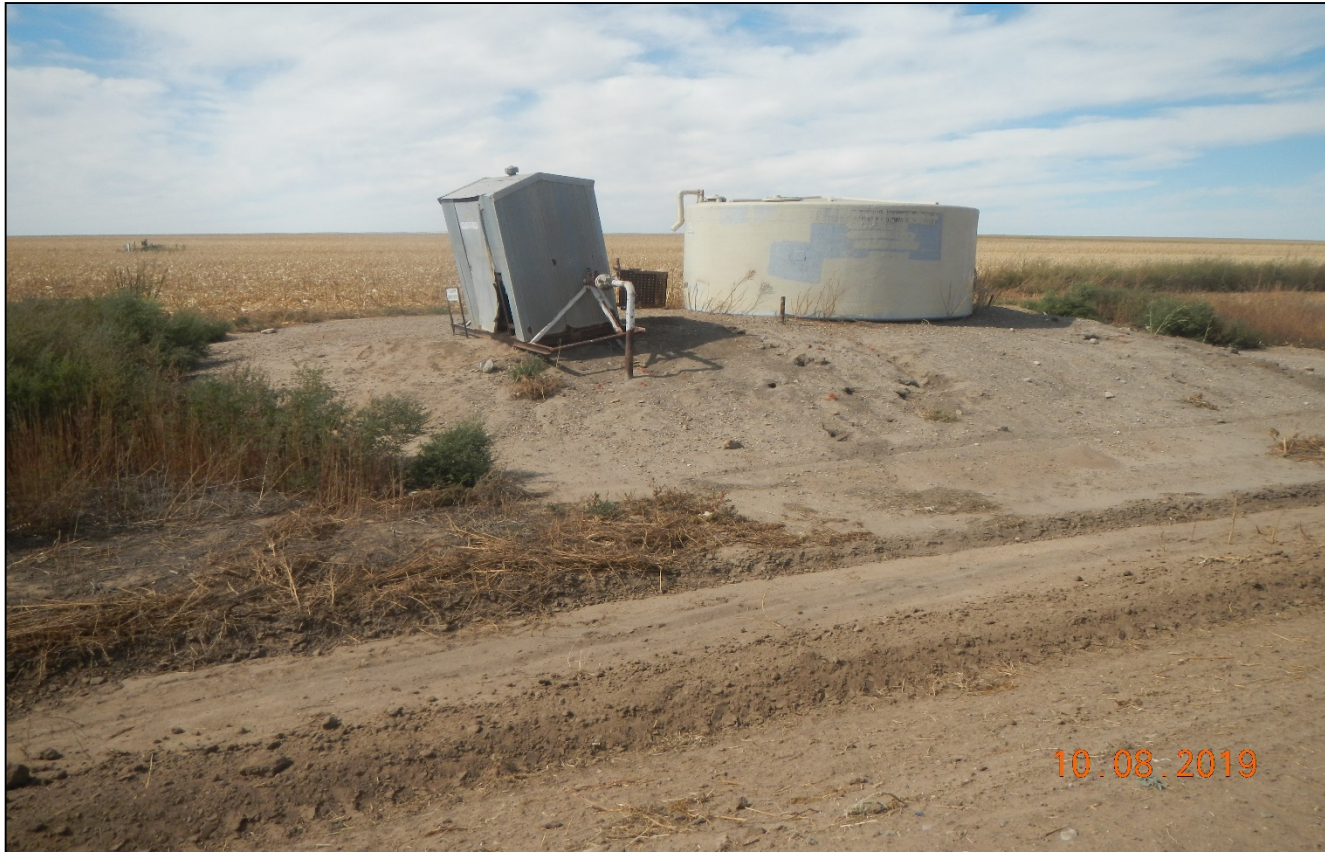
**Photo 1.** Facing west toward the PW tank and meter shed located adjacent to CR-49 and 575' east of the well. No operator sign installed at the battery site. Corrective actions of the previous inspection were not performed.

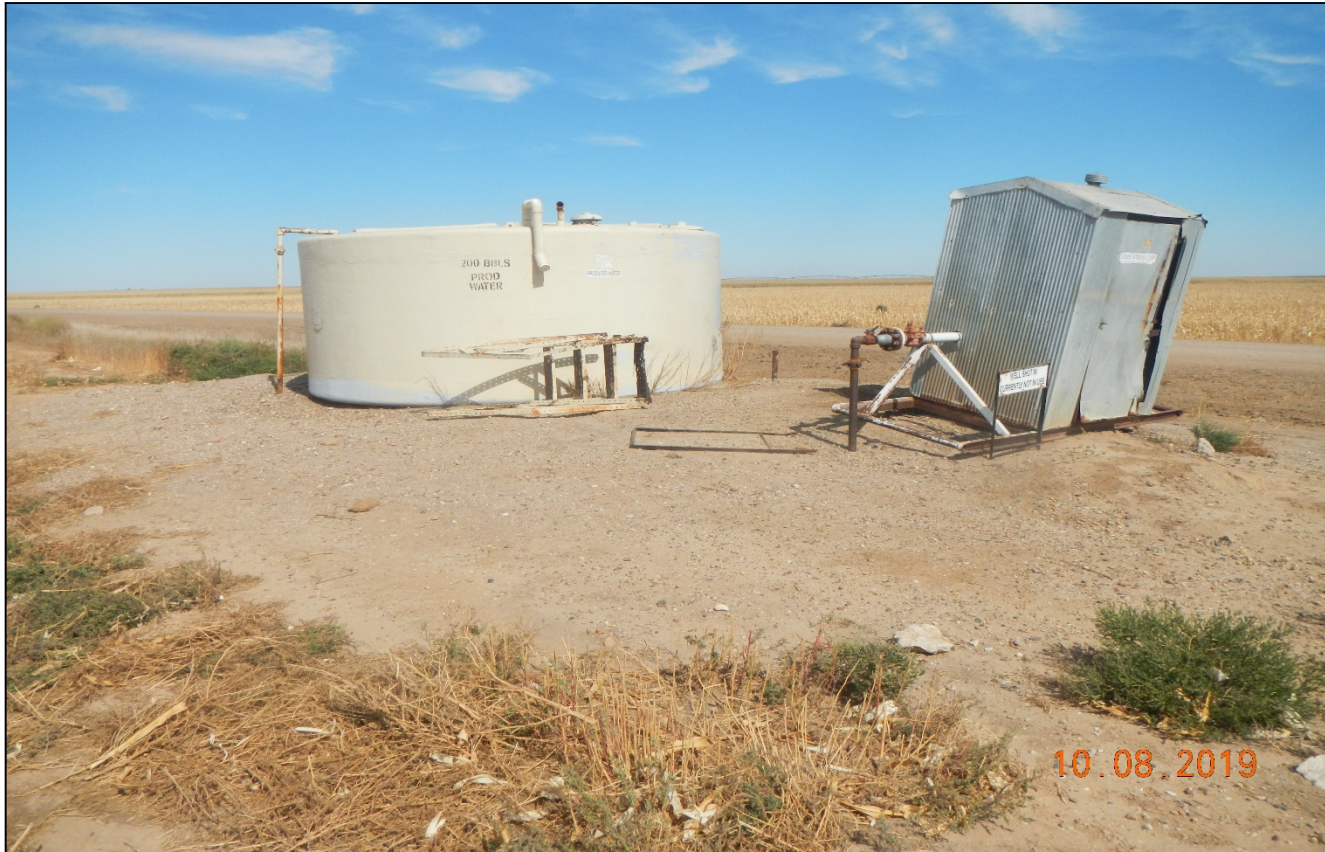
**Photo 2.** Corrective actions of the previous inspection were not performed. There is no berm around the 200 bbl tank. There is unused equipment at the location.

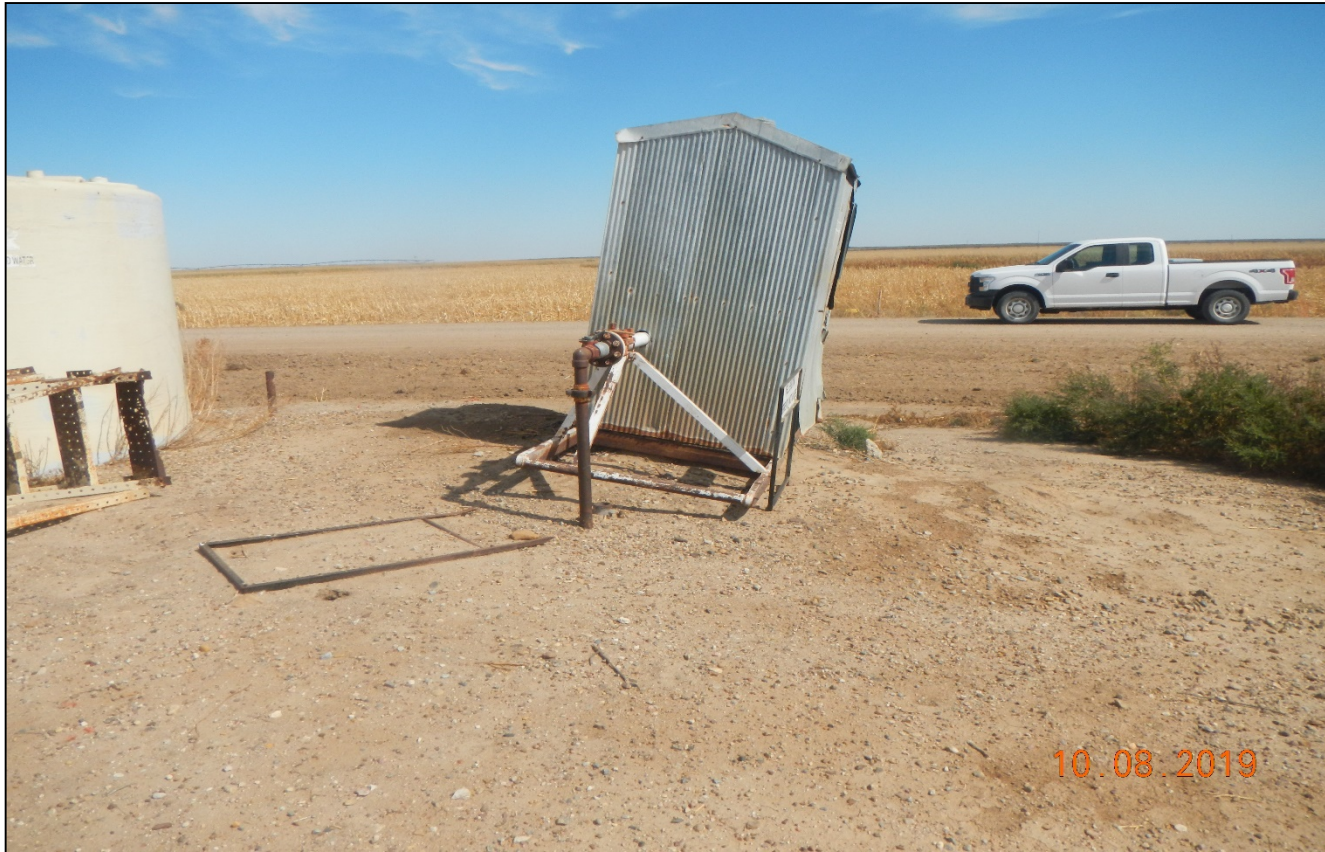
**Photo 3.** The meter shed does not appear to be stable and is leaning over which is a safety concern. Corrective actions of the previous inspection were not performed.

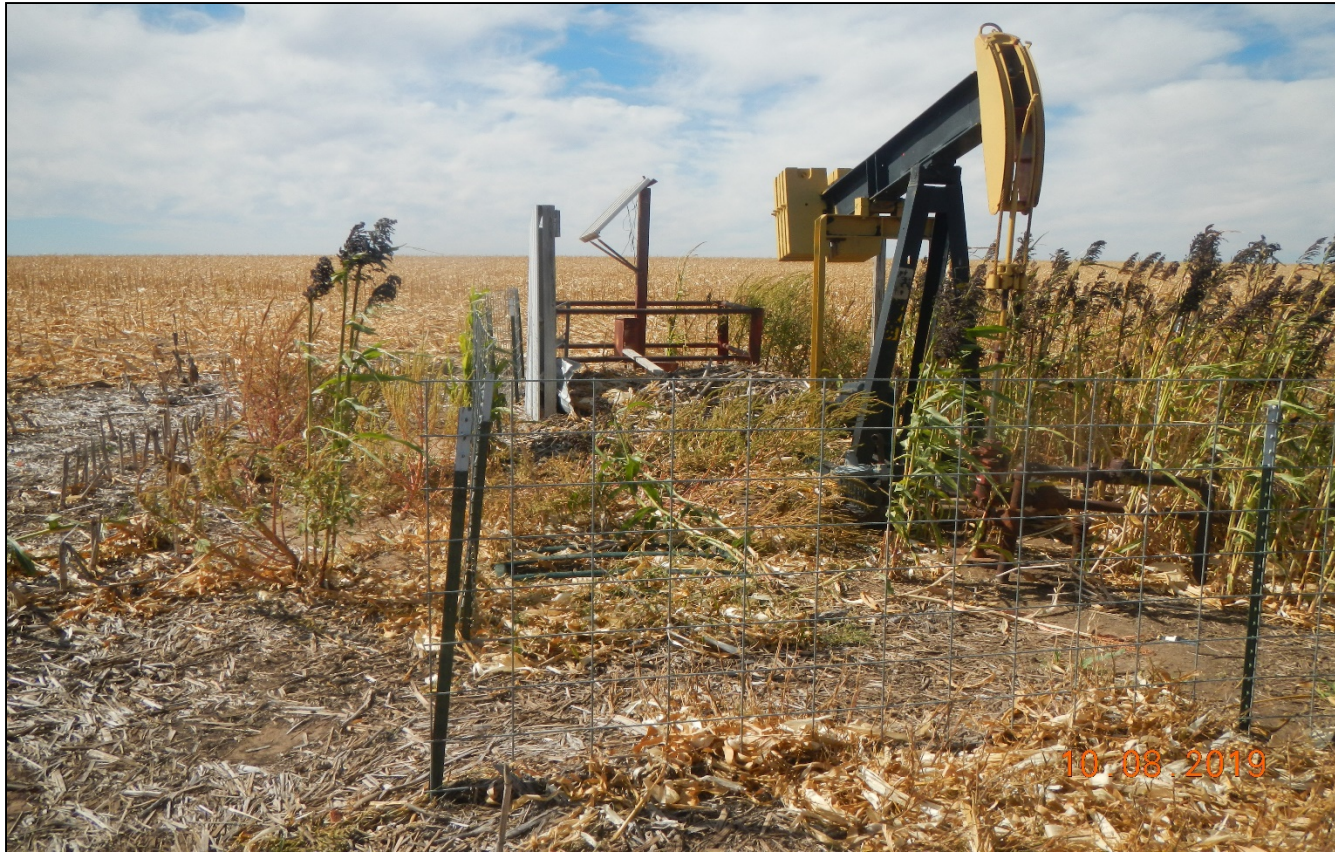
**Photo 5.** There debris and vegetation around the equipment which is a fire hazard. No well sign is posted.
