Inspection Photos

ID: 441082

Operator: DOVER ATWOOD CORPORATION

Inspection Date: 10/8/2019

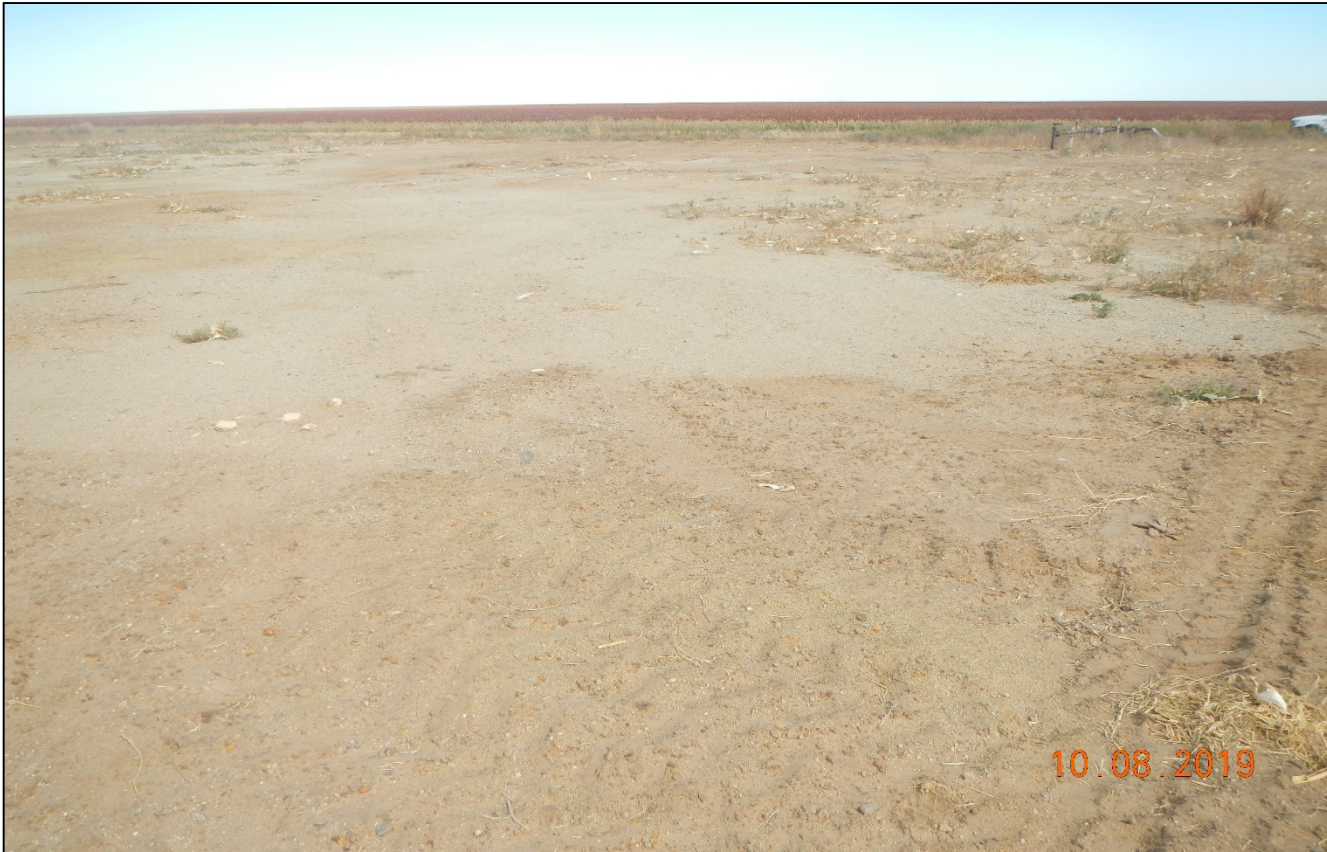
Photo 1. Facing northeast toward the location. The metal building has been removed since previous inspection.

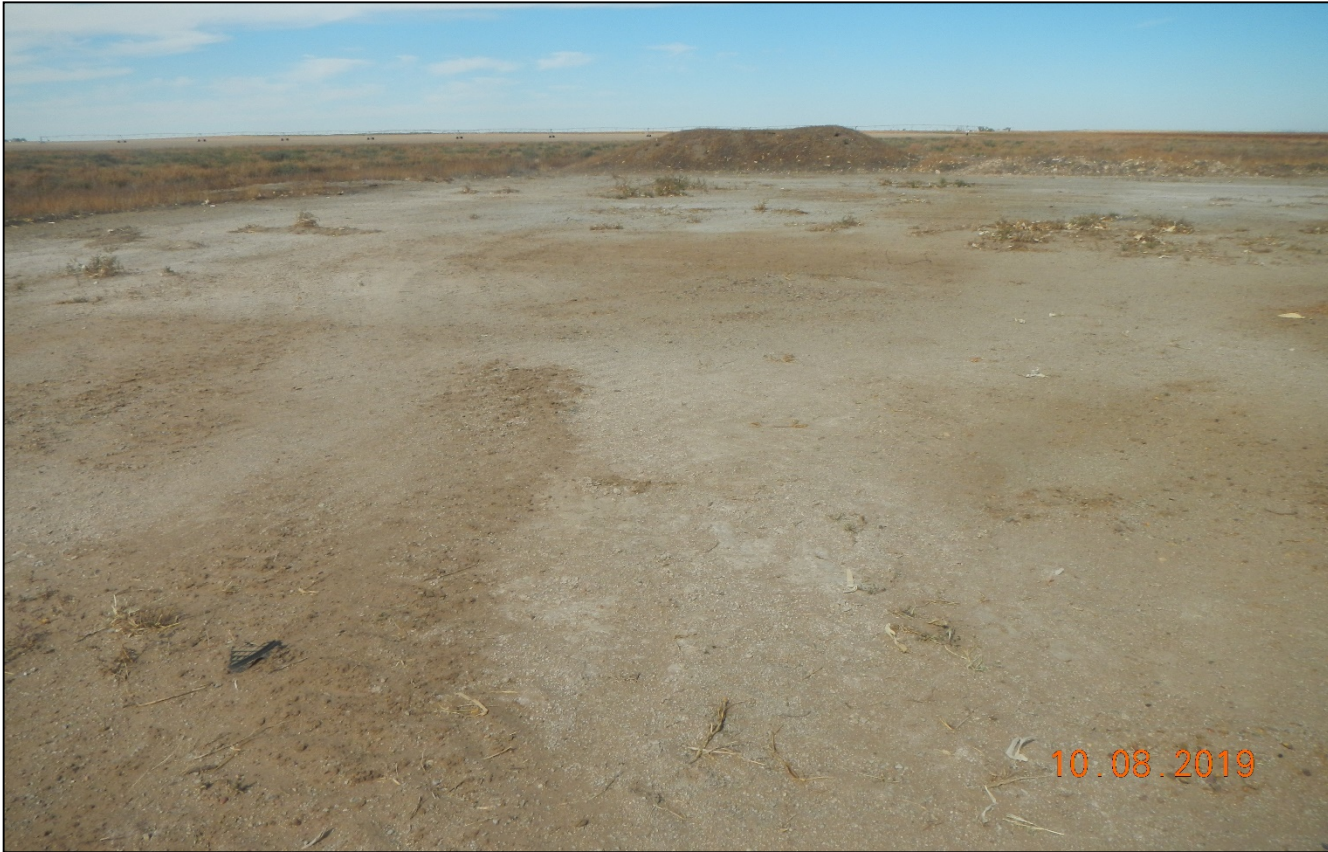
Photo 2. Facing north toward the location. Soils are compacted and the location has not been reclaimed yet.

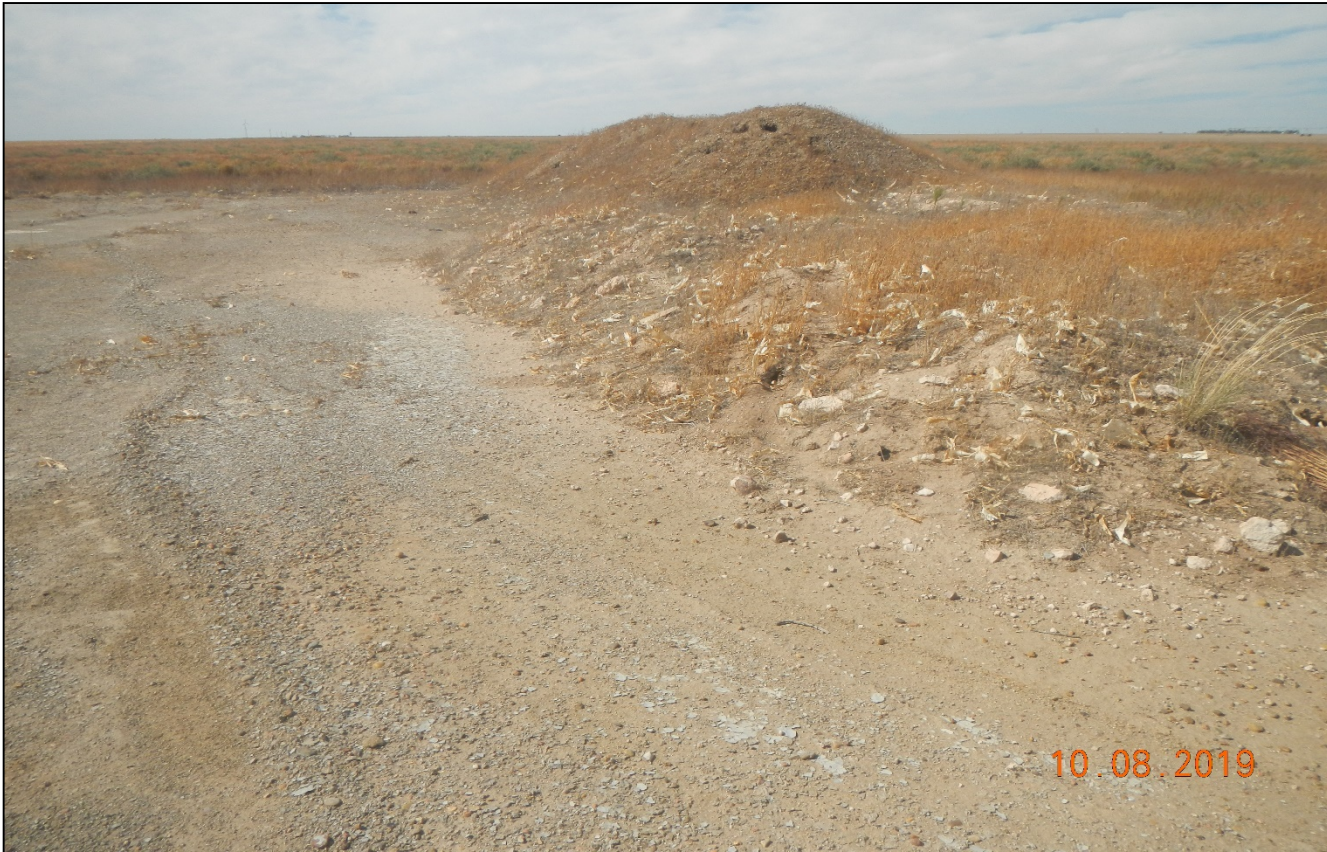
Photo 3. There is a material soil pile at the northwest corner of the location that remains.

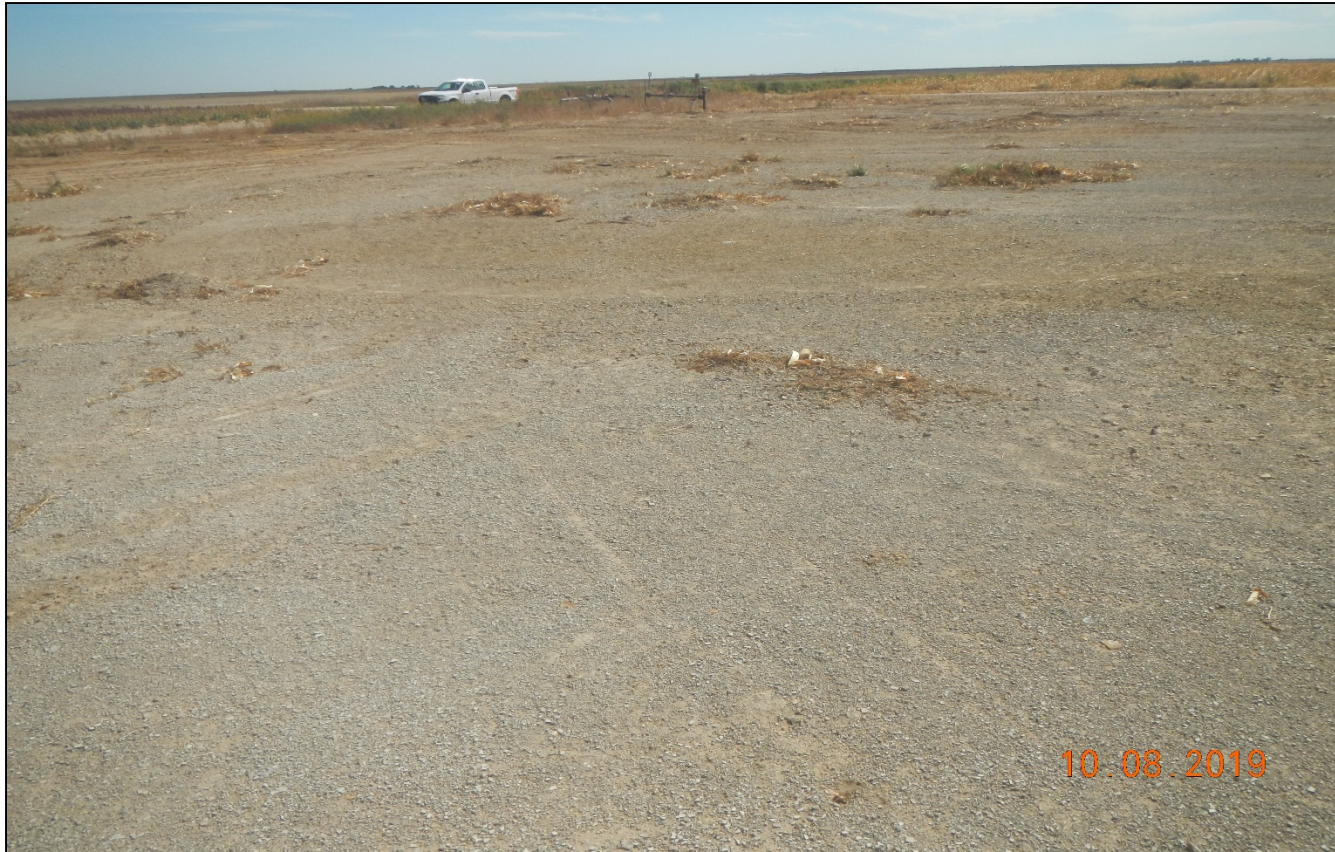
Photo 4. Facing southeast. Unused areas of the location must be reclaimed.

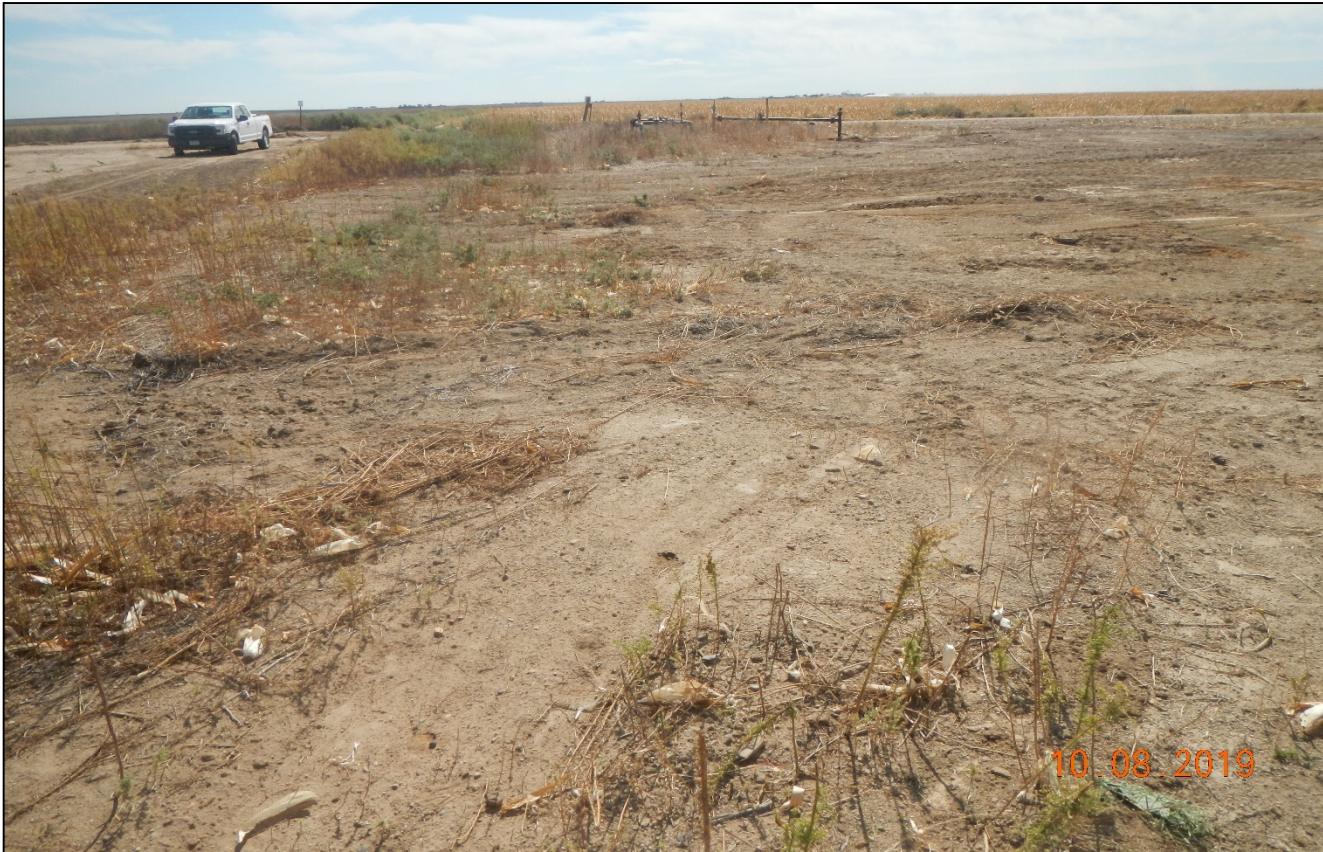
Photo 5. Facing south at the east side of the location. The pipe risers and cement pads have been removed from this area. There was some debris that remains.

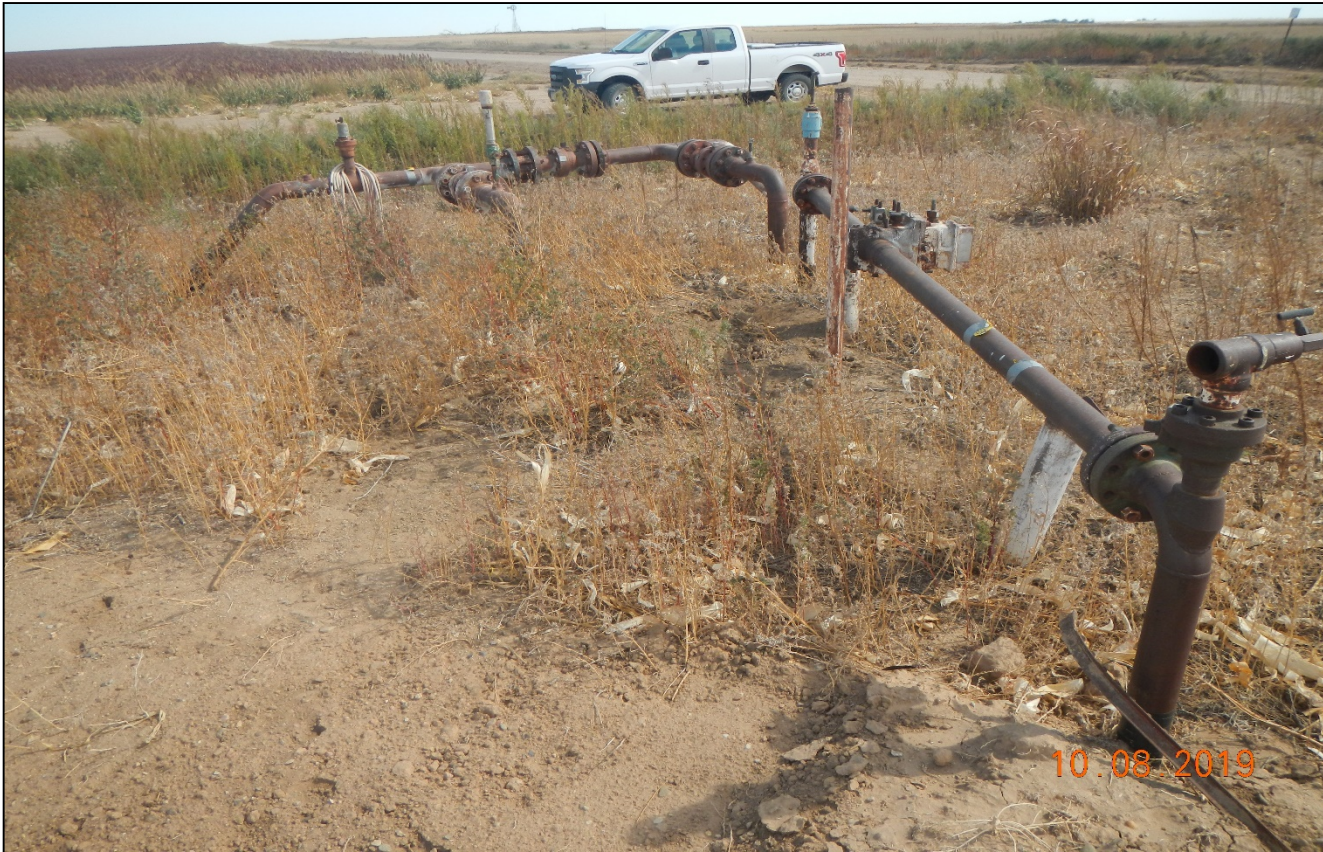
Photo 6. The gas pipeline remains at the southeast corner. The sign taped on previously is no longer present.

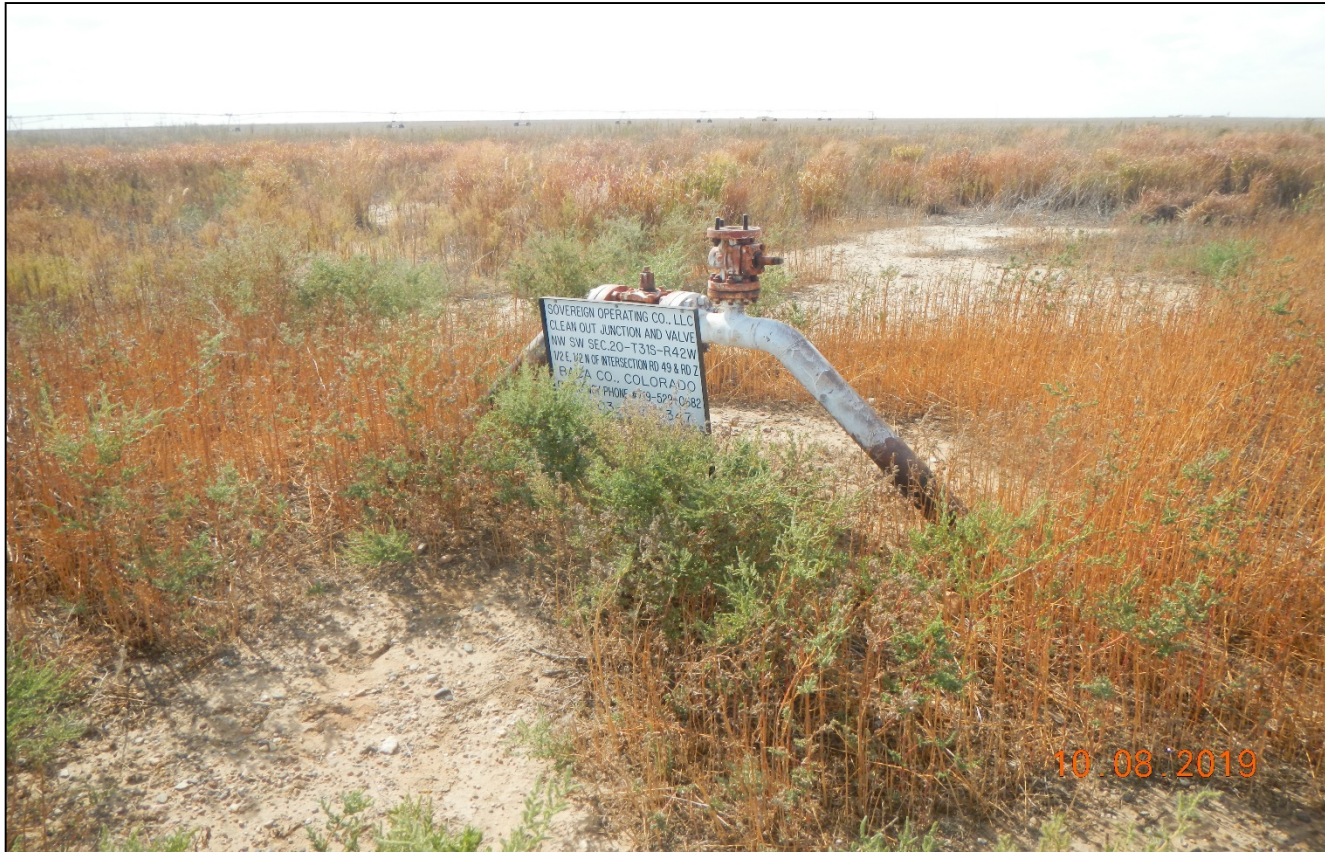
Photo 7. There is a clean out junction north of the pipeline shown in the previous photo that was associated with the compressor station. The sign is from the former operator and is outdated. The cleanout junction needs to be removed.
