APACHE CANYON 14-03 API# 05-071-06338 – TIMBER CREEK  
OGCC OPERATOR NUMBER 10672 - DATE: OCTOBER 14, 2019  
CORRECTIVE ACTIONS COMPLETED REGARDING COGCC FIR DOCUMENT # 689901235

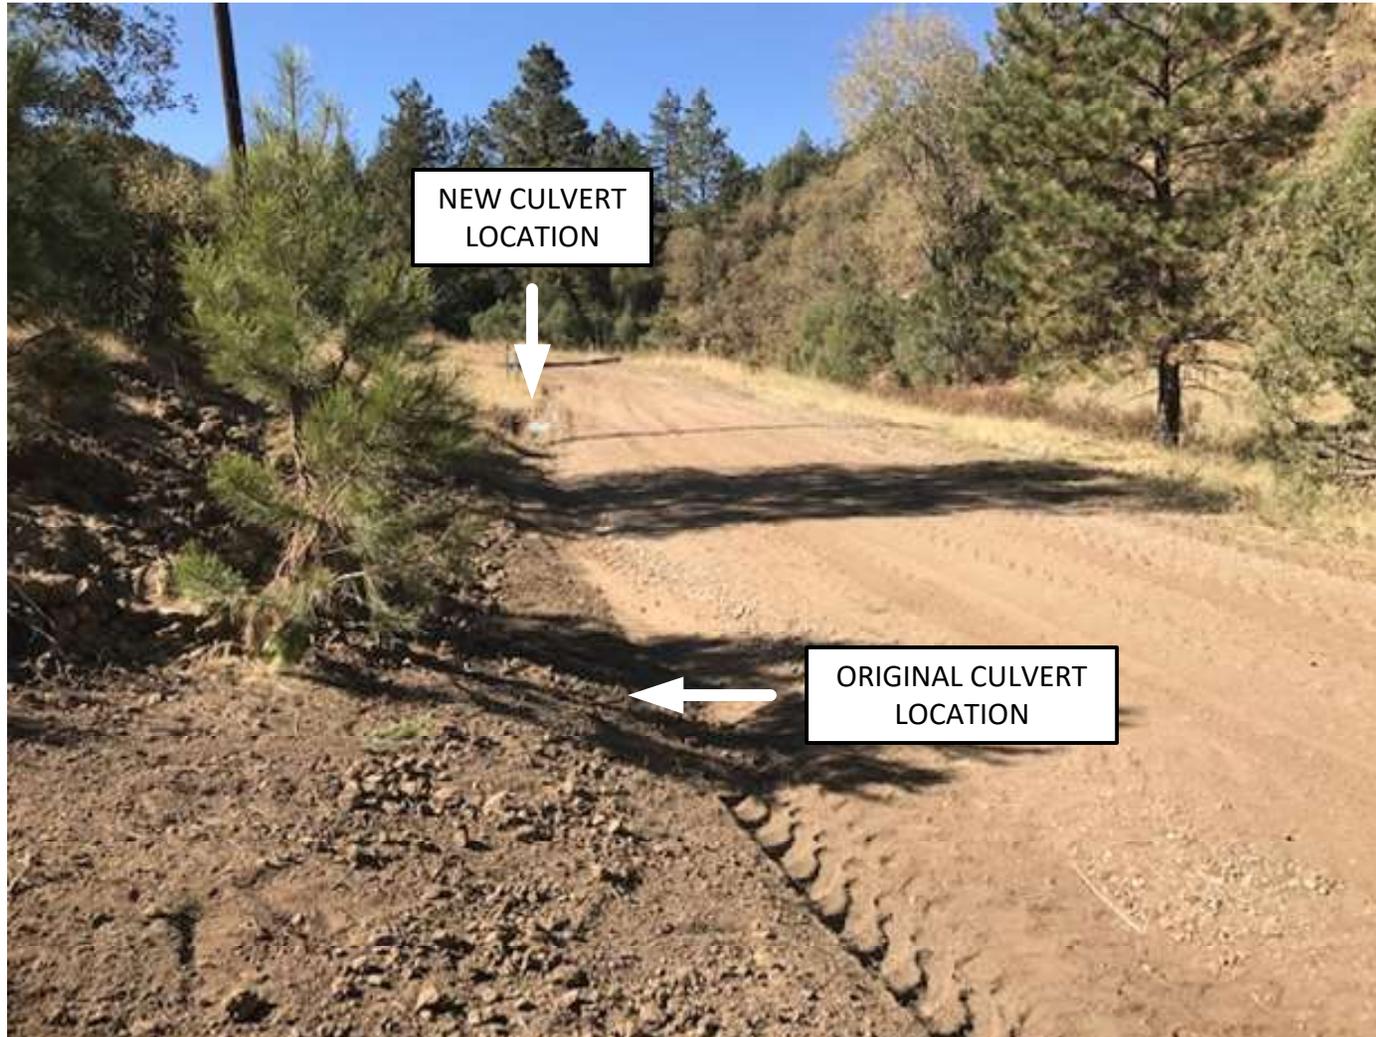
Photo 1: There was no erosion found up gradient of the culvert inlet. This culvert outlet did not have enough drop for the culvert to flow. The culvert outlet had too much vegetation in front of it to flow stormwater out of the culvert. This culvert was removed and a new culvert was installed further up the road.

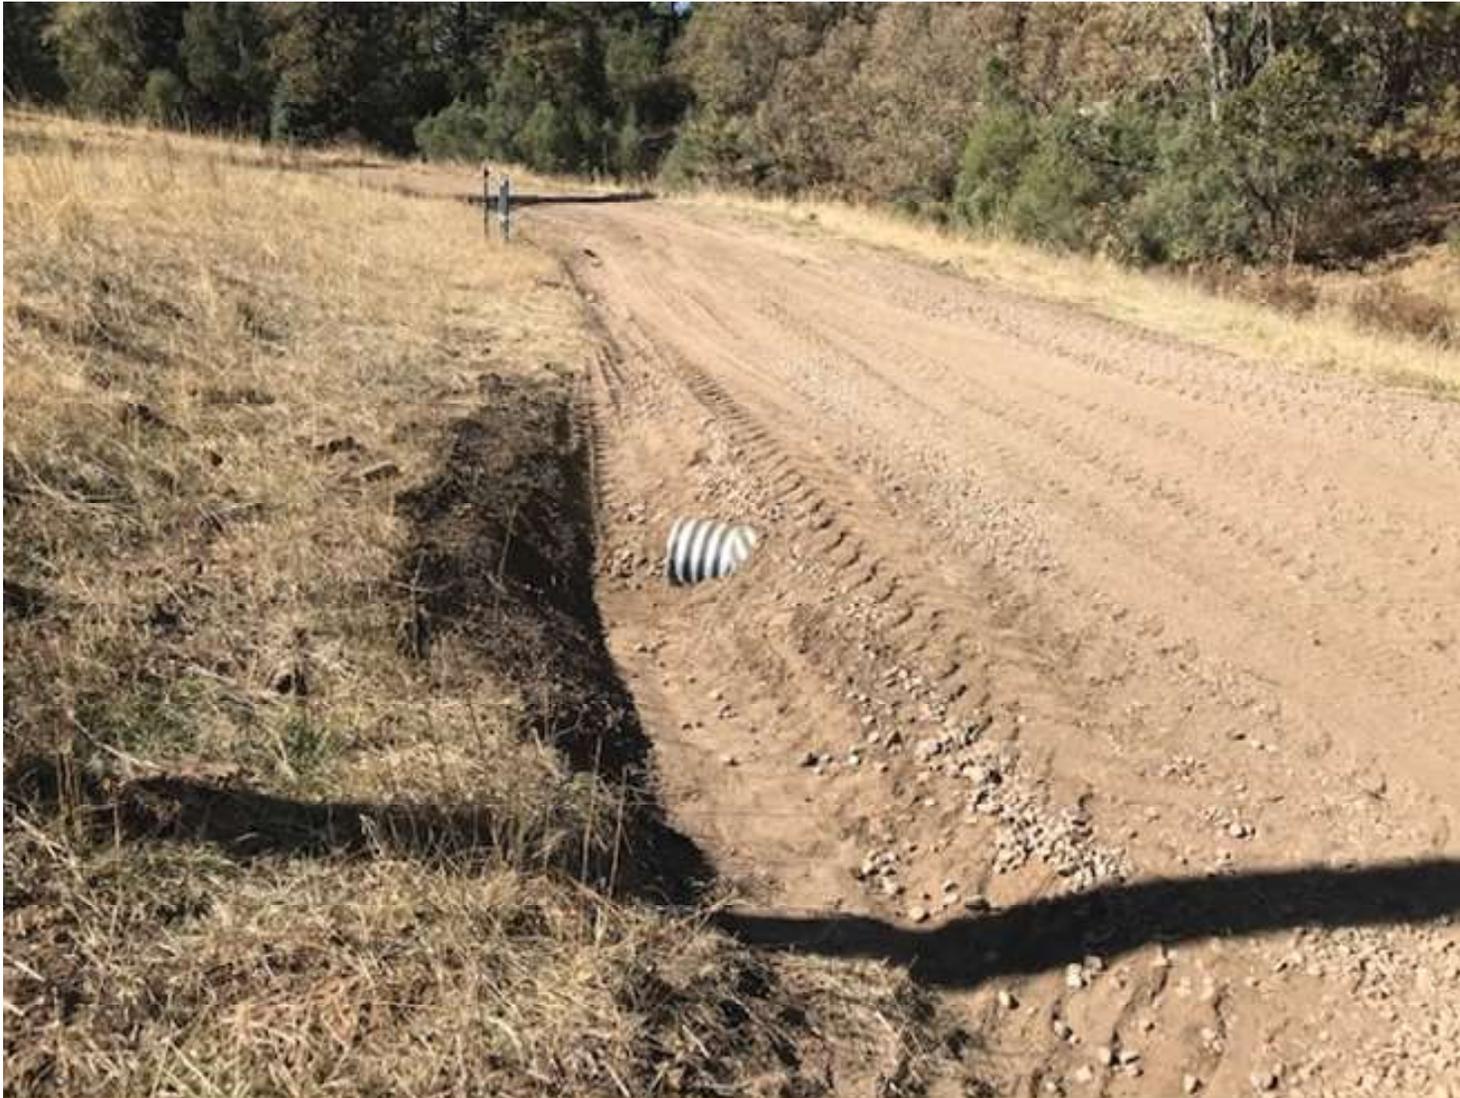
Photo 2: A new culvert was installed where there was some fill slope on the outlet side, to allow enough drop for the culvert to flow stormwater.

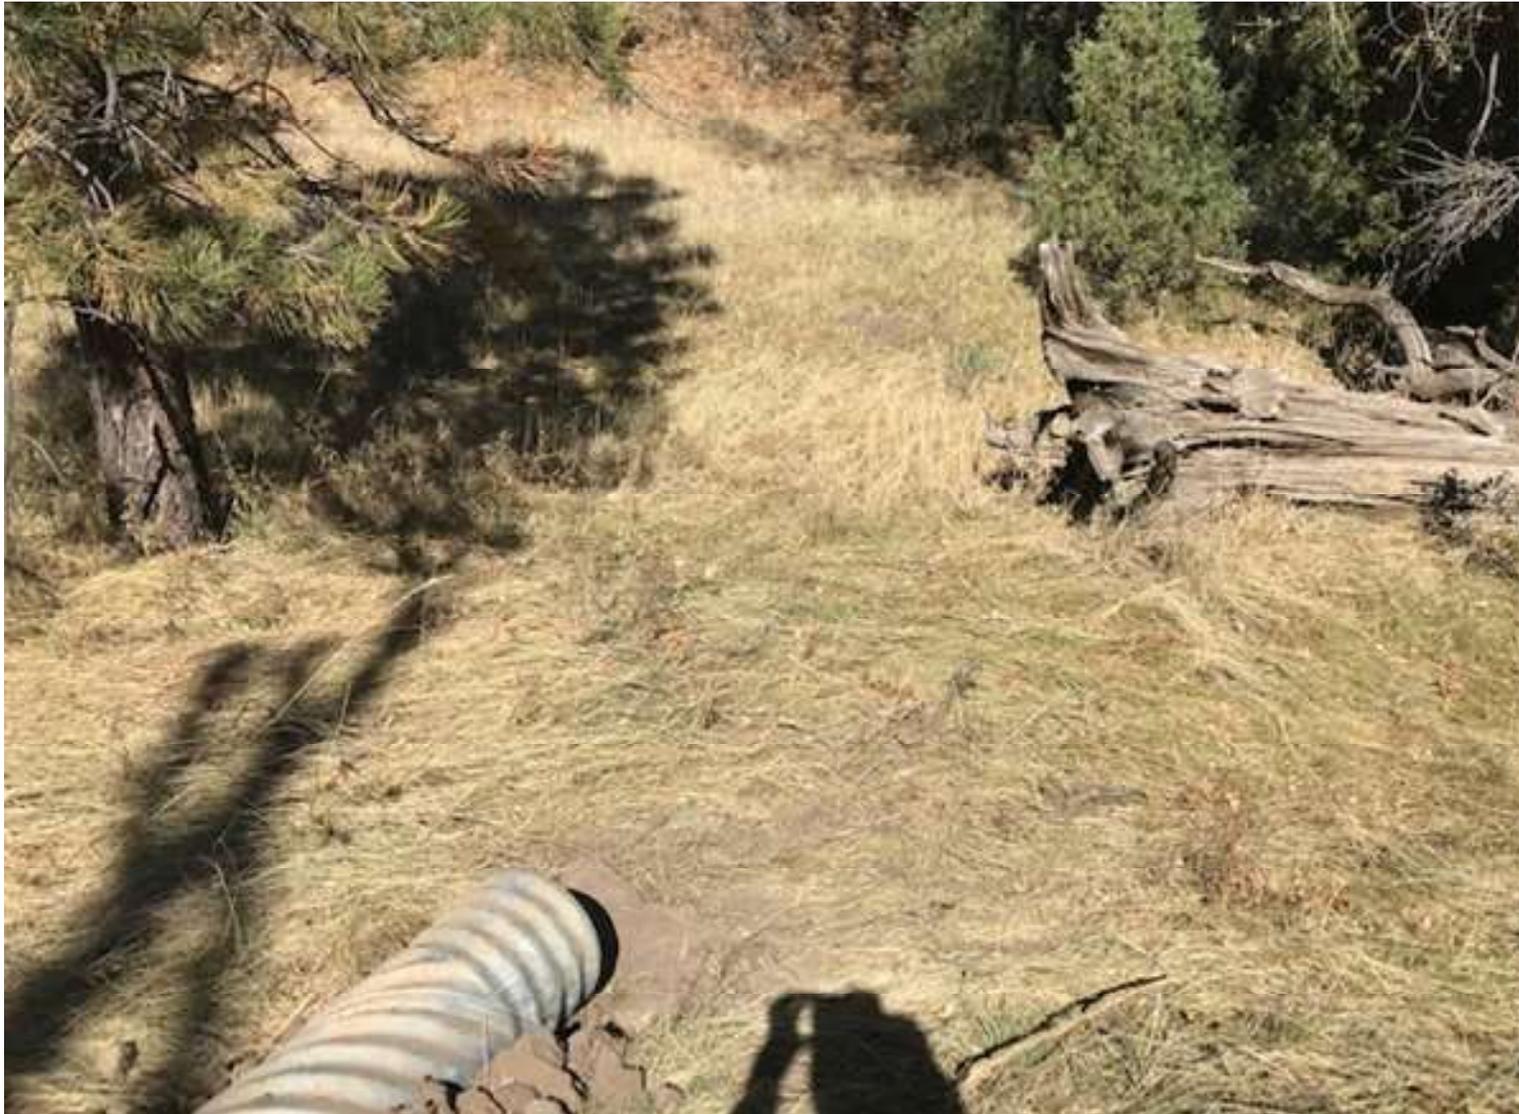
Photo 3: There was enough fill slope for the culvert outlet to be above grade on the outlet side.

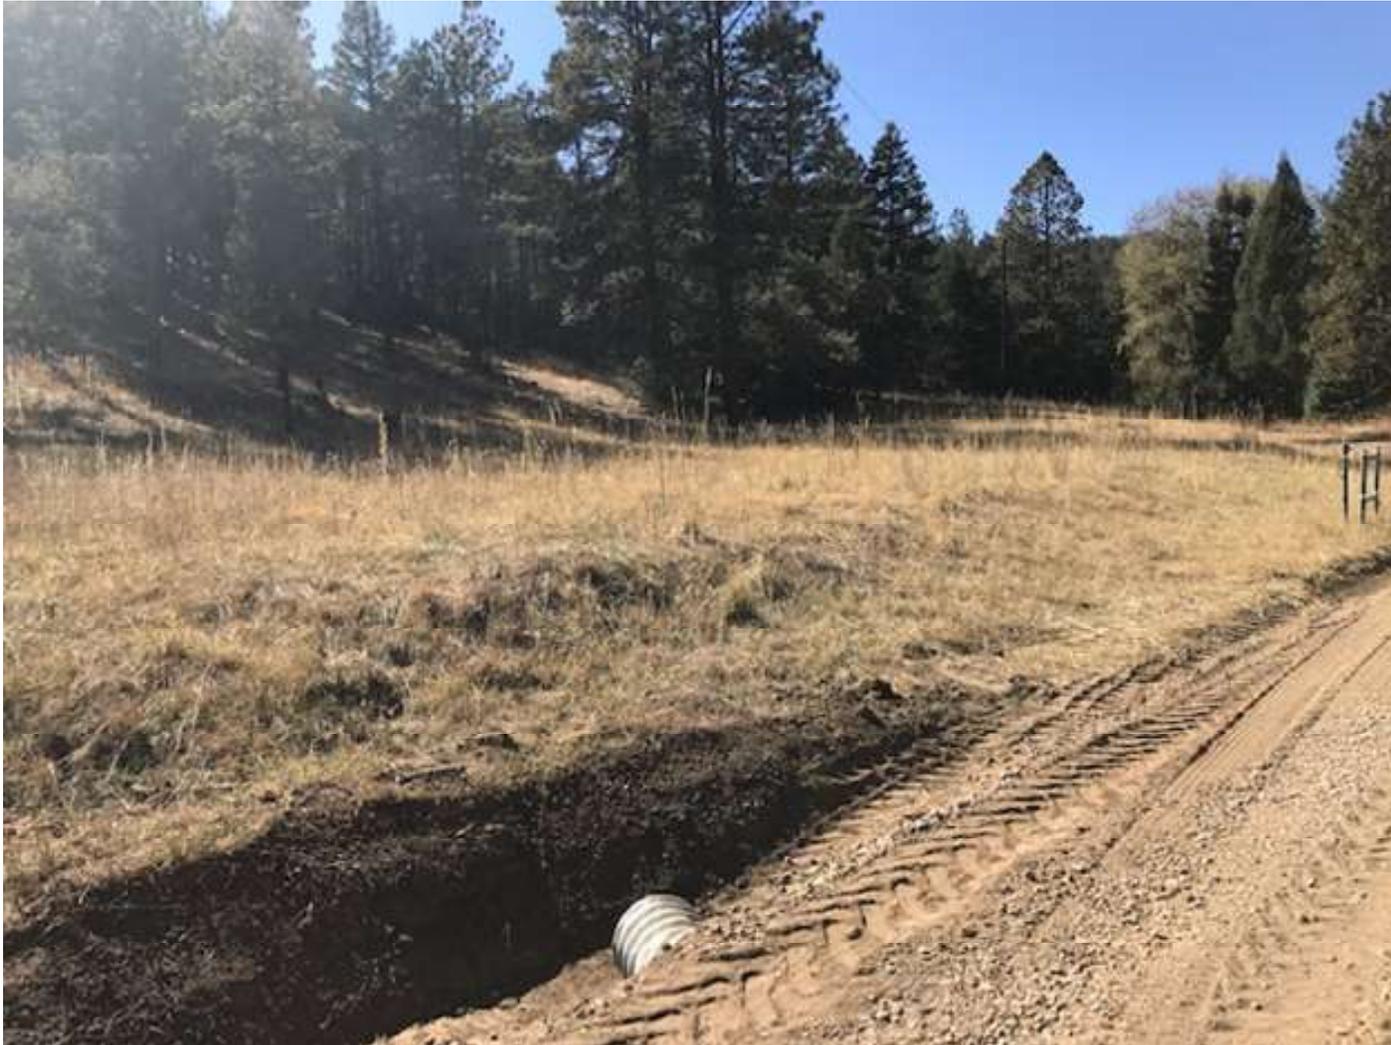
Photo 4: The upland watershed is well vegetated upgradient of the new culvert install.

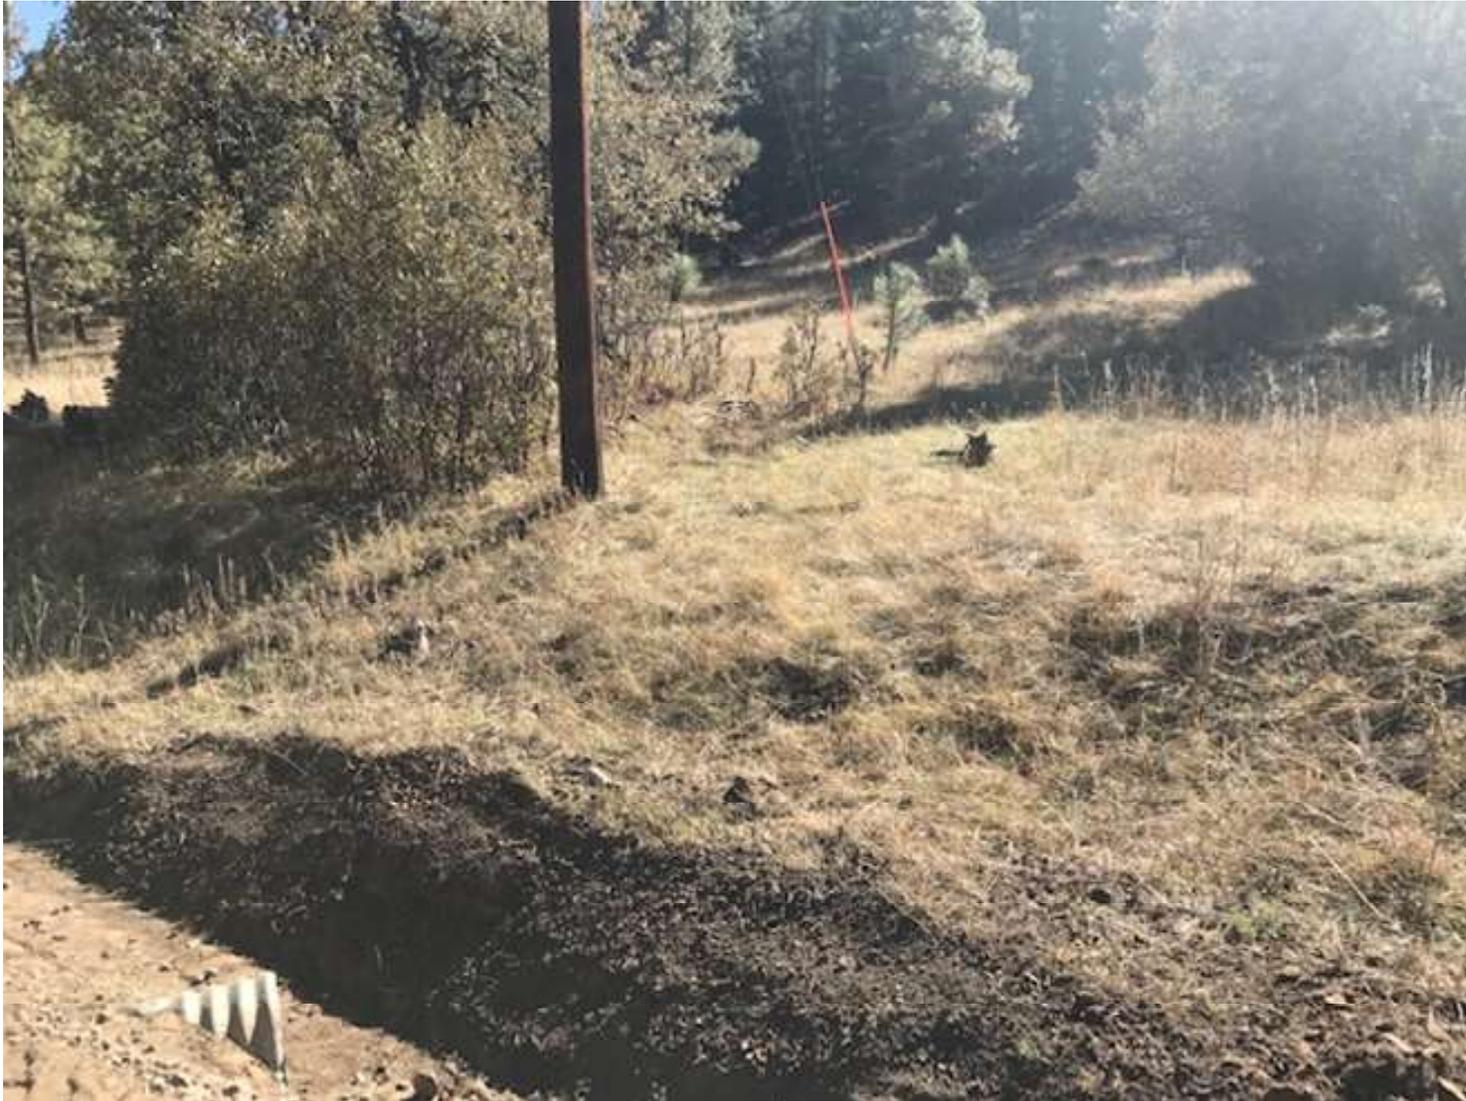
Photo 5: The upland watershed is well vegetated upgradient of the new culvert install.
