Inspection Photos

Operator: Petrox Resources
Location/API #: 007-06215
Date: 10-8-2019

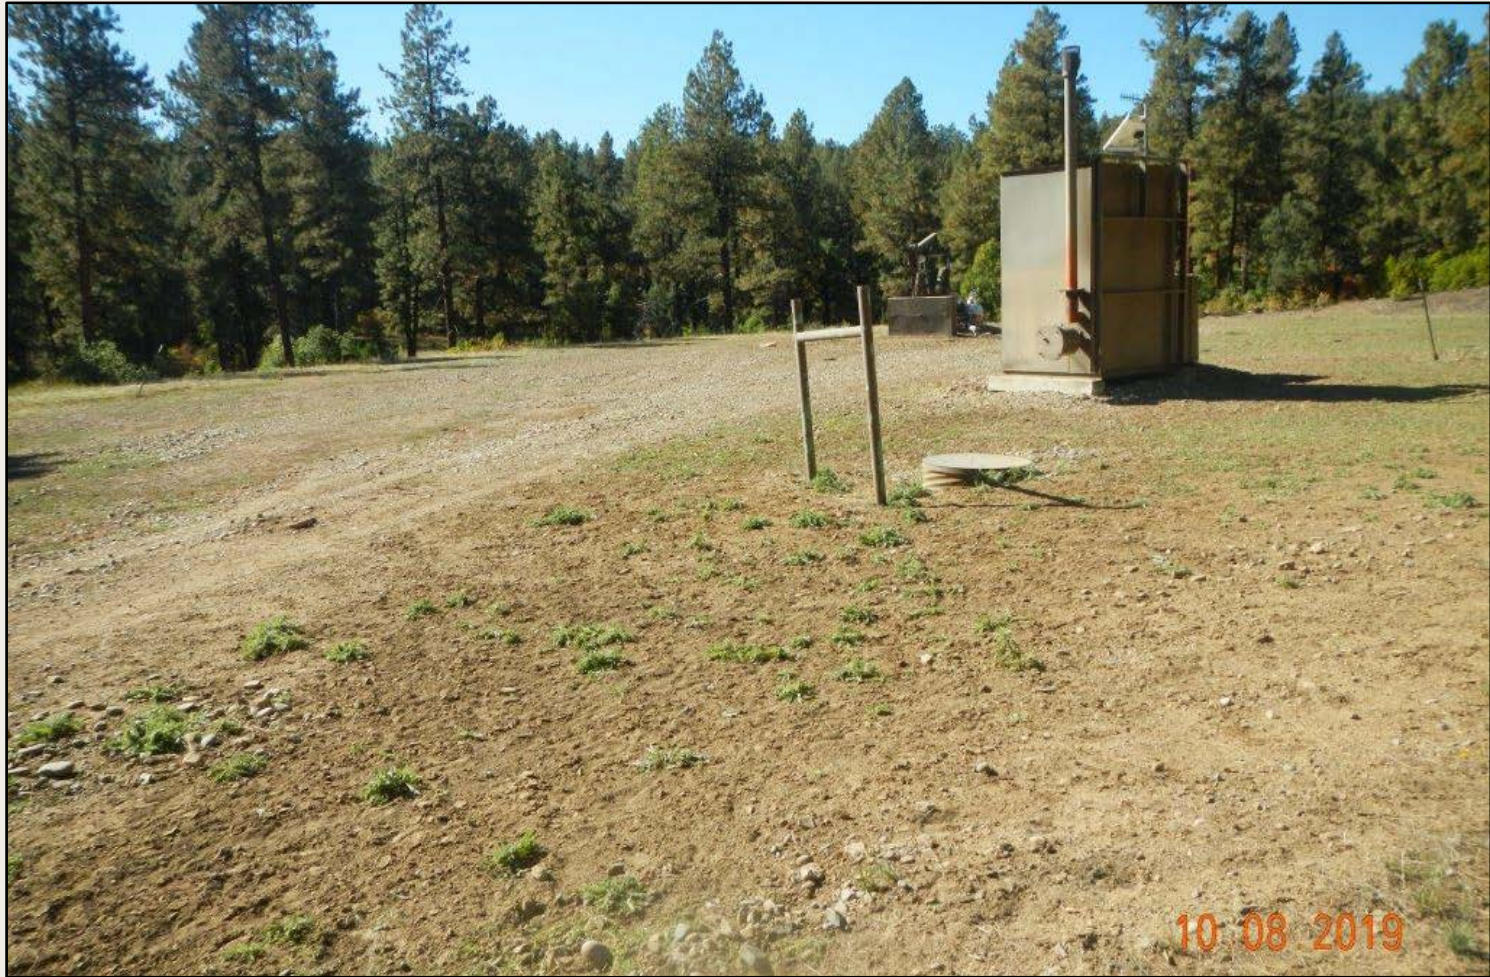
Photo 1. View of the project area from the well pad entrance facing center.

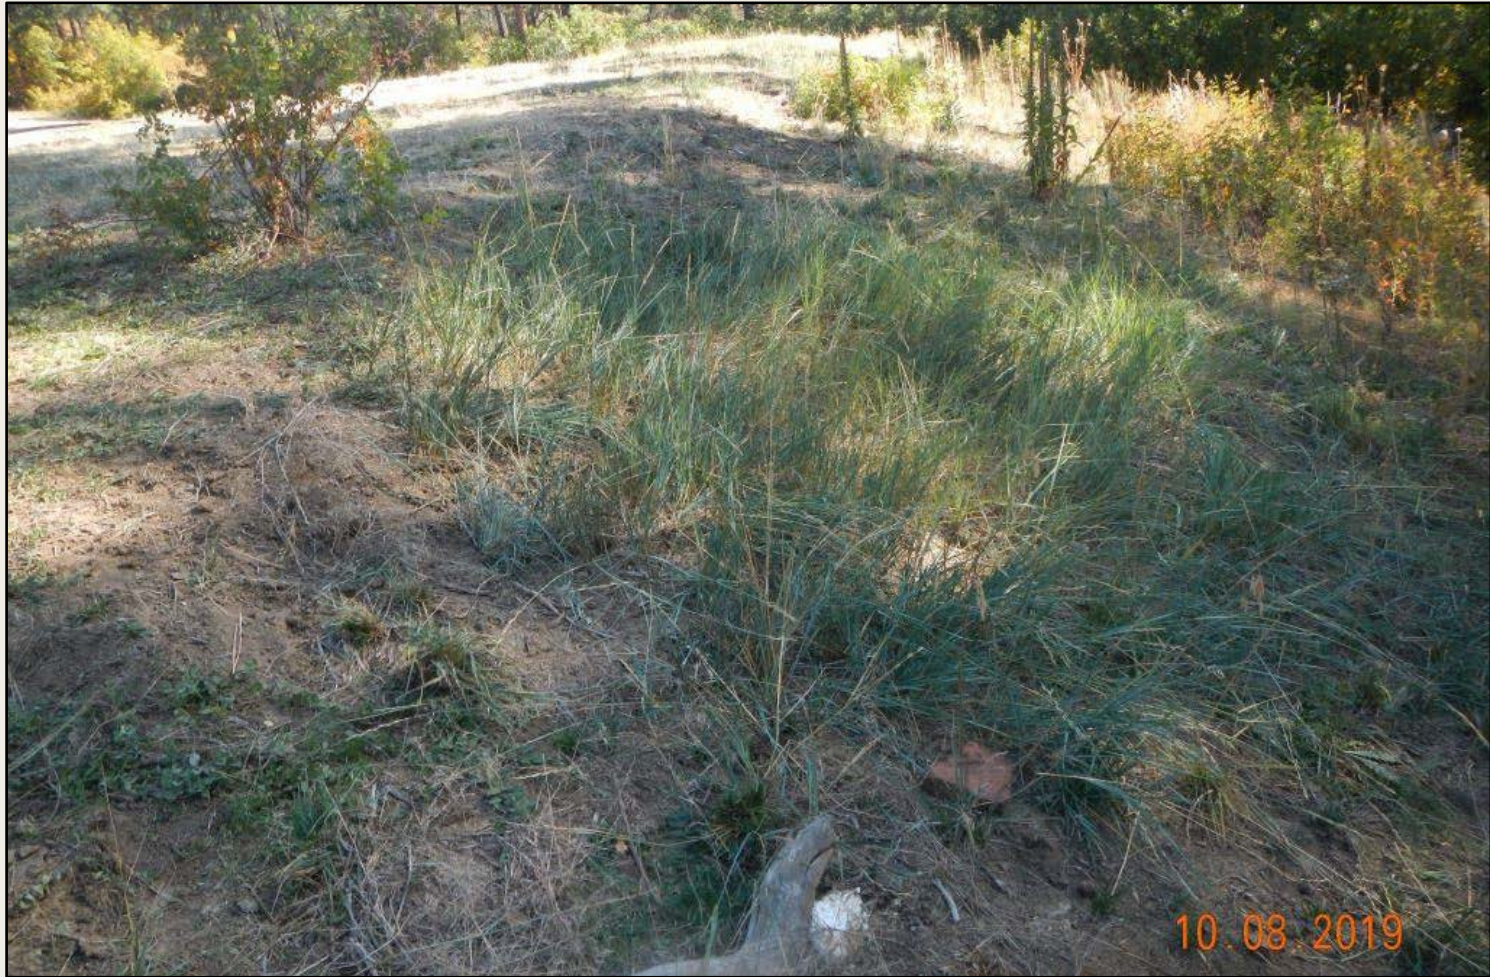
Photo 2. View of the southern fill slope from the southwestern edge facing eastward. Revegetation is progressing in portions with grasses such as western wheatgrass as seen in the foreground, but remains weed infested with Canada and musk thistle, as seen in the background.

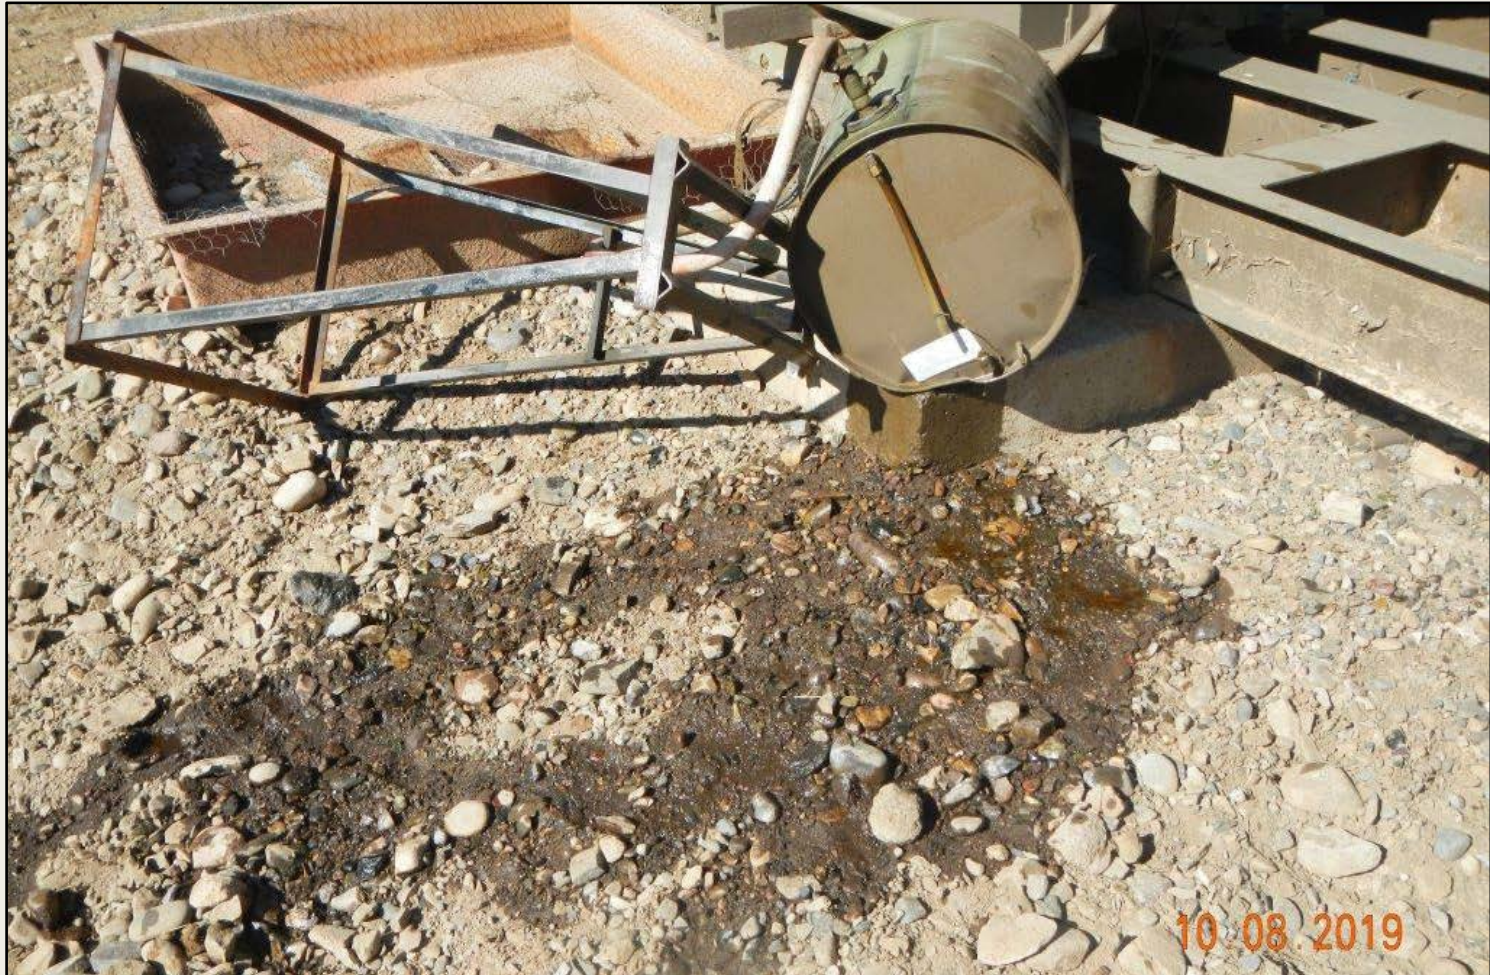
Photo 3. View of spilling oil material near the well head. Operator was notified on 10/9/2019 and communicated urgency to address the spill.

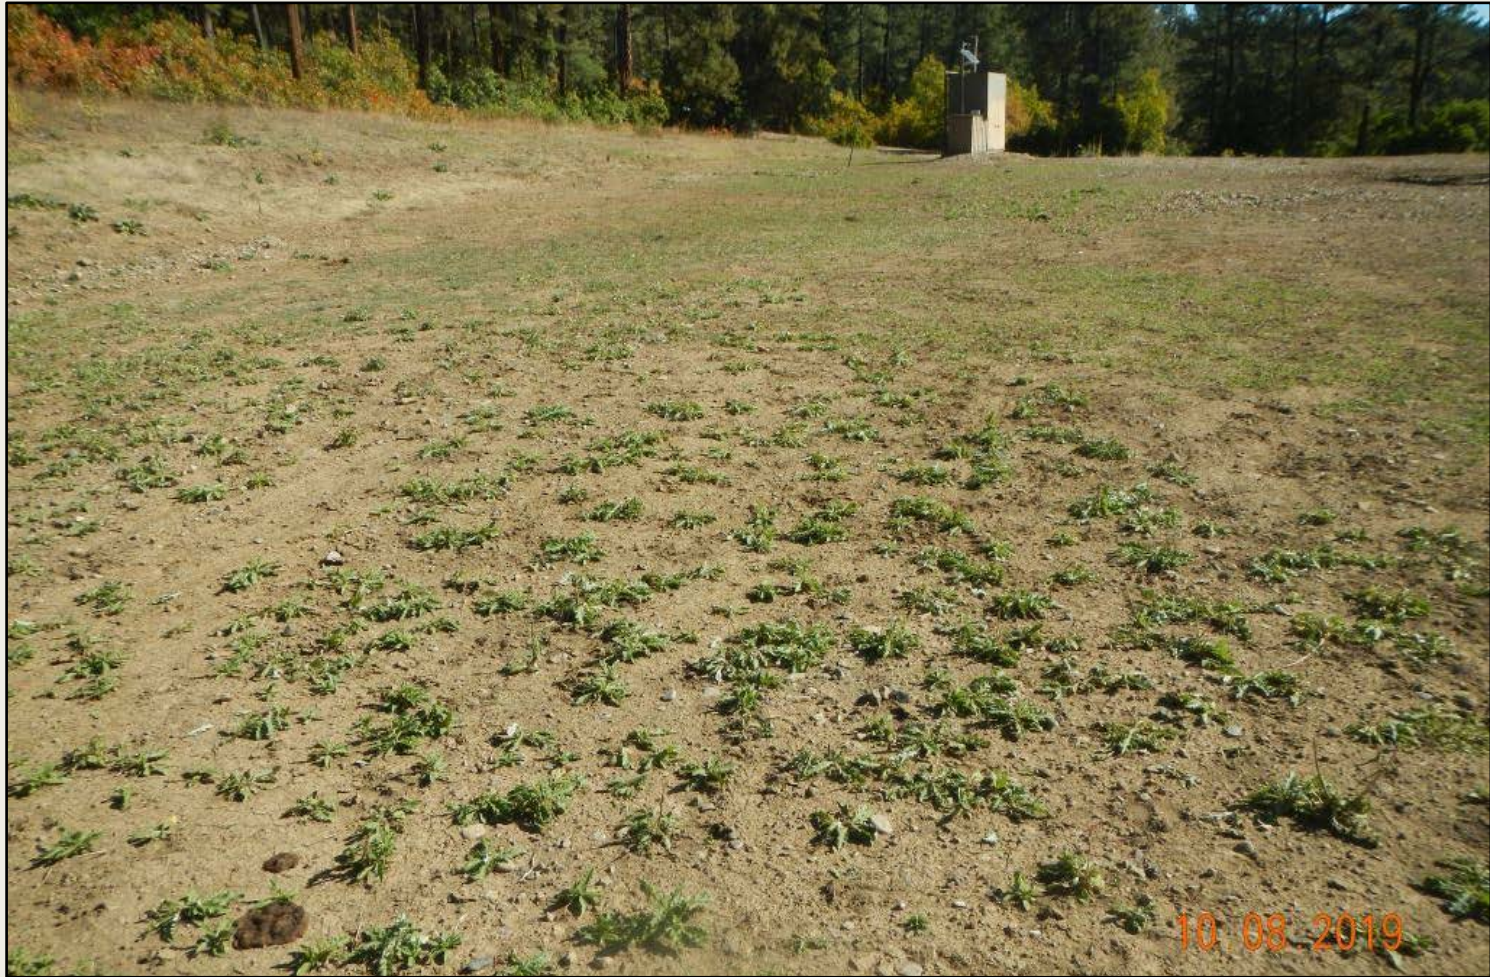
Photo 4. View of infestation of Canada thistles in the northern project area. Area needs to be treated and revegetated.

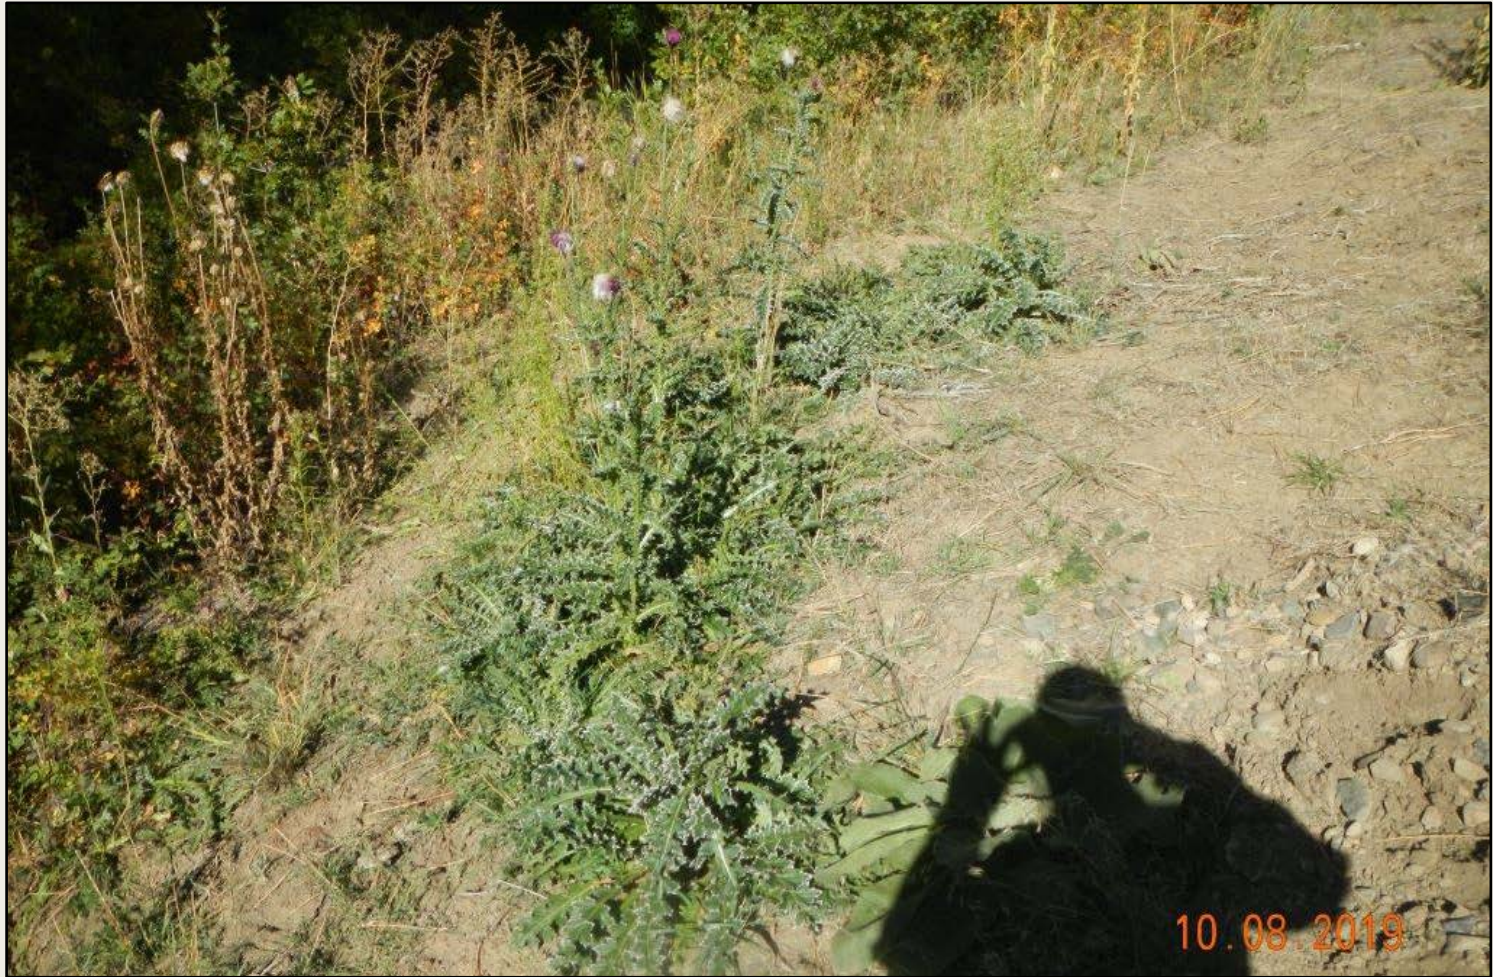
Photo 5. View of musk thistle infestation within the western project area.

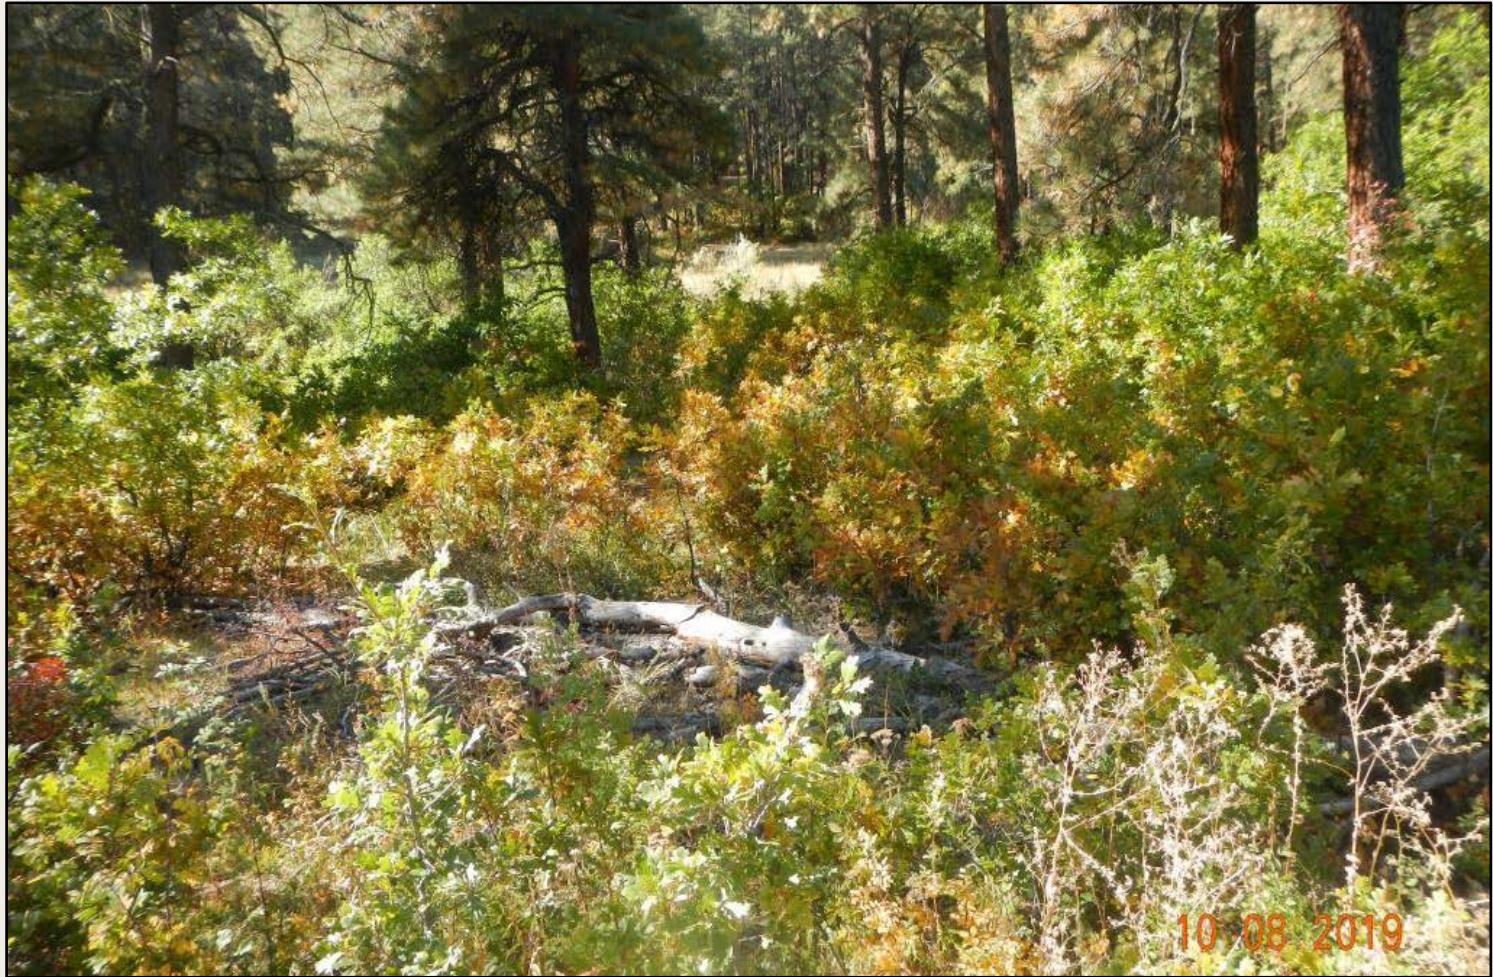
Photo 6. View of reference area vegetation comprised of a mosaic of ponderosa pine, gambel oak, and open grass fields.
