Inspection Photos
Operator: Petrox Resources
Location/API #: 007-06234
Date: 10-8-2019

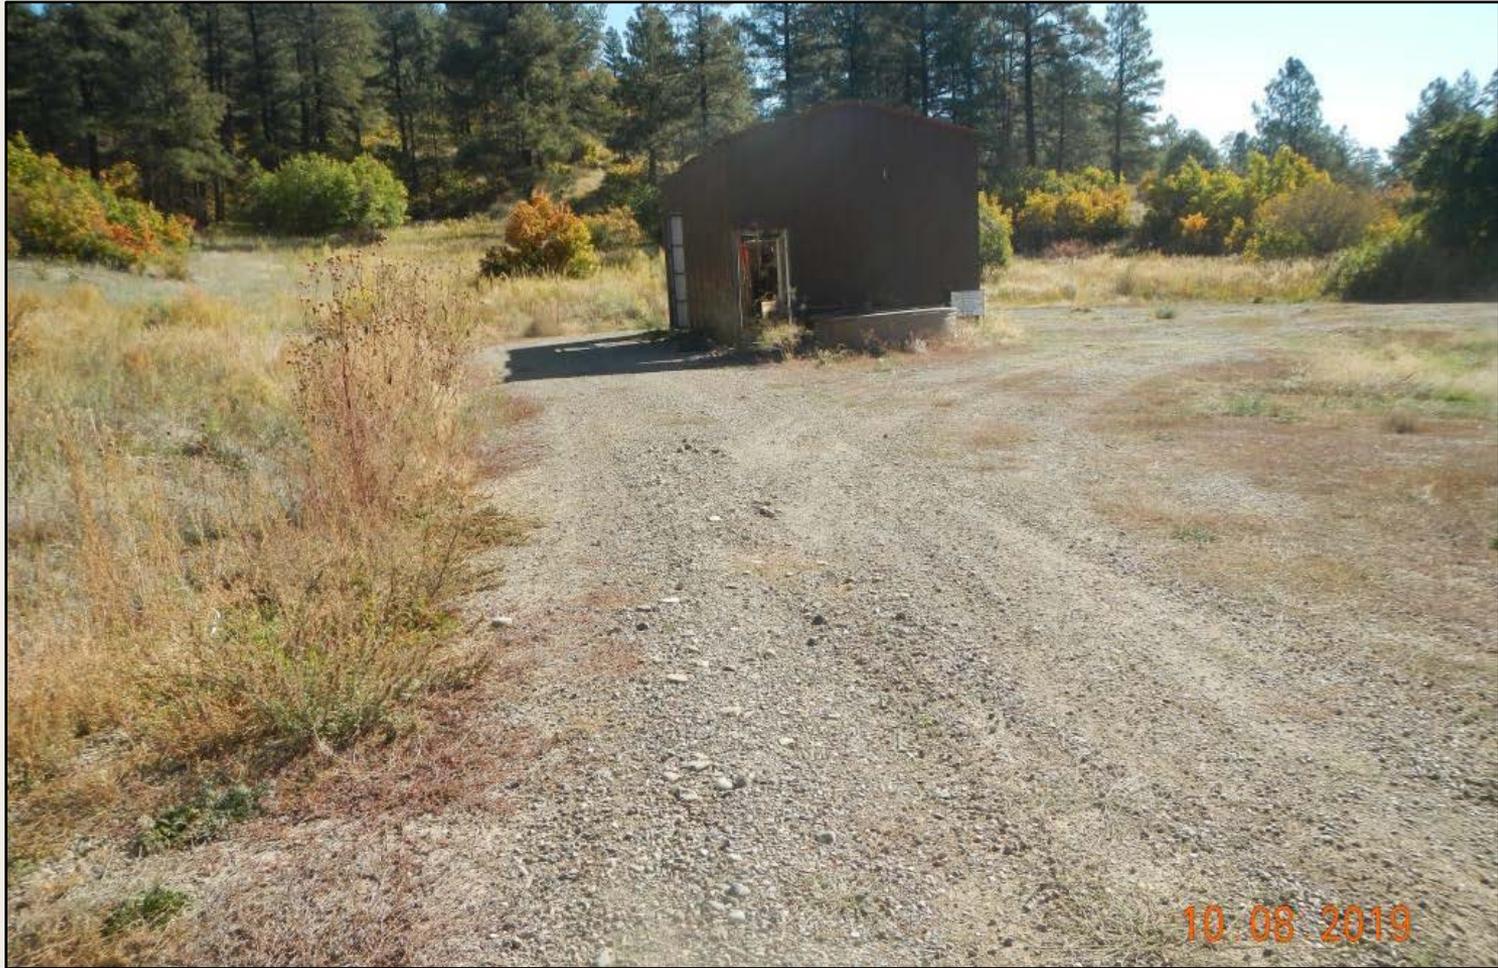
Photo 1. View of the project area from the well pad entrance facing center.

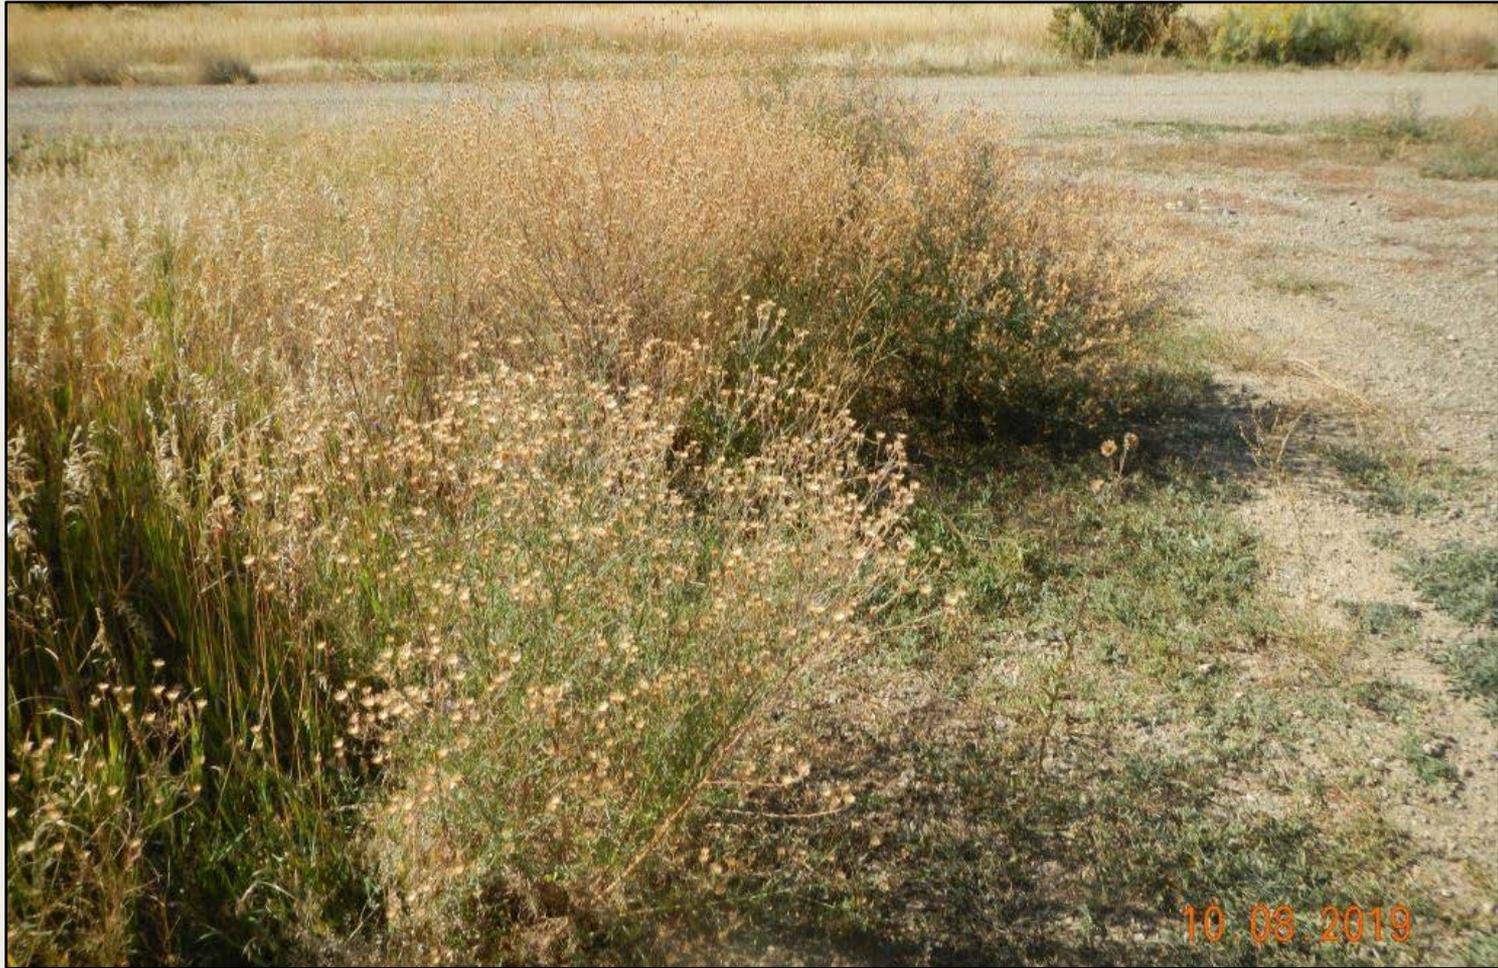
Photo 2. View of spotted knapweeds (*Centaurea maculosa*) flowering, at the well pad entrance. Approximately 200 individuals observed.

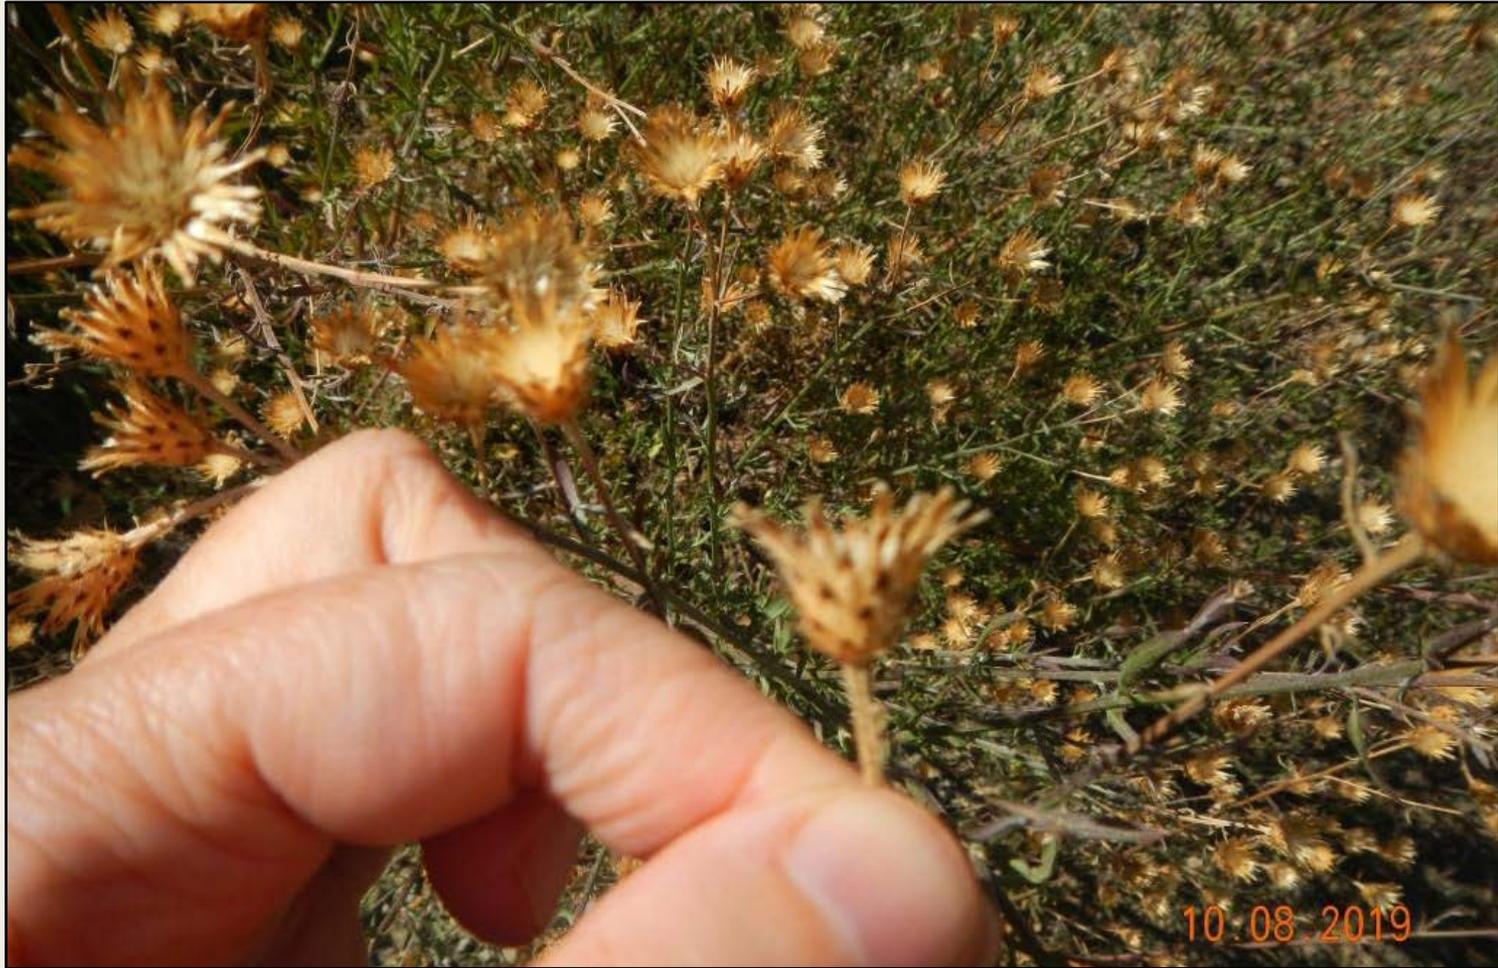
Photo 3. Closeup view of identifying characteristic of dark spot on flower bracts, indicating spotted knapweed.

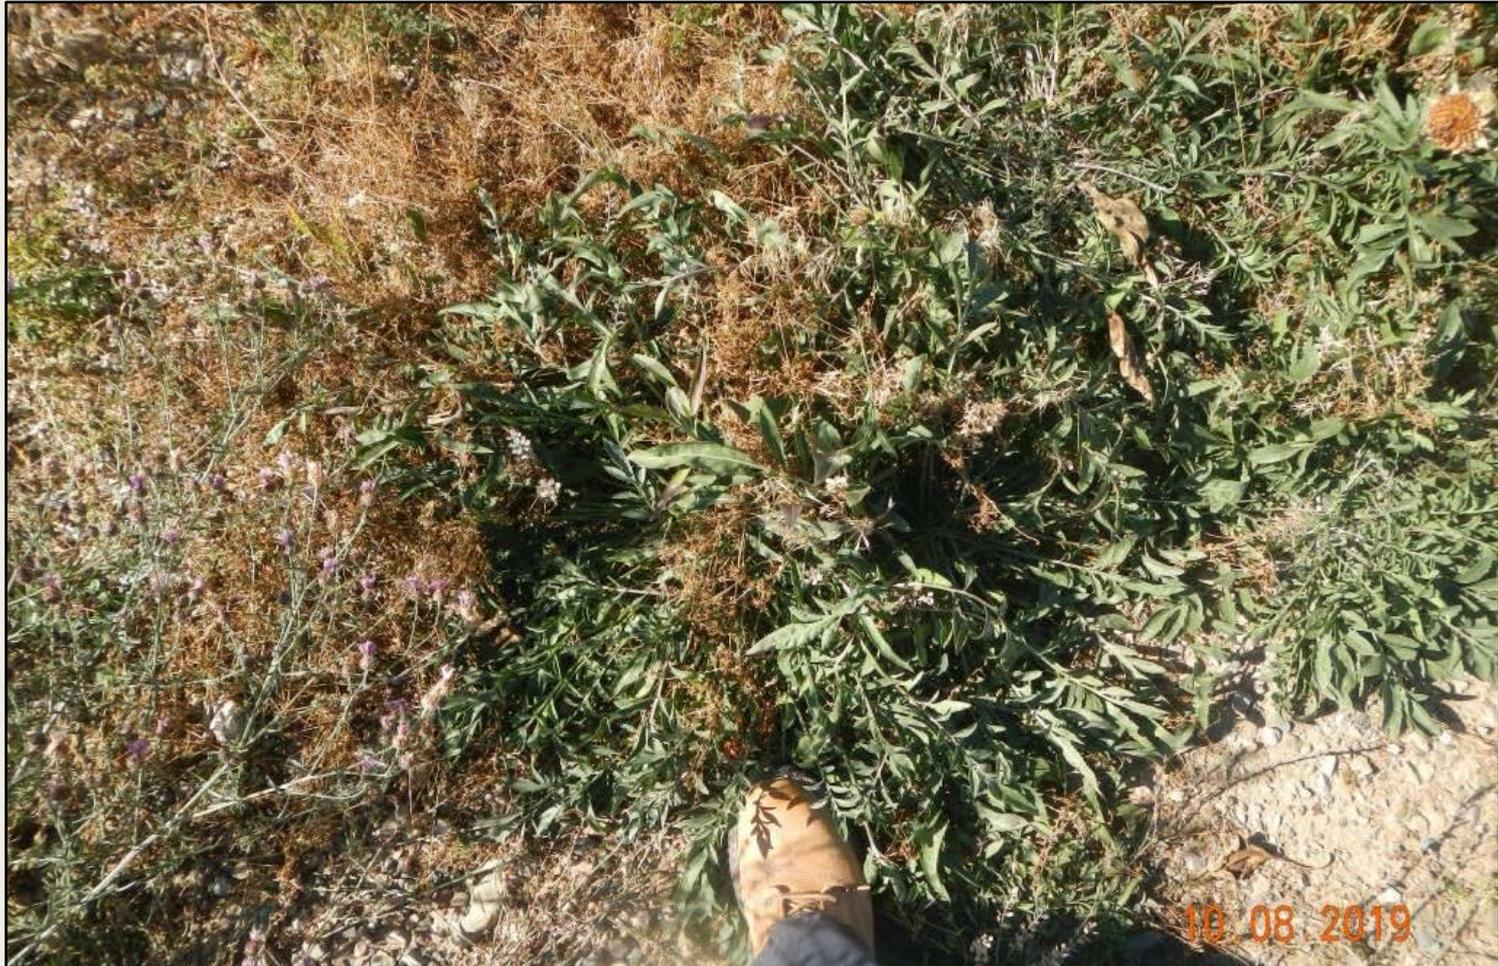
Photo 4. View of dense spotted knapweed rosettes within the project area.

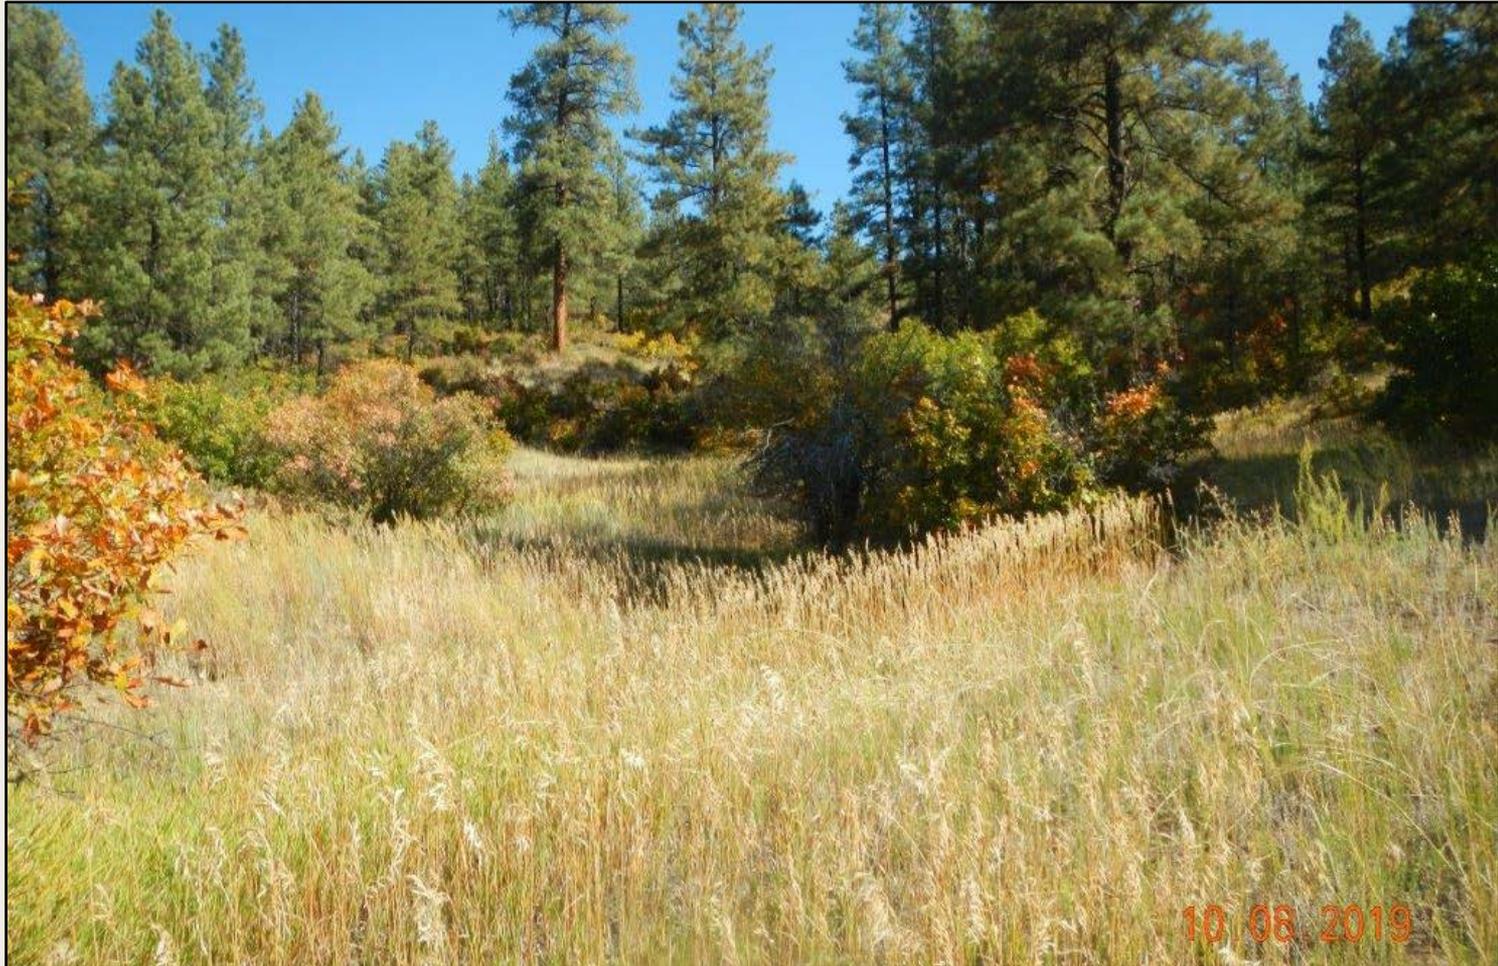
Photo 5. View of reference area vegetation comprised of a mosaic of ponderosa pine, gambel oak, and open grass fields.
