# Inspection Photos

Operator: Catamount Energy  
Location/API #: 007-06140  
Date: 10-8-2019

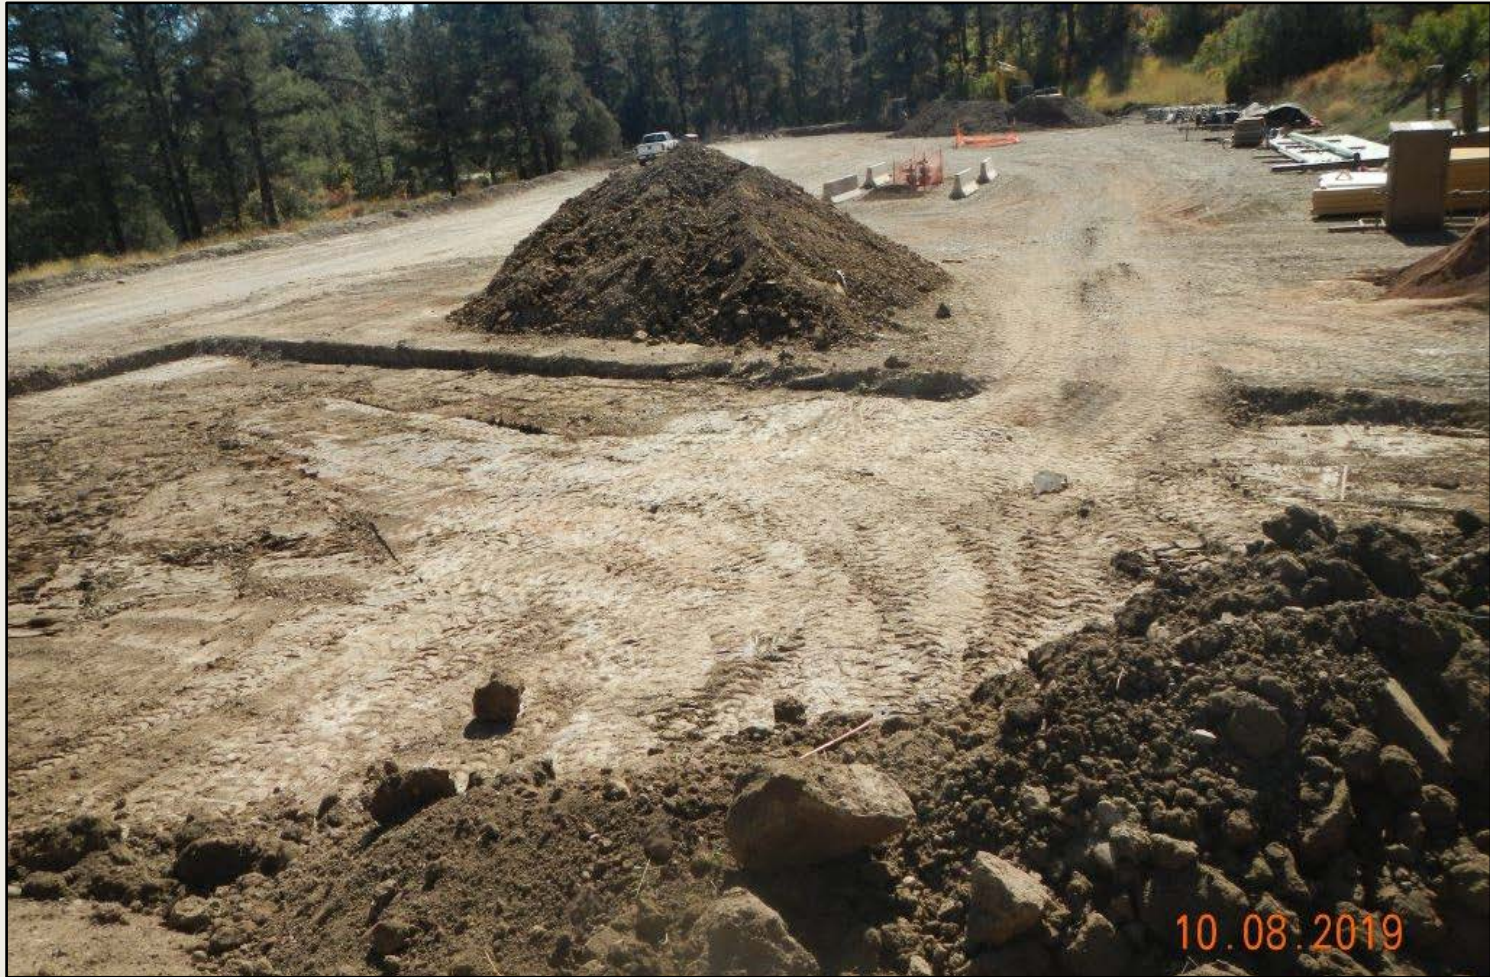
Photo 1. View of the project area from the northwestern corner facing center.

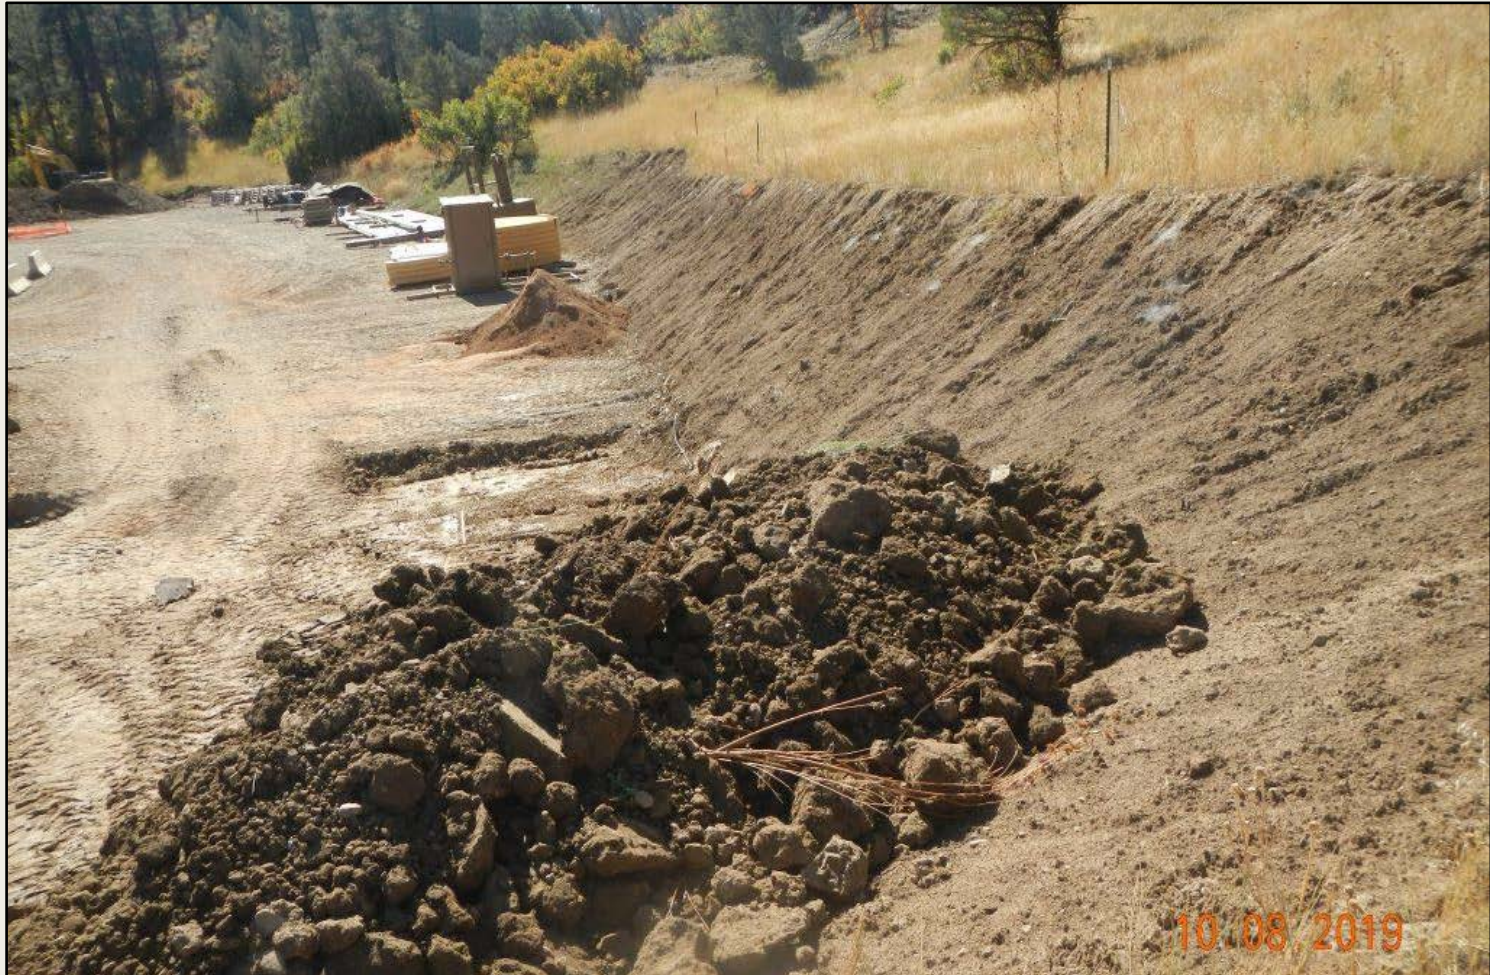
Photo 2. View of the western cut-slope from the northwestern corner facing southward. Slope appears too steep for vegetative stabilization.

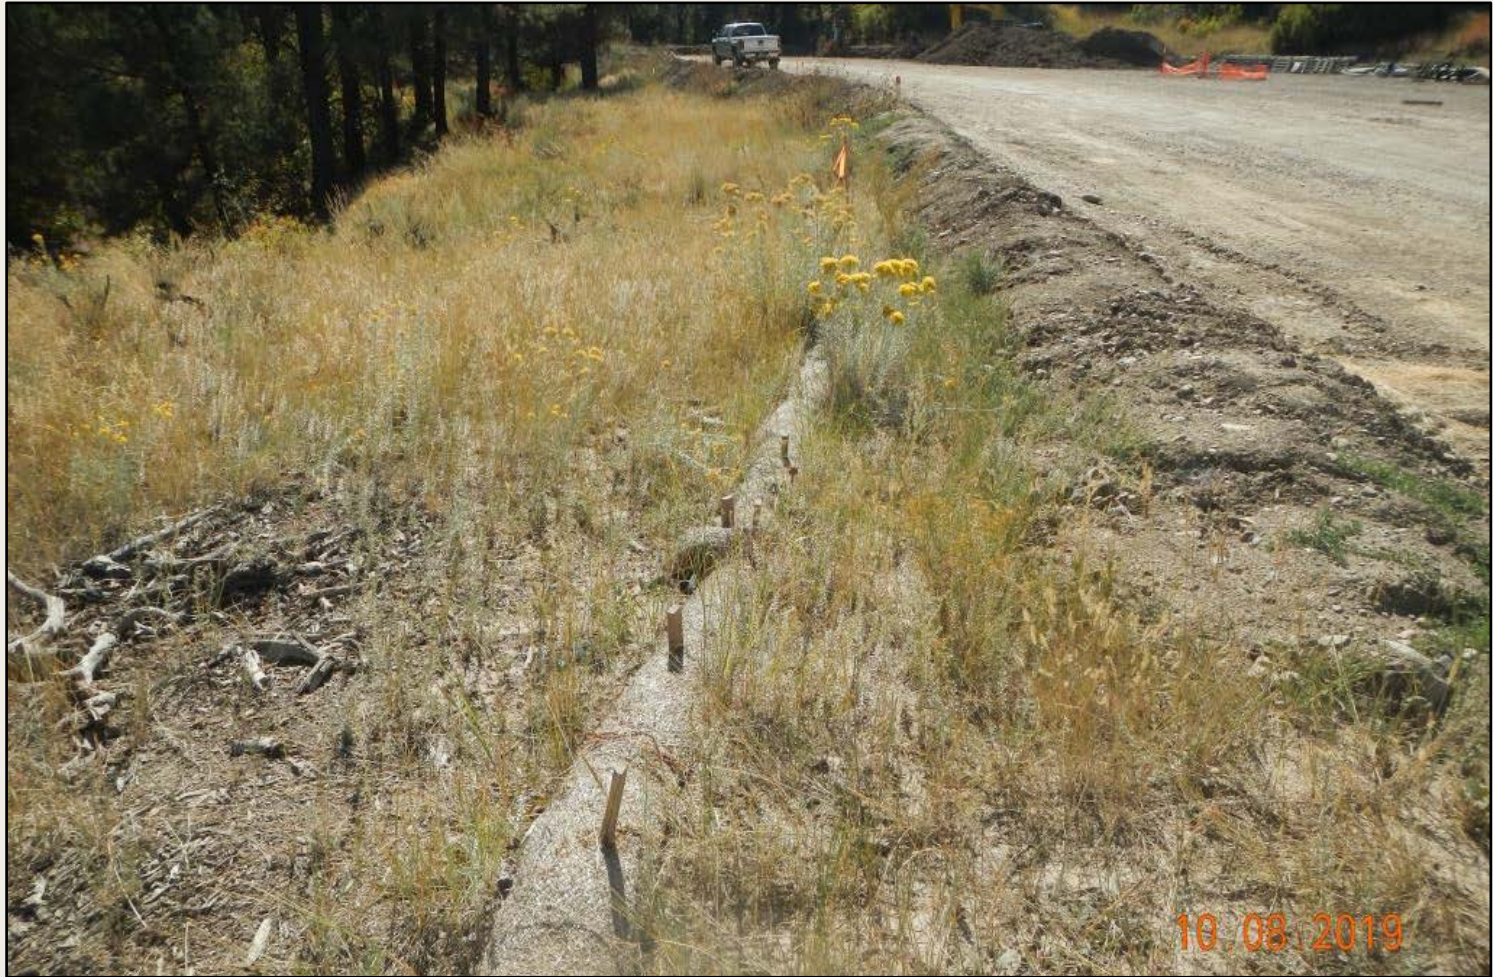
Photo 3. View of the eastern project area from the northeastern corner facing southward.

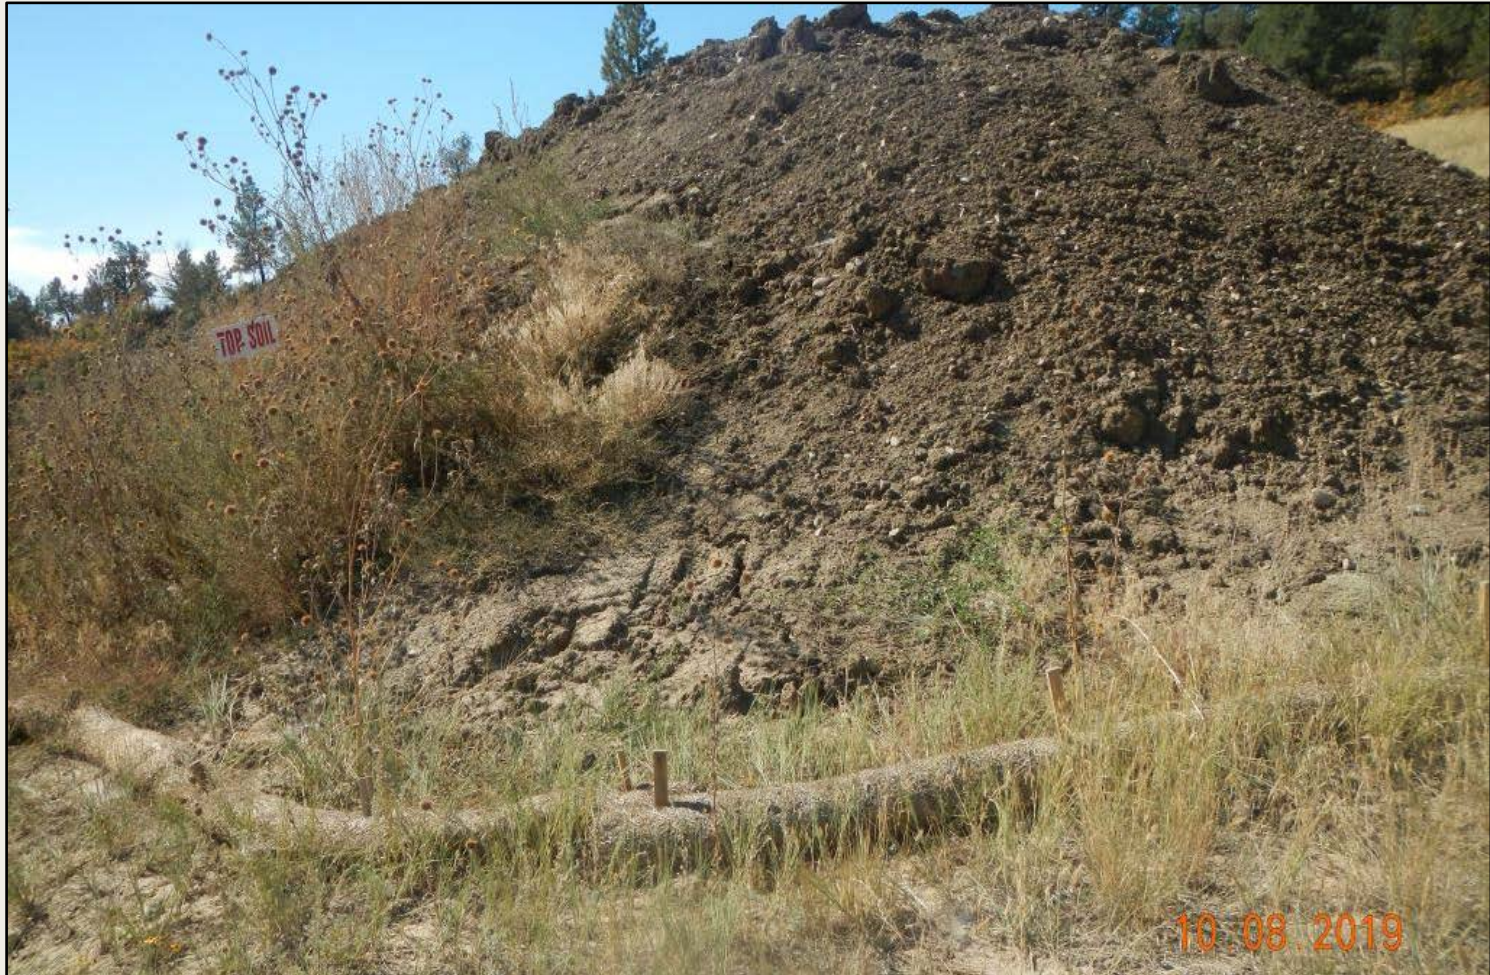
Photo 4. View of topsoil stockpile in the northern project area. Topsoil is not sufficiently protected, as tall pile is too deep to retain microbial activity, soil is bare or supporting weeds and exposed to erosion, and wattle surrounding the pile is not sufficient to prevent runoff of topsoil.

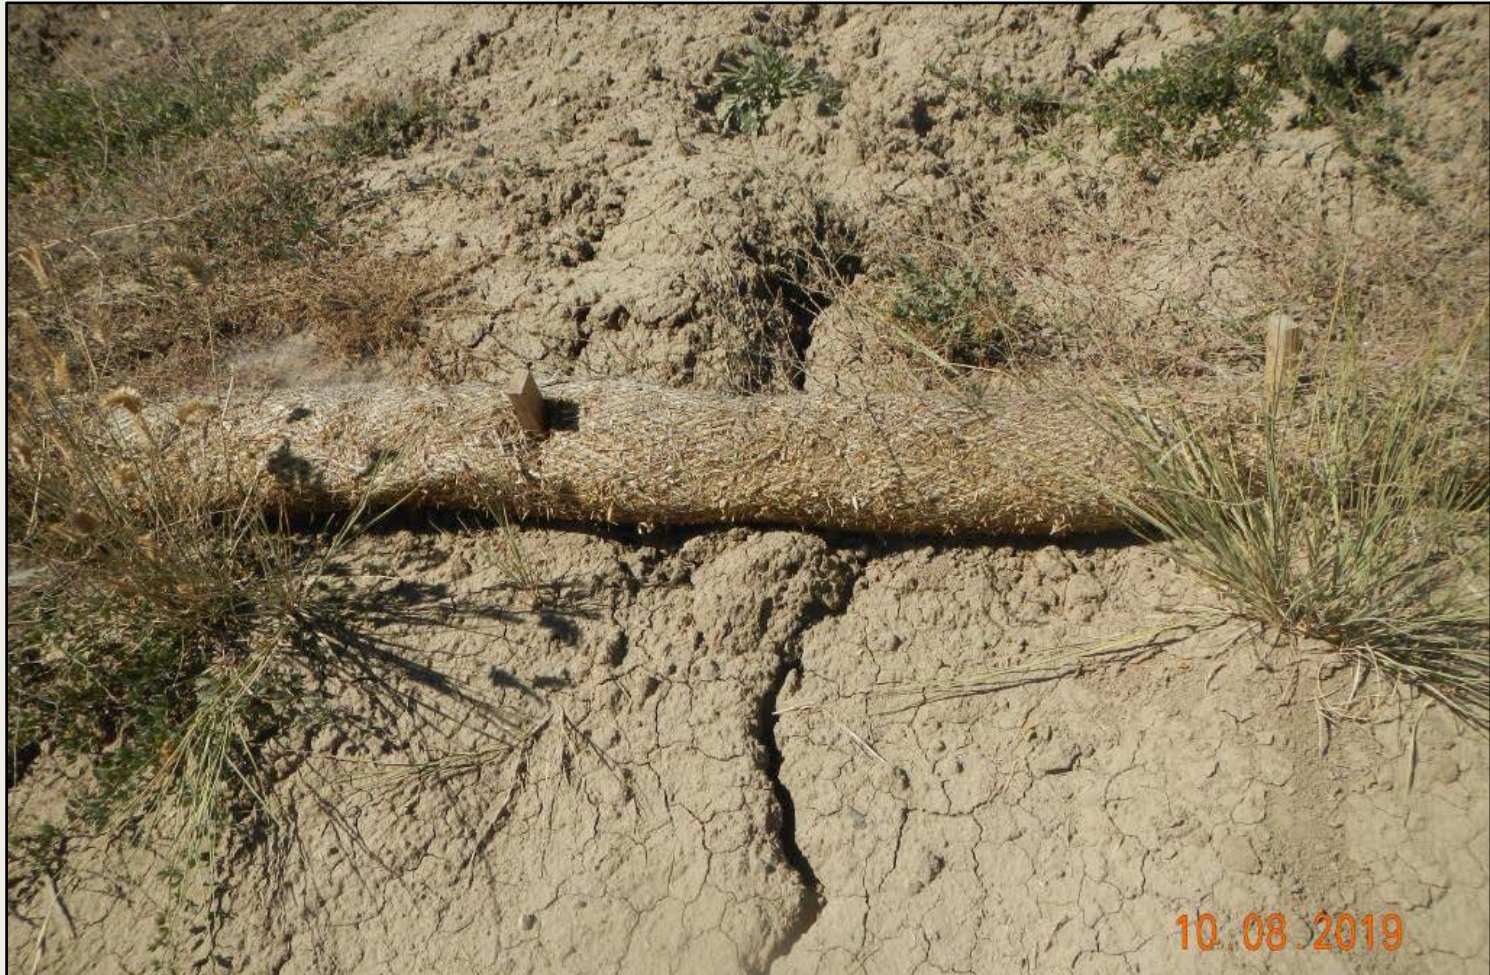
Photo 5. View of wattle at base of topsoil stockpile, that is not properly “trenched” into the soil, allowing runoff beneath the wattle and topsoil loss/sediment discharge.

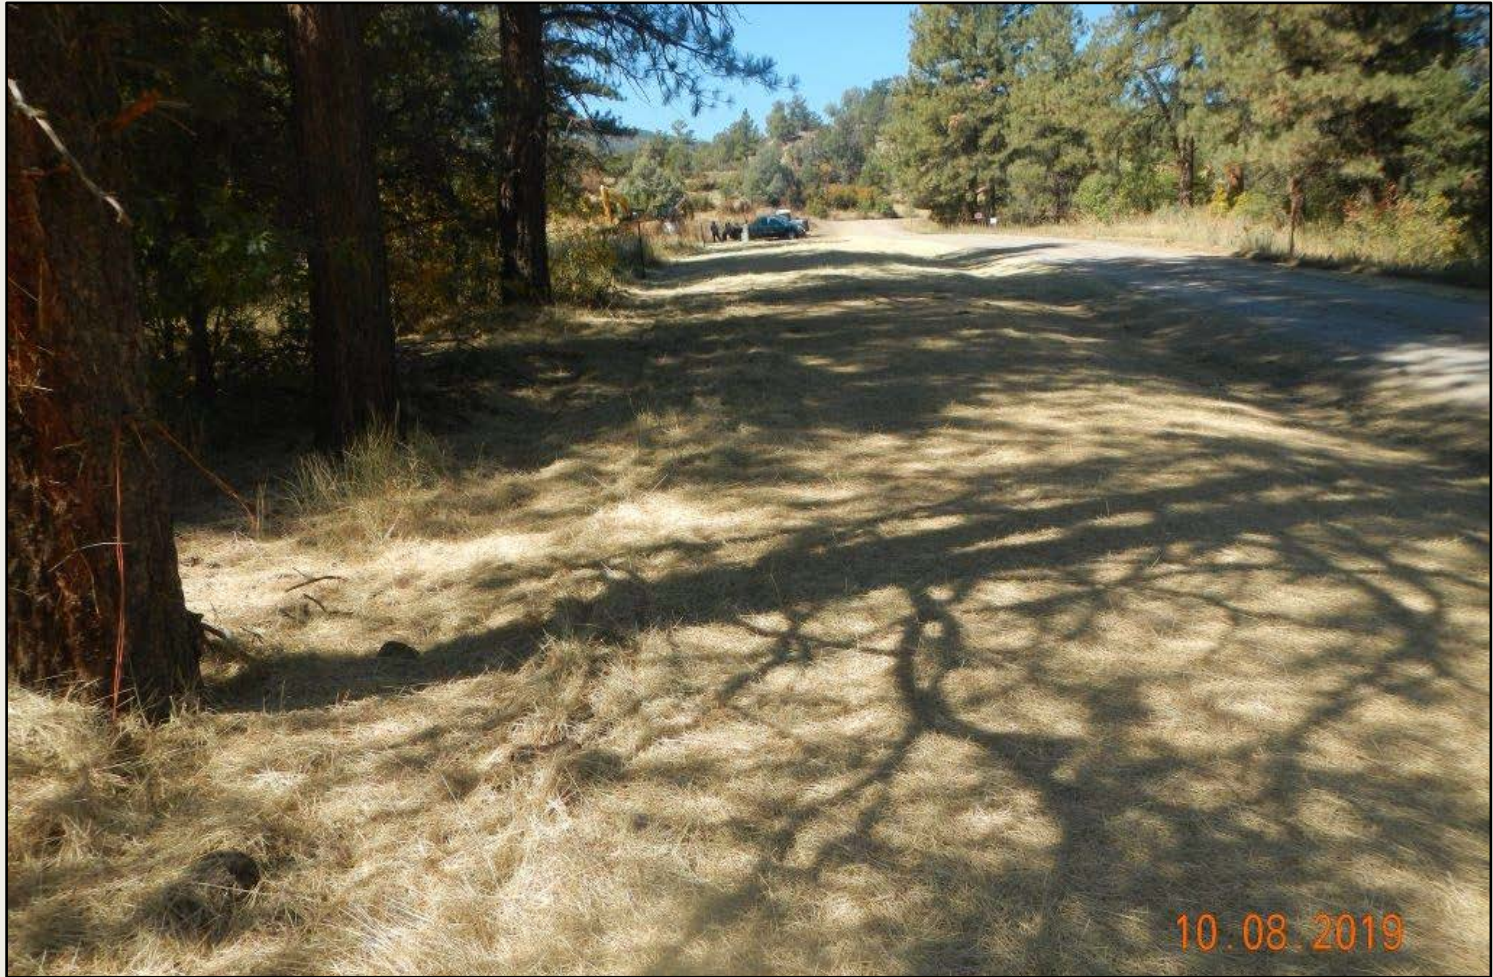
Photo 6. View of straw mulch along flowline right of way.

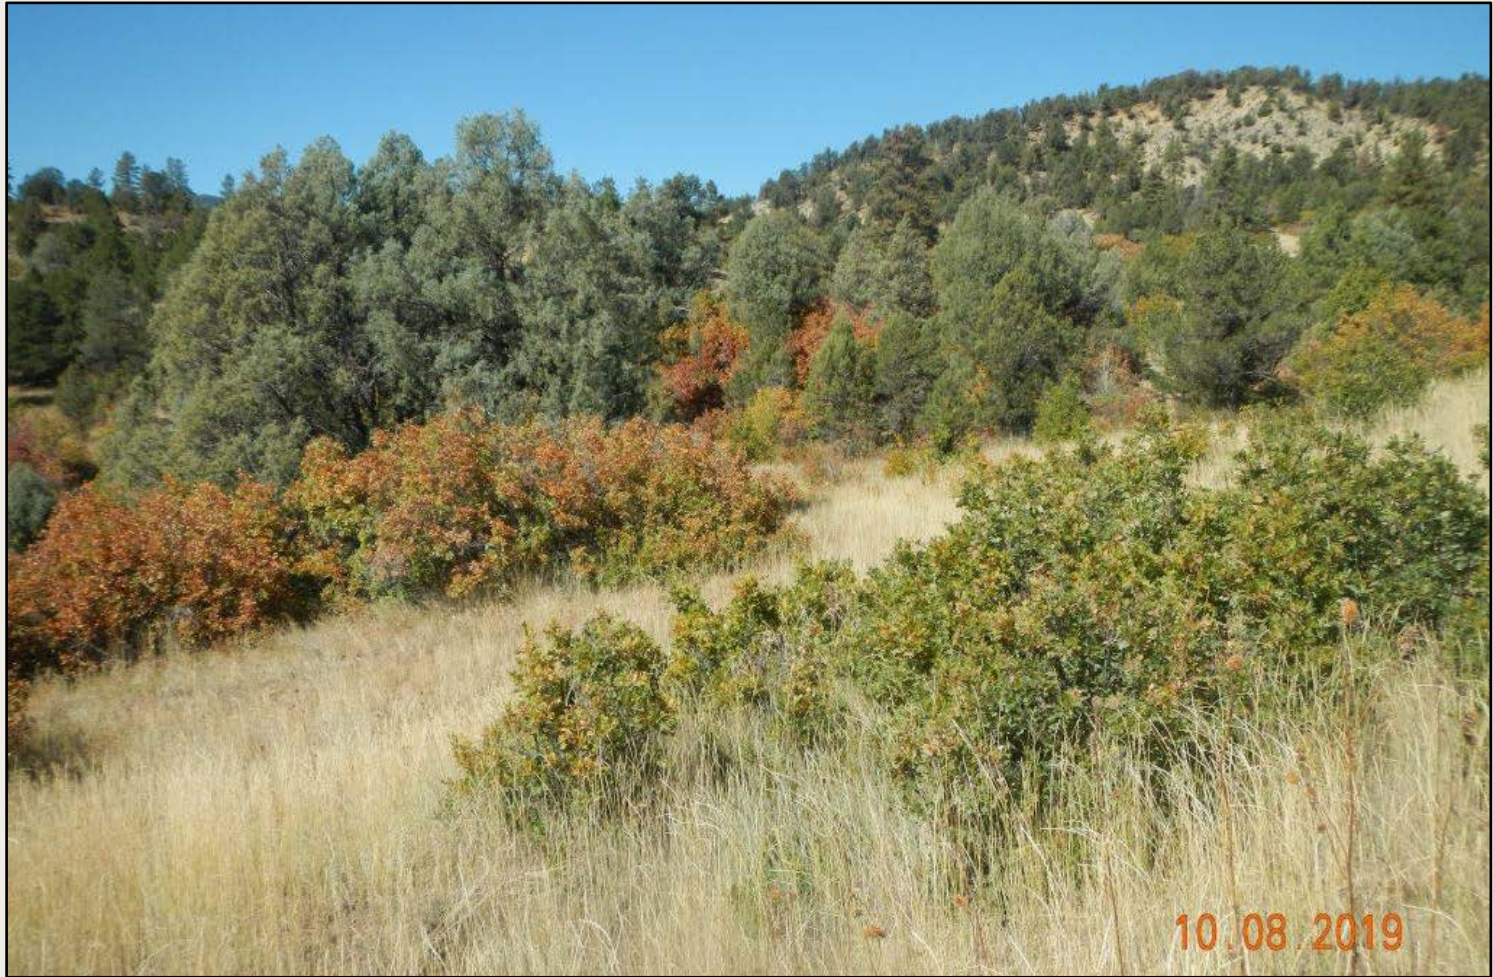
Photo 7. View of reference area vegetation comprised of a mosaic of ponderosa pine, juniper, gambel oak, and open grass fields.
