Inspection Photos
Operator: Catamount Energy
Location/API #: 007-06137
Date: 10-8-2019

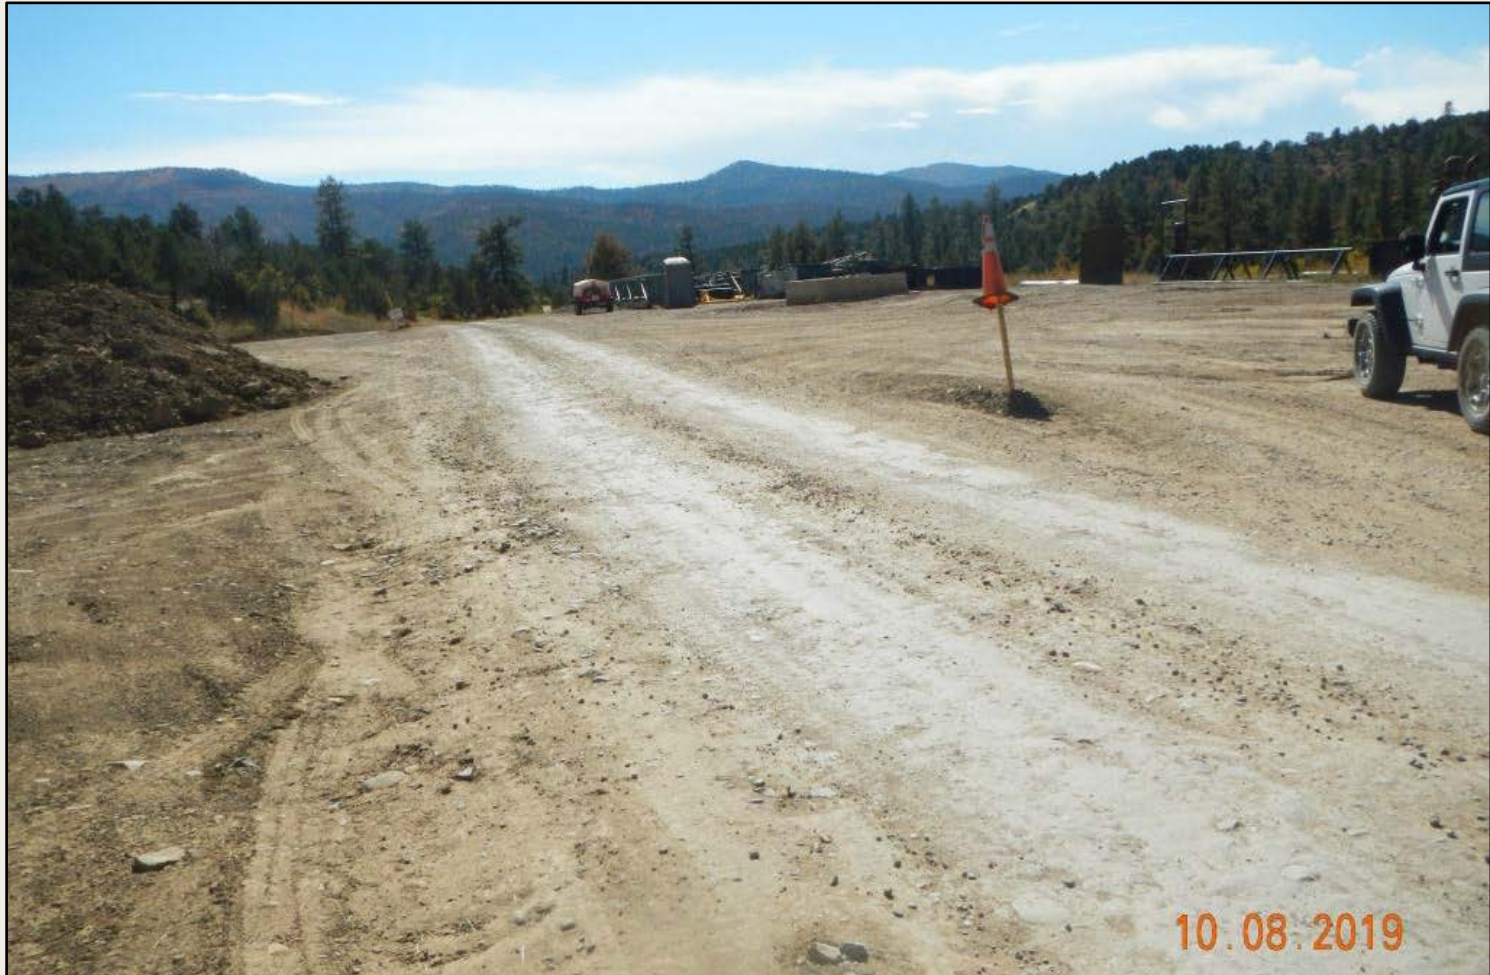
Photo 1. View of the project area from the northern entrance facing center. Equipment stored throughout the project area.

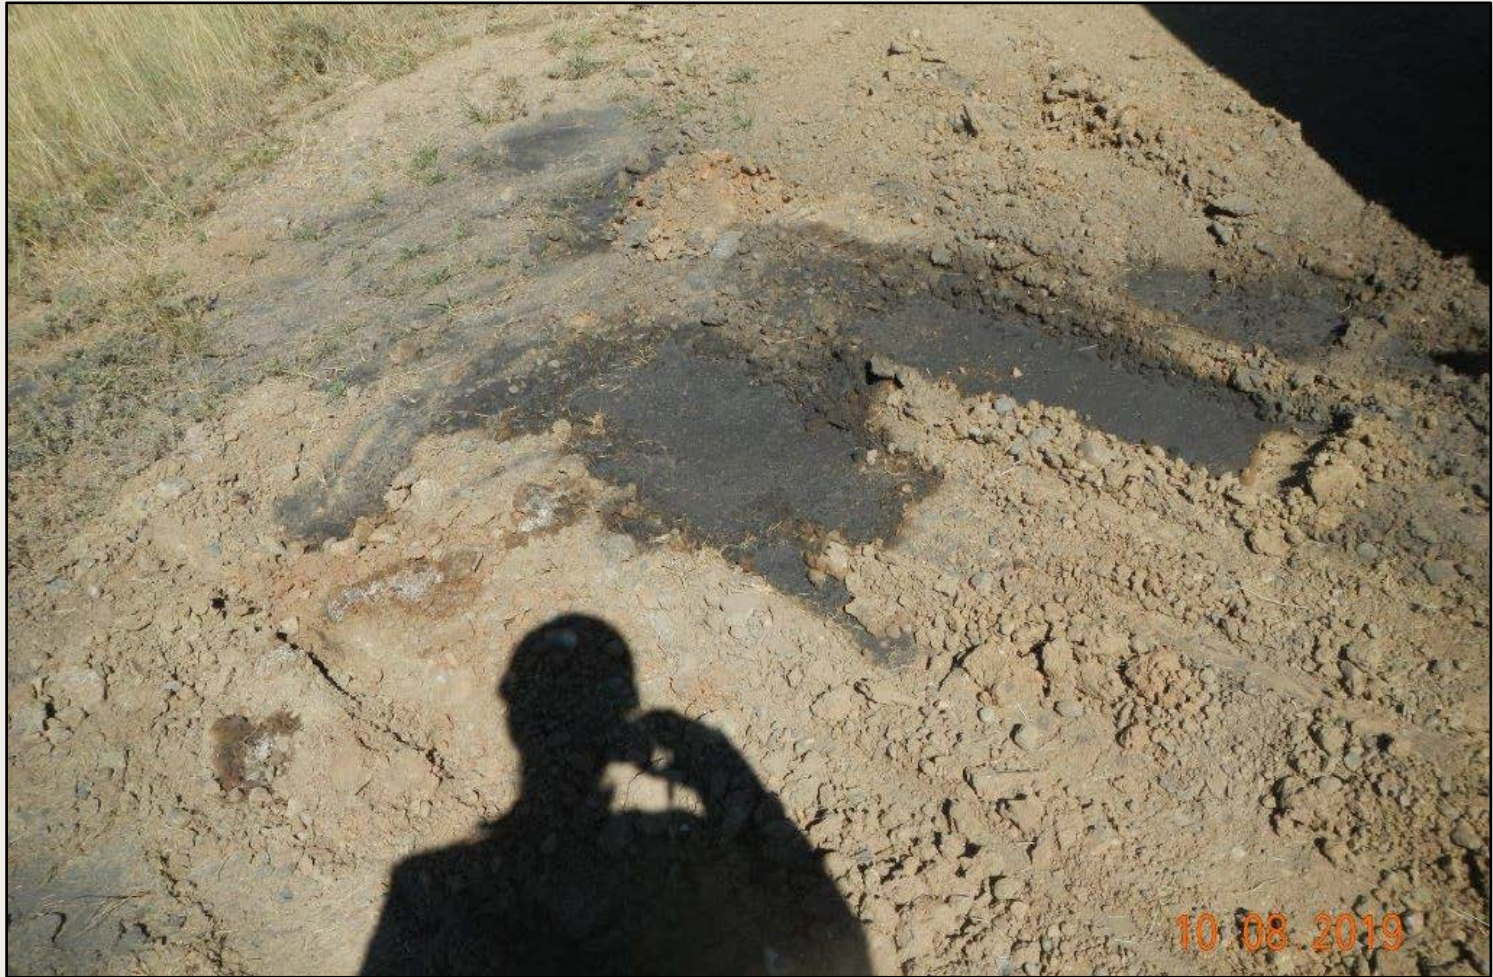
Photo 2. View of stained soils approximately 8 feet x 8 feet within the northern project area.

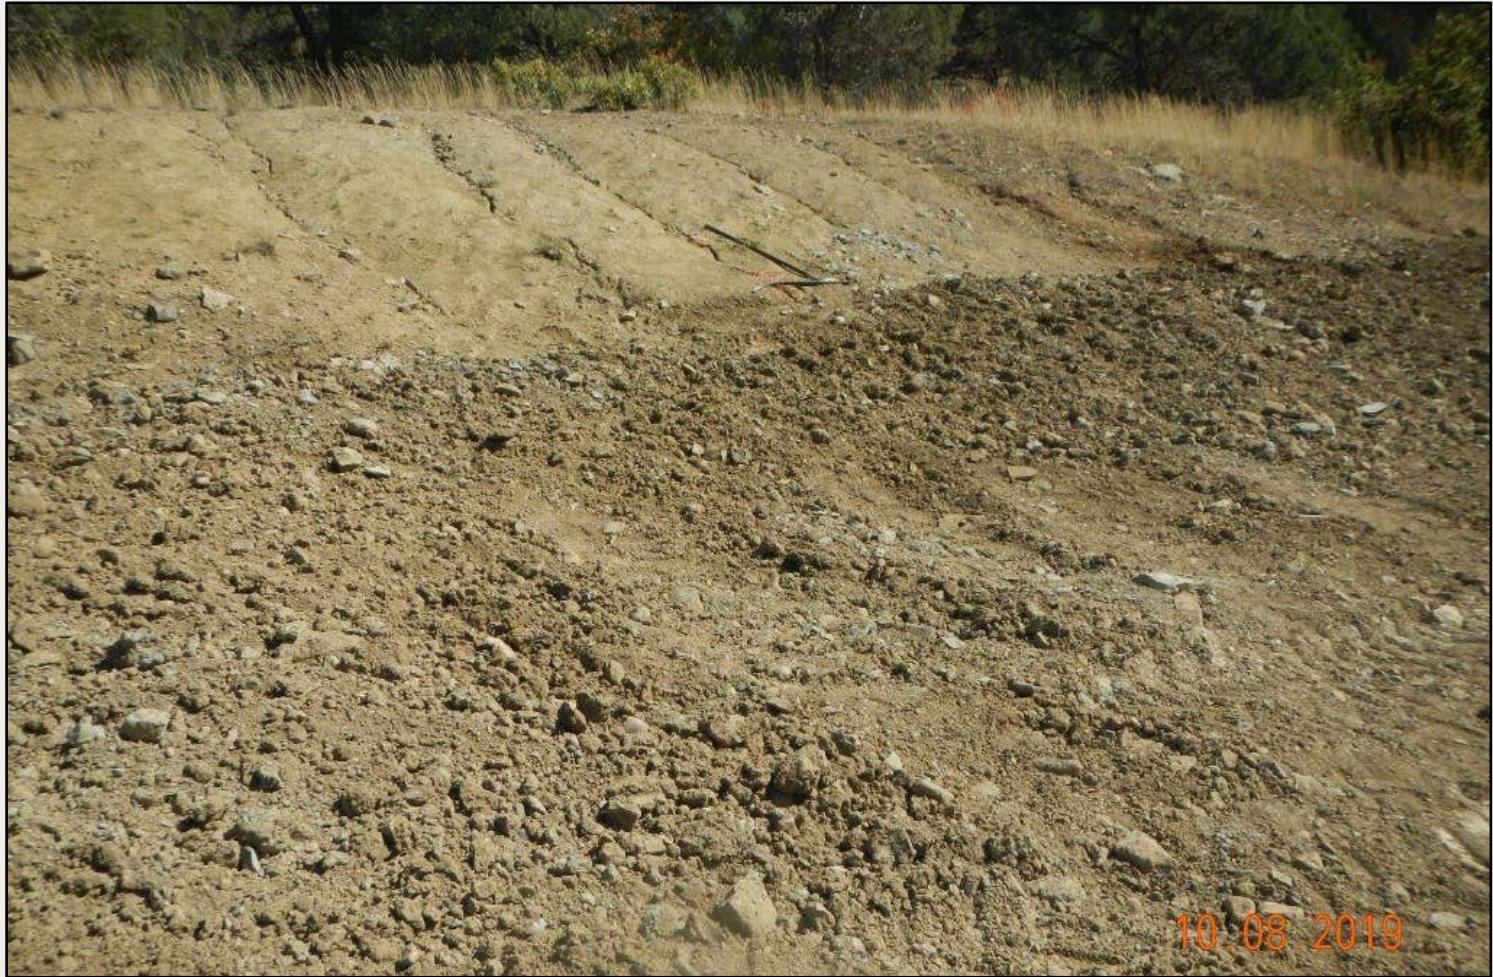
Photo 3. View of bare and eroding soils on the eastern cut-slope, not stabilized.

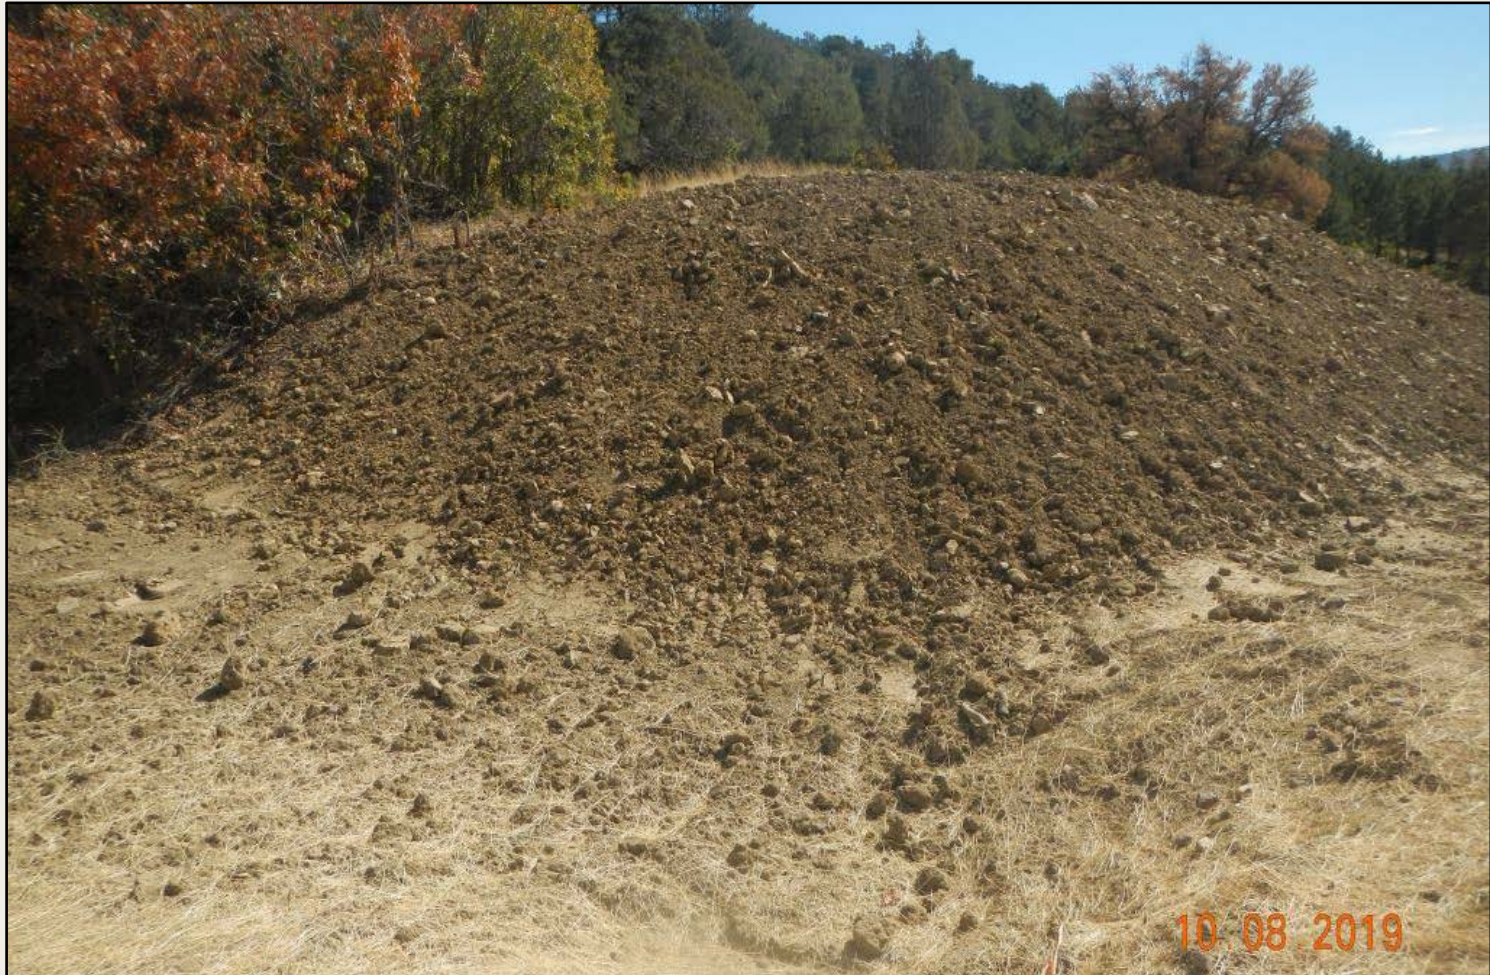
Photo 4. View of soil stockpile in the northeastern project area. Bare soil is not sufficiently protected/stabilized.

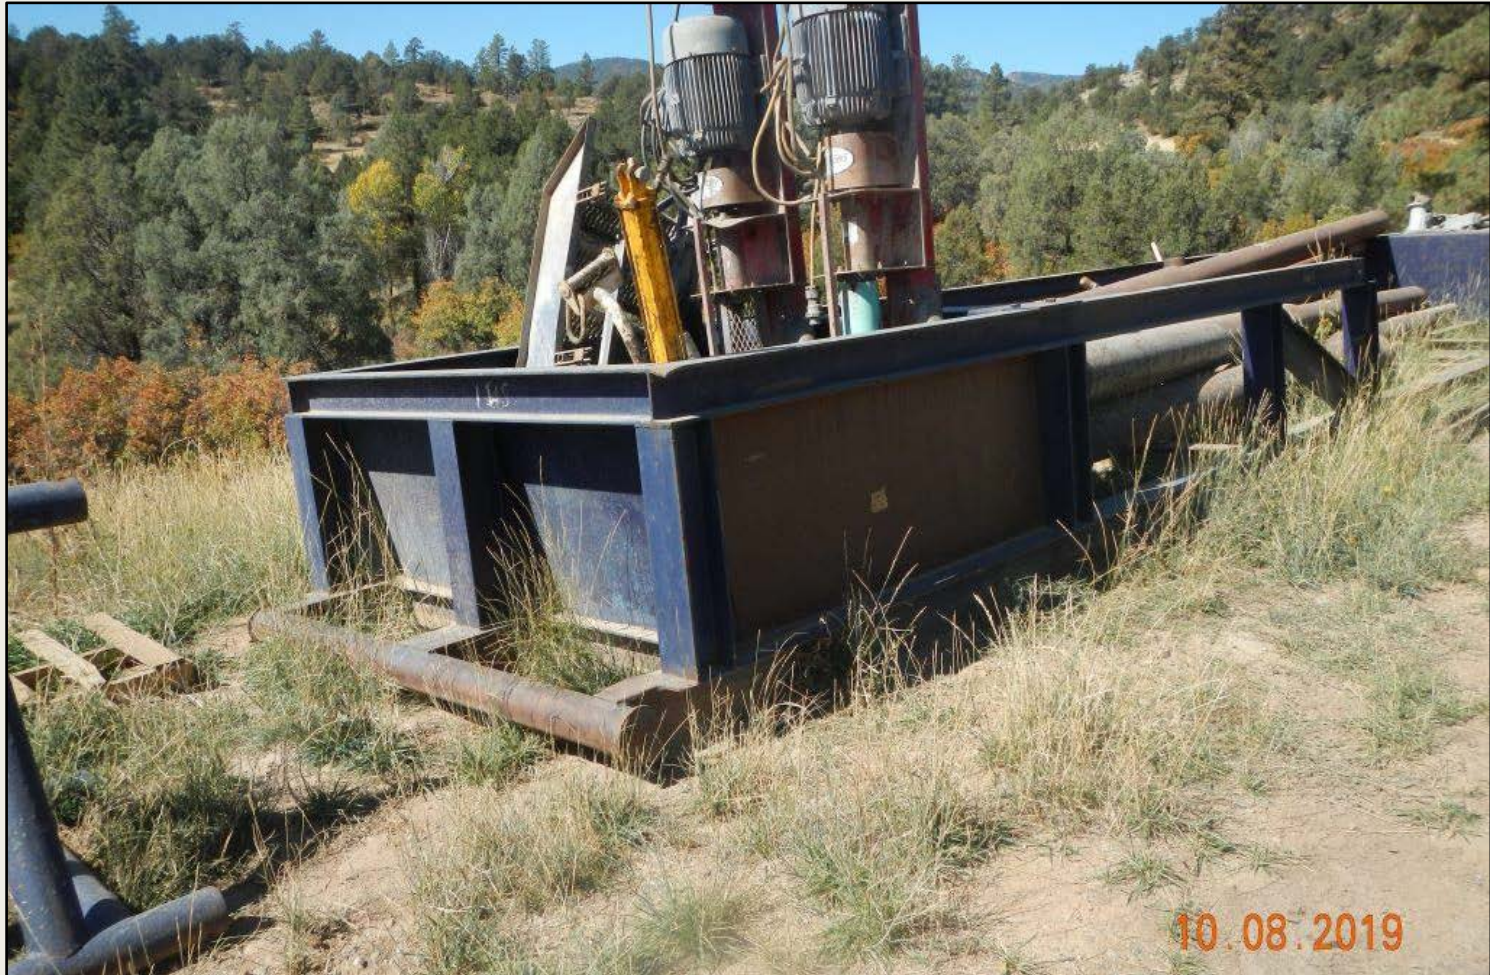
Photo 5. View of equipment stored in the interim reclamation area, needs to be removed and decompaction/revegetation will be needed after removal.

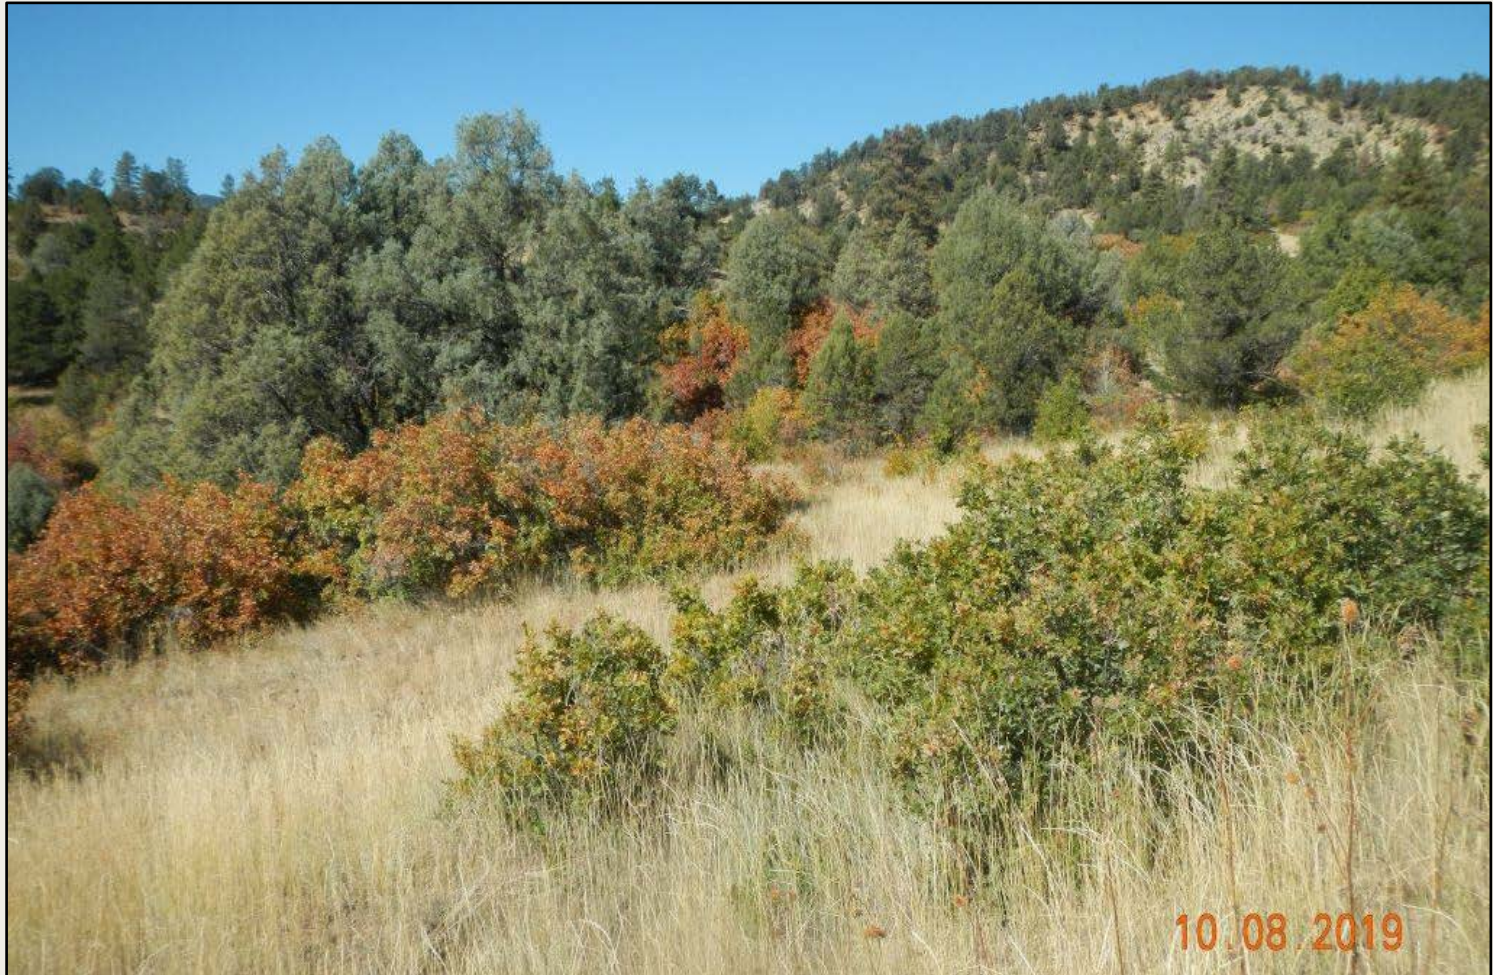
Photo 6. View of reference area vegetation comprised of a mosaic of ponderosa pine, juniper, gambel oak, and open grass fields.
