# Inspection Photos

Operator: Catamount Energy  
Location/API #: 007-06322  
Date: 10-8-2019

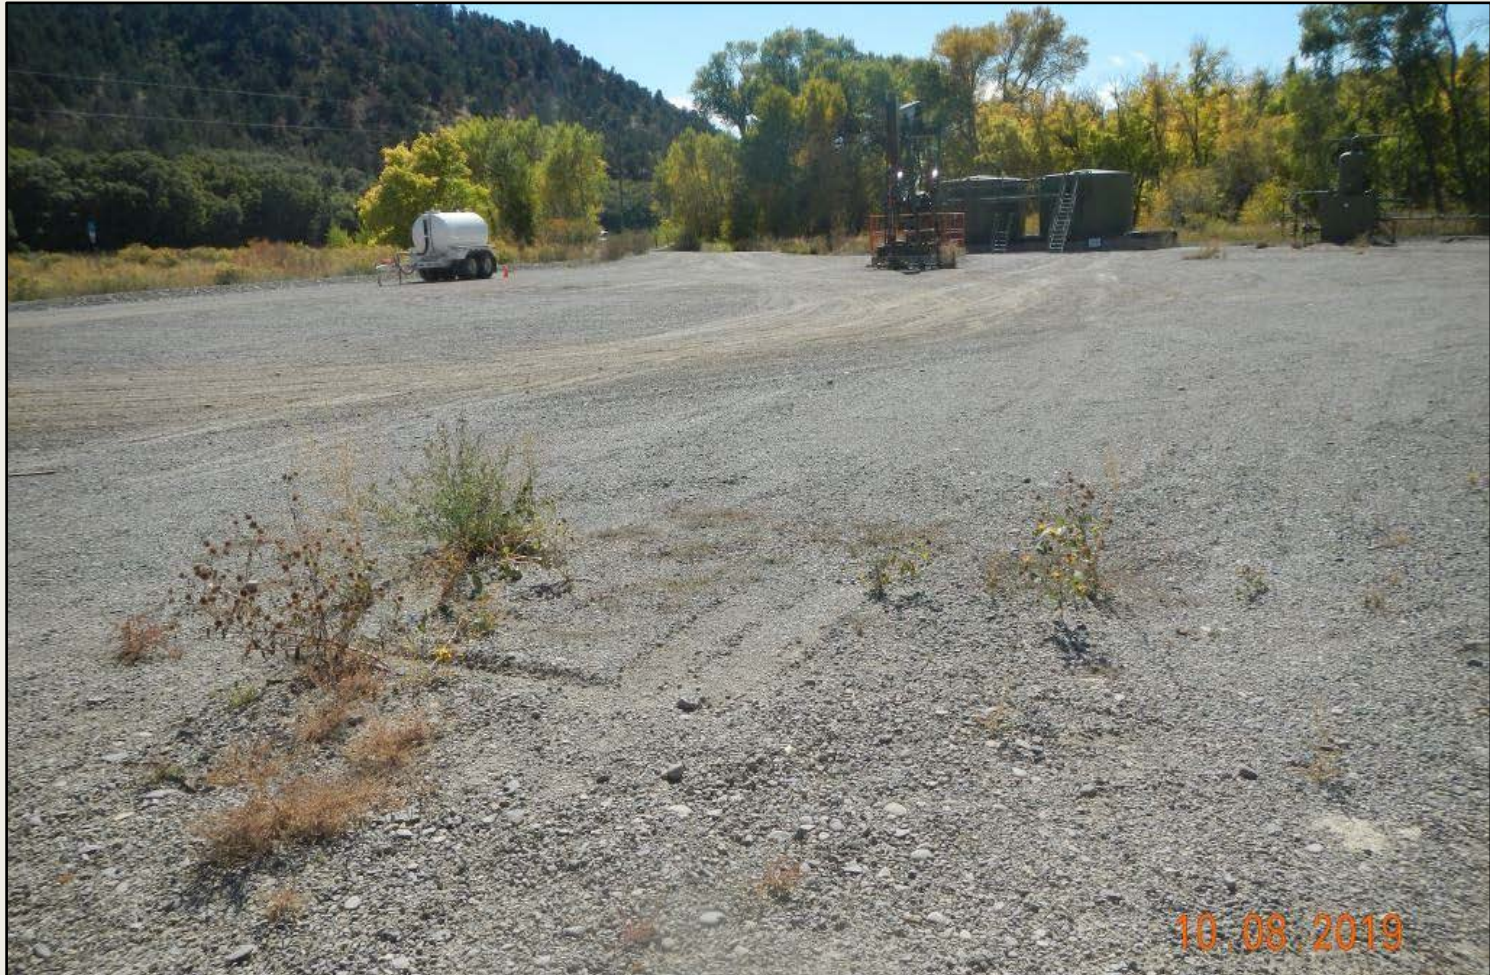
Photo 1. View of the project area from the northwestern edge of the working area, facing center.

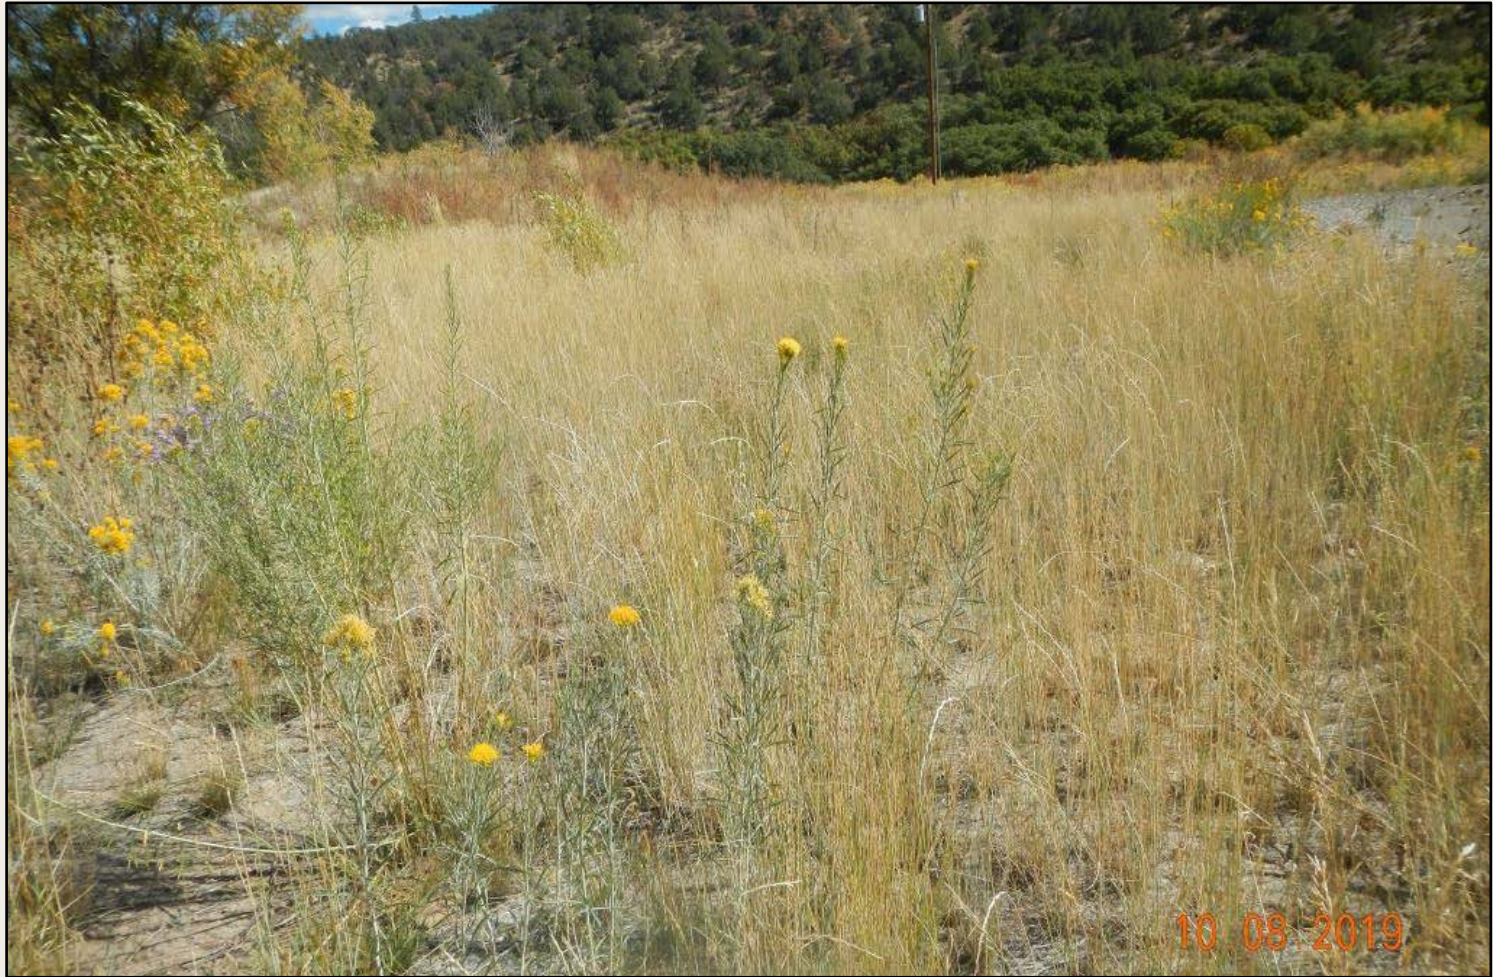
Photo 2. View of the northern project area from the northwestern edge facing eastward.

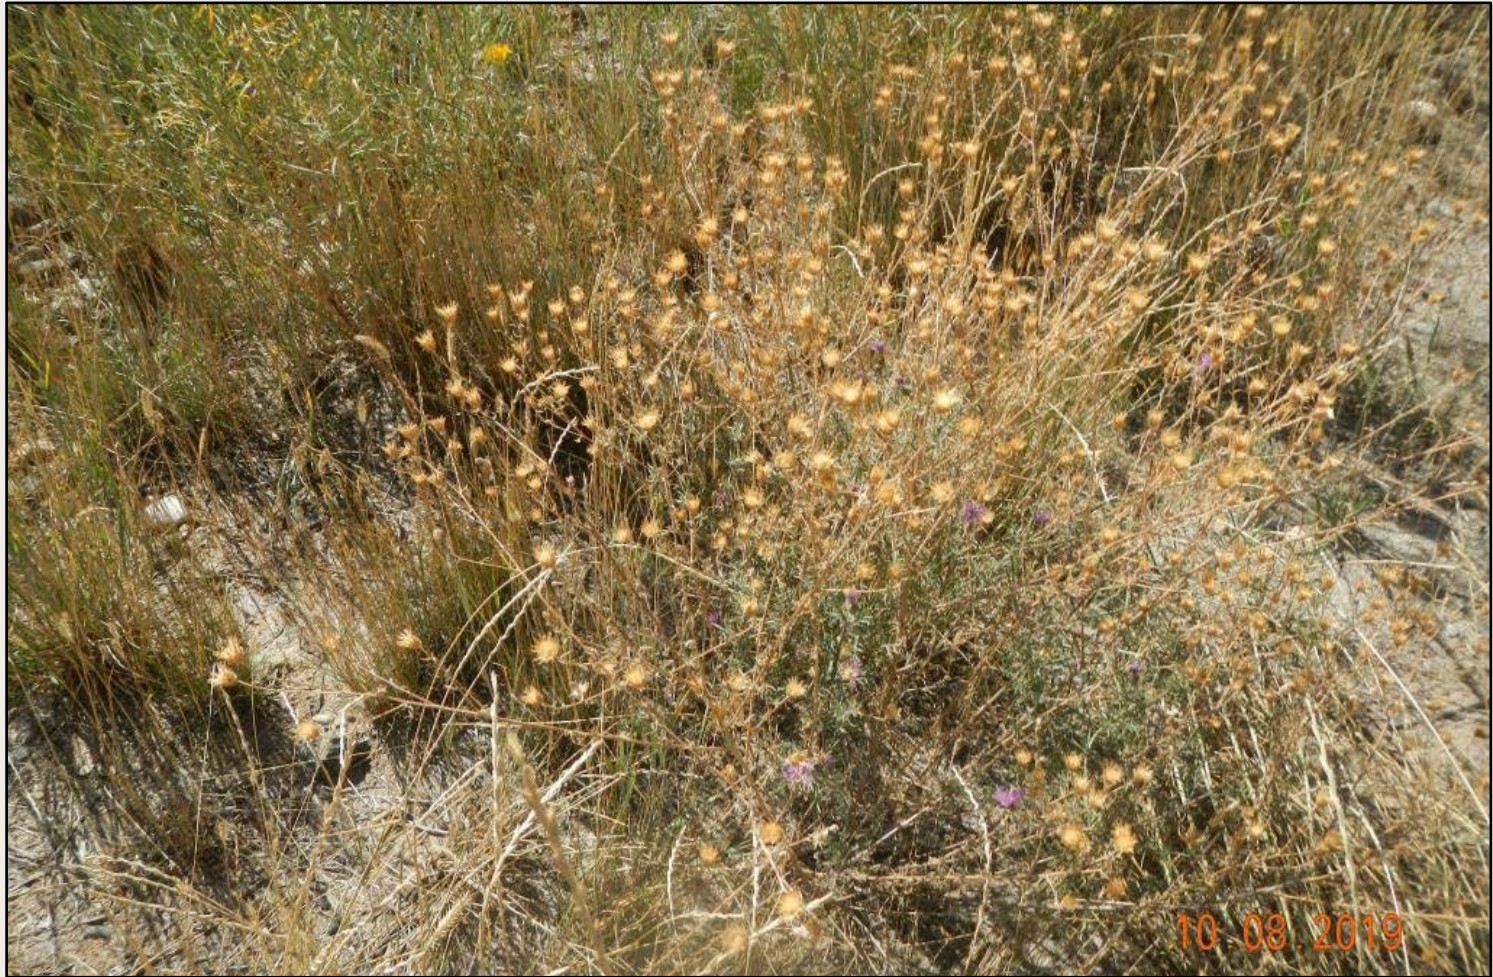
Photo 3. View of spotted knapweeds (*Centaurea maculosa*) within the eastern project area.

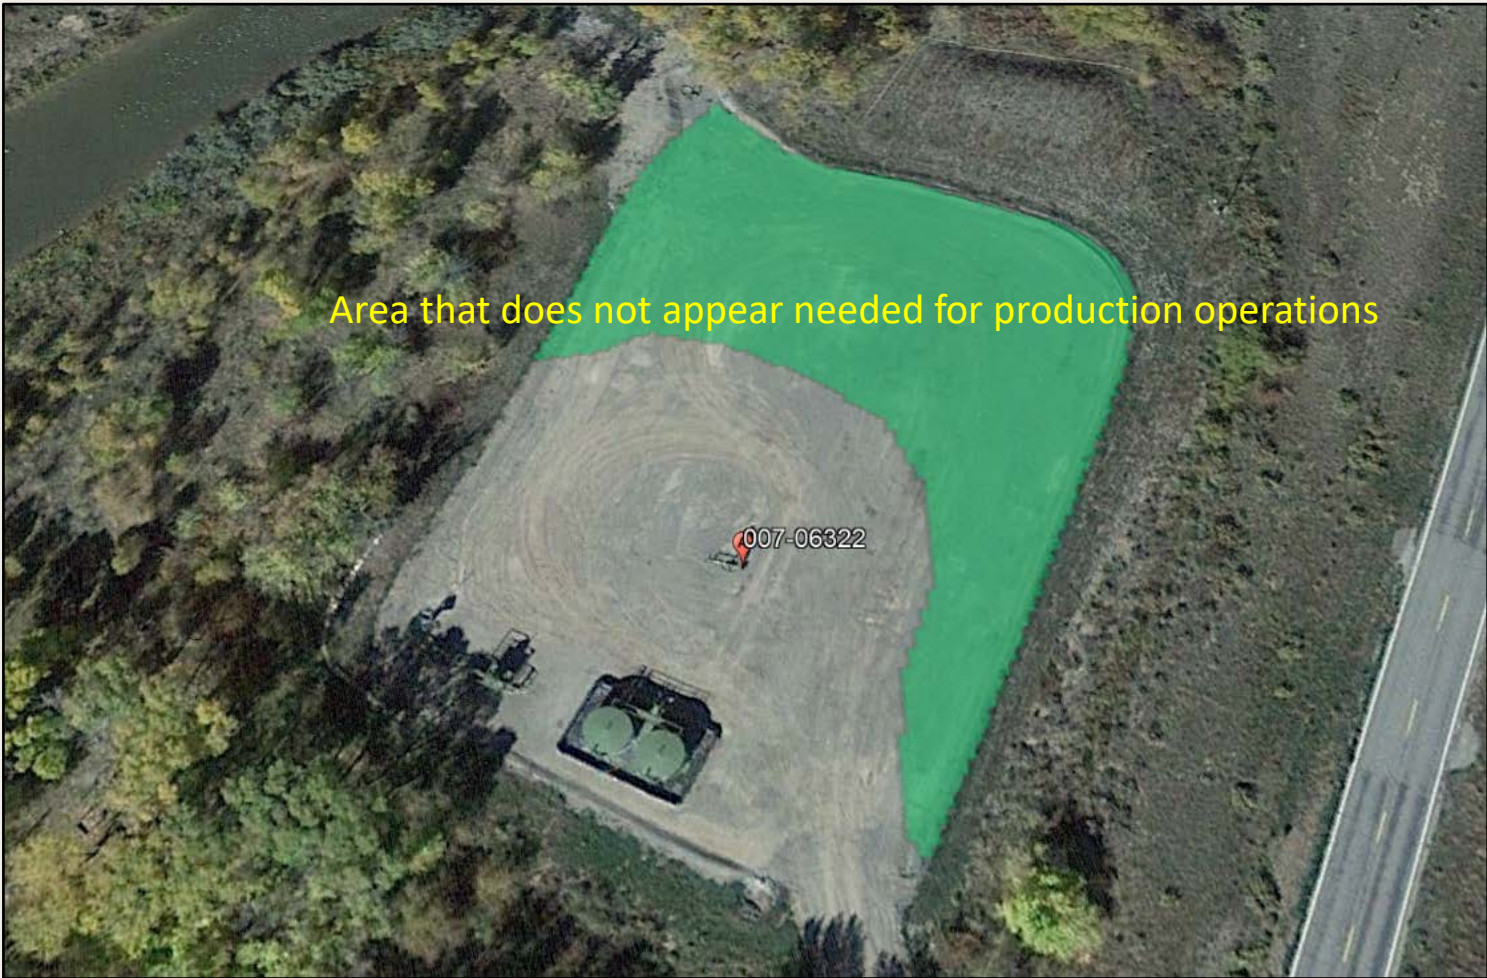
Photo 4. Portion of project area that does not appear needed for production operations and needs to be reclaimed is shaded in green.

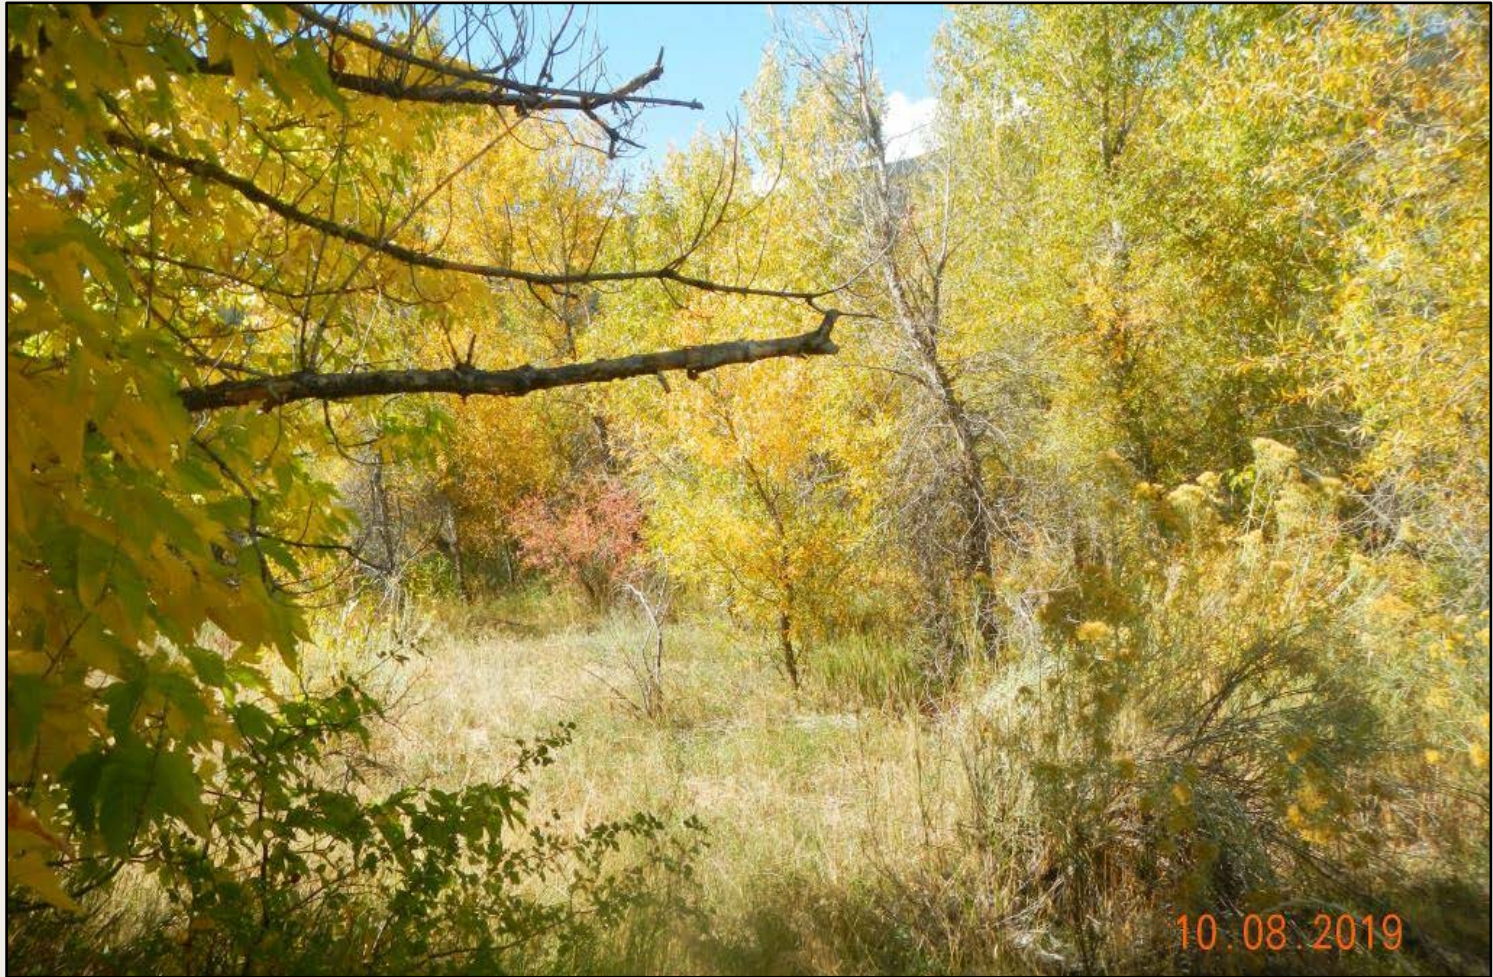
Photo 5. View of reference area vegetation comprised of riparian cottonwood forest.
