Inspection Photos
Location Name: McIntyre 1-3 St
Location ID: 312997

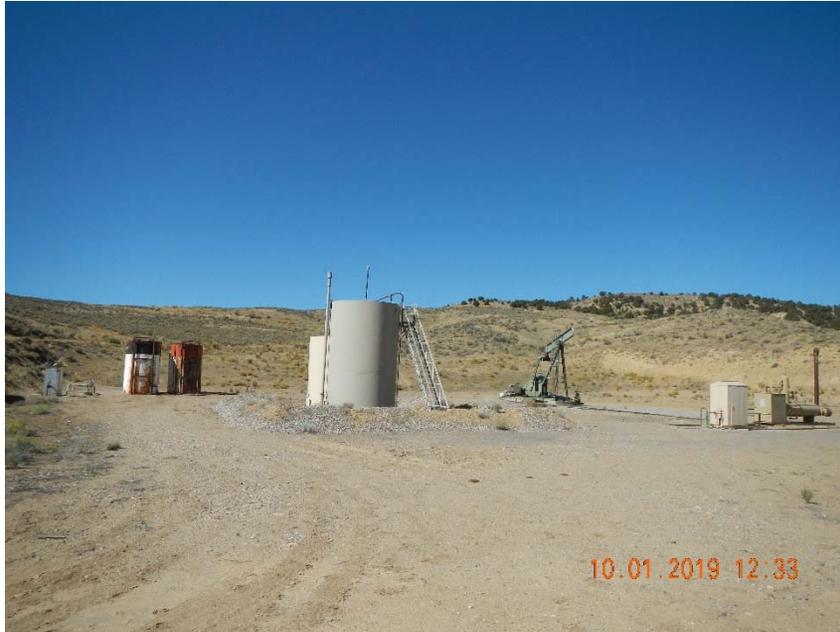
Photo 1. Overview of location taken facing north.

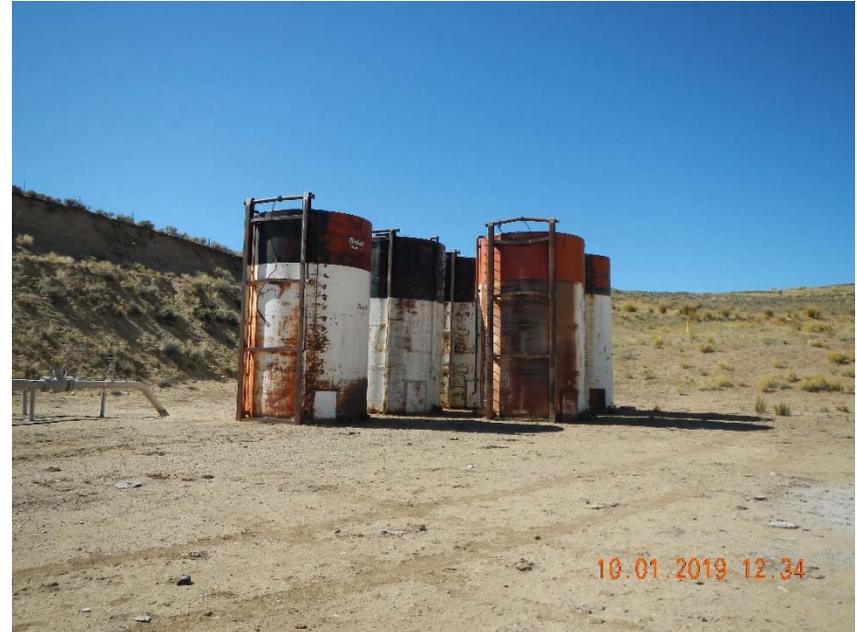
Photo 2. Frack tanks without containment and without labels.

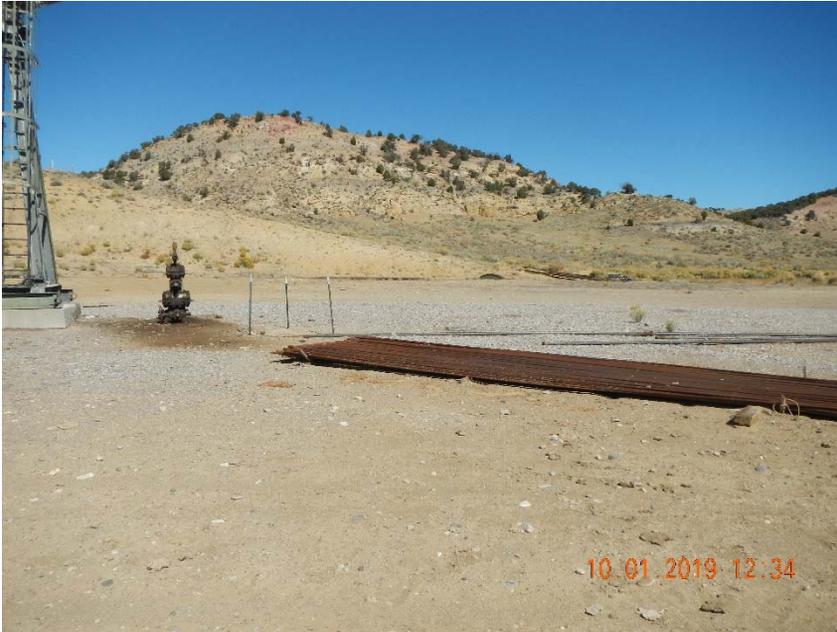
Photo 3. Tubing stored on location, stained soil at wellhead.

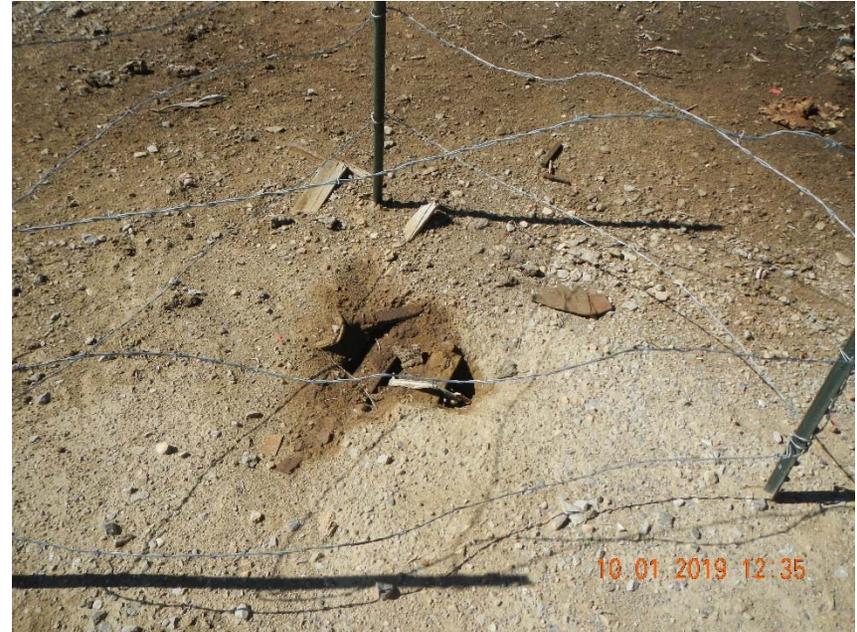
Photo 4. Open rathole and stained soil.

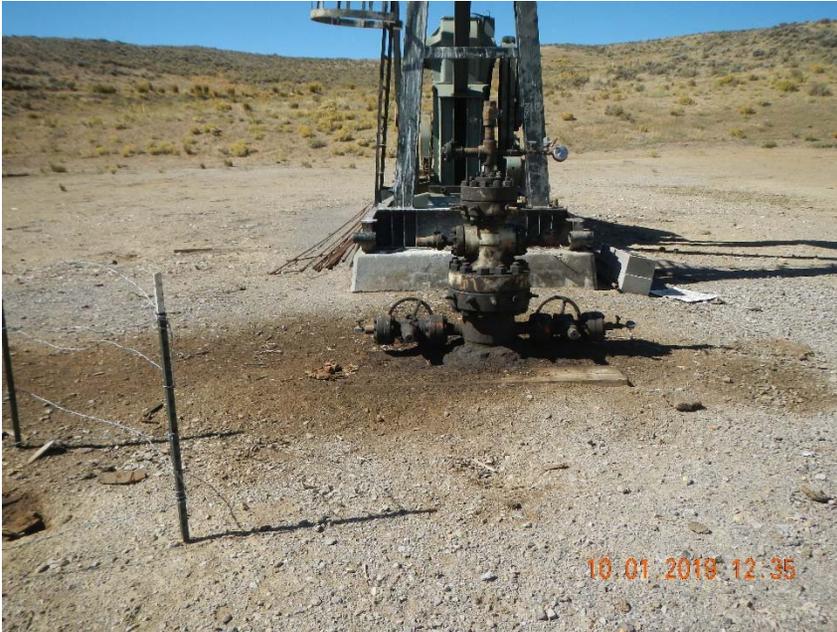
Photo 5. Stained soil at wellhead.

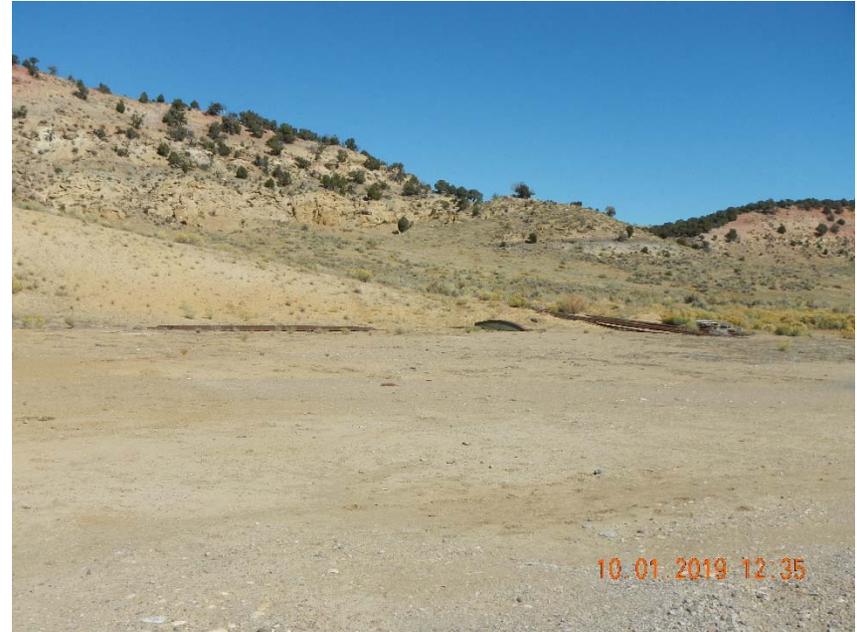
Photo 6. Tubing and equipment stored on location perimeter.

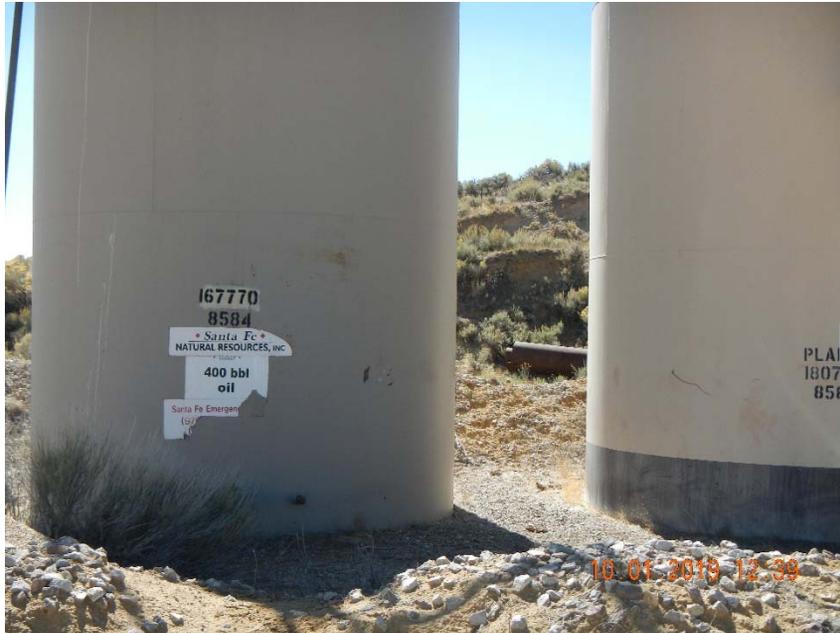
Photo 7. Incomplete tank labels.

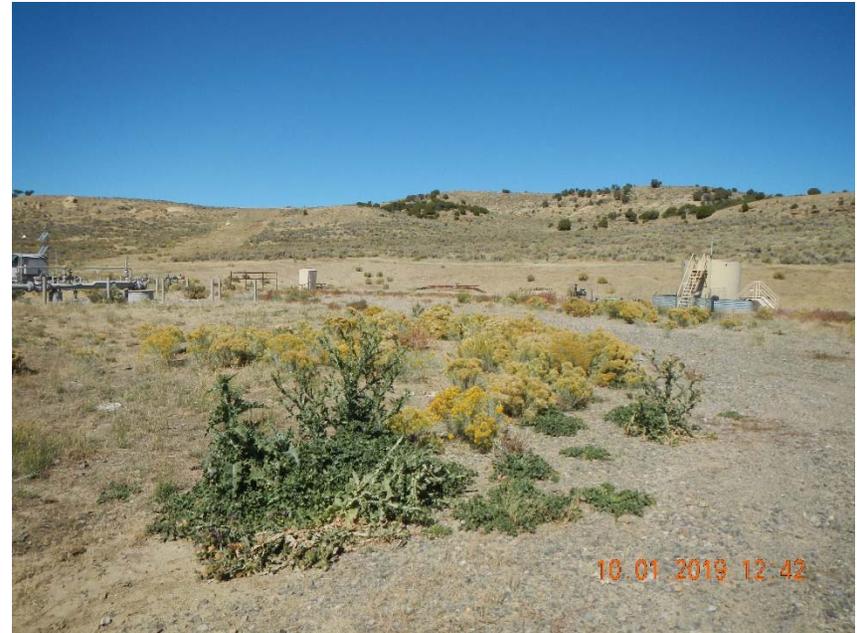
Photo 8. Noxious weeds on location.
