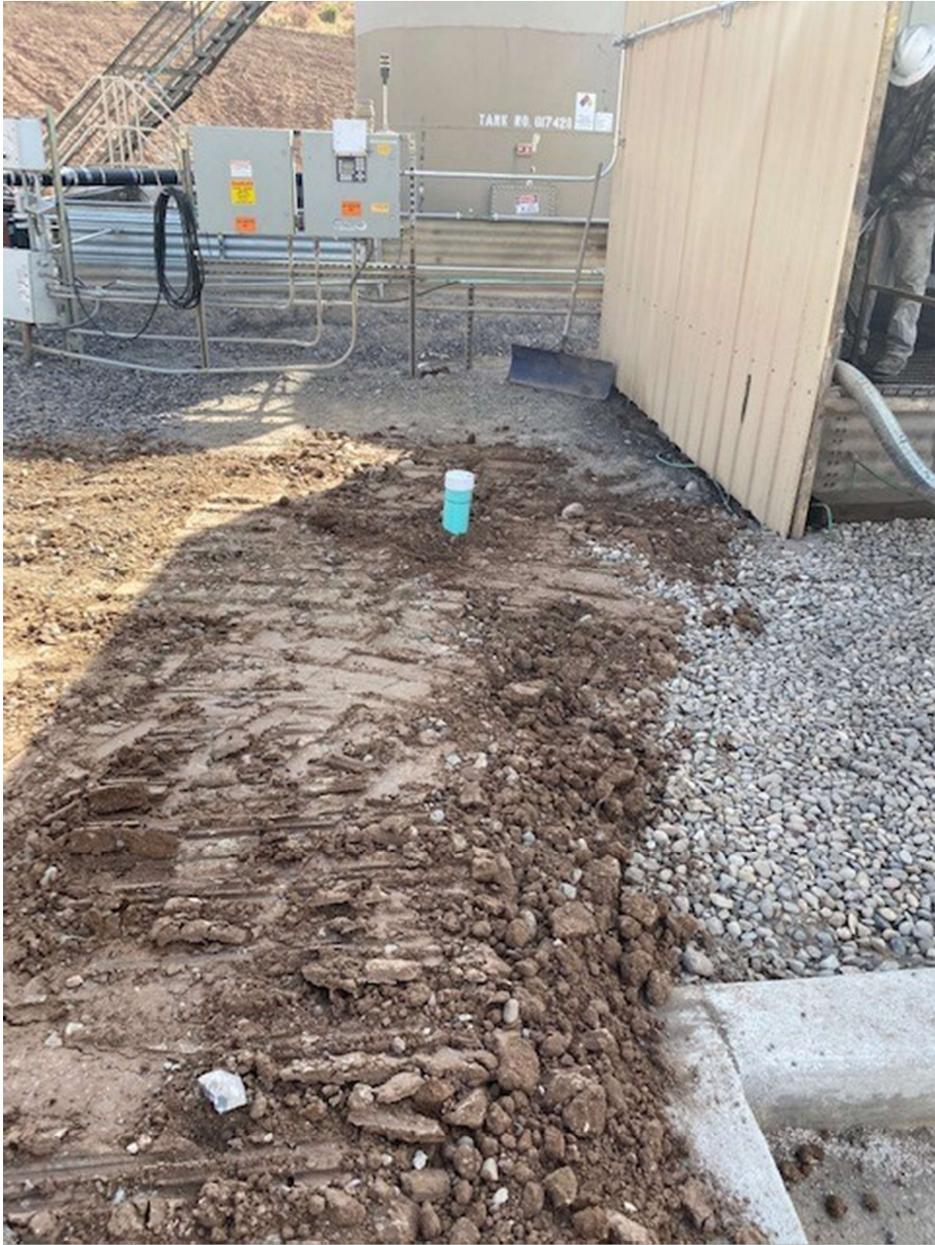
*Photo 1 – Vent Installed at E1 Sample Location*

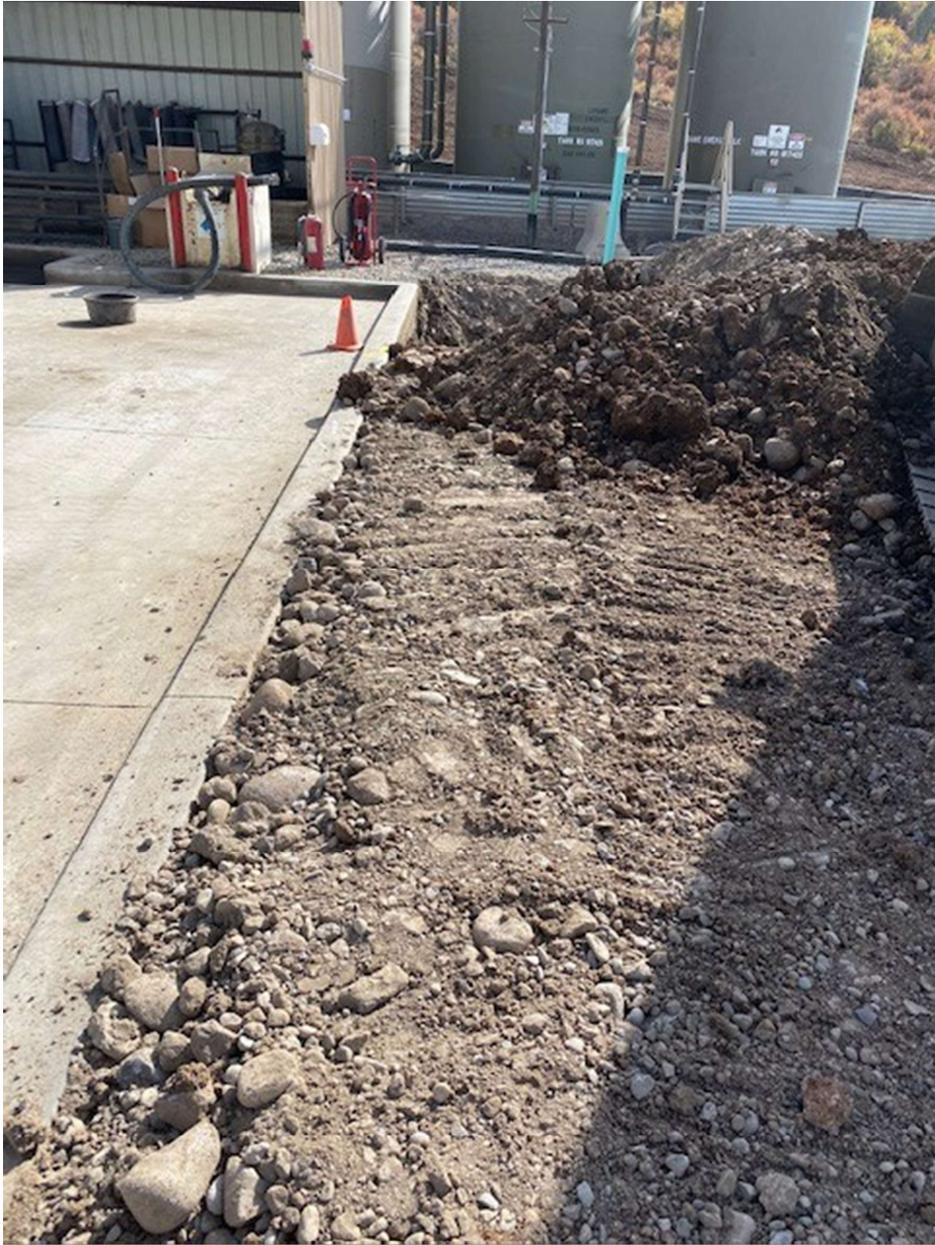
Photo 2 – W2 Location after Backfill

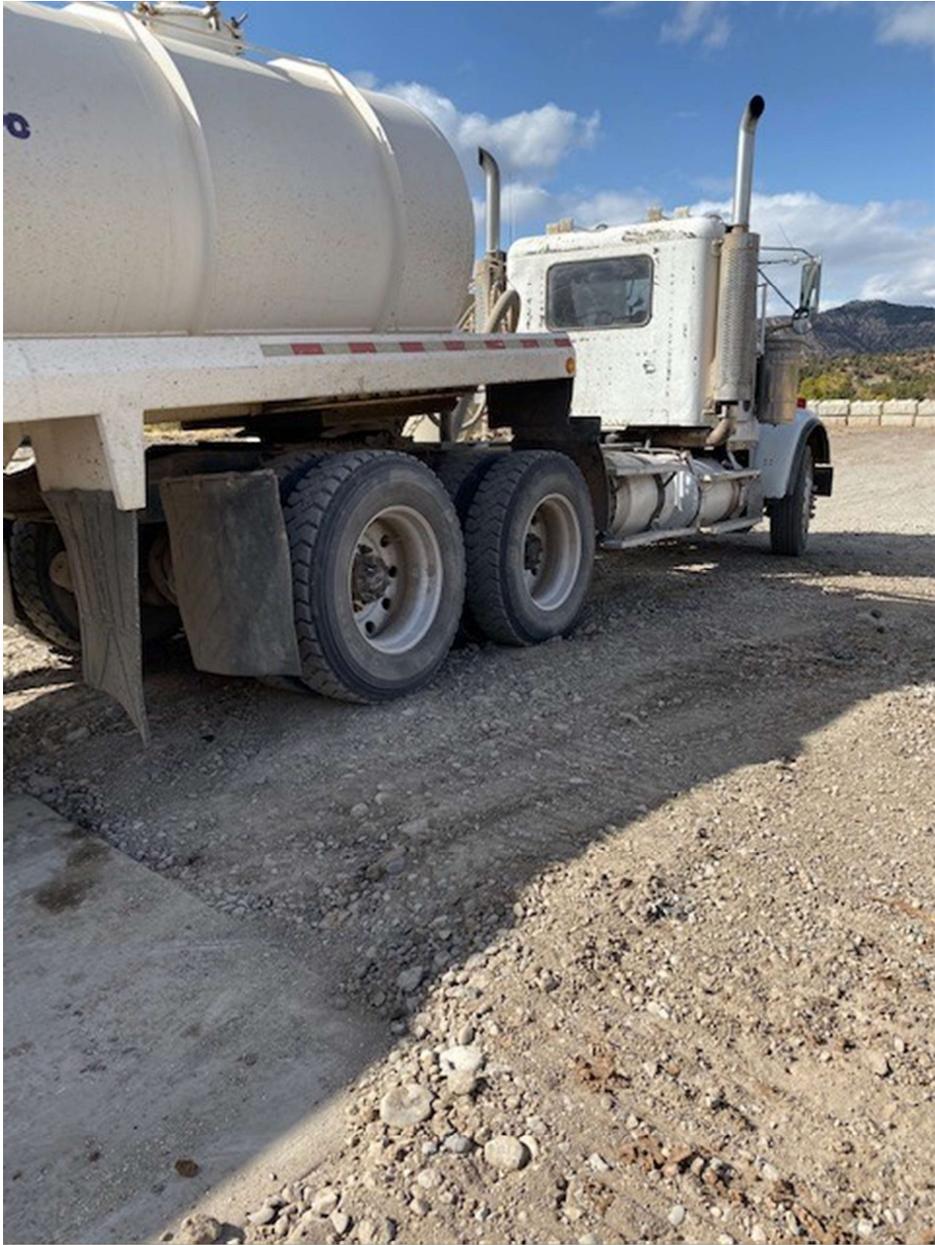
*Photo 3 – Locations N1 and N2 after Backfill*
