**Inspection Photos**  
**Location Name: Falcon Seaboard #3**  
**API: 05-051-06045**

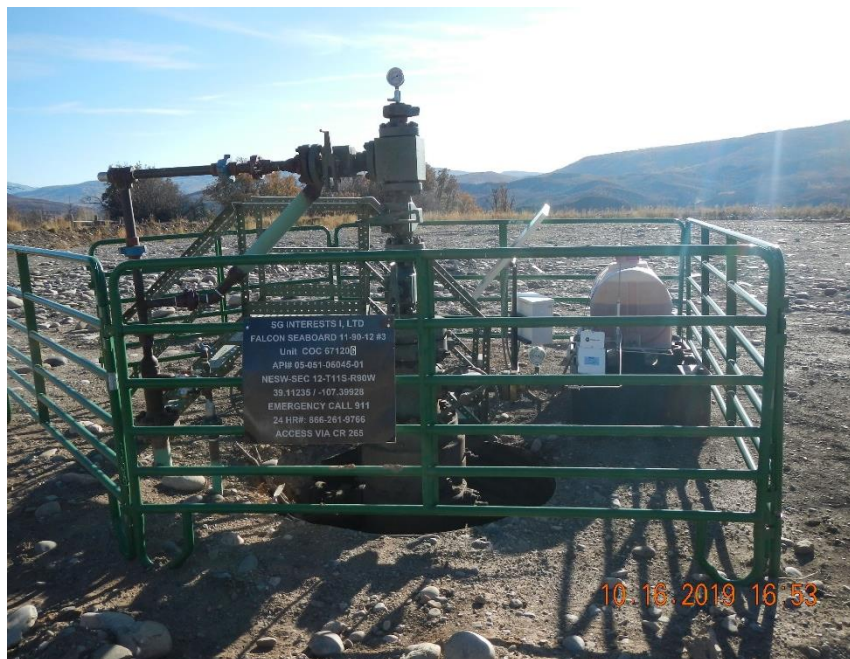
**Falcon Seaboard #3 well head.**

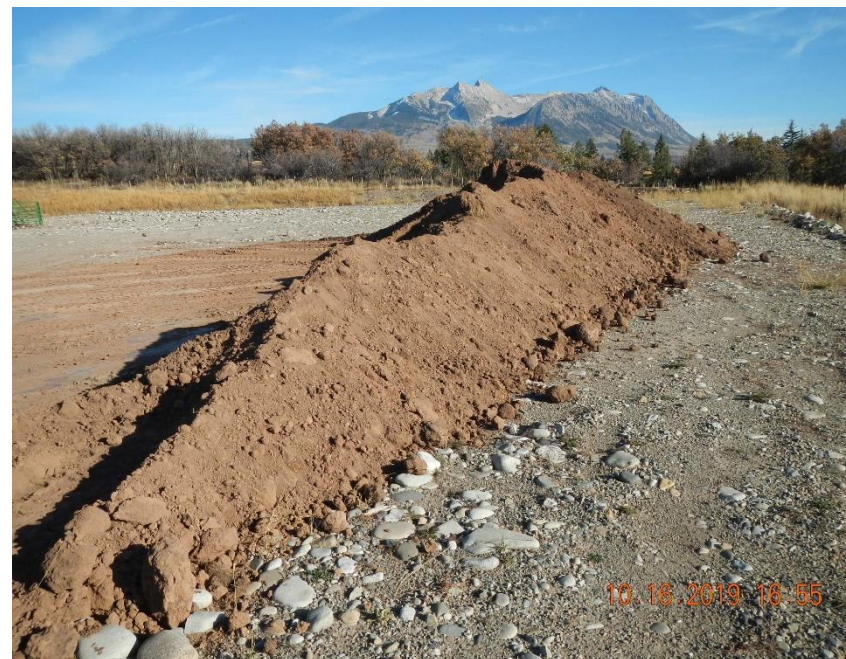
**Stock pile of soil near southwest edge of location.**

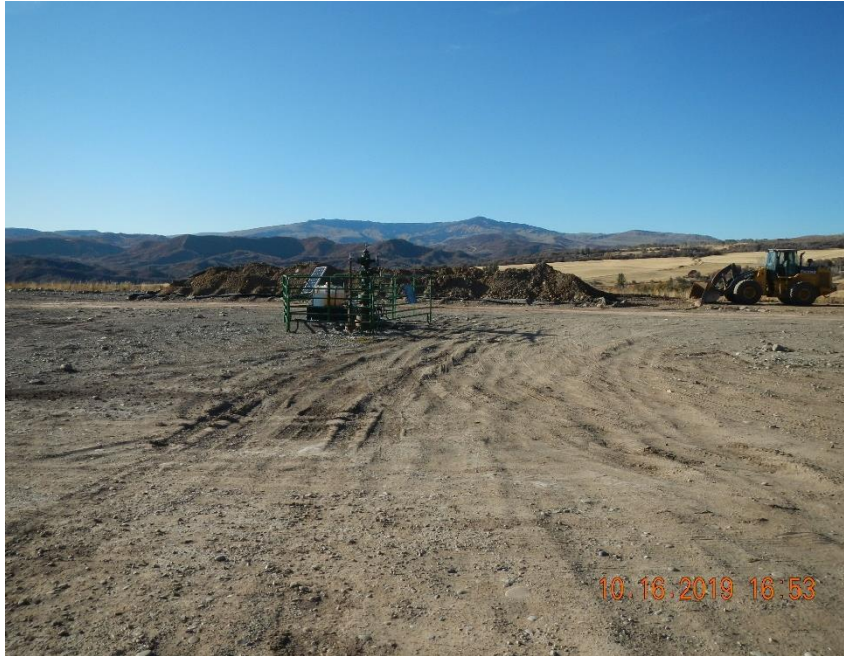
**Impacted soil stock piled along NW edge of location.**

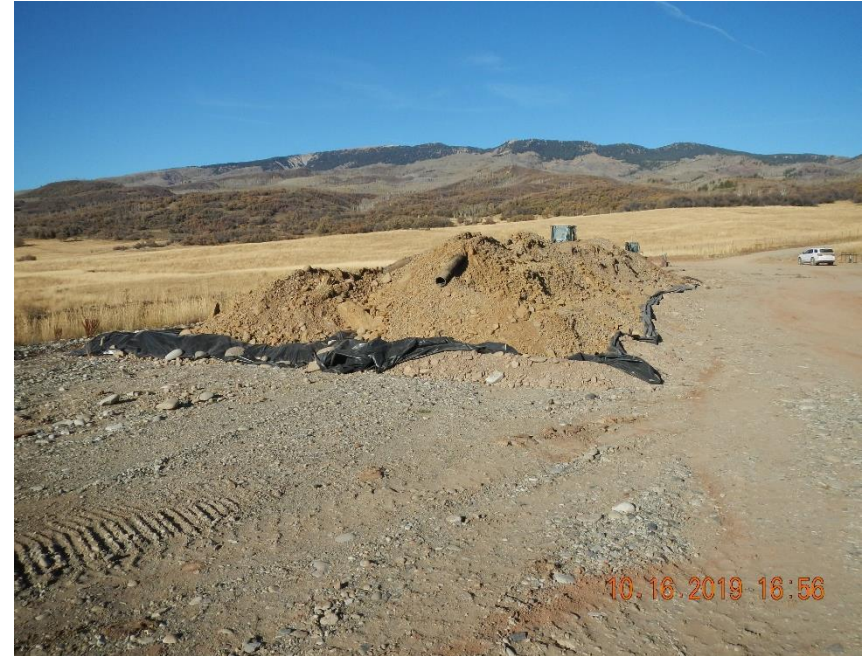
**Insufficient containment for impacted material.**

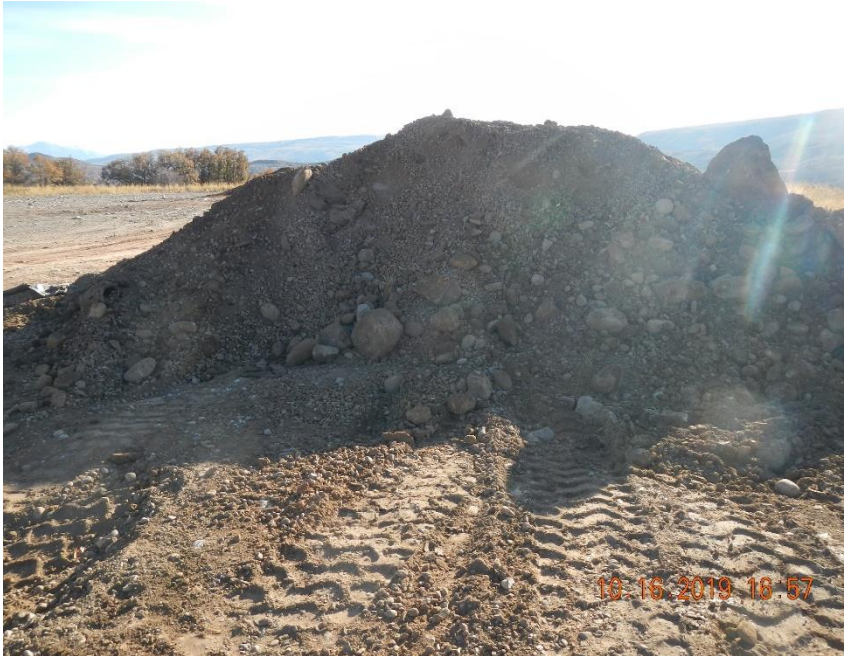
**No containment for impacted material along northern edge of stock pile.**

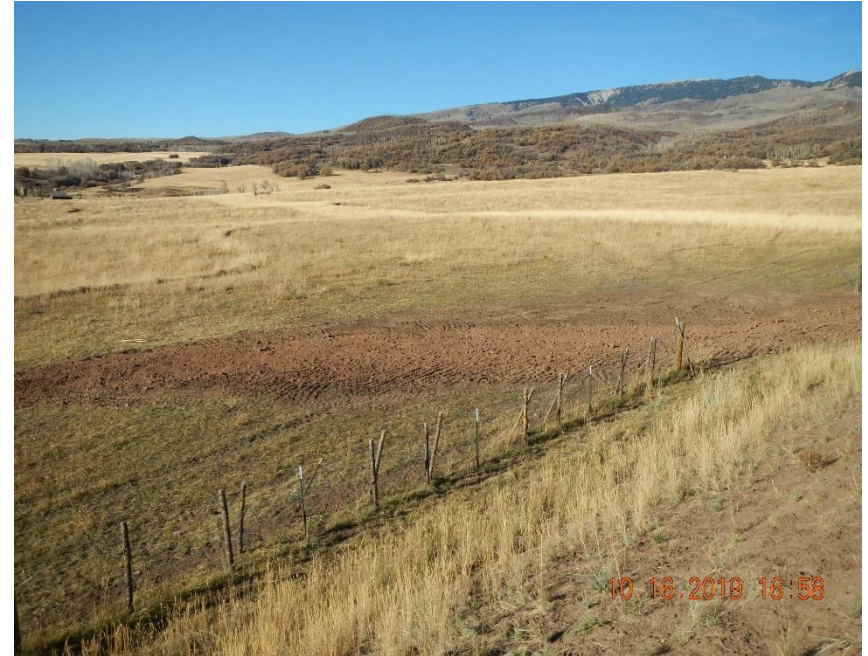
**Off location flow path of Spill/Release Point ID #467789 has been backfilled.**

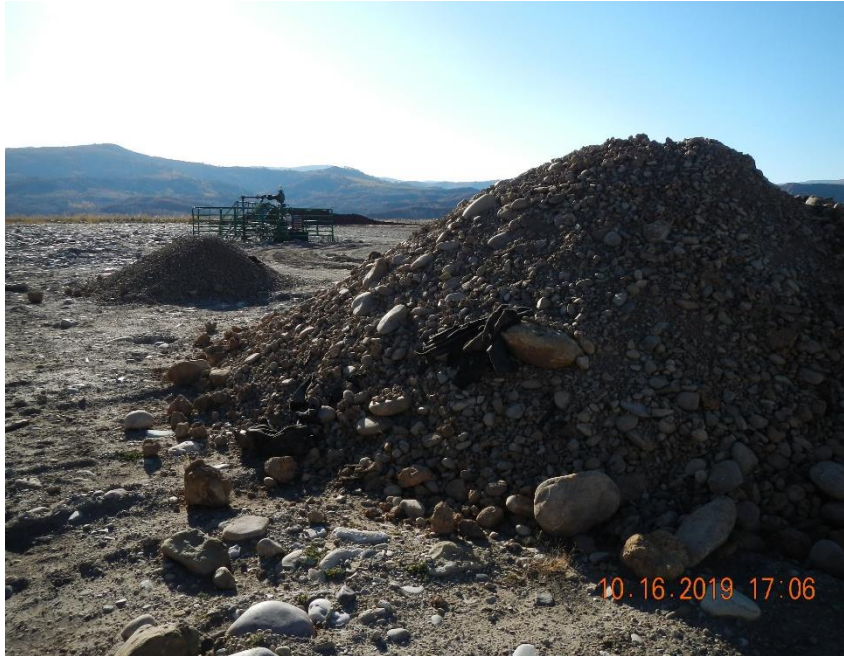
**Unknown piles of soil and rock along SE edge of location.**

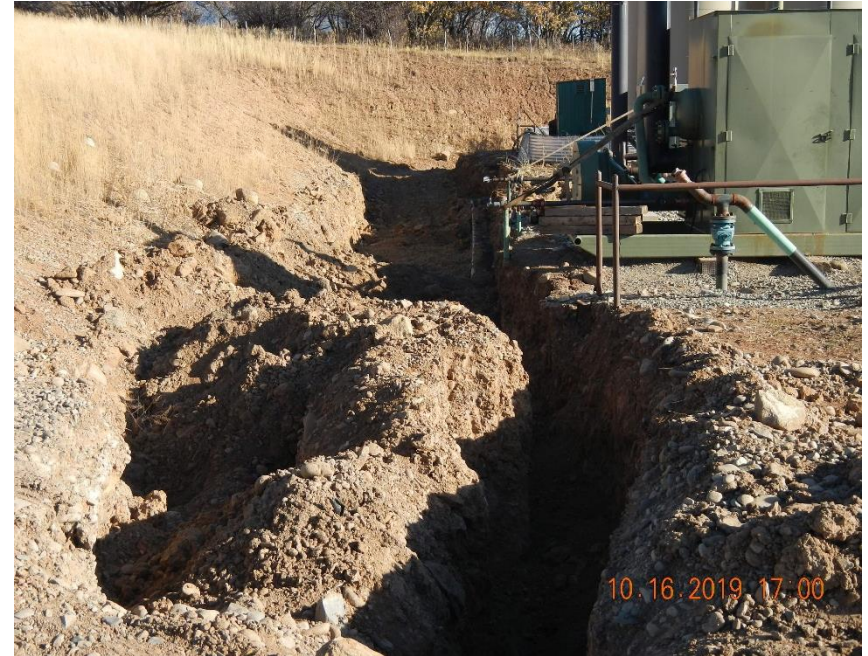
**Excavated area along NE edge of location.**

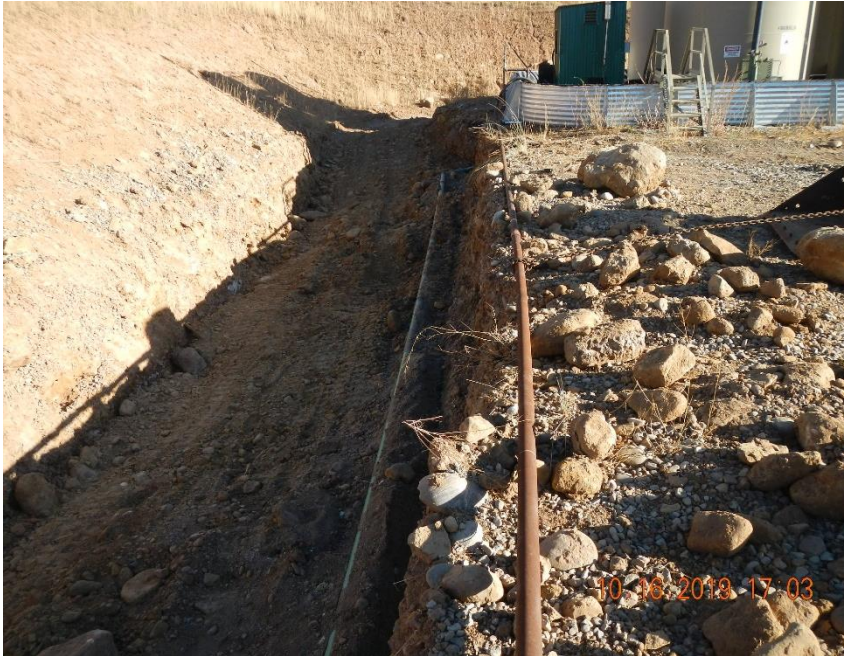
**Above ground replacement dump line anchored by chains to skid steer and secondary containment stairway railing.**

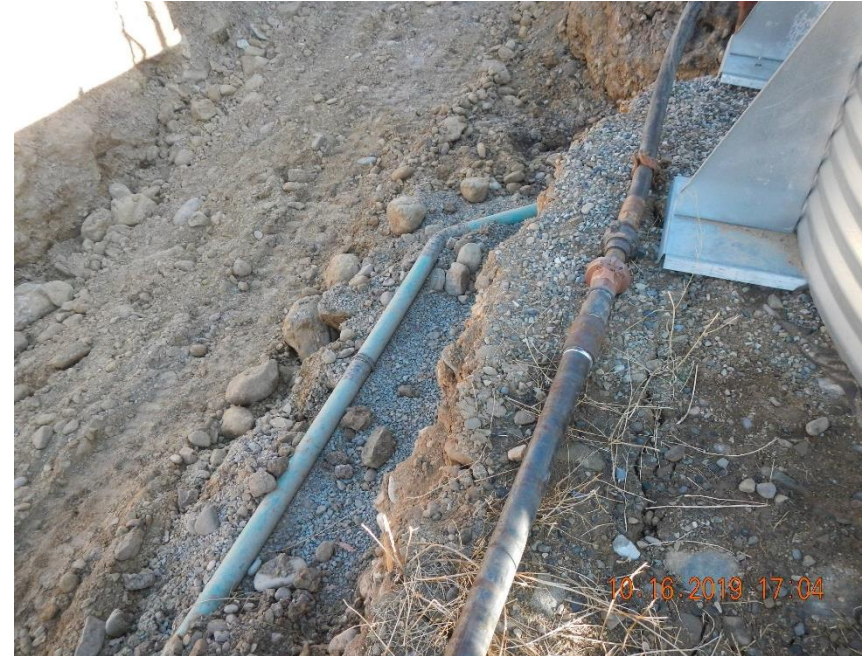
**Replacement above ground dump line.**

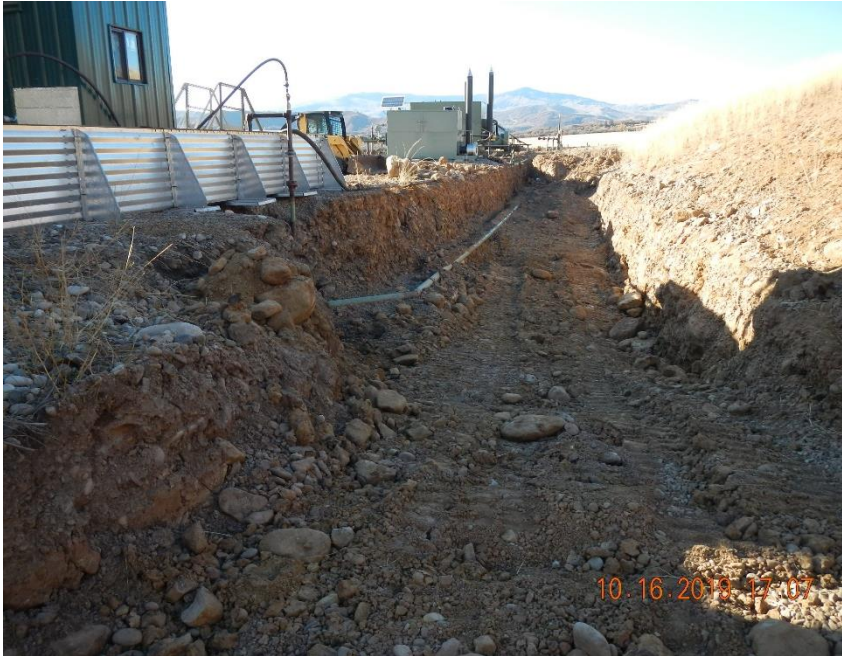
**Excavated area along NE edge of location.**

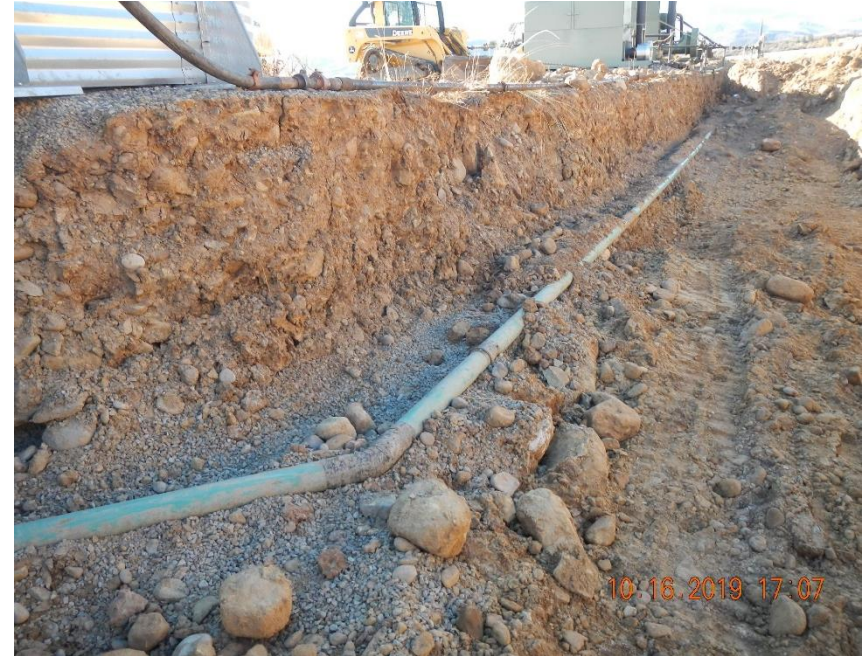
**Excavated dump line from separators to tank battery.**
