## Inspection Photos

Location Name: NORRIS 44-31 FOLLOWUP

API#: 05-071-08074

INSP. #: 695101578

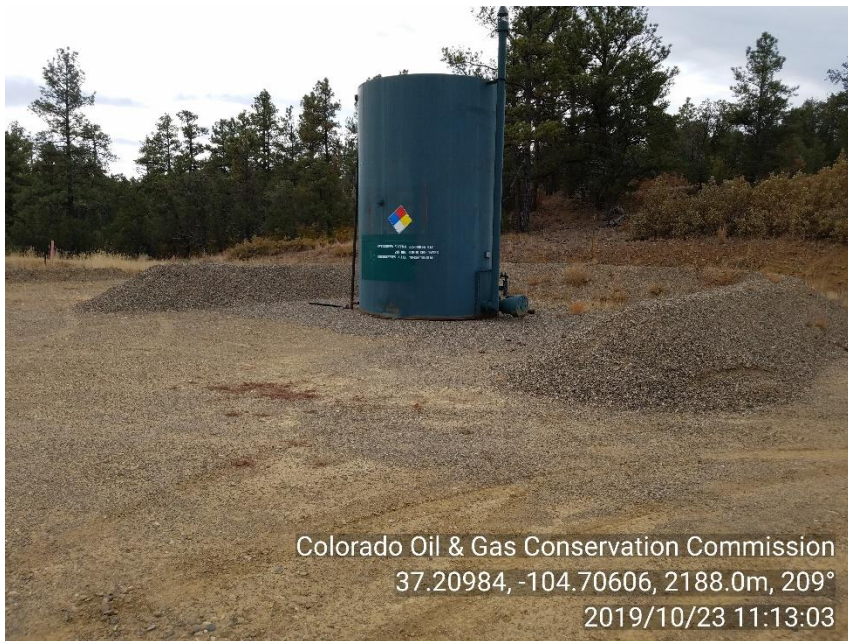
**PHOTO 3: Inadequate berms around tank.**  
**Repair or install berms or other secondary containment devices per Rule 605.a.(4). CA DATE 11-23-19.**

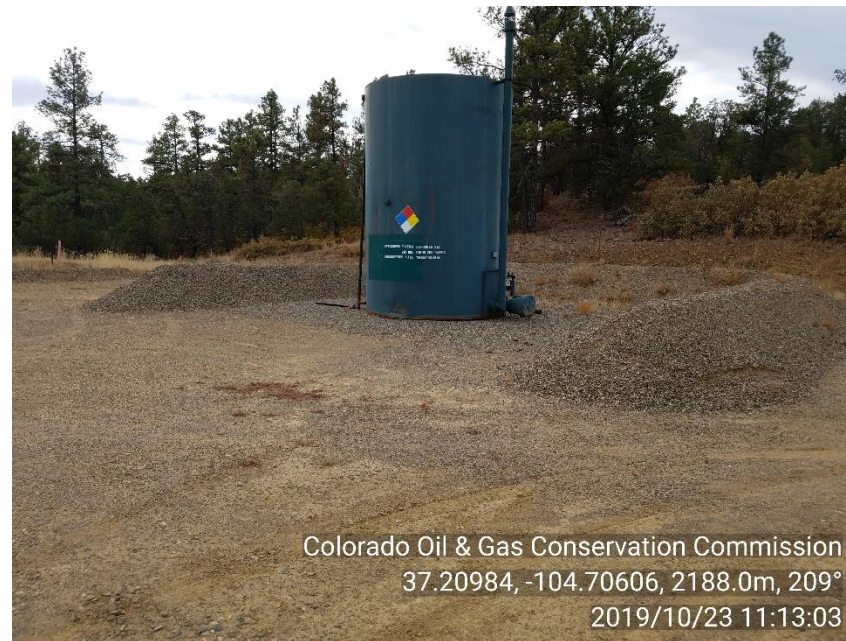
**PHOTO 4: THIS TANK DOES NOT APPEAR TO BEING PLUMBED IN OR IN USE. UNUSED EQUIPMENT. REMOVE UNUSED EQUIPMENTN PER RULE 603.f. CA DATE 11-23-19.**

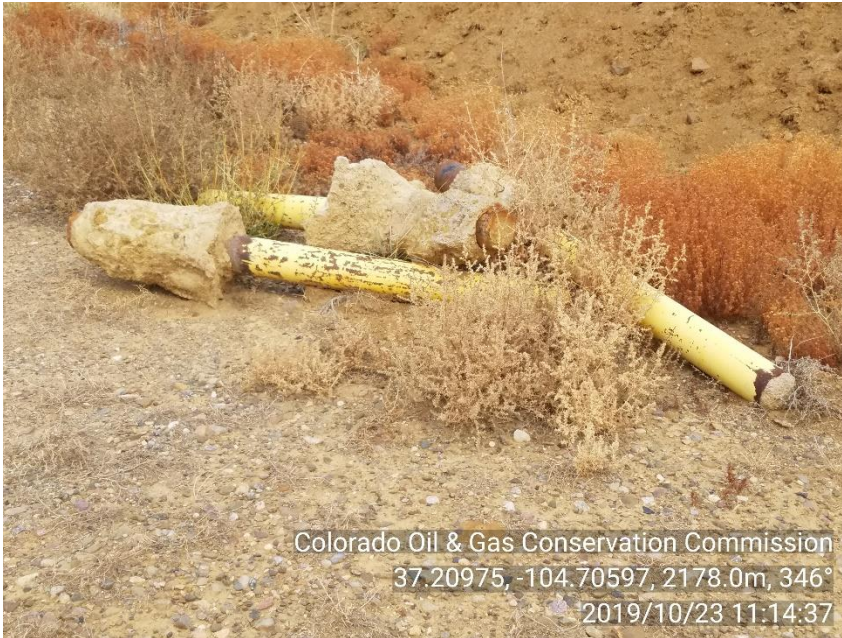
**PHOTO 5: UNUSED EQUIPMENT. REMOVE  
UNUSED EQUIPMENT PER RULE 603.f. CA  
DATE 11-23-19.**

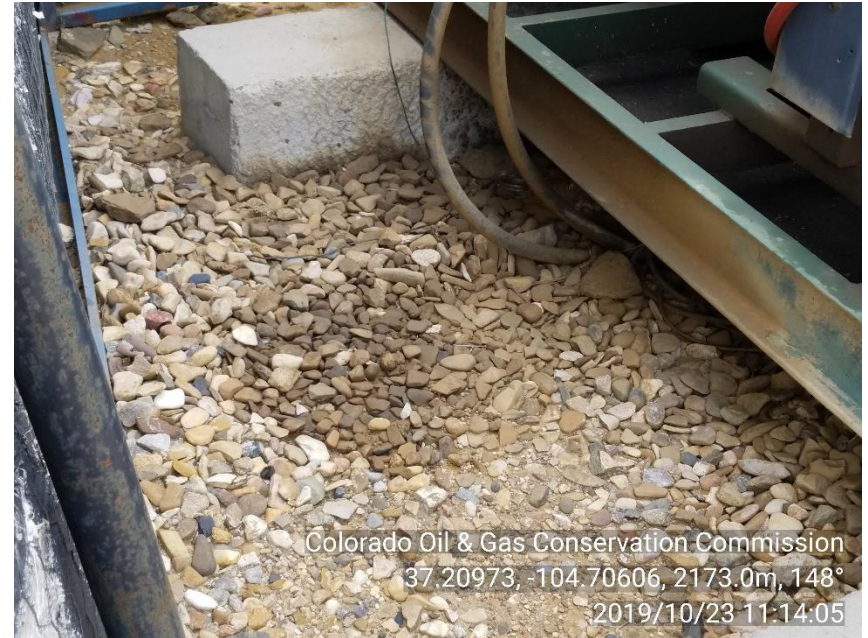
**PHOTO 6: AREA OF IMPACTED SOIL NEAR ENGINE SKID.  
Properly treat or dispose of oily waste in accordance with  
907.e. CA DATE 11-23-19.**
