Inspection Photos

Operator: Catamount Energy
Location/API #: 067-09972
Date: 10-16-2019

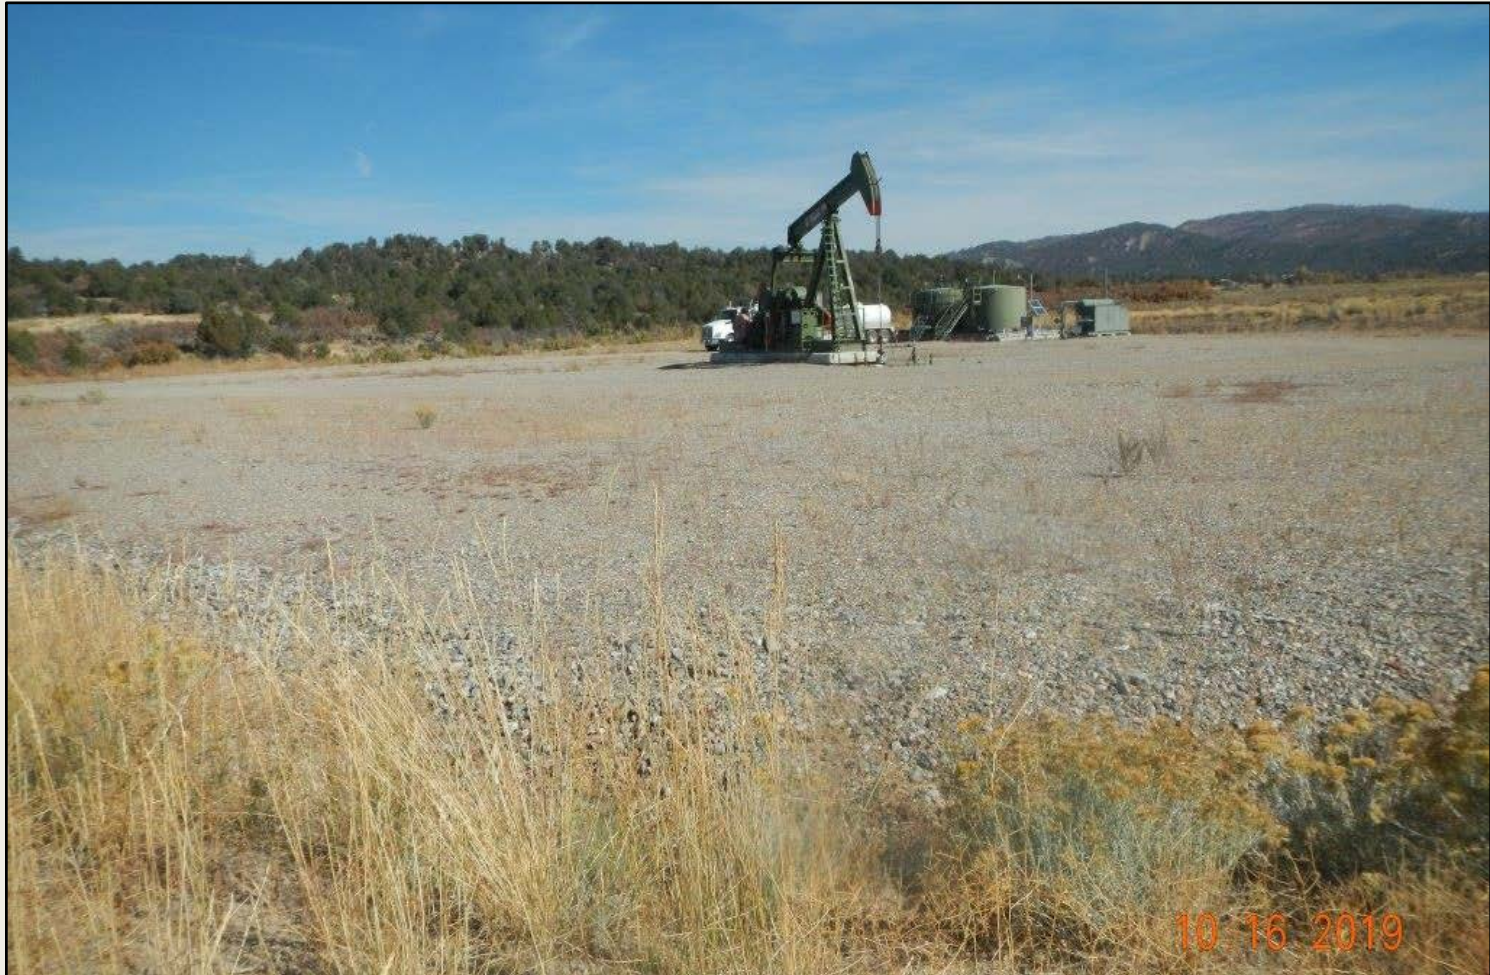
Photo 1. View of the project area from the southwestern project area facing center.

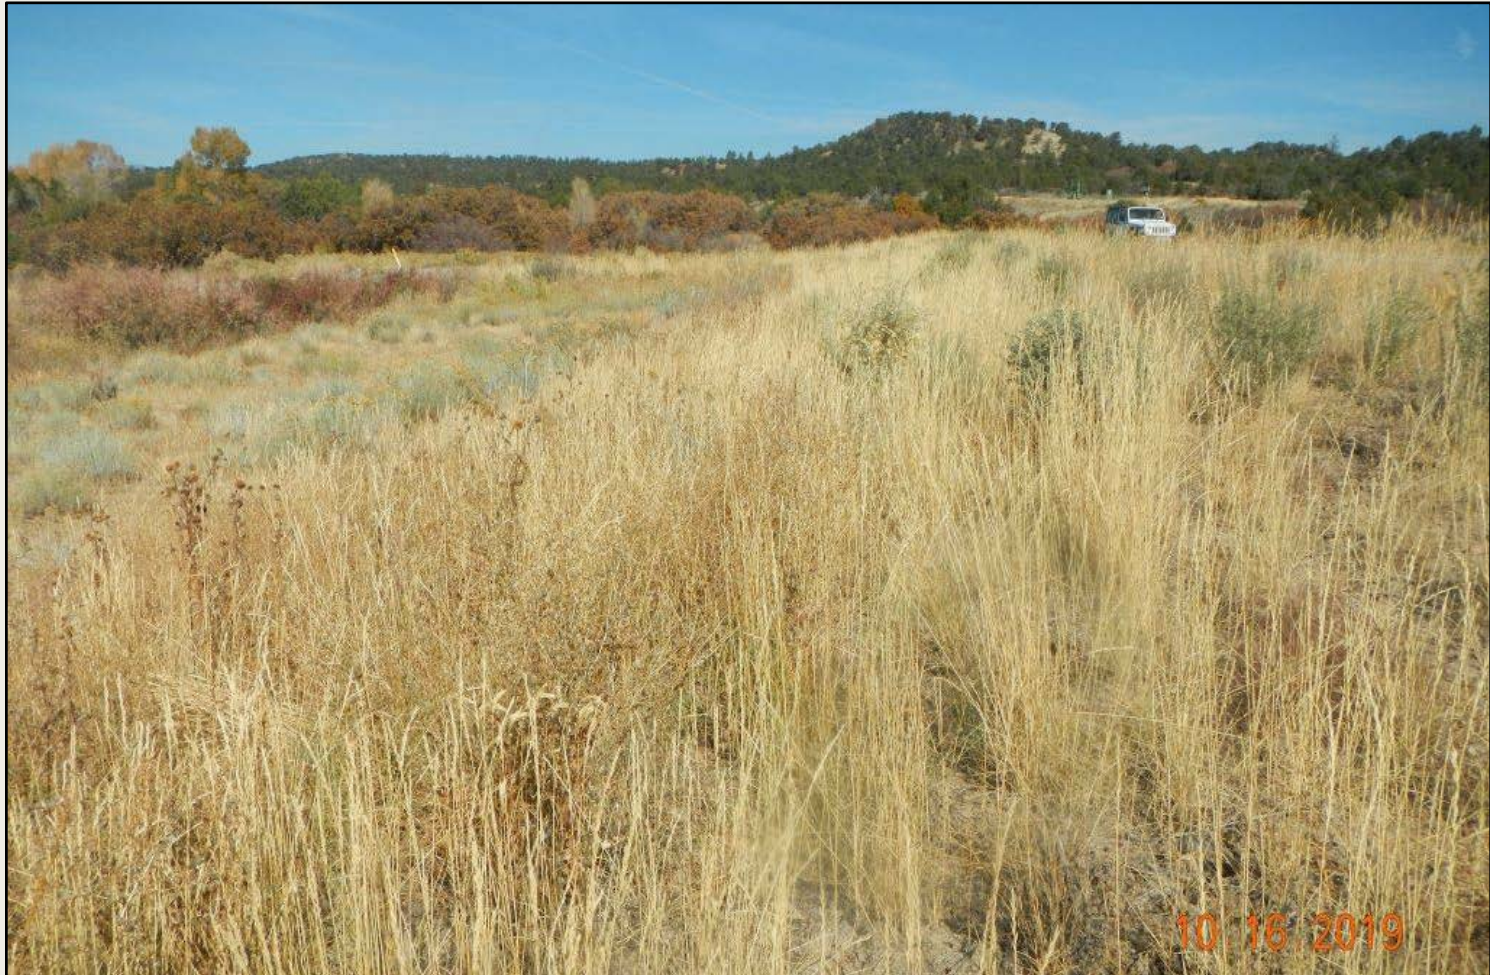
Photo 2. View of the western project area from the southwestern corner facing northward. Vegetation is becoming established, with grasses such as intermediate wheatgrass and crested wheatgrass. Portions of the revegetation area remain sparse and weedy, and may need re-seeding if not progressing.

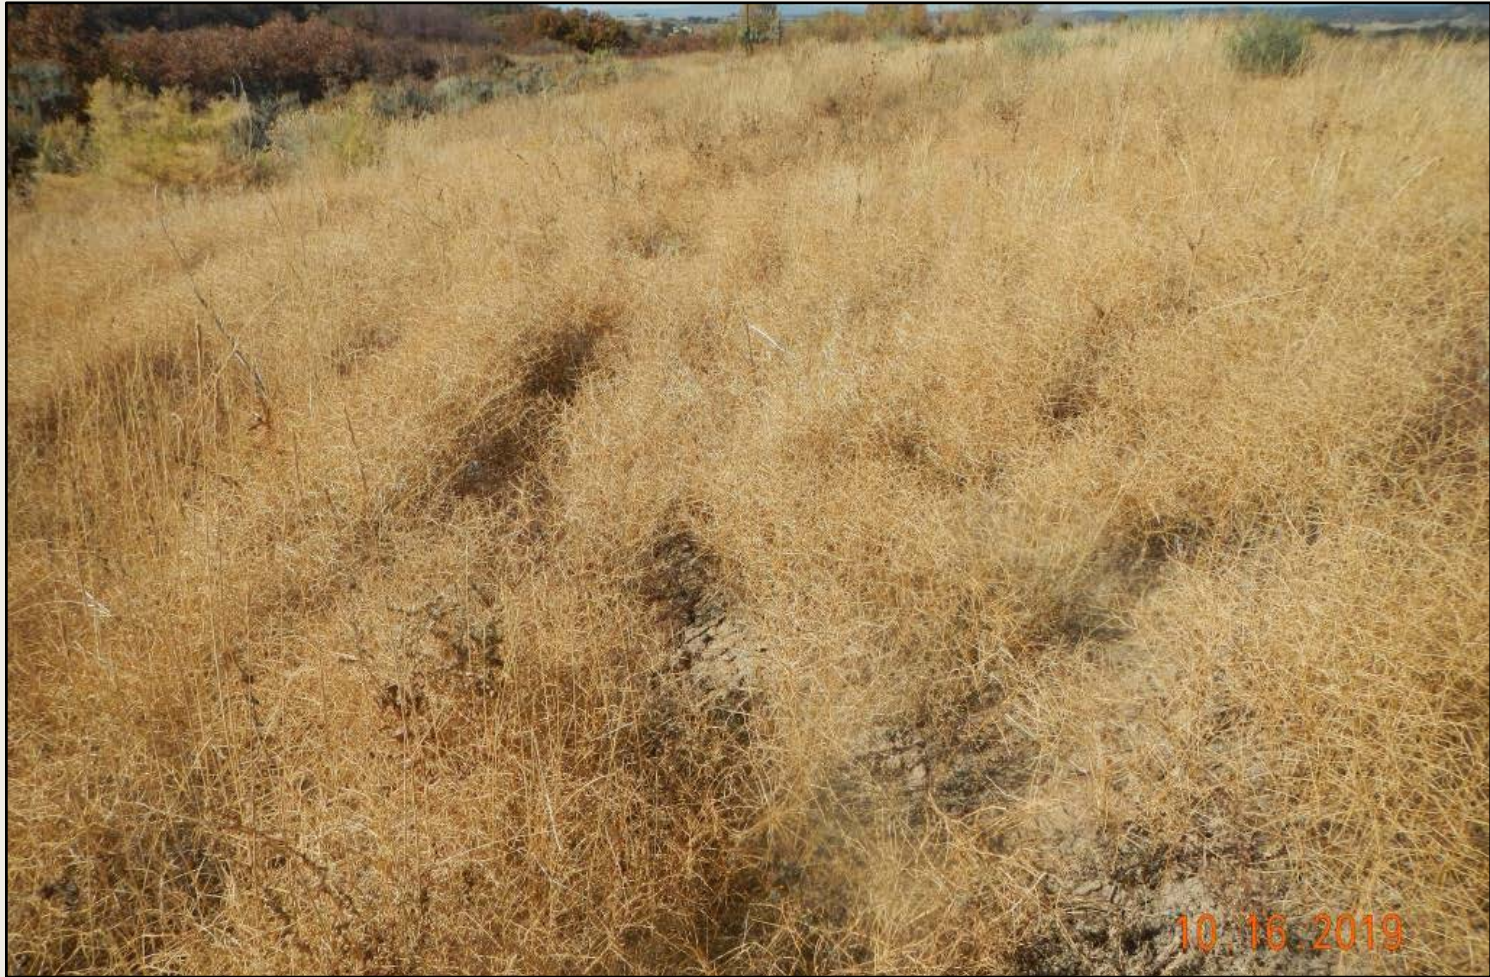
Photo 3. View of the southern project area where desirable vegetation appears to becoming established, but are threatened by dense annual weedy vegetation. Annual weeds need to be managed for successful revegetation.

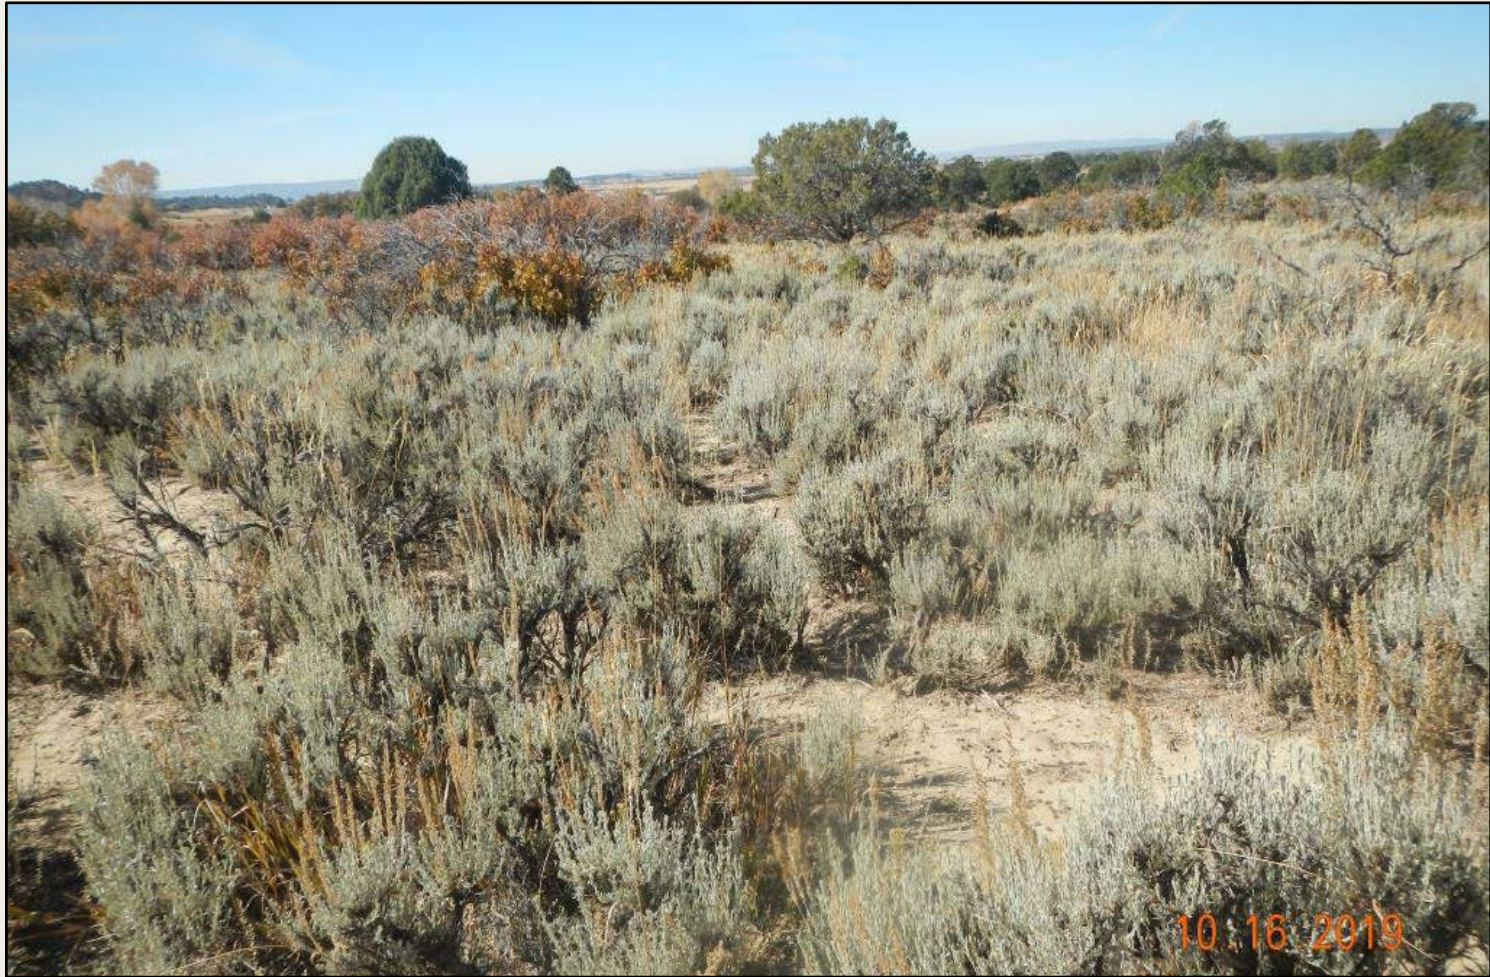
Photo 4. View of reference area vegetation comprised of sagebrush, gambel oaks, and perennial grasses and forbs representative of the sagebrush shrubland vegetation type.
