**KP Kauffman - COGCC Inspection Photos**  
**Location: Nessu 1 Flowline Release**  
**Spill ID # 468756**

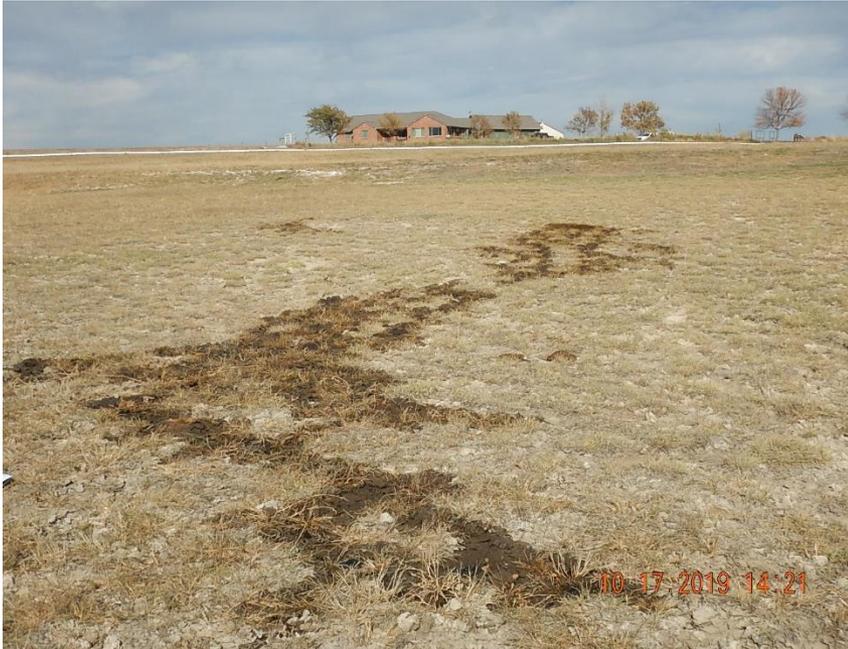
**View of fluid release up-slope (looking North East)**

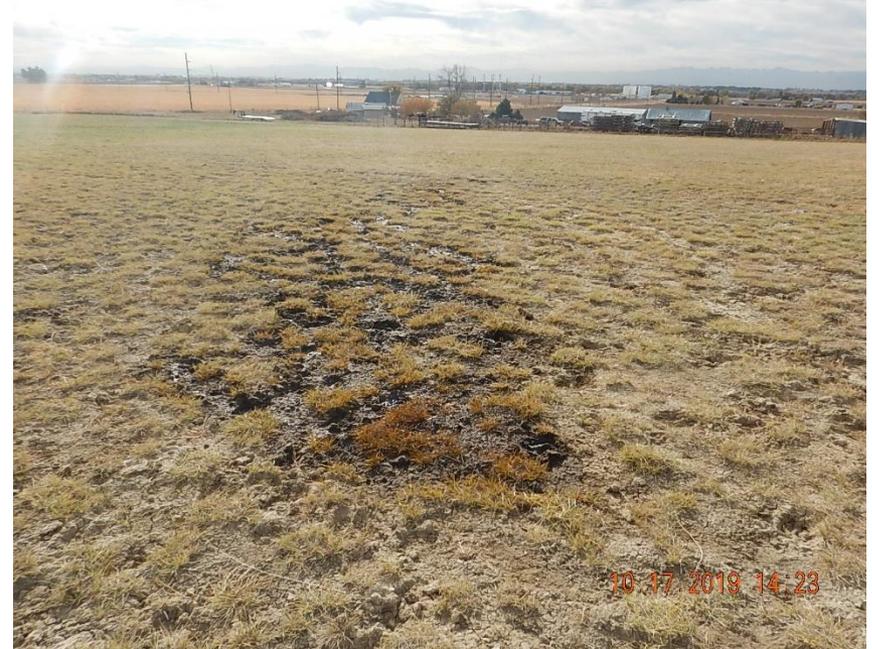
**View of fluid release down gradient (looking South West)**

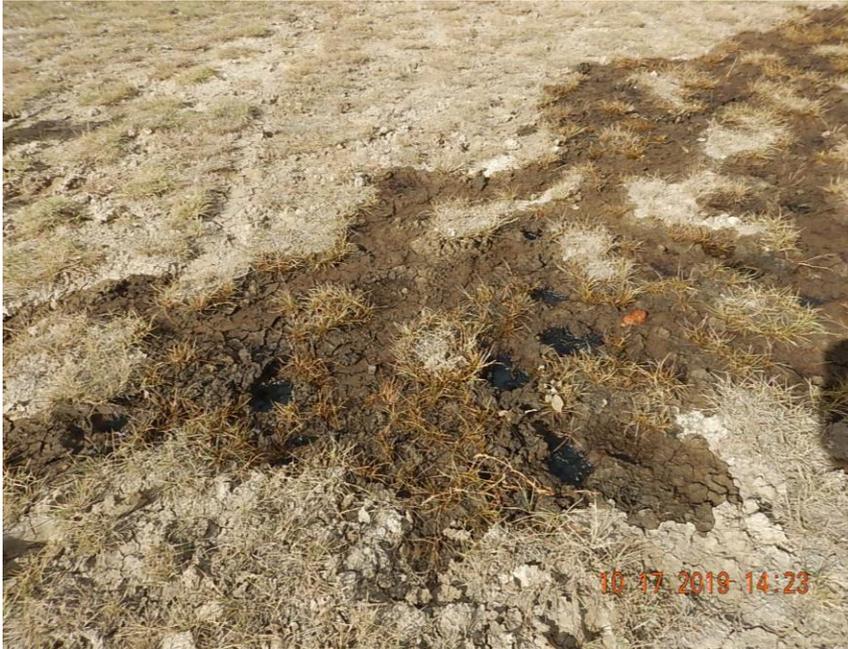
**Close up view of pooled fluid (primarily crude oil) on surface**

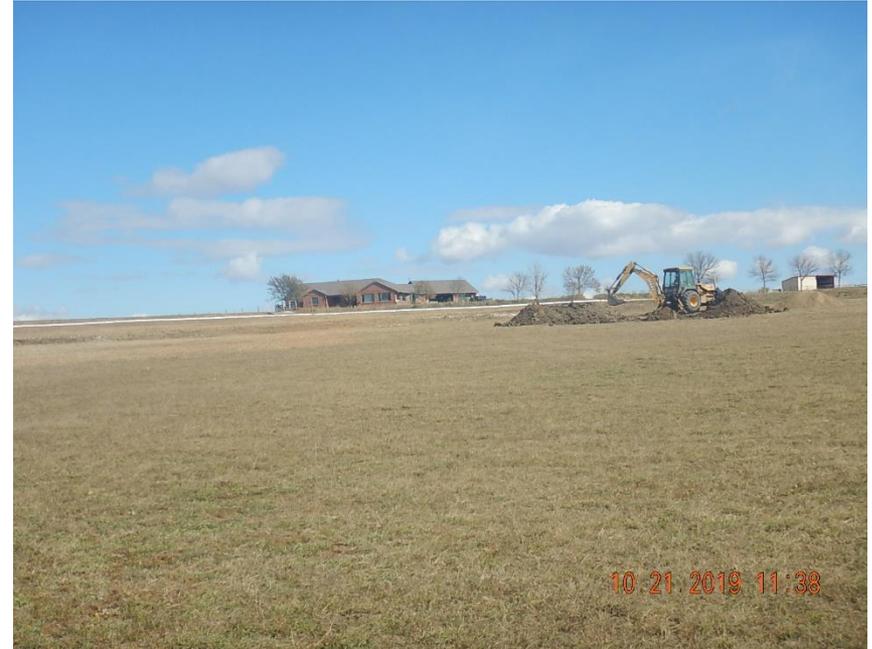
**View of excavation work being completed by KPK personnel at Spill ID #468756 on 10/21/2019.**

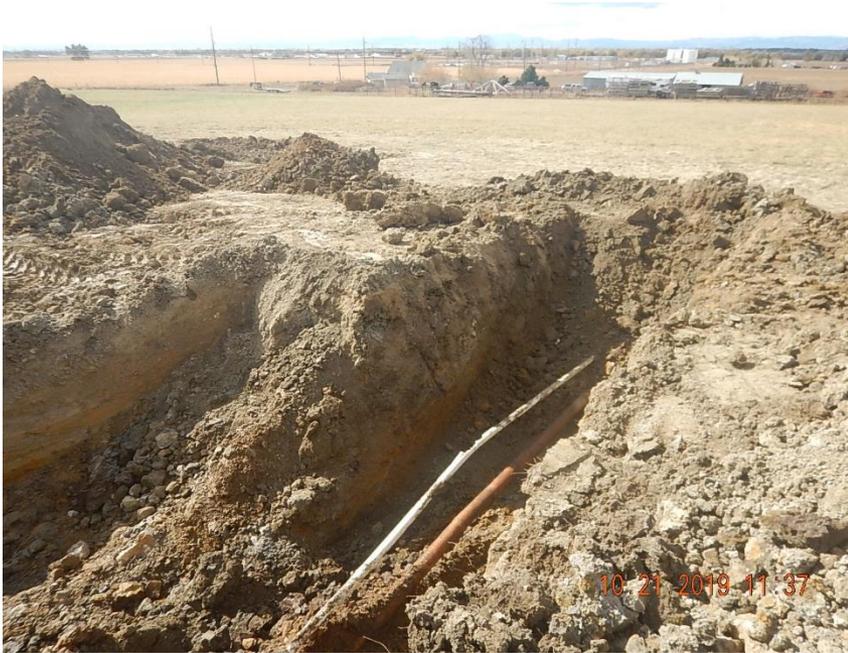
**View of off location flowlines exposed in excavation (1.5" PVC gas supply line & 3" fiberglass wellhead flowline); looking SW**

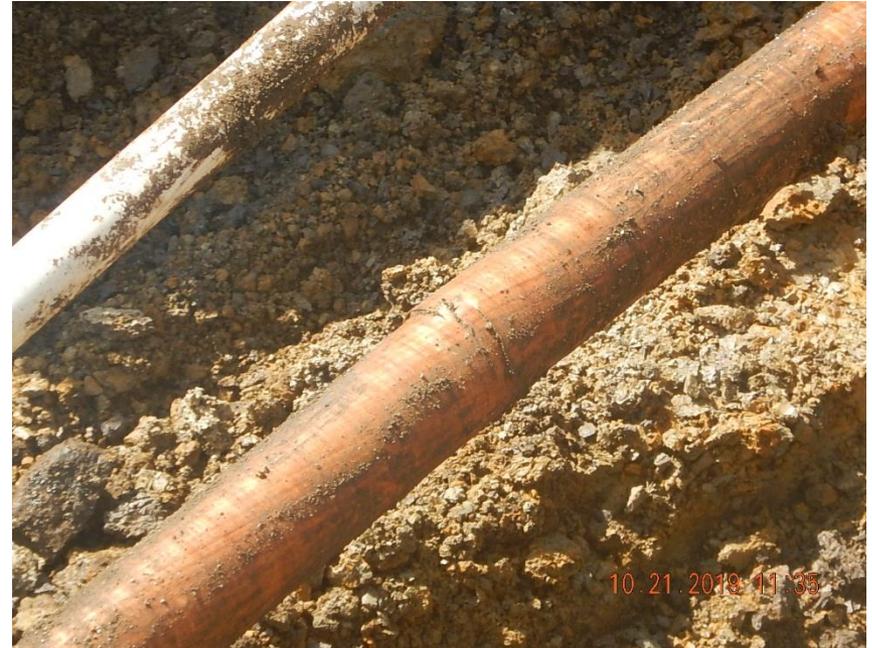
**Close up view of failure identified on 3" fiberglass flowline (spiral type fracture).**
