**Inspection Photos**  
**Location Name: Shideler-66S92W 32NESW Pad**  
**Location ID: #334837**  
**Inspection Date: October 15, 2019**

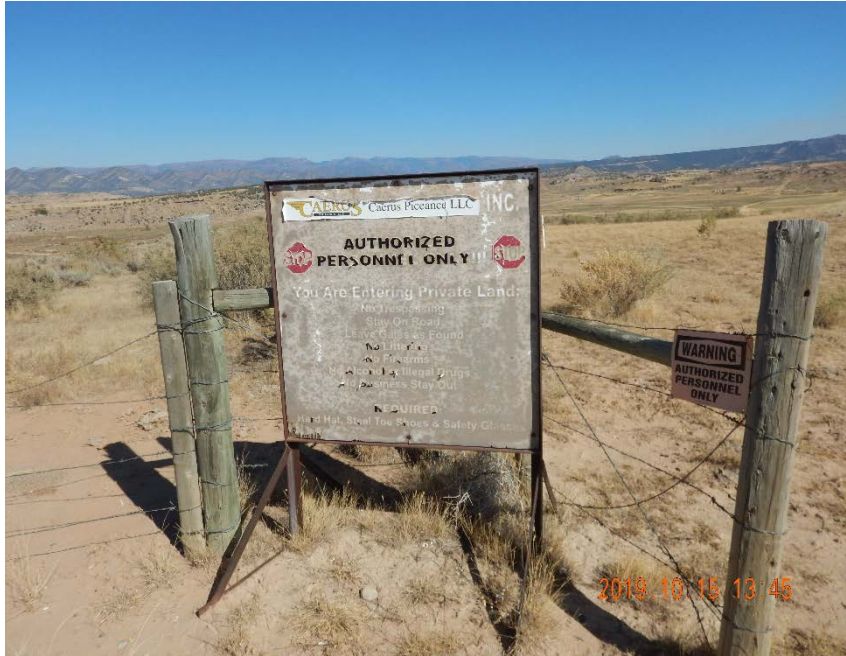
**Photo #1 – Sign located at entrance of location needs repair.**

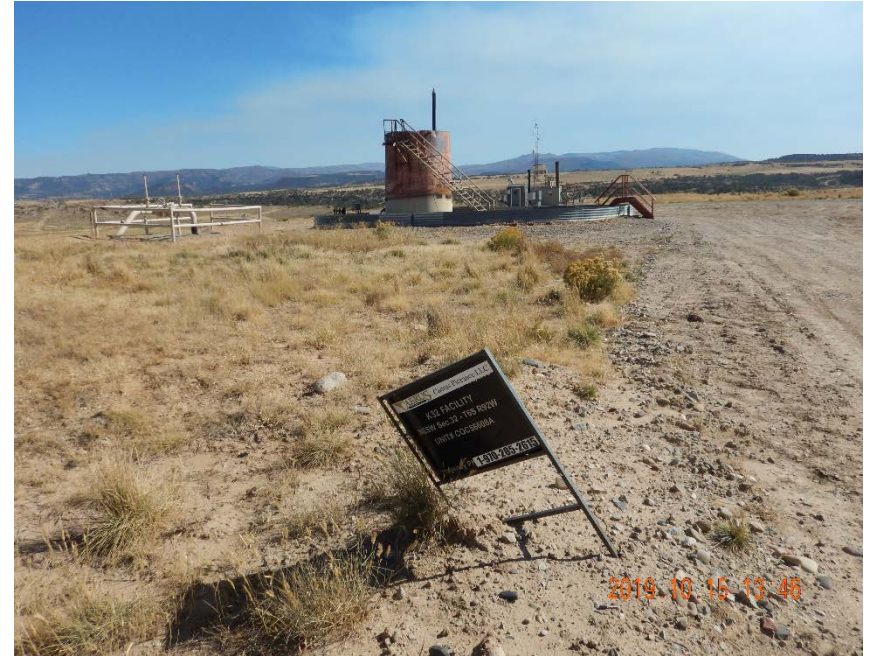
**Photo #2 – View of tank battery sign and tank battery, from northwest.**

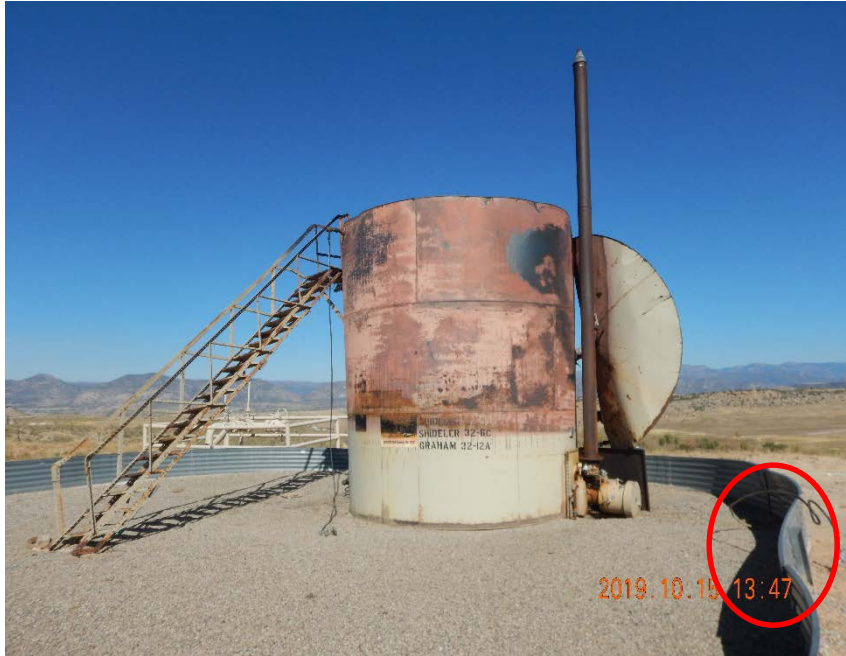
**Photo #3 – View of damaged condensate AST from west.  
Note top blown off tank and metal berm damaged (red circle).**

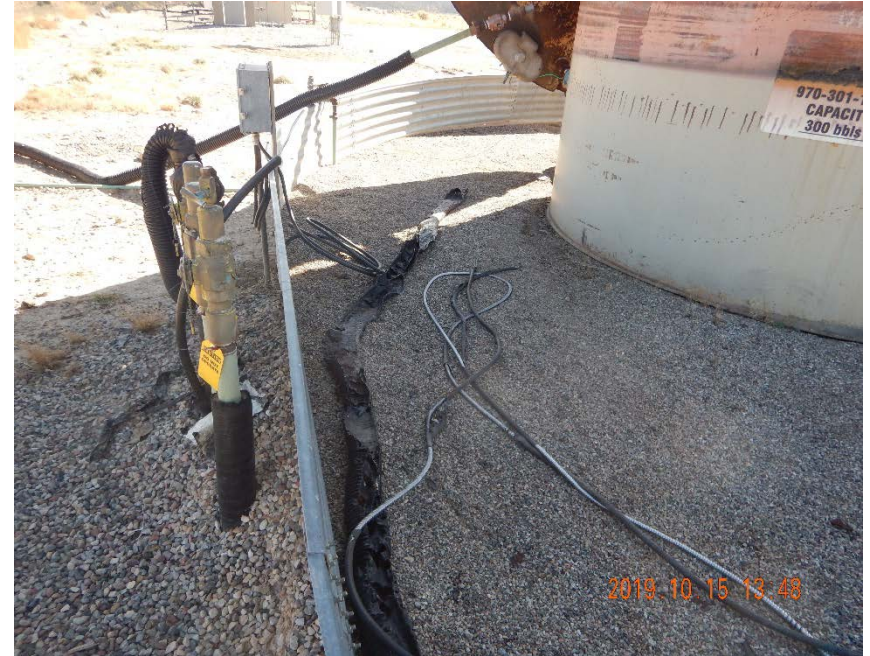
**Photo #4 – Flowline risers and damaged equipment located northeast of tank (1).**

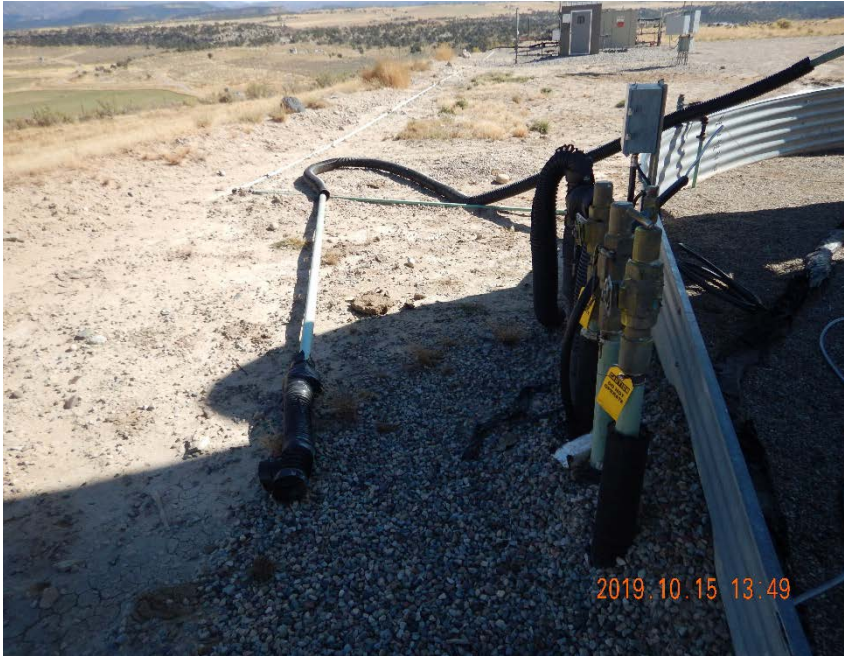
**Photo #5 - Flowline risers and damaged equipment located northeast of tank (2).**

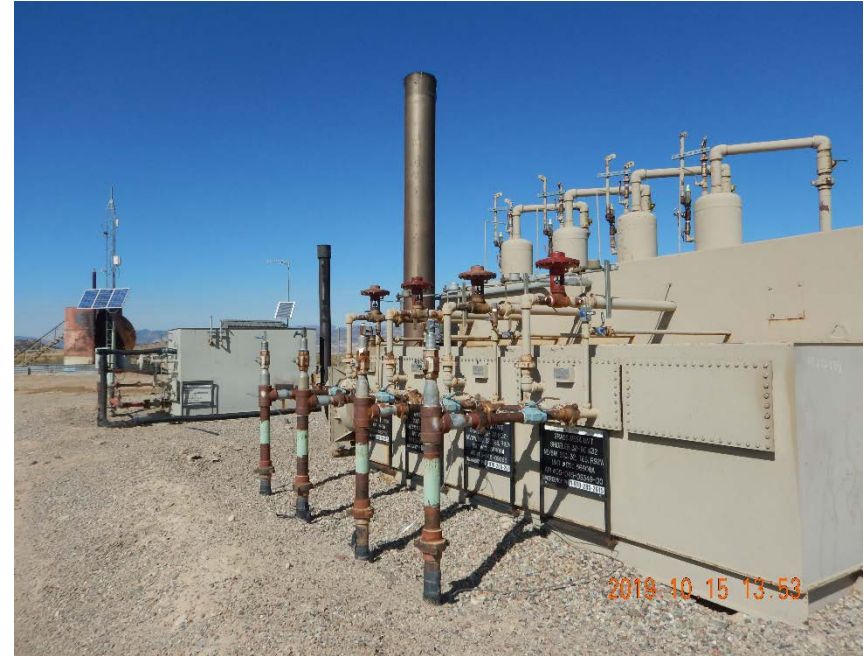
**Photo #6 – View of (1) horizontal and (4) vertical separators from south.**

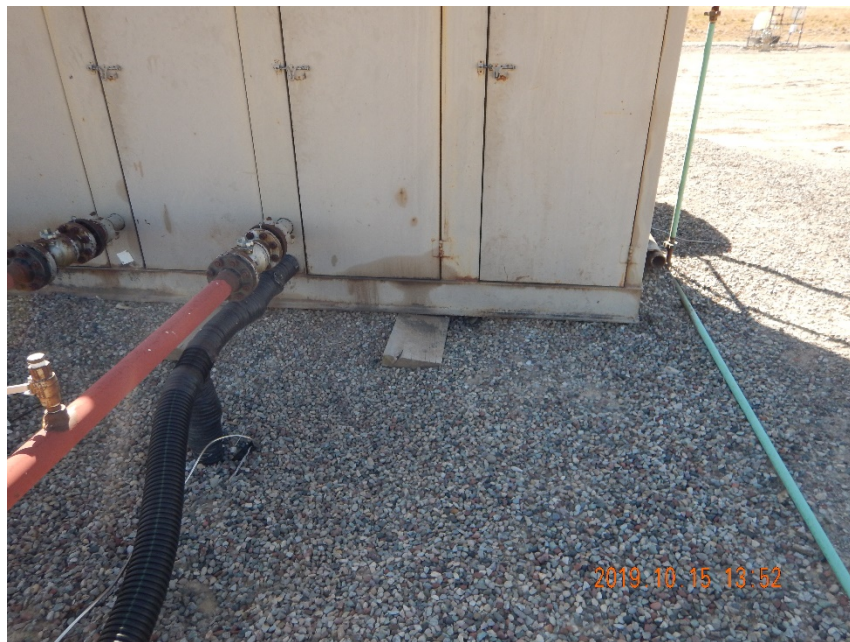
**Photo #7 – View of stained area of heated horizontal separators (NE side).**

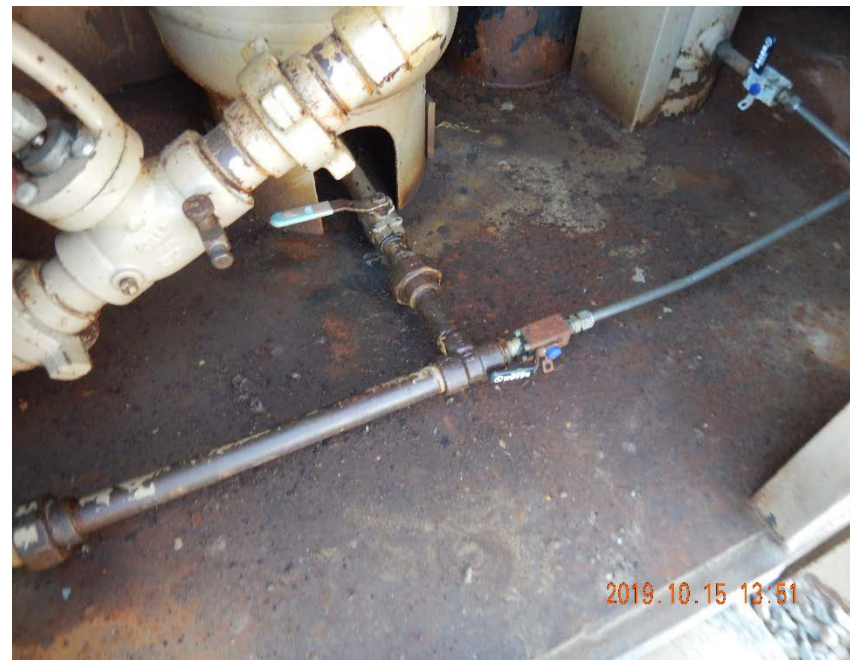
**Photo #8 – Hydrocarbon odors observed in vicinity of staining on heated horizontal separators.**

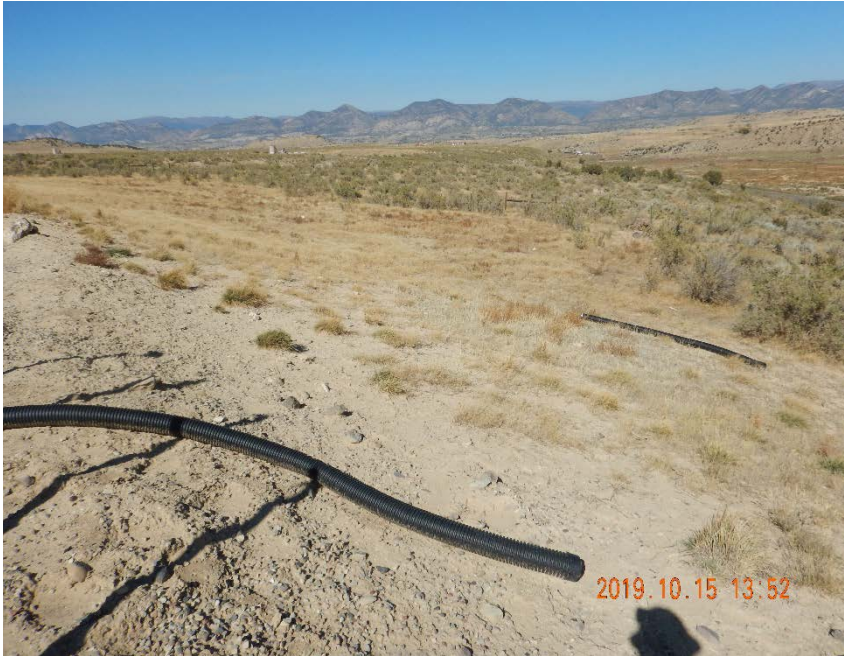
**Photo #9 – Unused equipment (black conduit) located northeast of separators.**

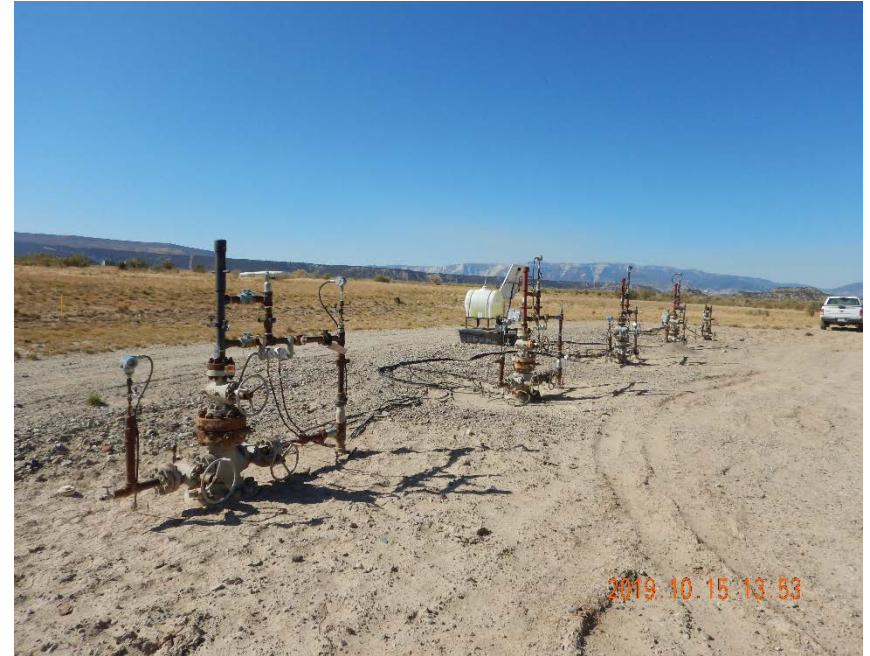
**Photo #10 – Overview of wellheads, from southeast.**

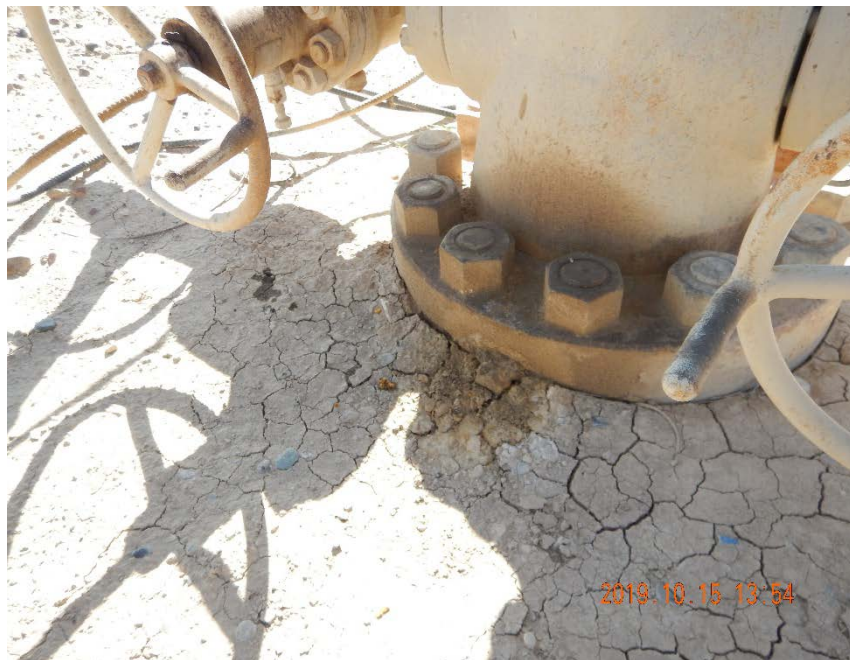
**Photo #11 – Localized accumulations of oil-stained soil beneath wellhead for Graham 32-12A.**

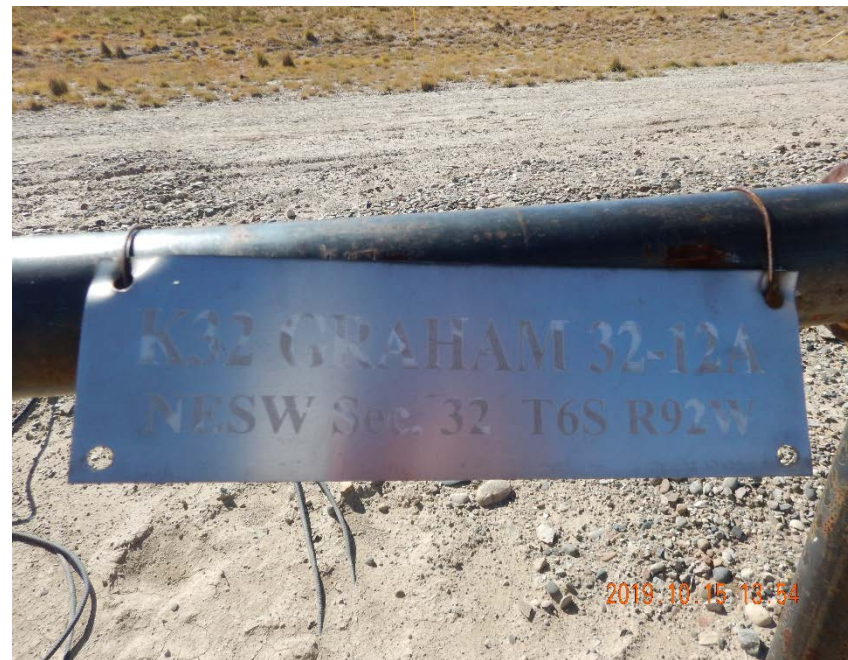
**Photo #12 – Sign at wellhead from previous photo.**
