Inspection Photos
Location Name: Washburn GX 15-62HN
Location ID: 428699

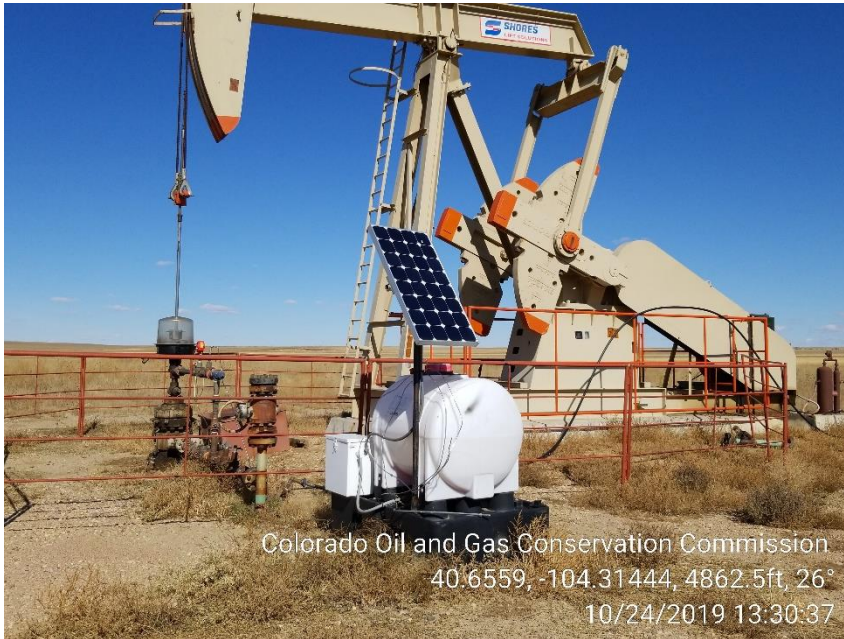
Photo 1 – Pumping Unit, weeds

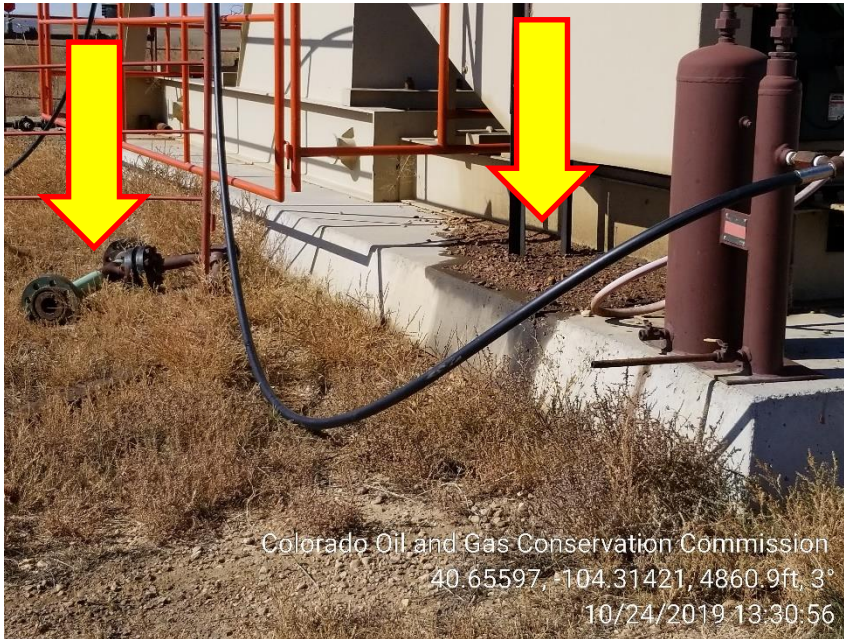
Photo 3 – Stained Oil at engine and unused equipment

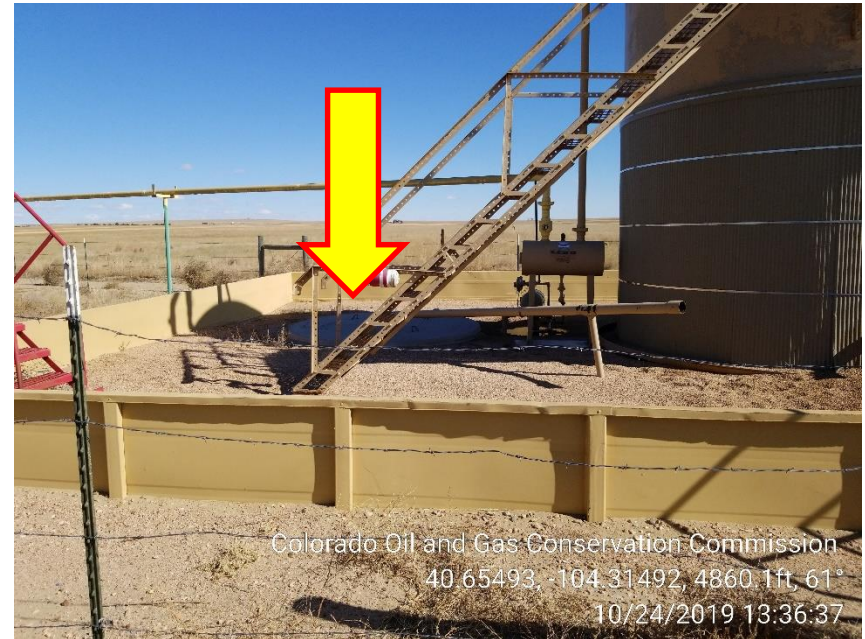
Photo 4 – PBV Concrete vault is missing Content and Capacity

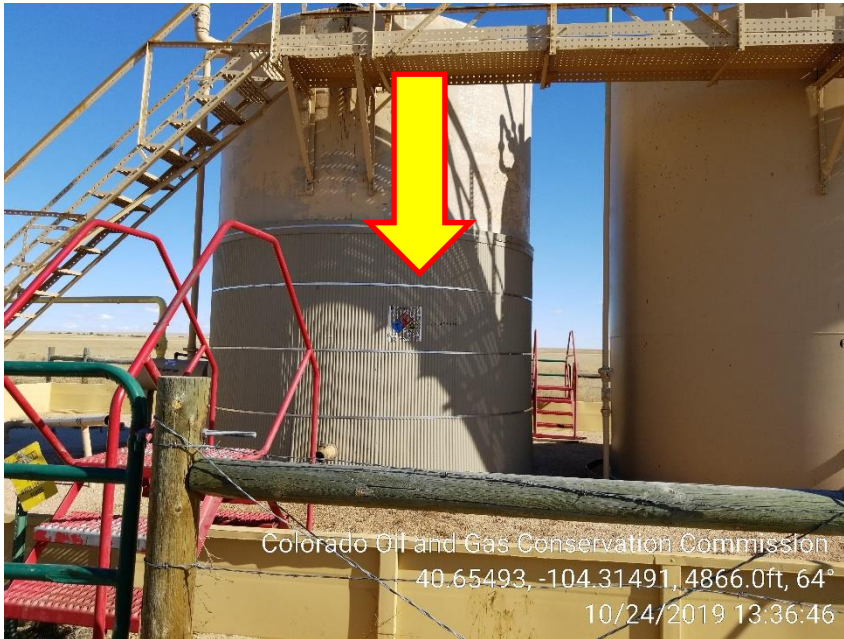
Photo 5 – 300 BBL Tank missing Content and Capacity, NFPA label is fading.

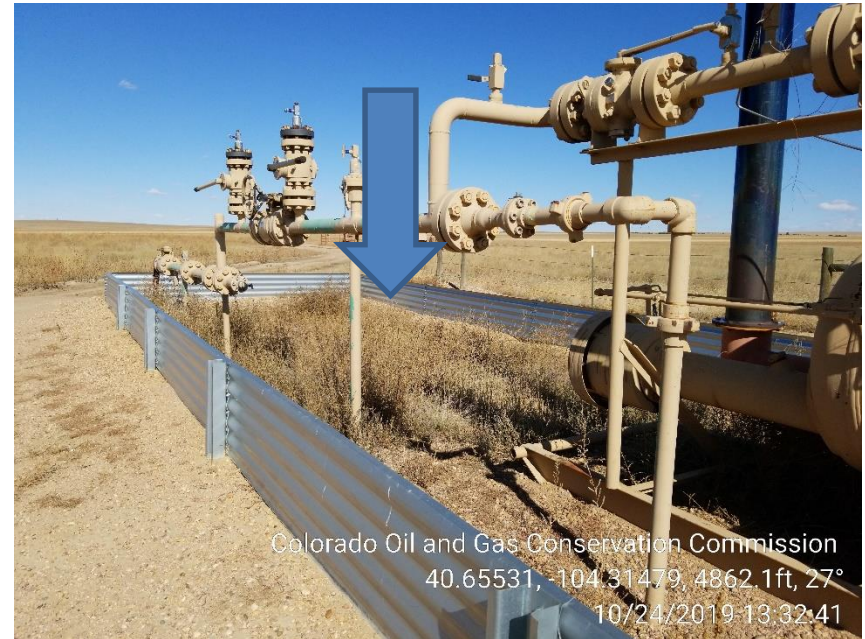
Photo 6 – Weeds at Separator
