Inspection Photos
Operator: BP America
Location/API #: 067-05787
Date: 10-22-2019

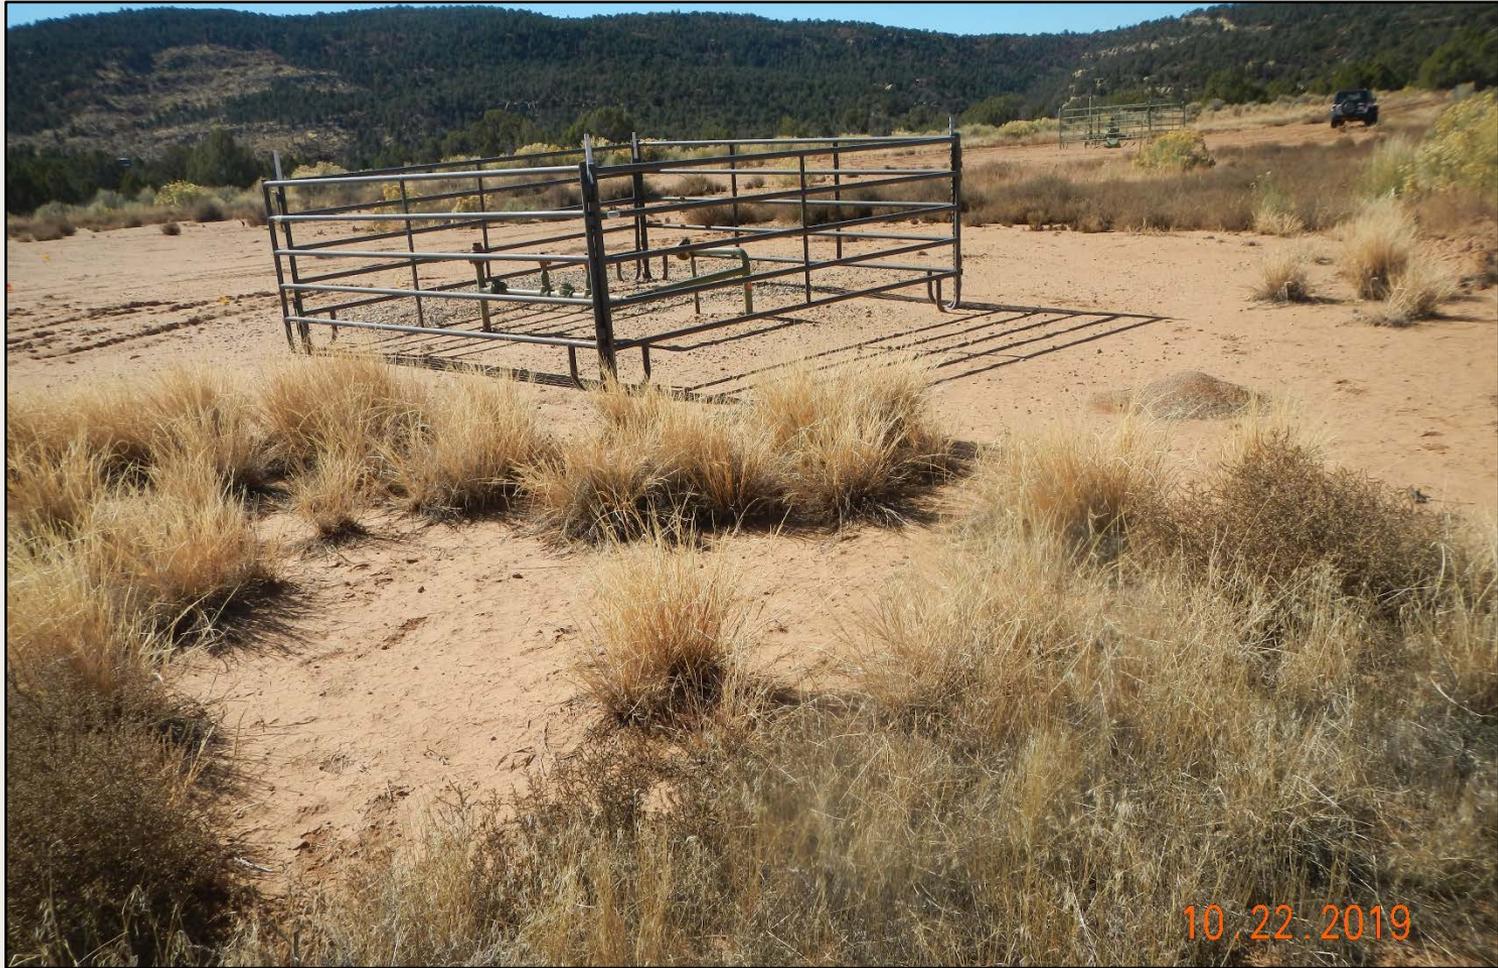
Photo 1. View of the project area from the eastern corner facing center.

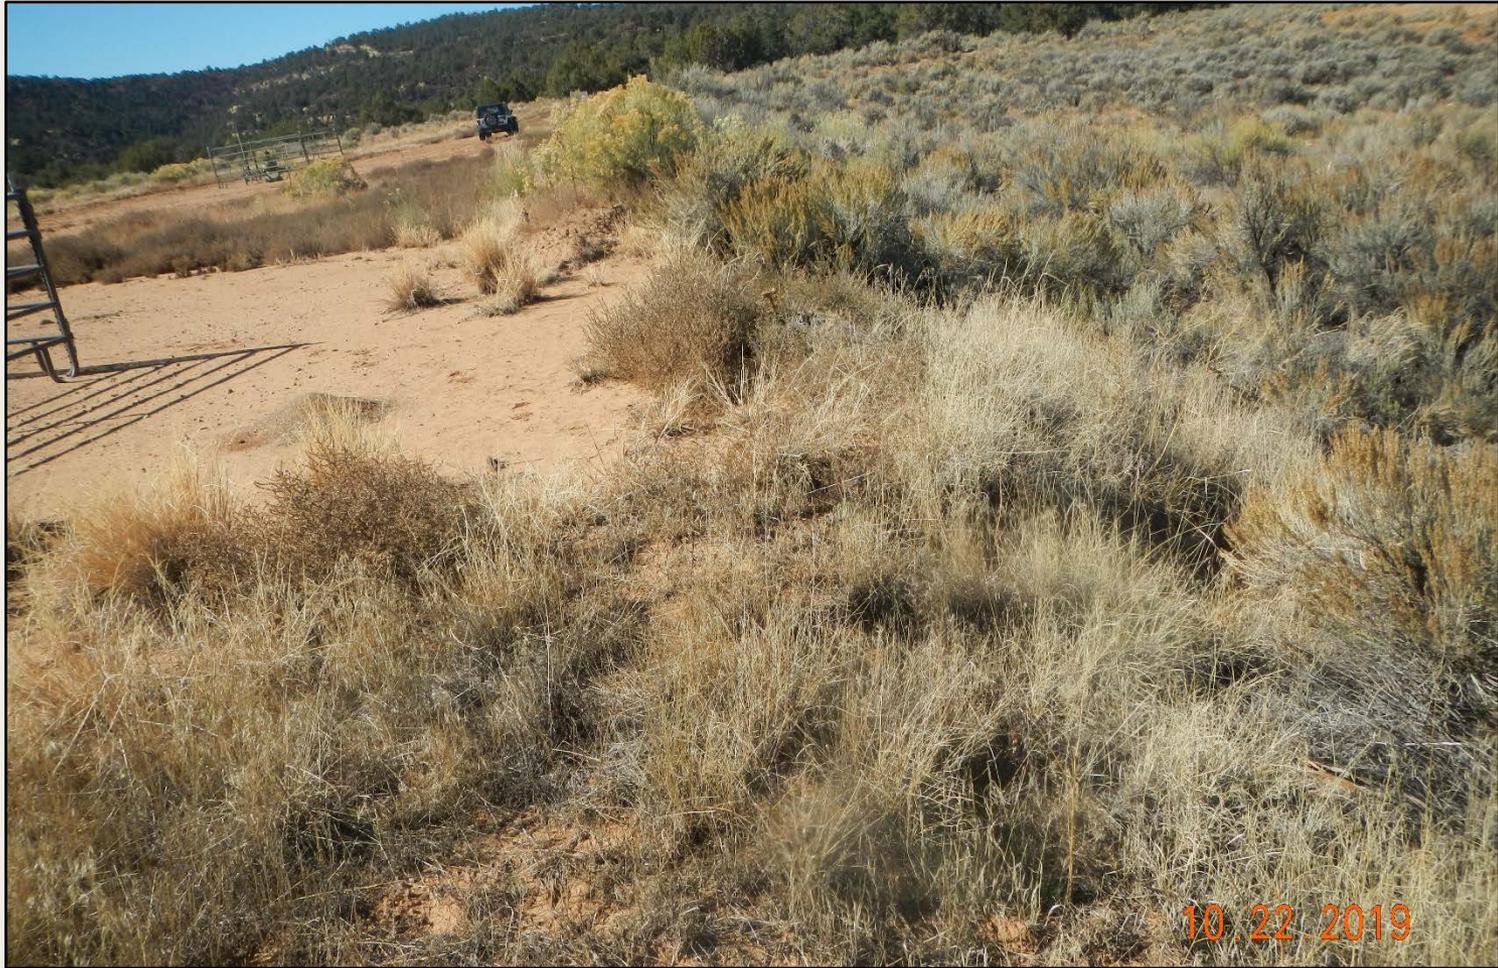
Photo 2. View of the the northern project area from the northeastern corner facing westward.

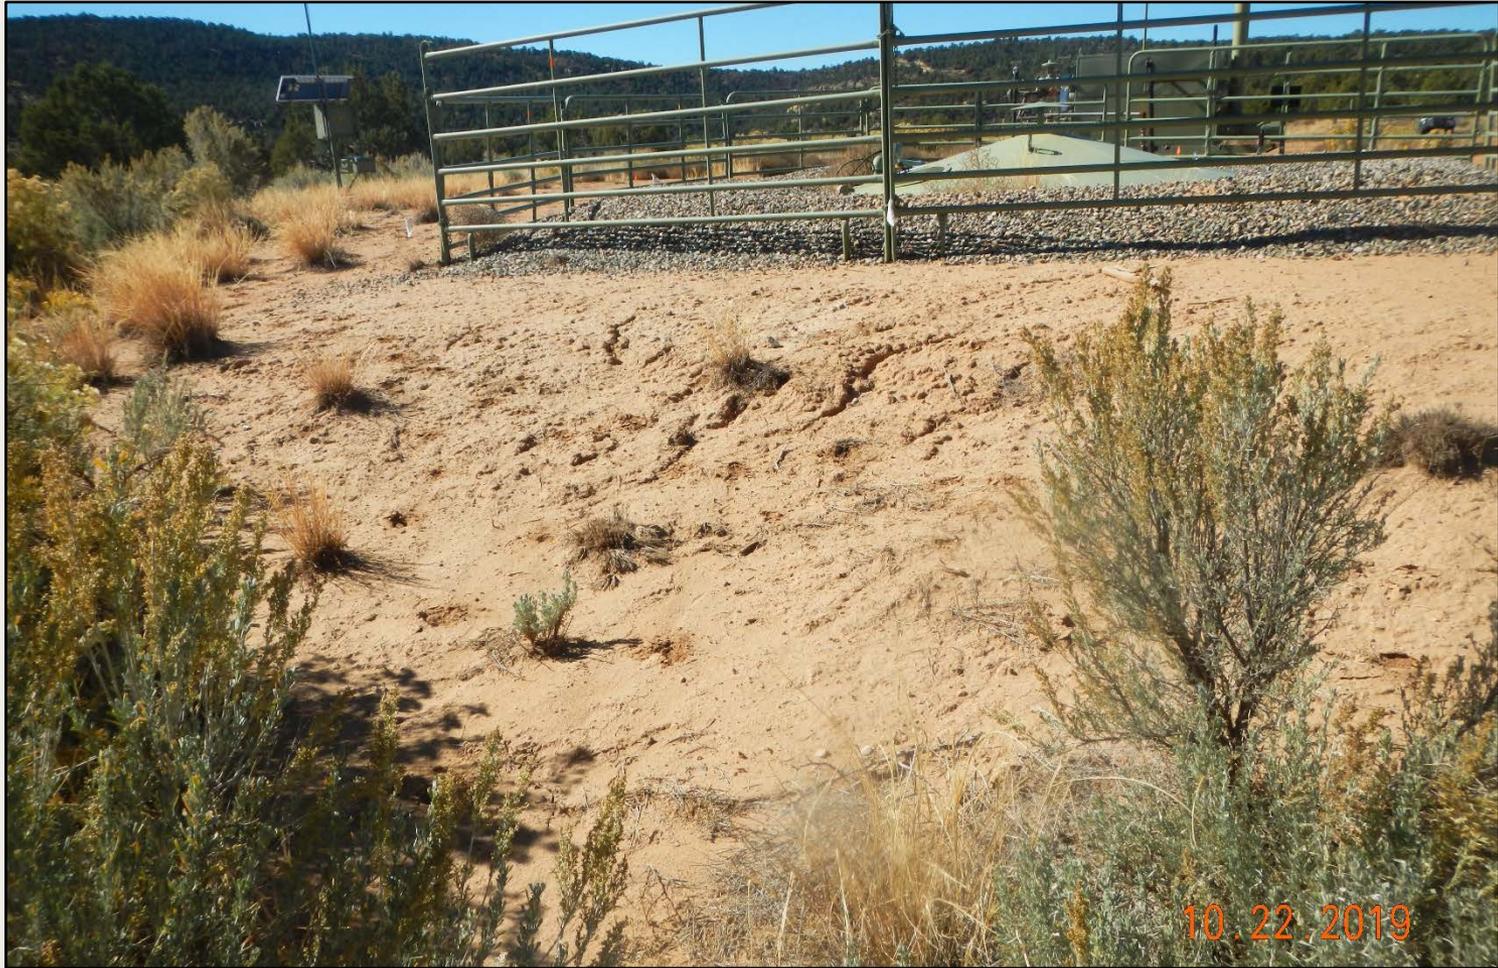
Photo 3. View of the erosional rilling that continues within the eastern project area.

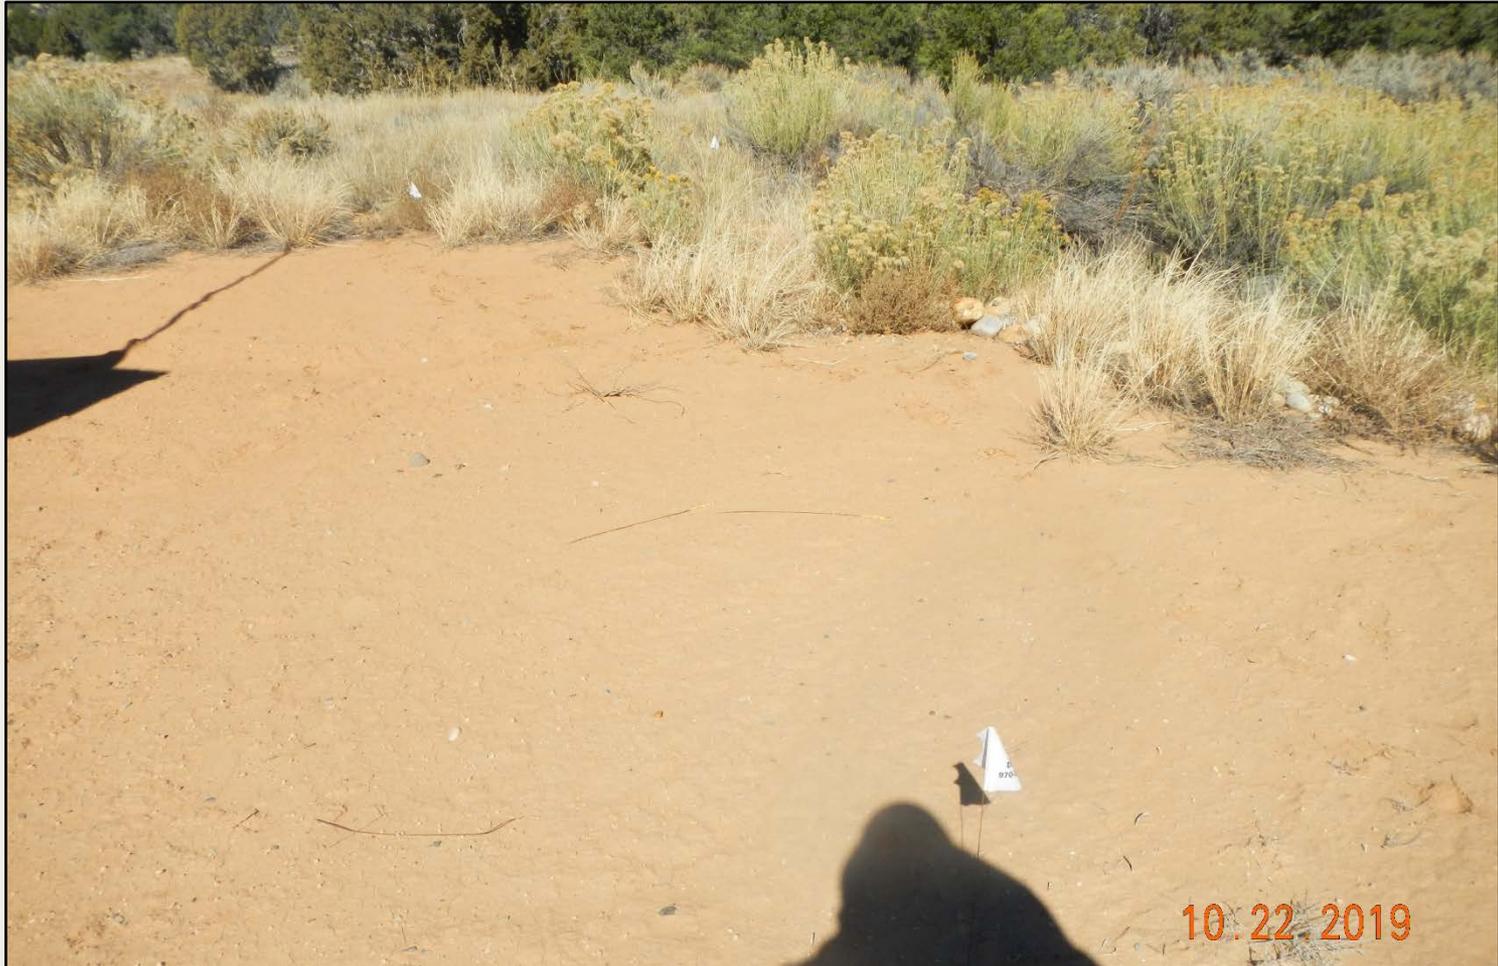
Photo 4. Downstream view of sediment discharge and bare soils in the eastern project area, where sediment flows off of the well pad, and stabilization is needed.

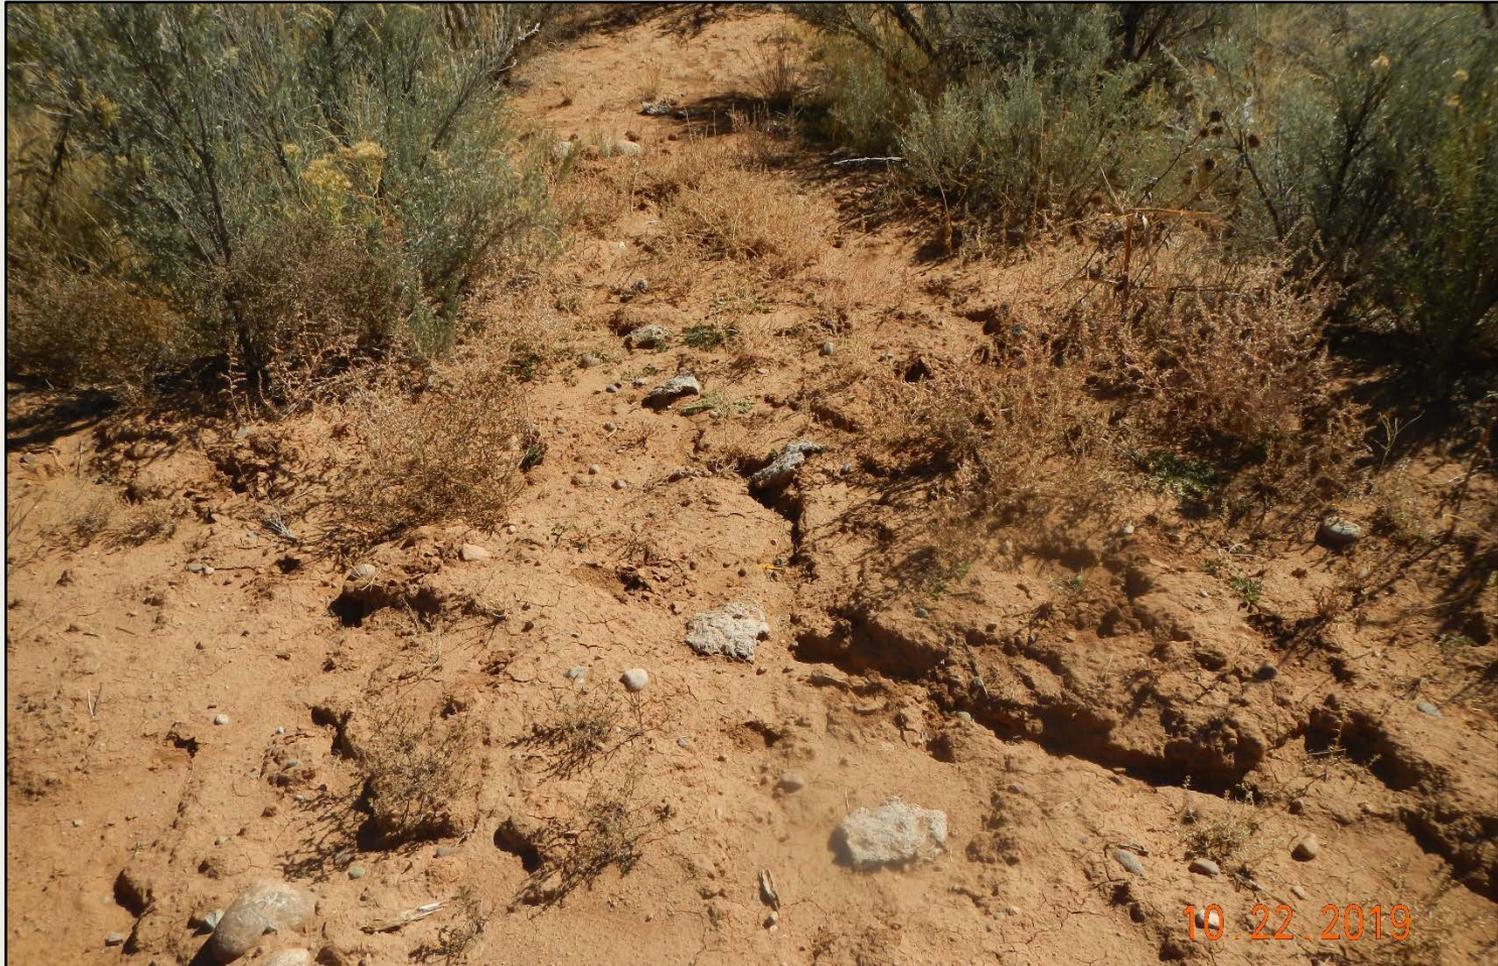
Photo 5. View of erosional channel within the southeastern project area, continues to erode.

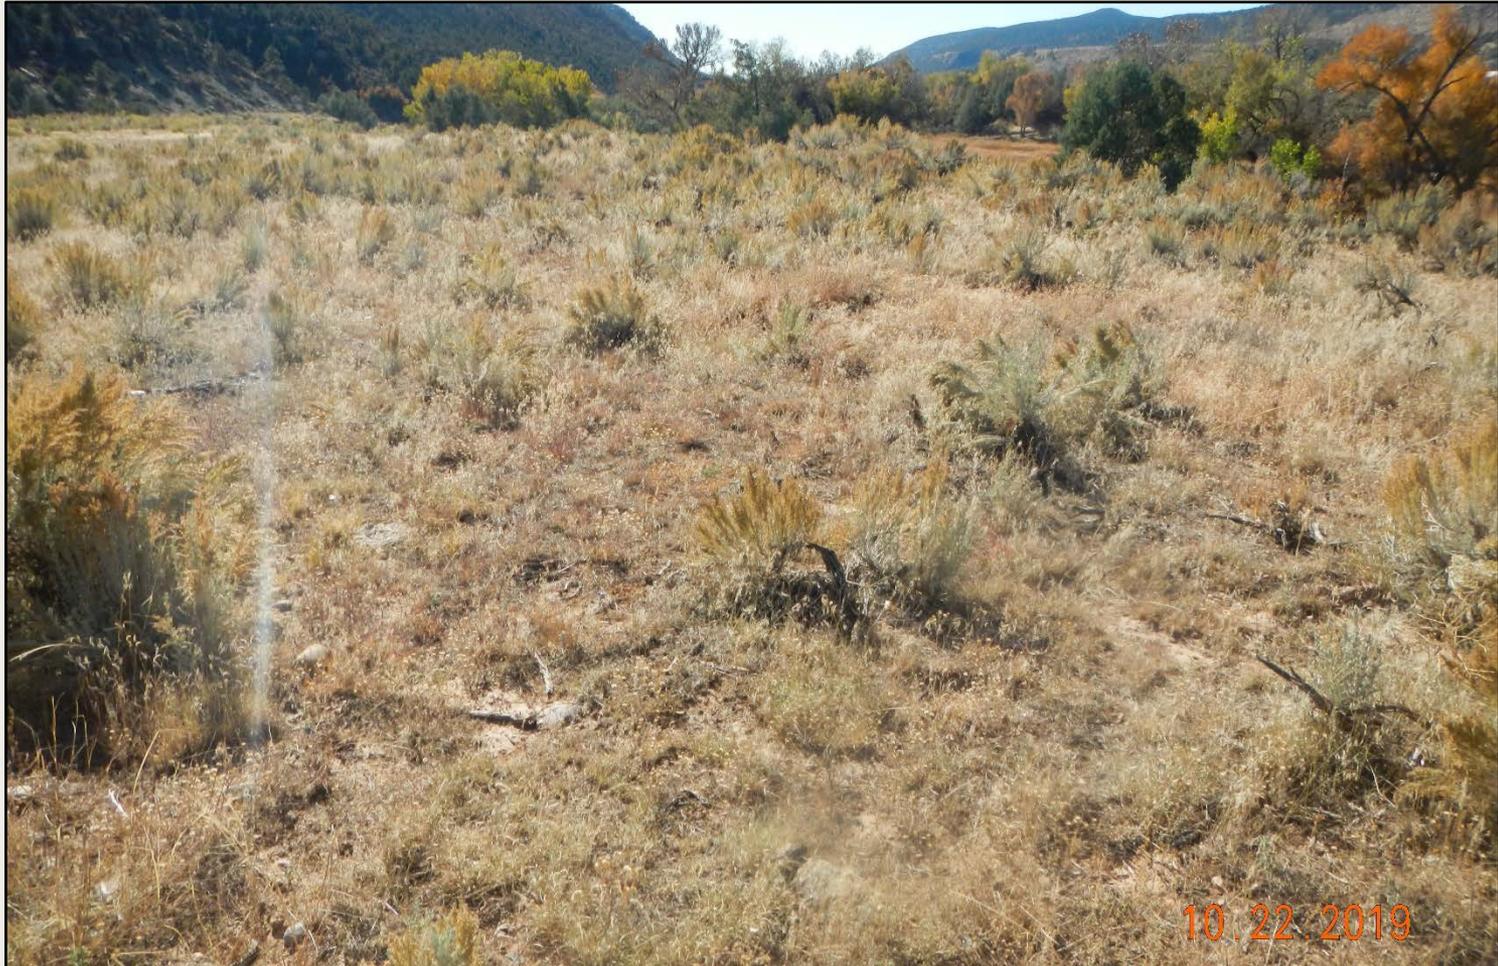
Photo 6. View of reference area vegetation comprised of sagebrush shrubland, largely interspersed with mixed native grasses and forbs.
