CD-3 CO2 Well Location Photos
API #05-083-06726 / Facility ID #450246
FIR #693900935 / CA #131840 & #131841
FIRR #402227401

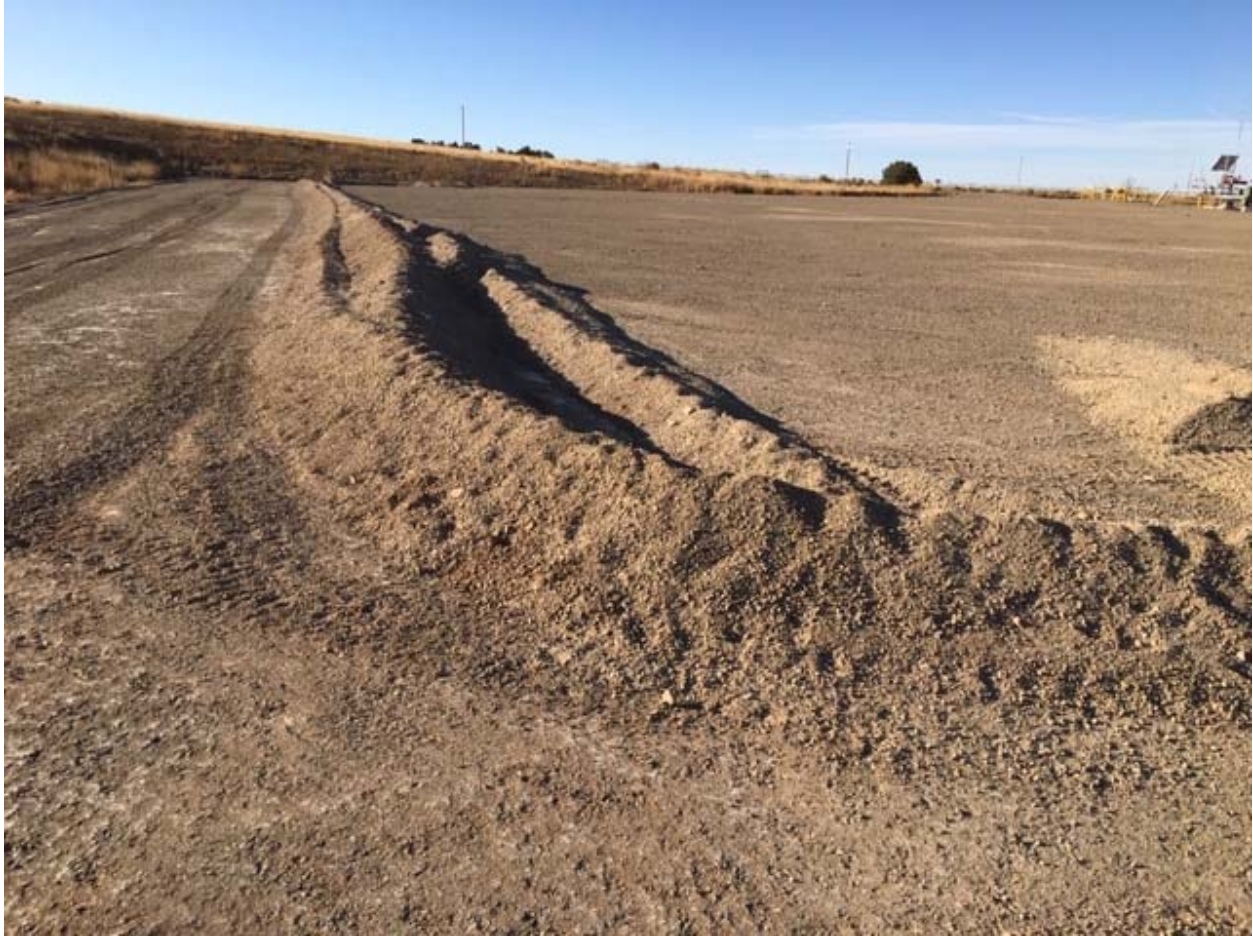
Comment: *Interim reclamation is not conducted and was due by October 3, 2019.*

Windrowed 3/4-inch gravel on the east side of the CD-3 location

At the time of the inspection by Catherine Roy on 10/11/2019, interim reclamation at the CD-3 location had already commenced as evidenced by the windrow of 3/4-inch gravel shown in the background of Photo 1 taken during the inspection. Interim reclamation activities commenced on September 30, 2019 at both the CD-3 and CX-14 locations. The comment that reclamation was due by October 3, 2019 is not correct. The drilling rig was released on April 3, 2019 however completion activities did not conclude until April 26, 2019 as stated in the CD-3 Form 5A (Document #402049167). Interim reclamation activities are currently underway and we anticipate completion by December 6, 2019 (weather permitting). Evidence of interim reclamation at the CD-3 location is shown in the photograph below.

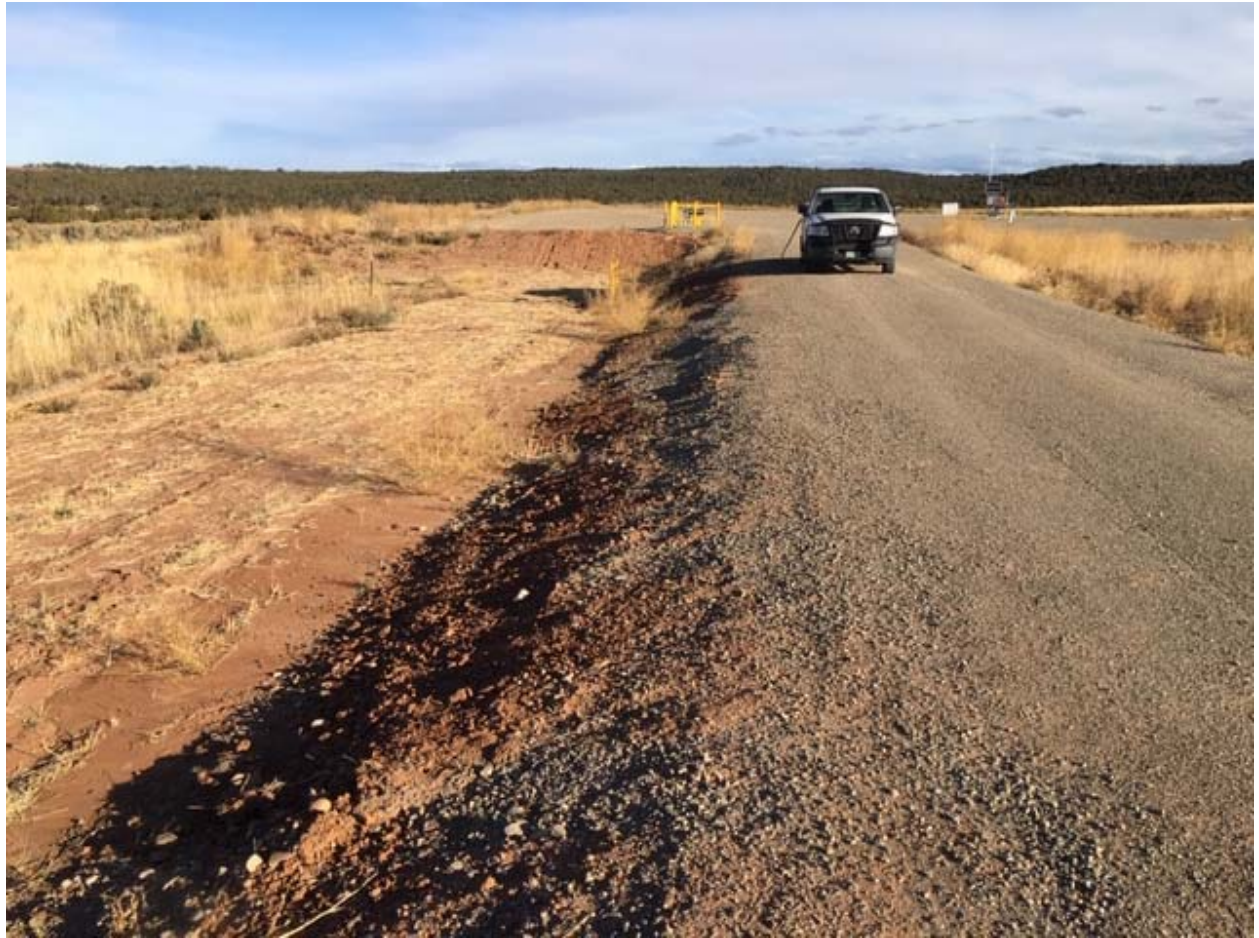
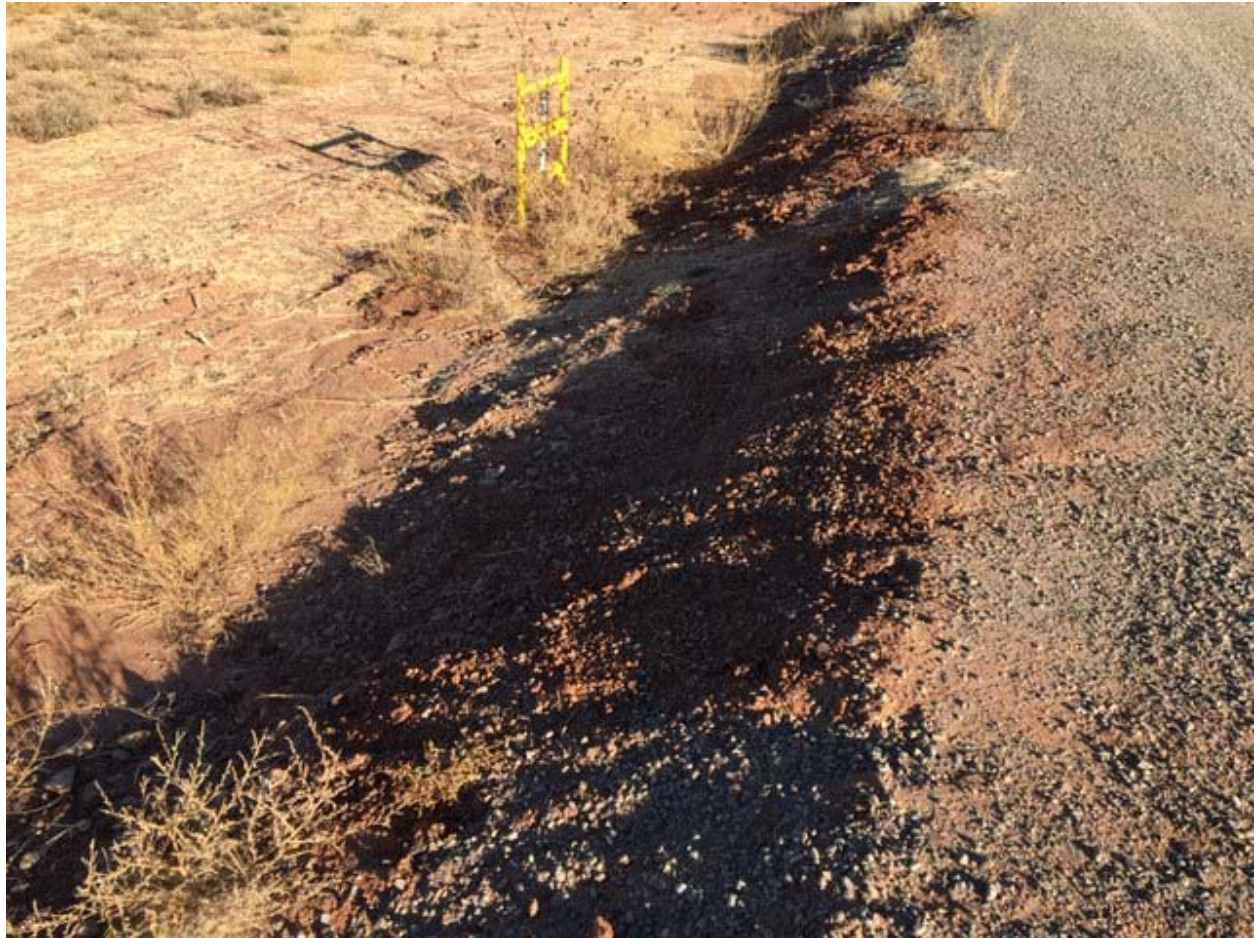
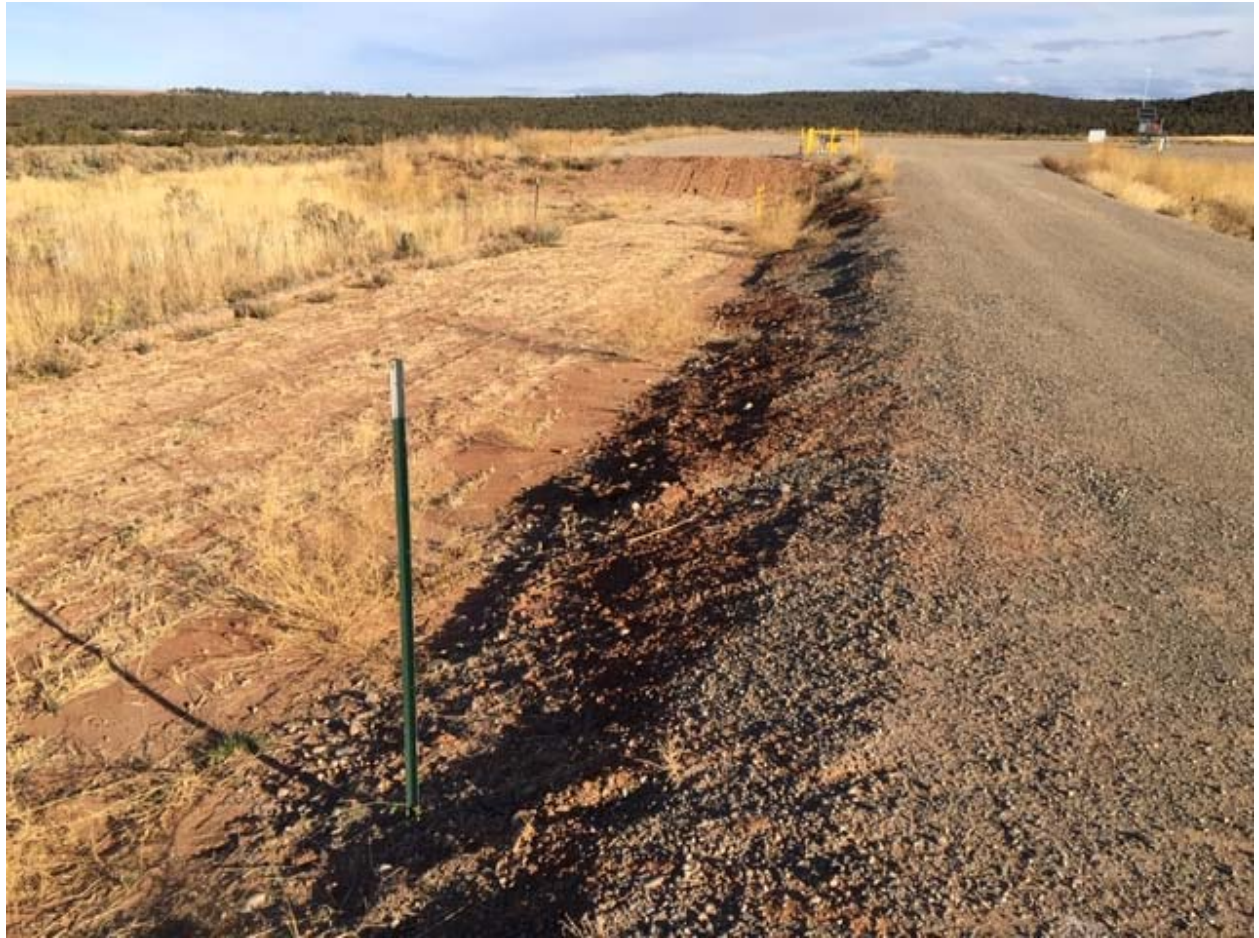
Comment: *Erosional rilling and sediment deposition is occurring along the access road.*

The erosional rills shown in Photo 3 of the inspection report photos are the result of a brief but heavy precipitation event that occurred during the week of September 30, 2019. All erosional rill were raked out during the week of October 14, 2019. Refer to the photos below.
