Construction and Stormwater Inspection

Operator: EDGE ENERGY II LLC- #10671

Location ID: 460397

Inspection Photos
Location Name: Akbary /1A Pad
Location ID: 460397

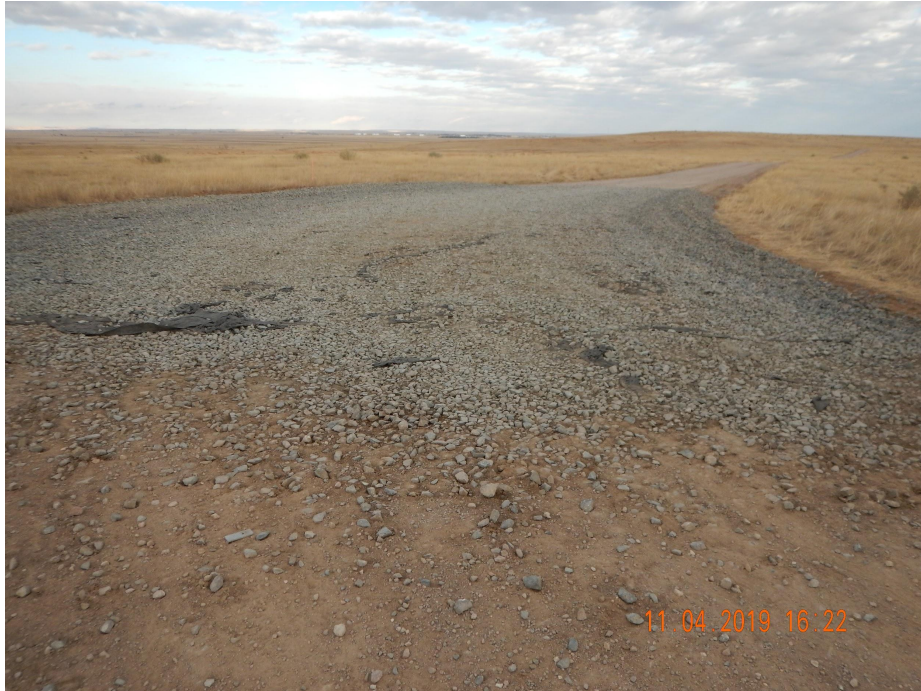
Photo 1. Photo taken from the entrance of location, facing East. Photo illustrates Operator has installed a vehicle tracking device BMP.

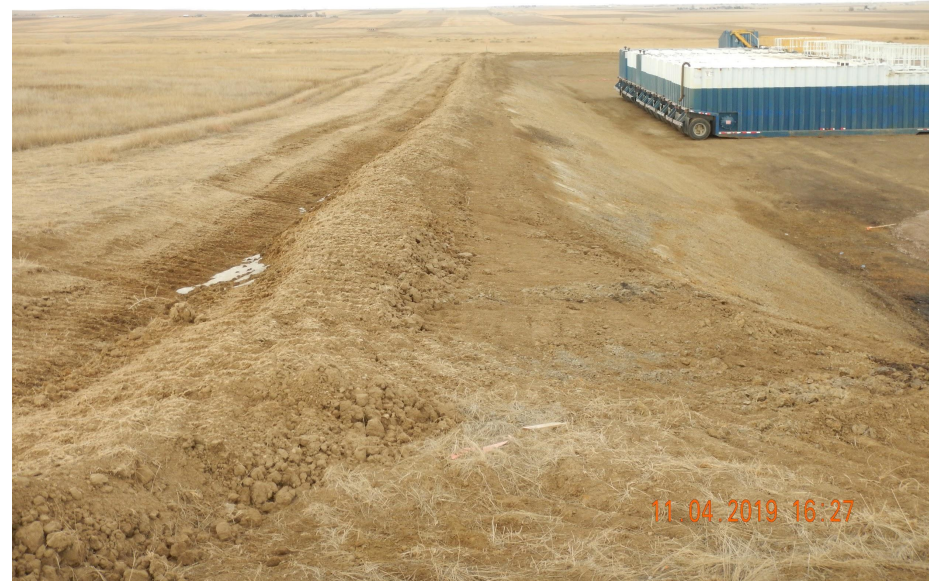
Photo 2. Photo taken from the southwestern location, facing North. Photo illustrates a ditch and berm BMP which has been temporarily stabilized with hydromulch.

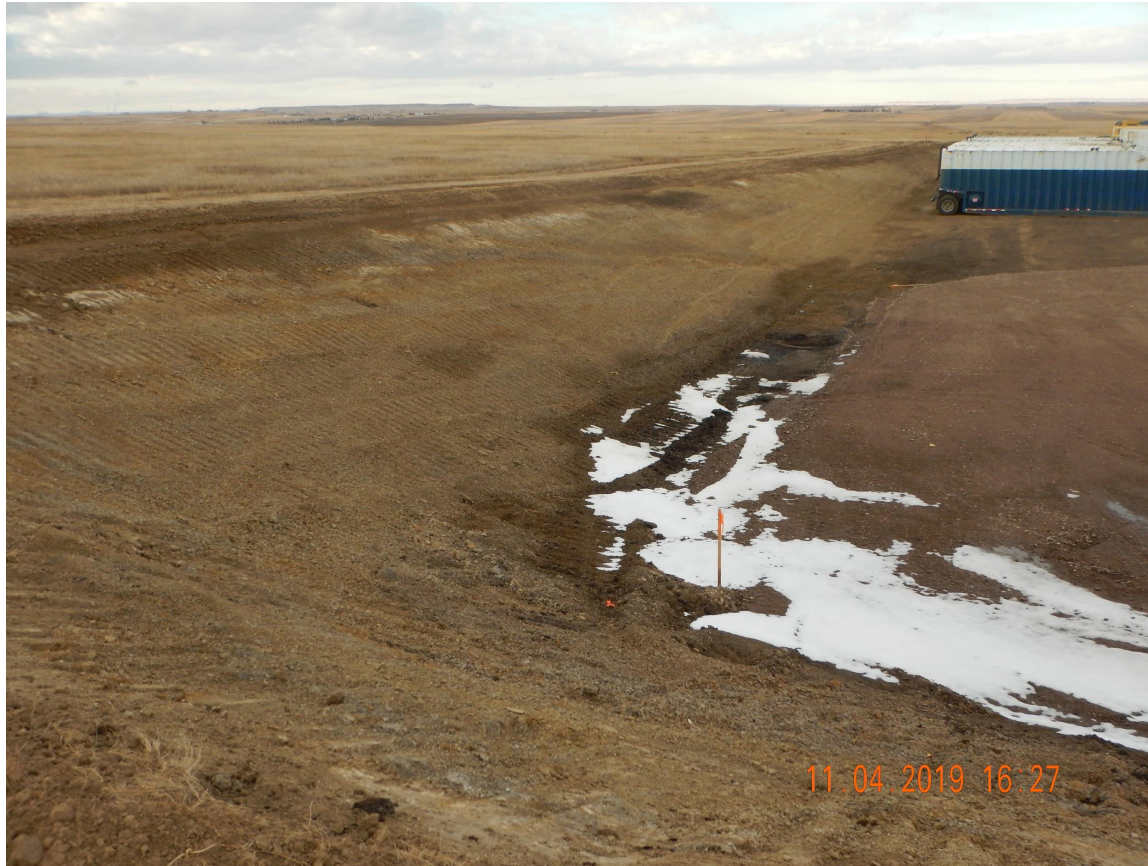
Photo 3. Photo taken from the southwestern location, facing North. Photo illustrates the cut slopes have been temporarily tracked with equipment. Note: tracking should be conducted perpendicular to the slopes. Tracking as shown here was done the opposite and would facilitate stormwater flow which would create rills that form gully erosion. Operator shall stabilize the cut slopes for long-term stabilization to comply with site degradation rule 1002.f.

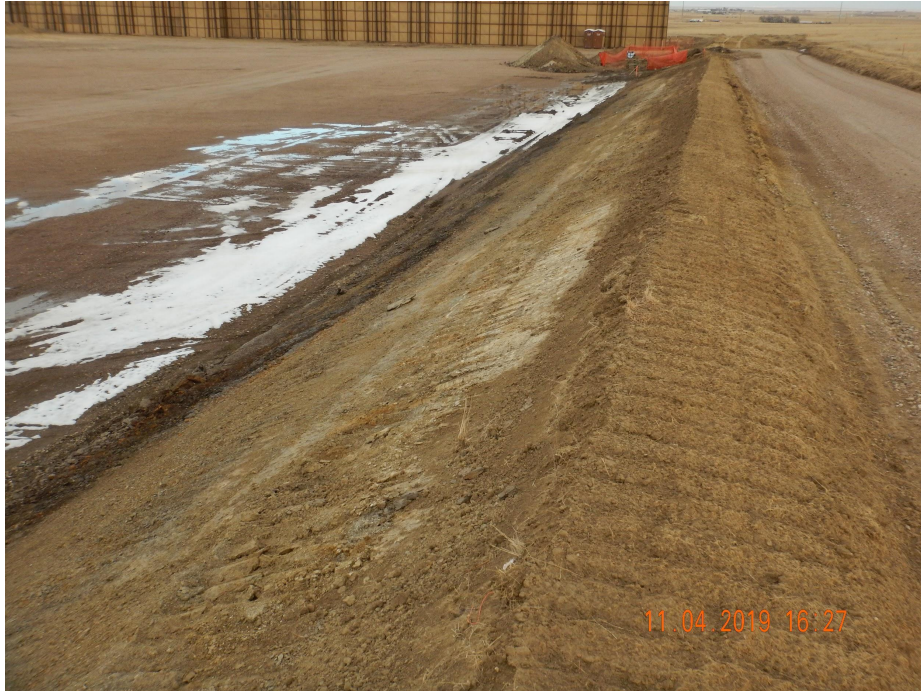
Photo 4. Photo taken from the southern location, facing East. Photo illustrates Operator has temporarily stabilized the top slope (berm) of the cut slope with hydromulch.

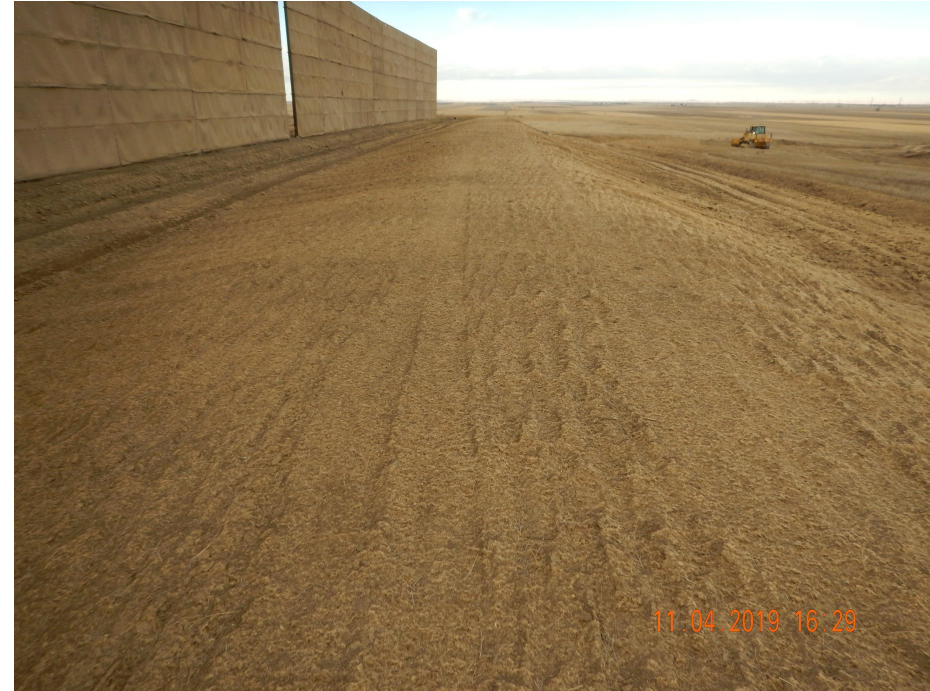
Photo 5. Photo taken from the eastern location, facing North. Photo illustrates the topsoil stockpile has been temporarily stabilized with hydromulch and equipment tracking.

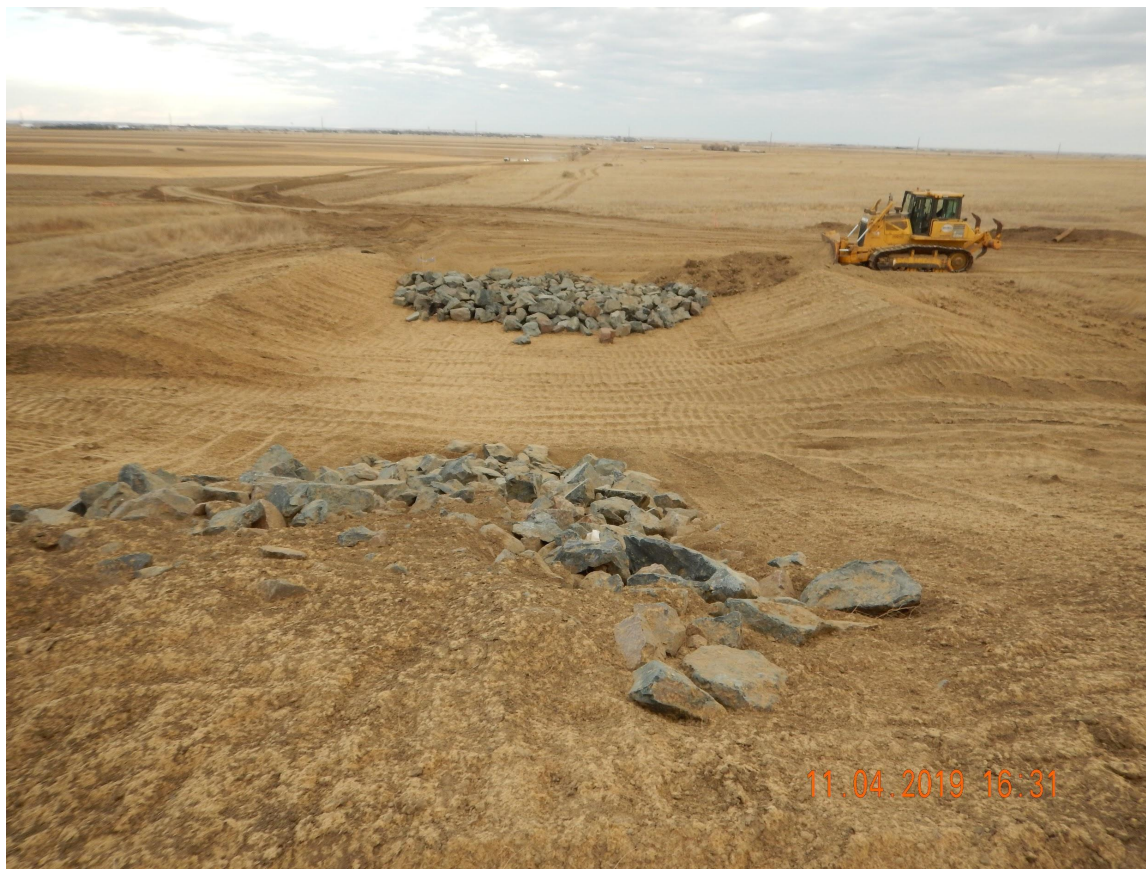
Photo 6. Photo taken from the northeastern location, facing East. Photo illustrates a sediment trap installed with a stabilized outlet. Appears the outlet material may have been compromised due to the pipeline installation.

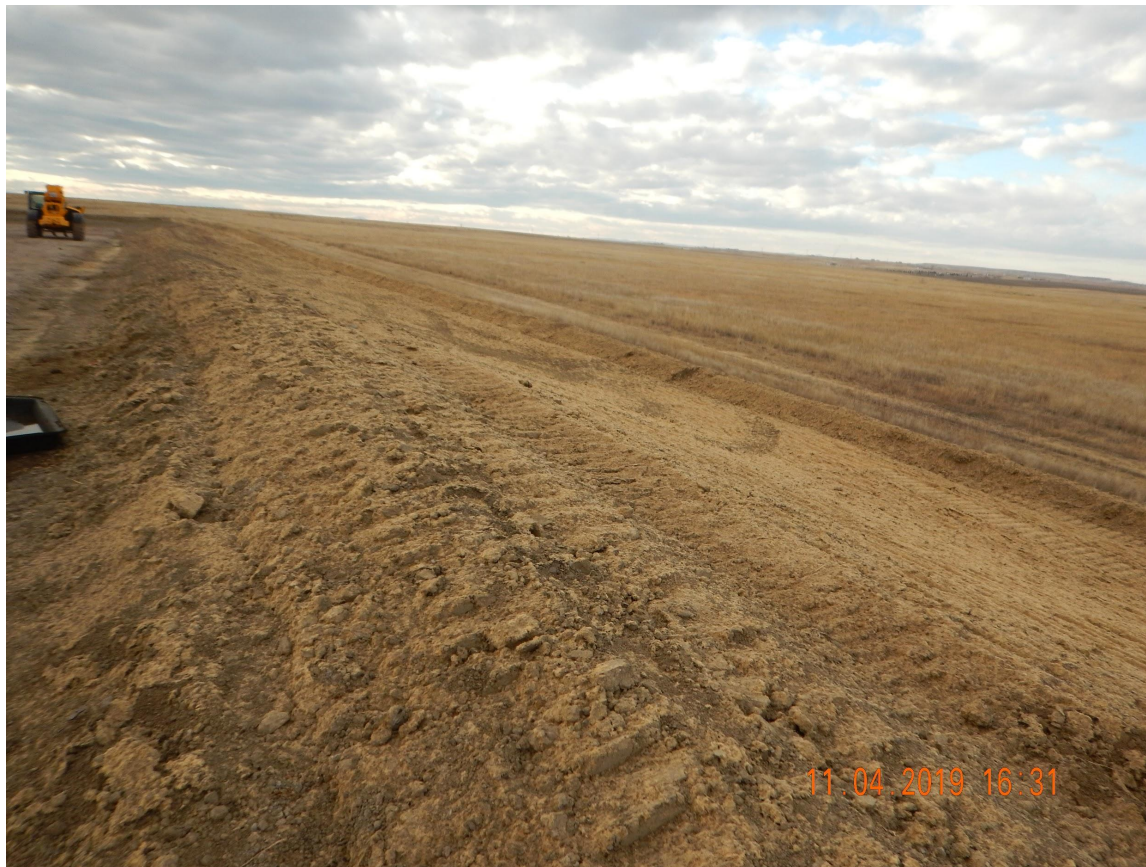
Photo 7. Photo taken from the northeastern location, facing West. Photo illustrates the fill slope has been temporarily stabilized with hydromulch.

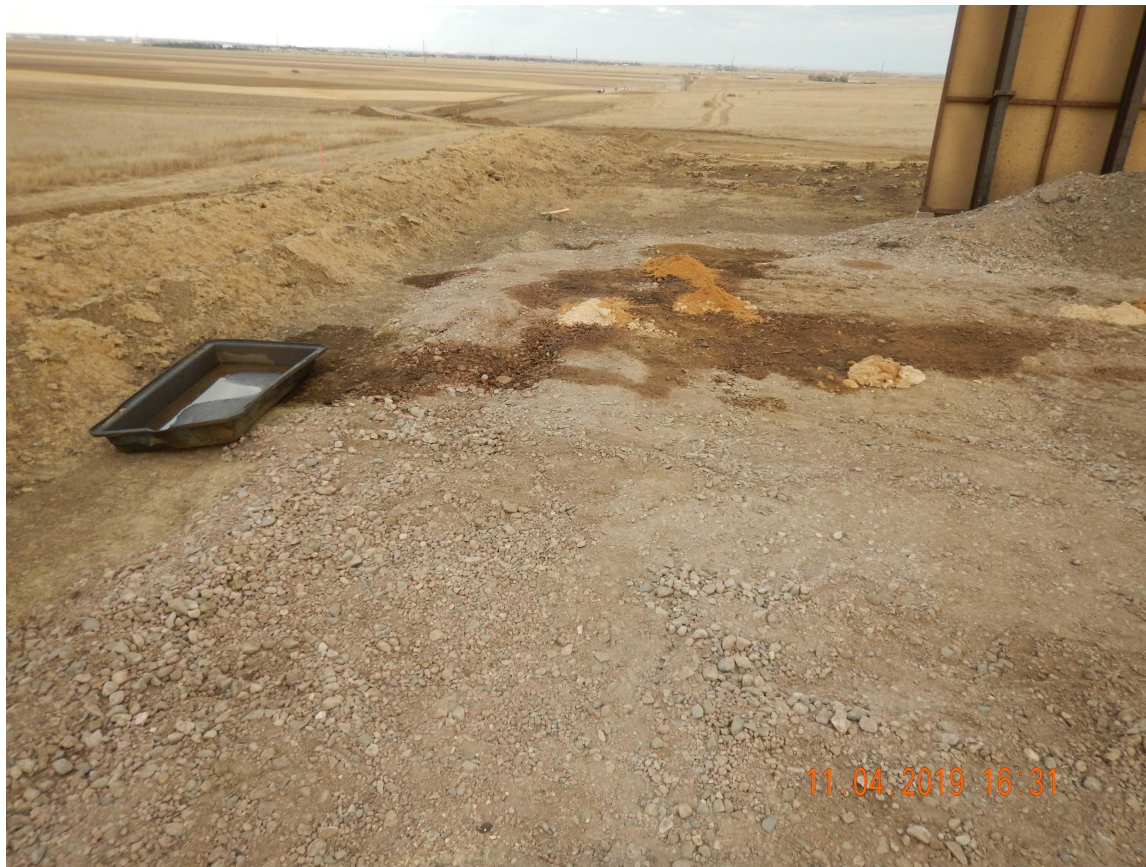
Photo 8. Photo taken from the northeastern well pad location, facing East.
Photo illustrates a spill area.
