Inspection Photos
Operator: Swepi LP
Location/API #: 083-06413
Date: 10-11-2019

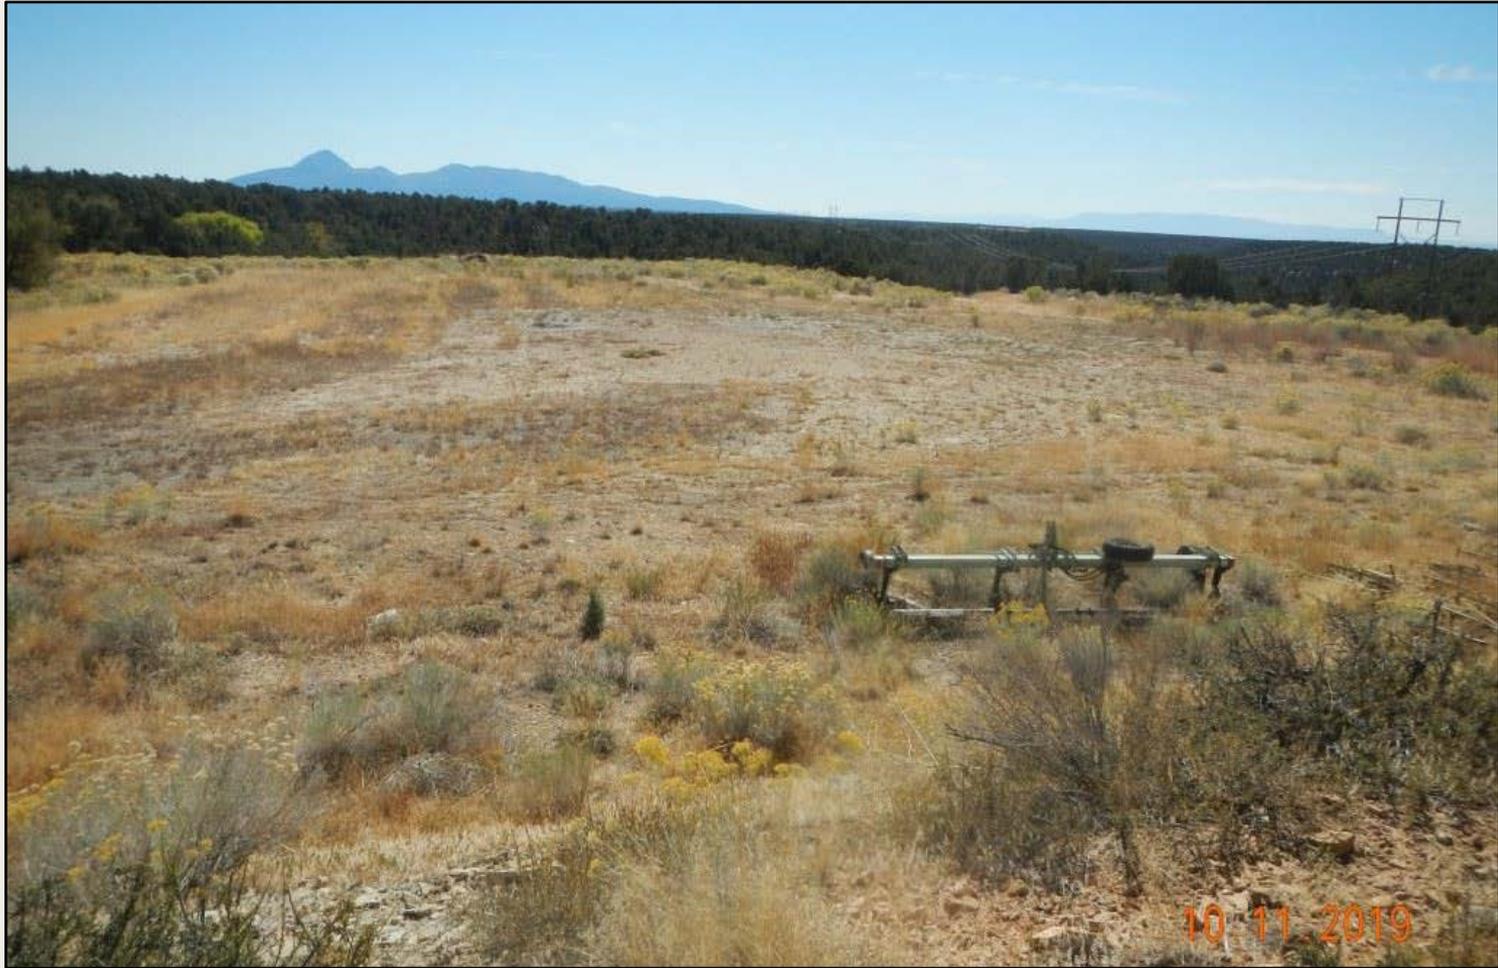
Photo 1. View of the project area from the northern edge facing center. Well pad is not reclaimed.

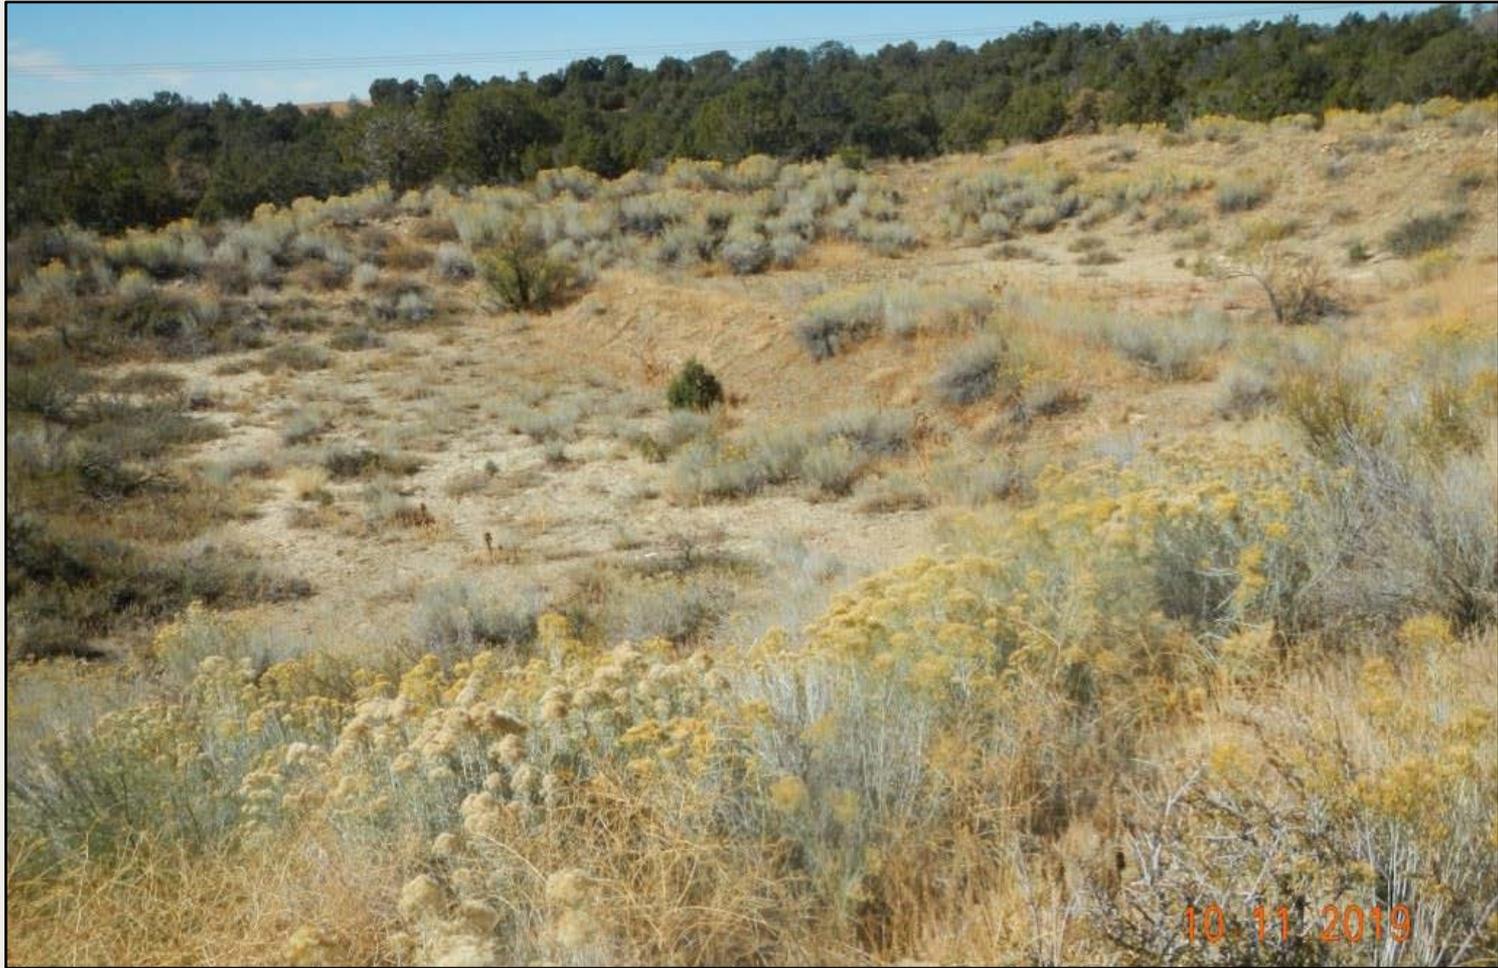
Photo 2. View of pits constructed and needing final reclamation.

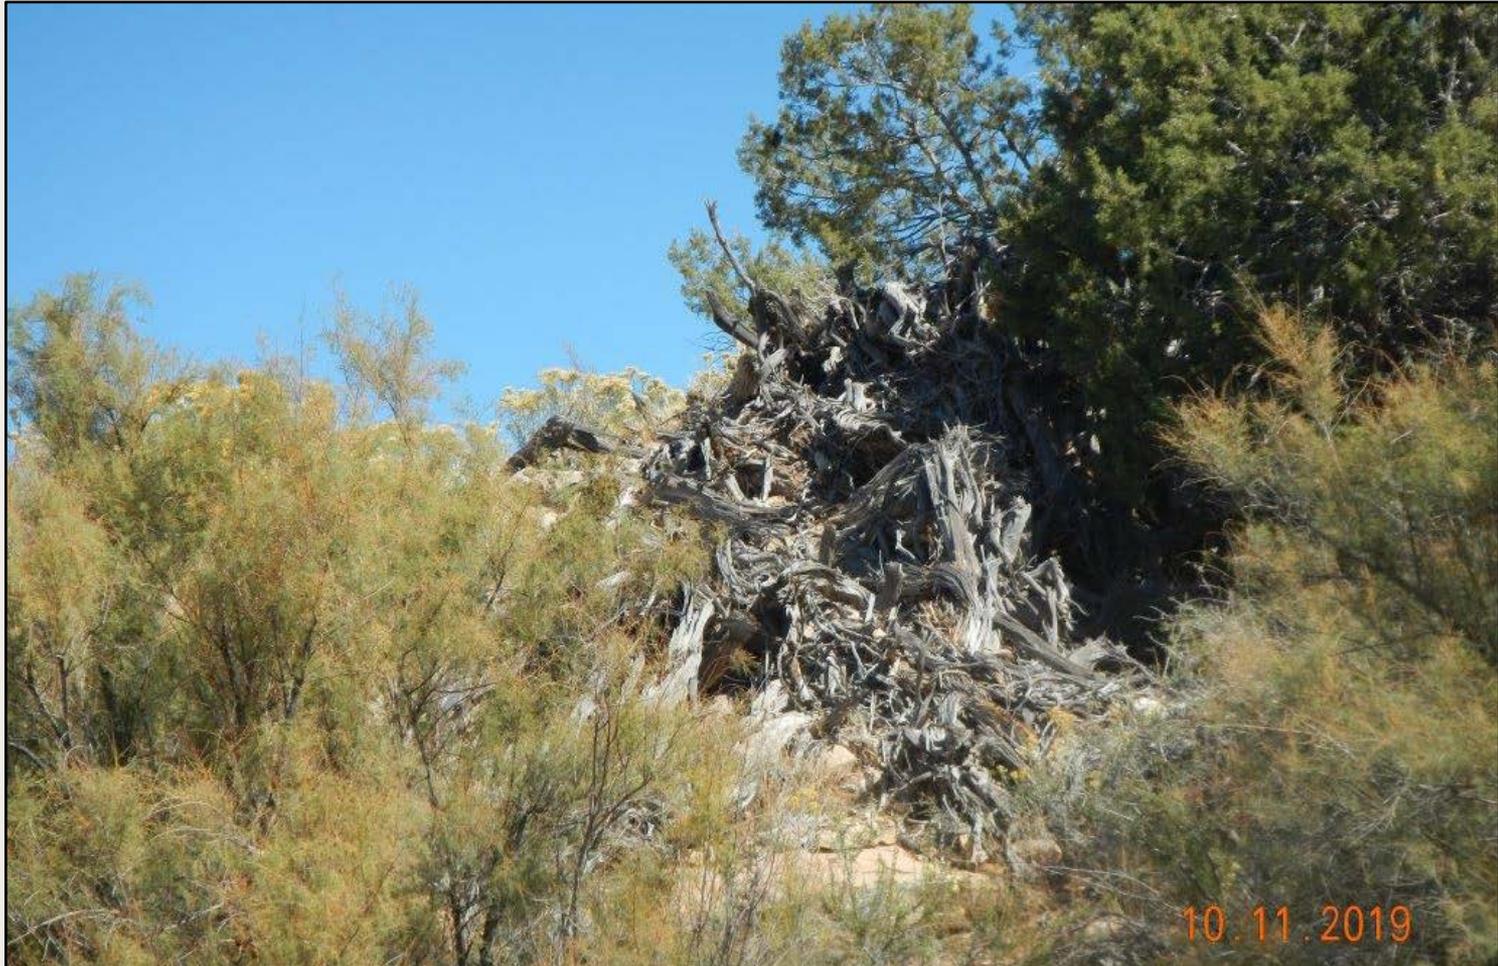
Photo 3. View of wood debris and salt cedar weeds within the eastern project area.

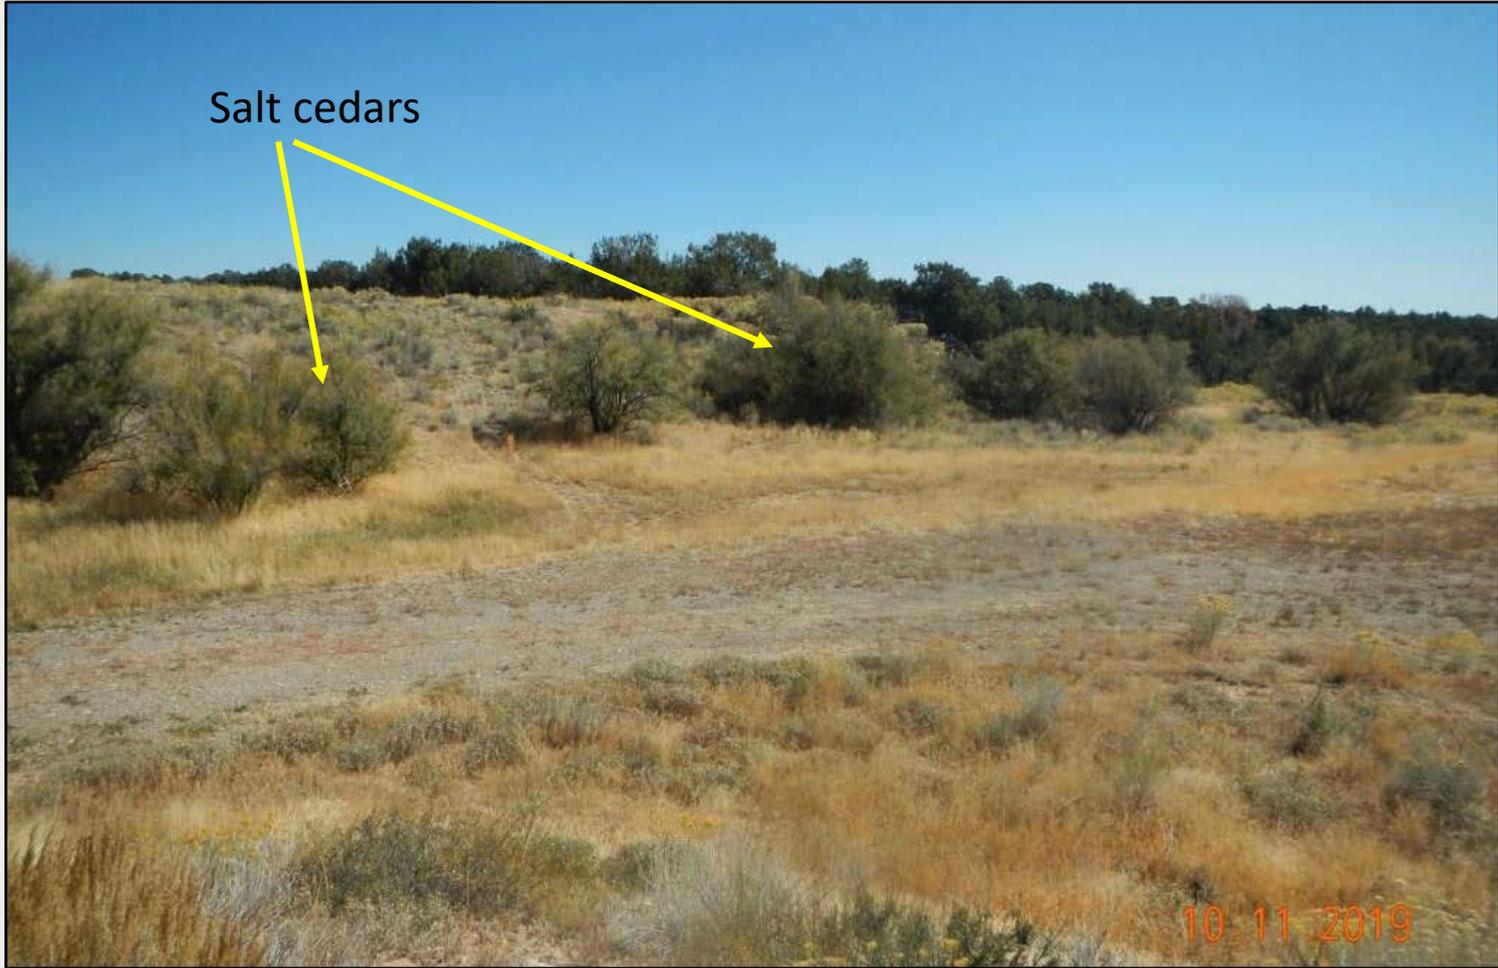
Photo 4. View of invasive salt cedars (*Tamarisk* sp) within the eastern project area.

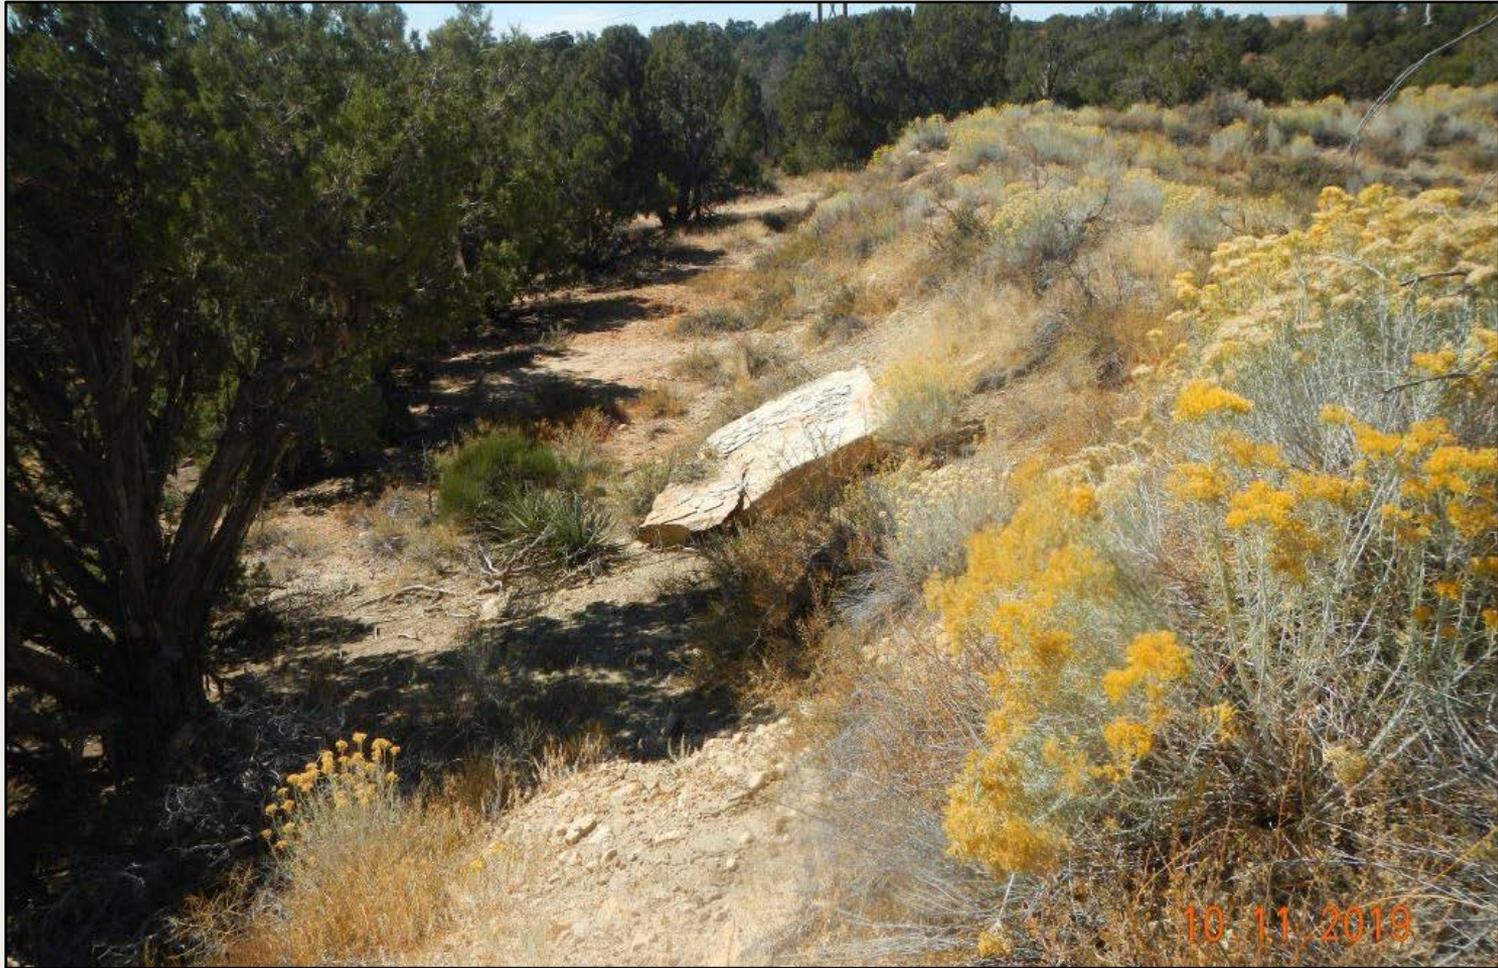
Photo 5. View of the southern fill slope from the southeastern edge facing westward.

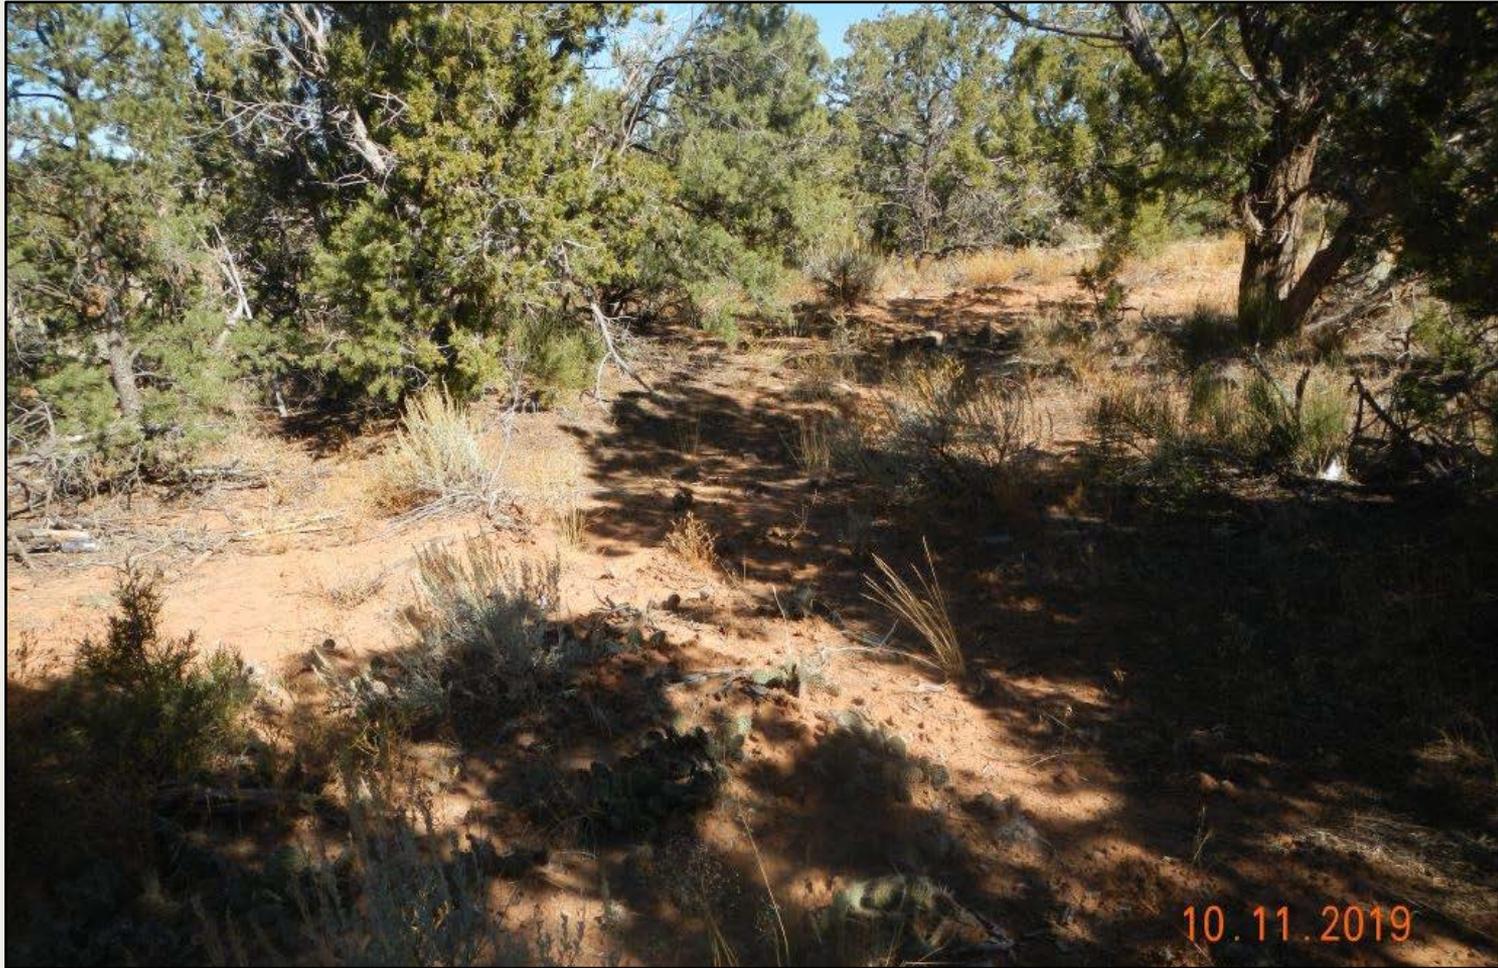
Photo 6. View of reference area vegetation comprised of pinyon-juniper woodland with sagebrush and native grasses and forbs in the understory.
