Location Name: Magpie Operating Inc. – Warnecke – Rem #13484
Inspection Date: 10/21/2019

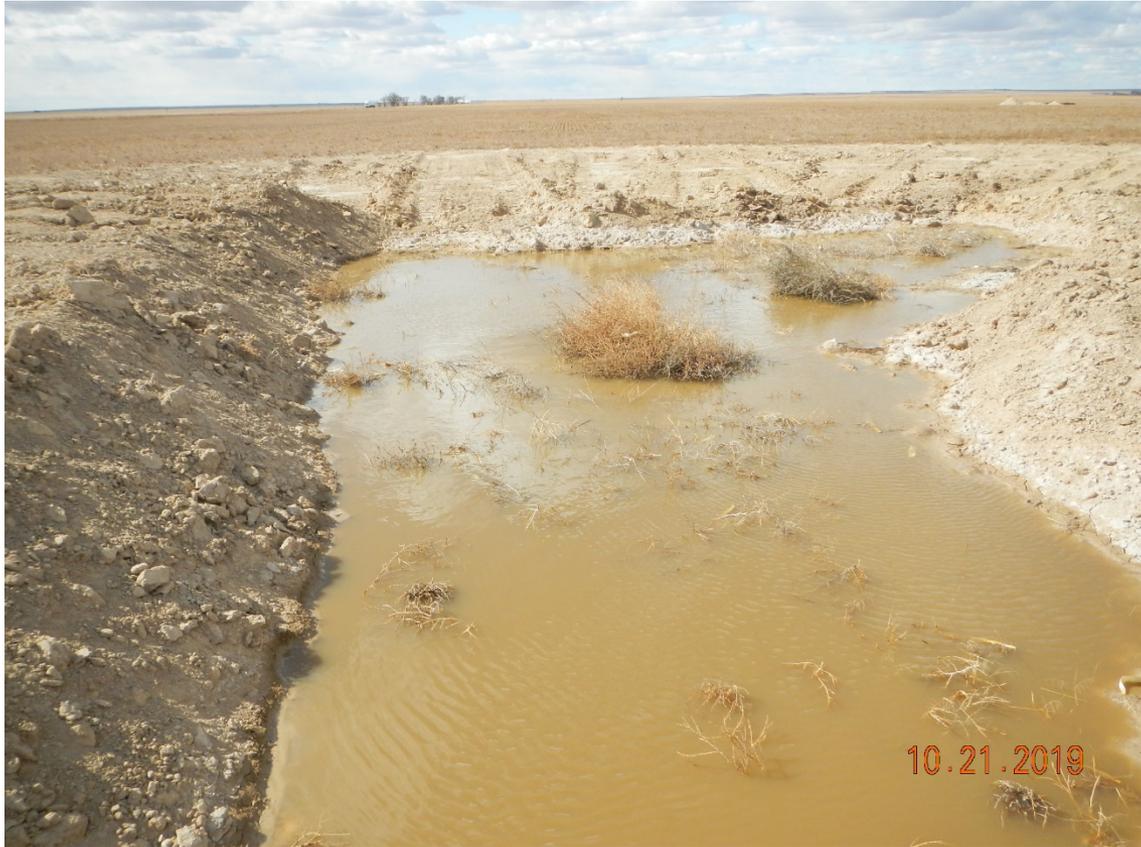
Photo # 1 – View west across partially backfilled produced water pit

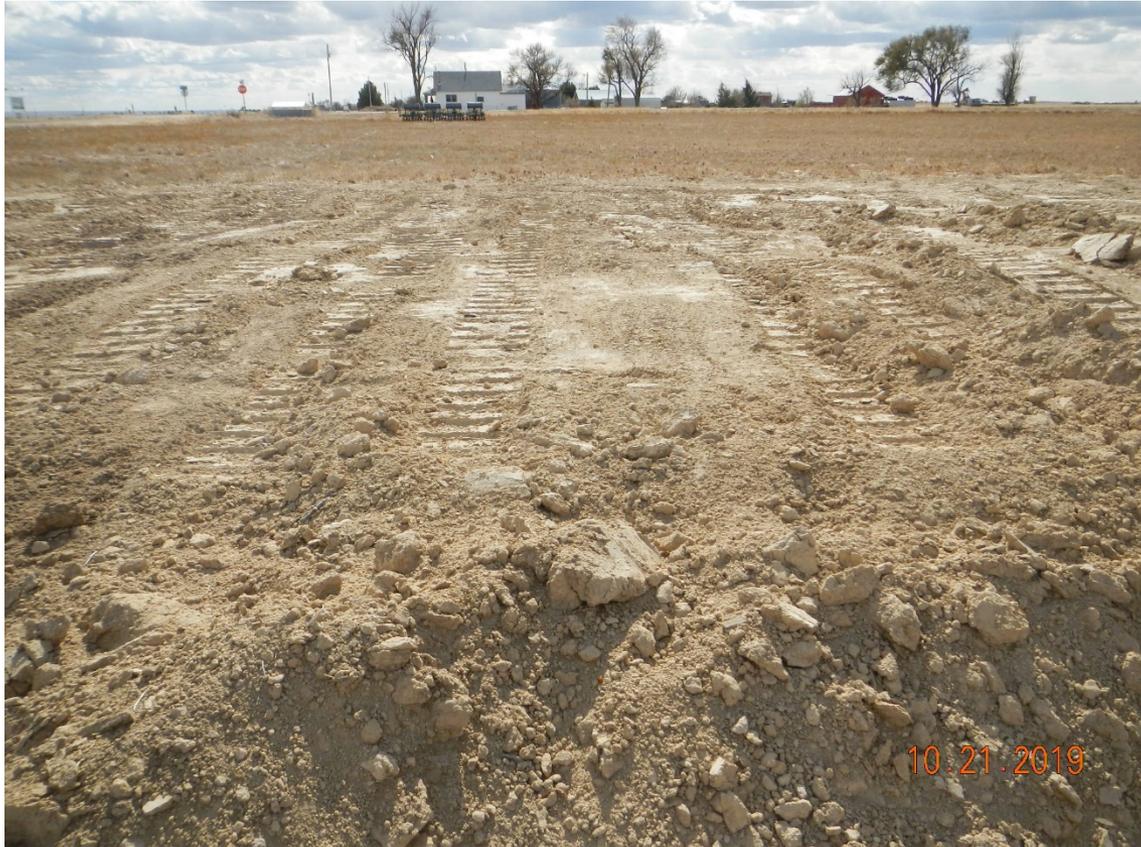
Photo # 2 – View south, pit berms pushed into pit

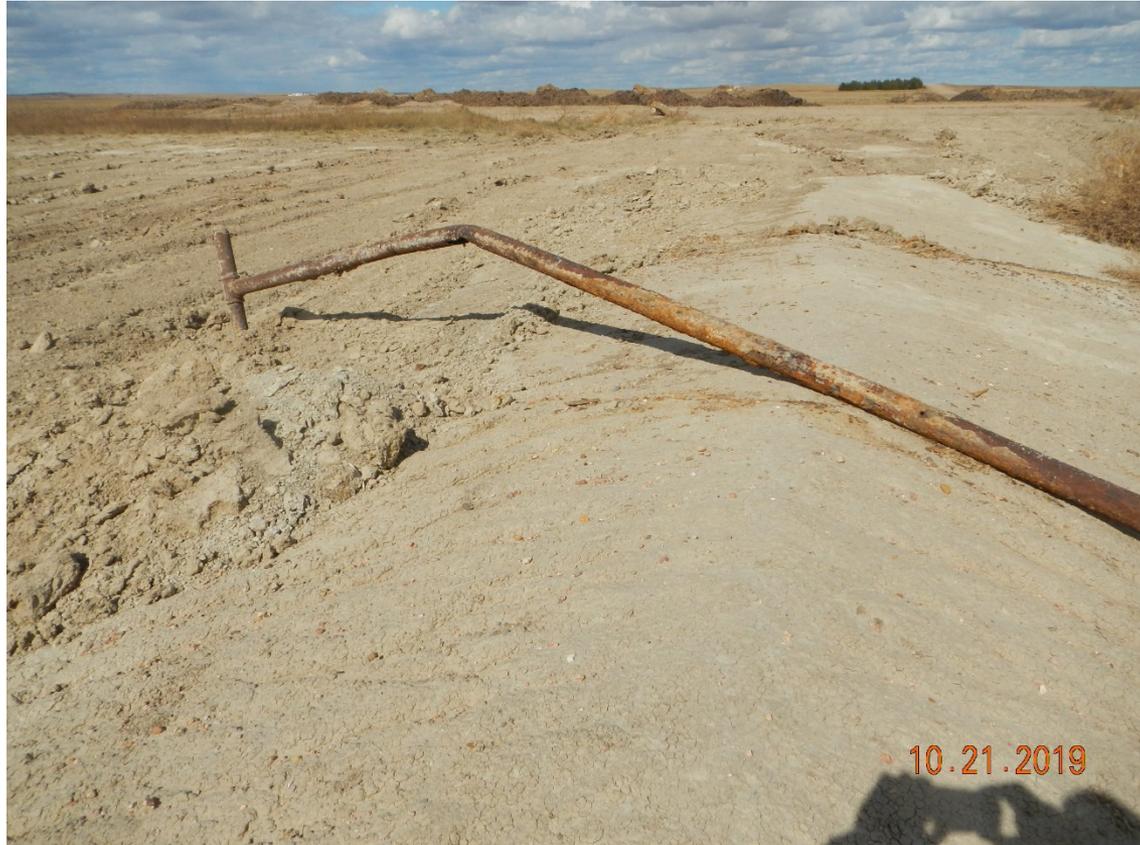
Photo # 3 – View north, siphon pipe across partial pit dividing berms requires removal, pit berm requires pH, EC and SAR analysis

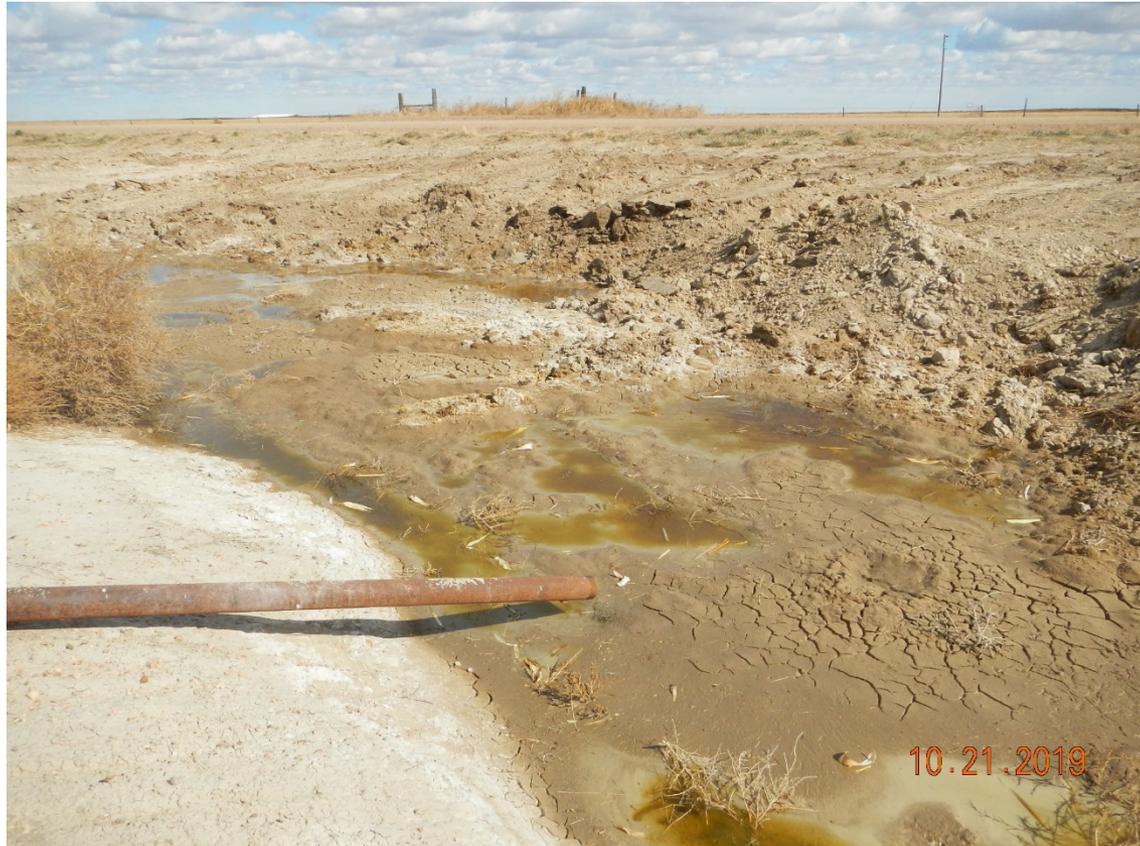
Photo # 4 – View northeast, siphon pipe across partial pit dividing berms requires removal

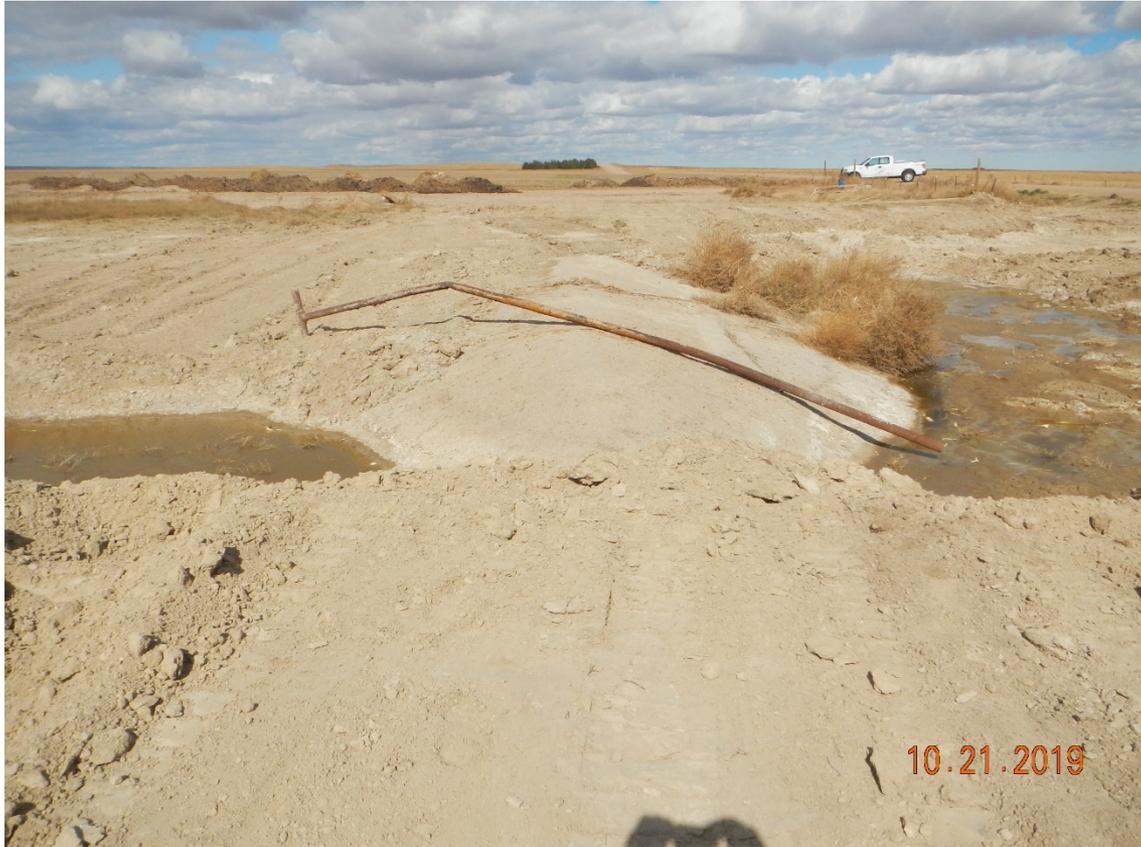
Photo # 5 – View north, siphon pipe across partial pit dividing berms requires removal

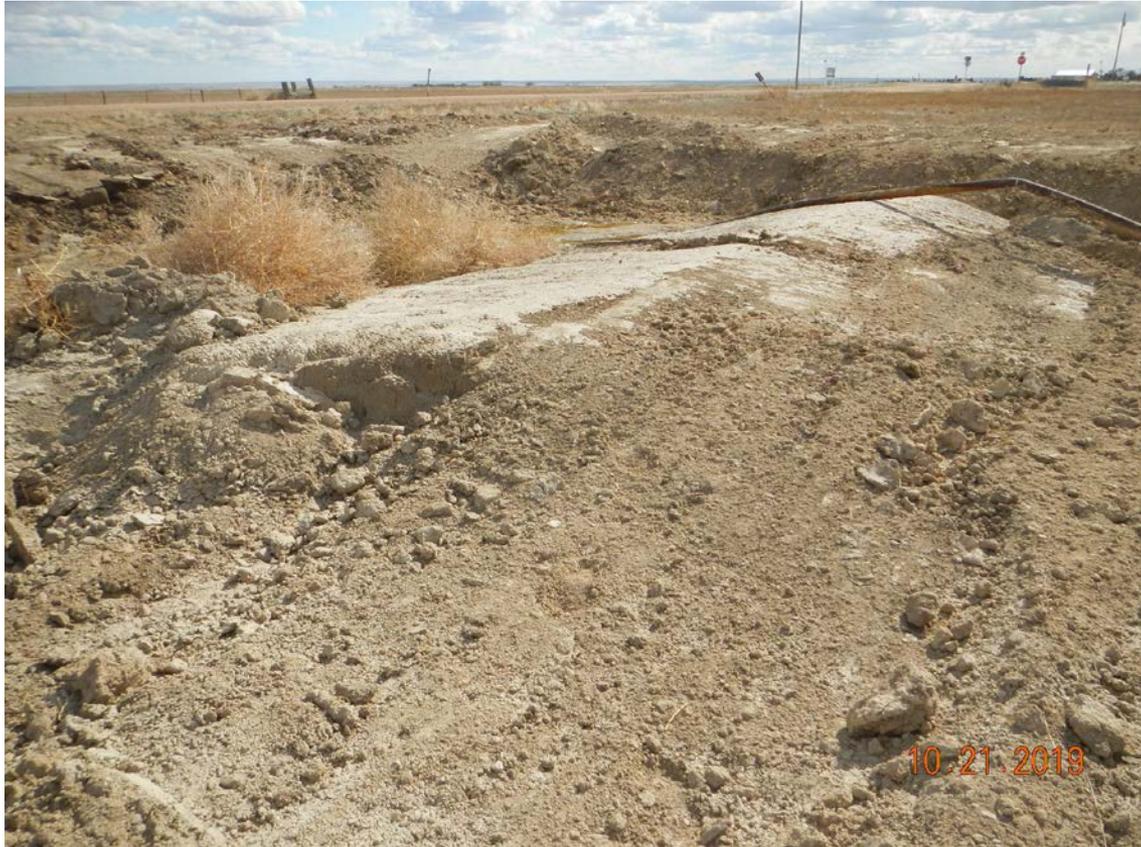
Photo # 5 – View south, siphon pipe across partial pit dividing berms requires removal, pit berm is not three feet below grade

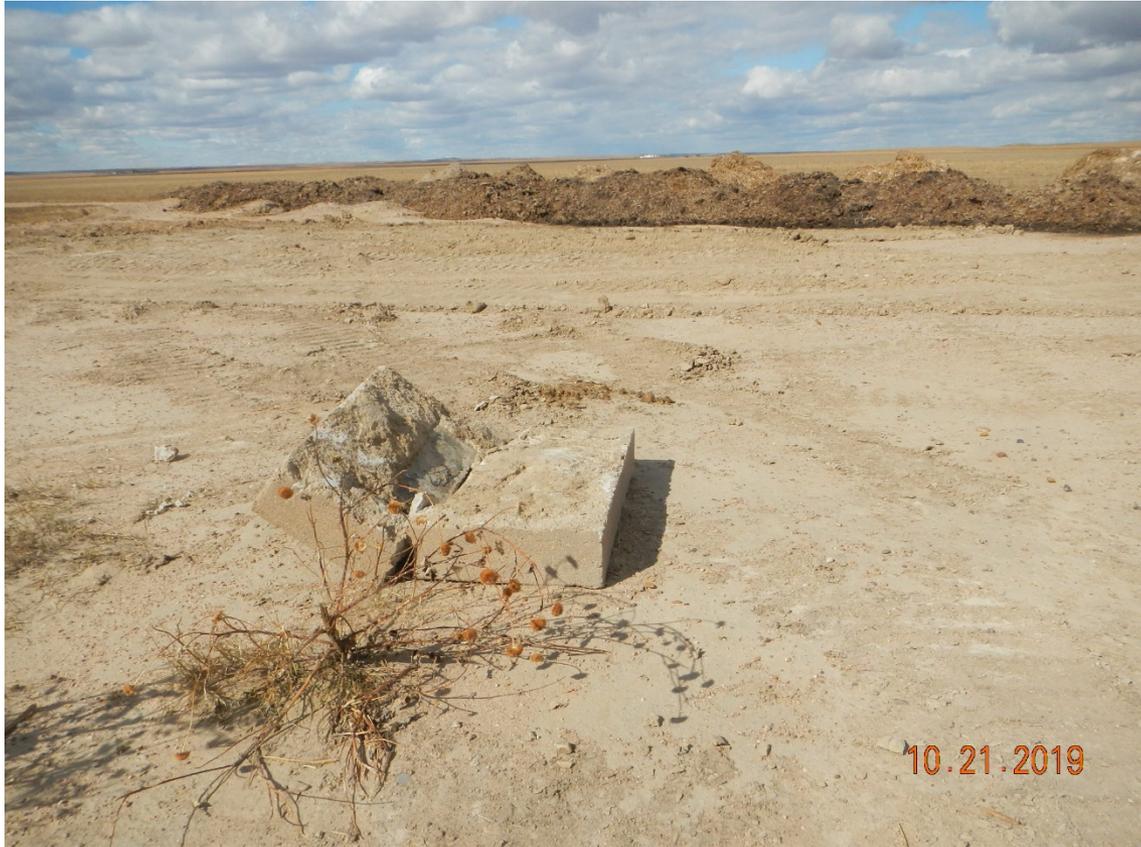
Photo # 5 – Concrete debris requires removal

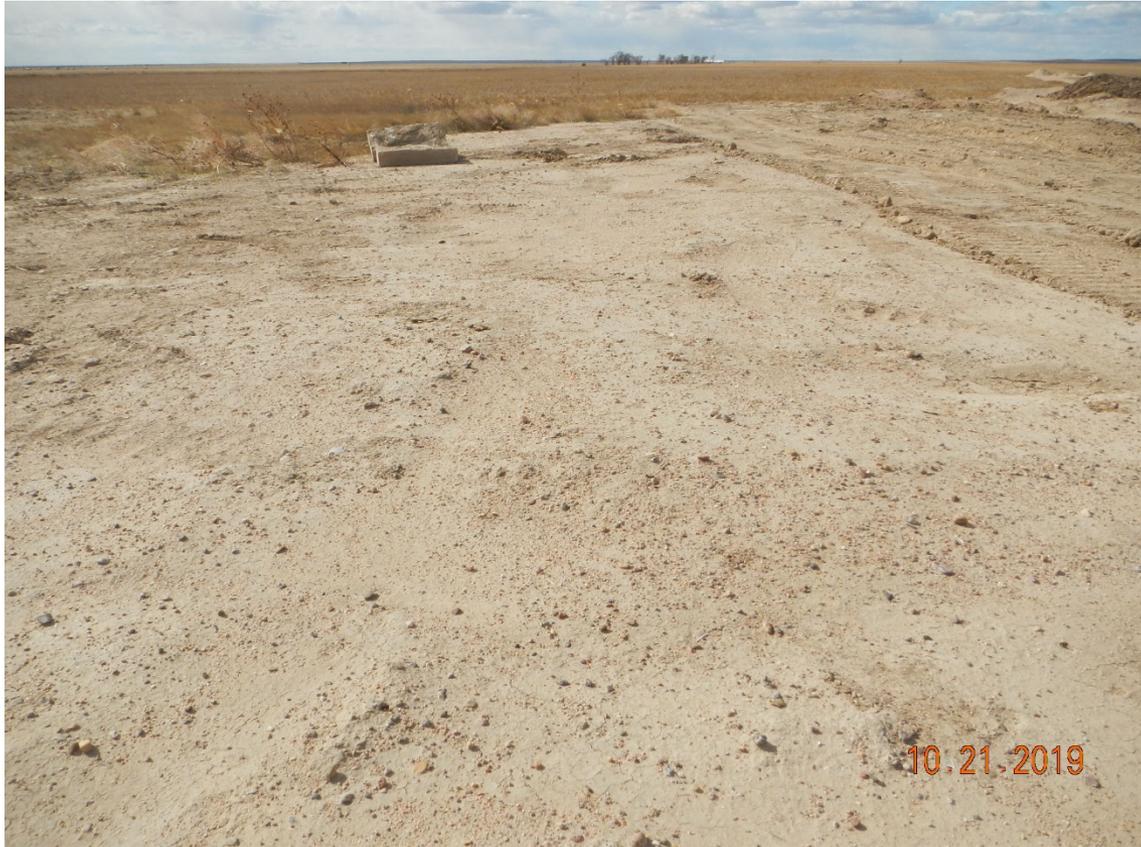
Photo # 6 – Former separator area, gravelly soil requires pH, EC and SAR analysis

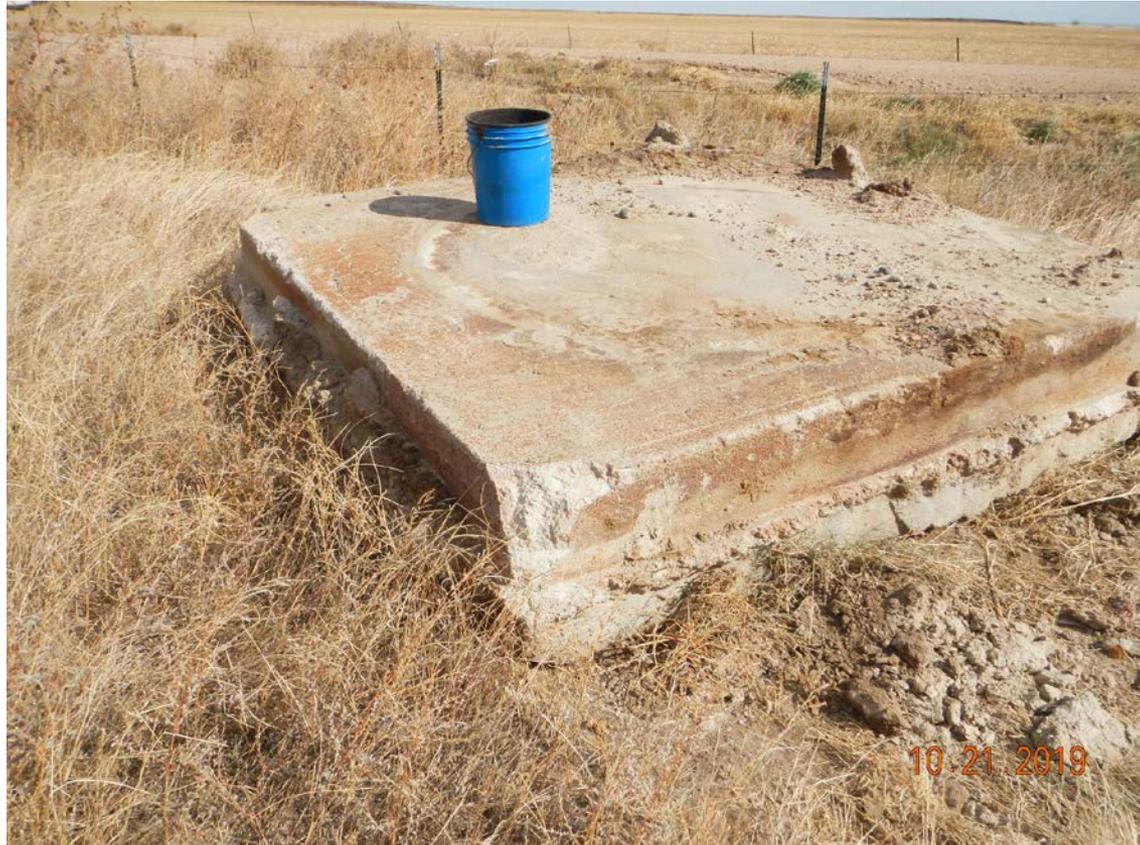
Photo # 7 – East of former separator area, concrete base and oily bucket require disposal
