# Interim Reclamation and Stormwater Inspection

November 4, 2019

Operator: LONGS PEAK RESOURCES LLC- #10611

Location ID: 439459

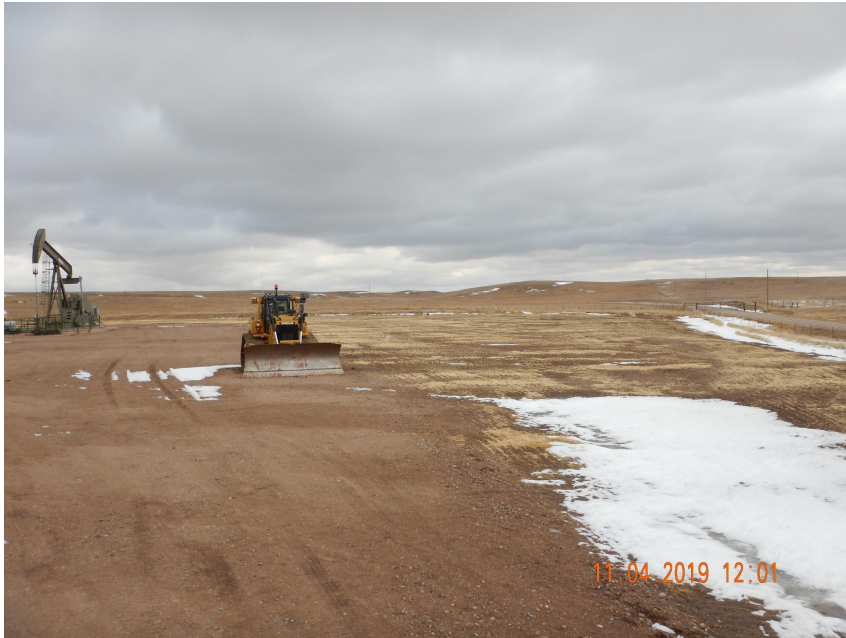
**Photo 1.** Photo taken from the entrance of location, facing East. Photo illustrates Operator has performed interim reclamation to reduce areas only needed for production operations per Rule 1003. Note: Appears straw mulch was crimped as an erosion control but has already blown off location which will not ensure the seeded soil is stabilized. COGCC staff would recommend re-installing erosion controls and using long-fiber weed-free mulch.

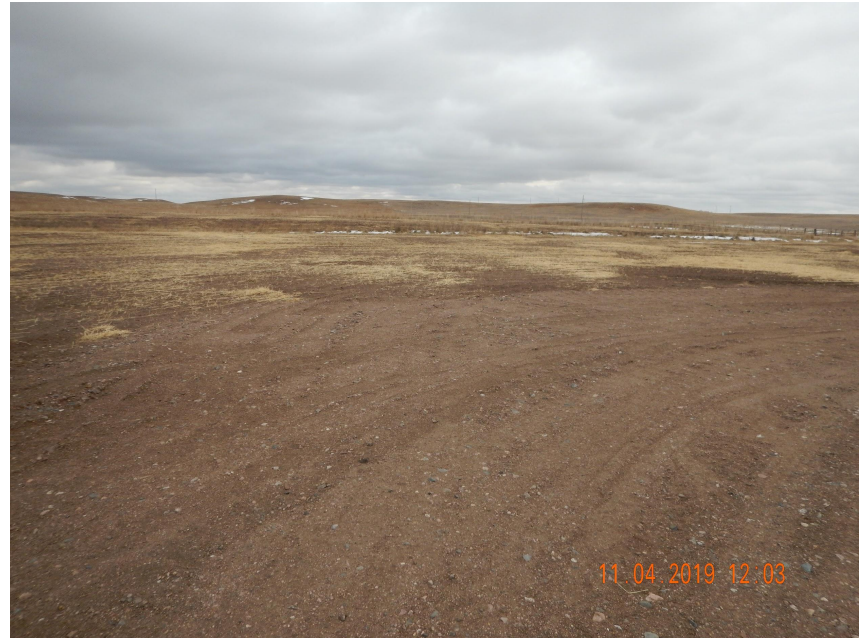
**Photo 2.** Photo taken from the eastern location, facing East. See comments under Photo 1.

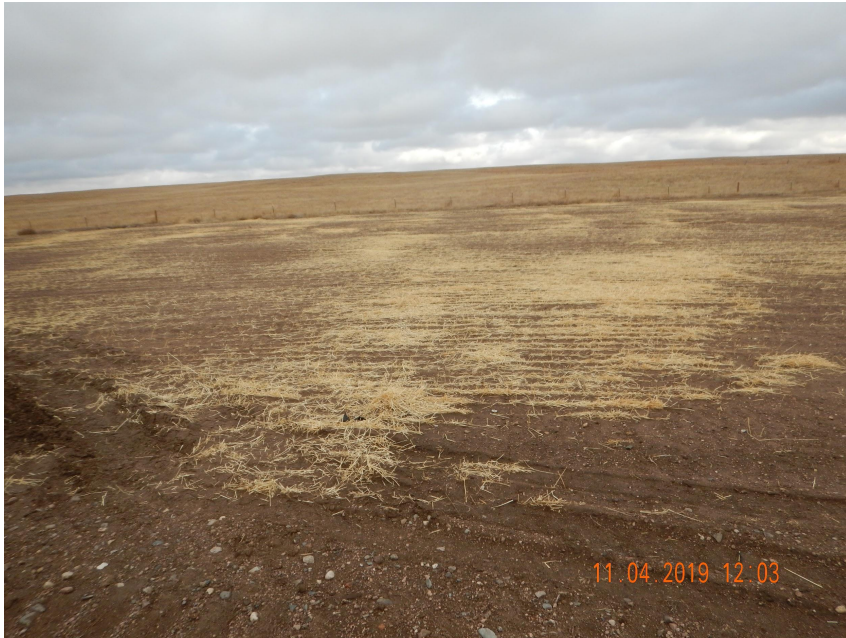
**Photo 3.** Photo taken from the southeastern well pad, facing North. See comments under Photo 1.

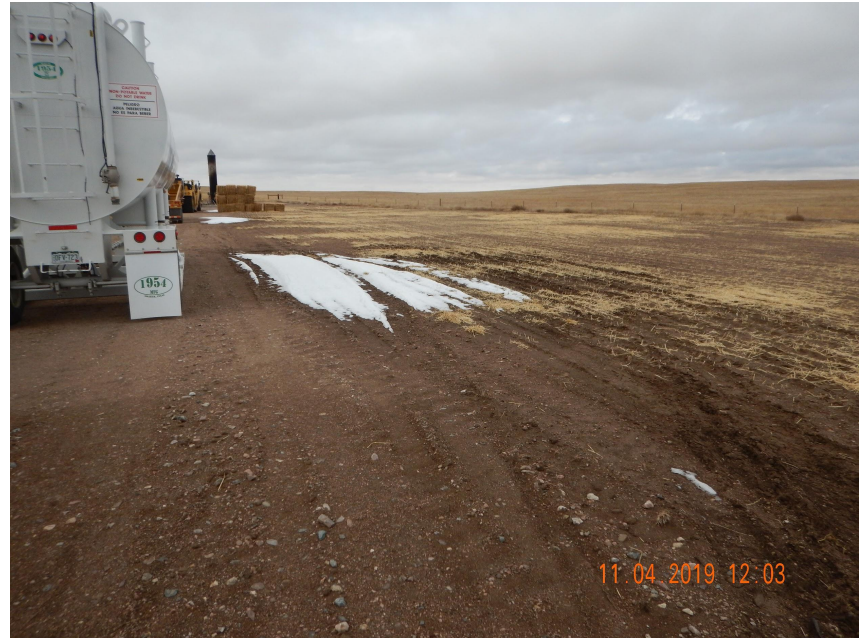
**Photo 4.** Photo taken from the southeastern well pad, facing West. See comments under Photo 1.

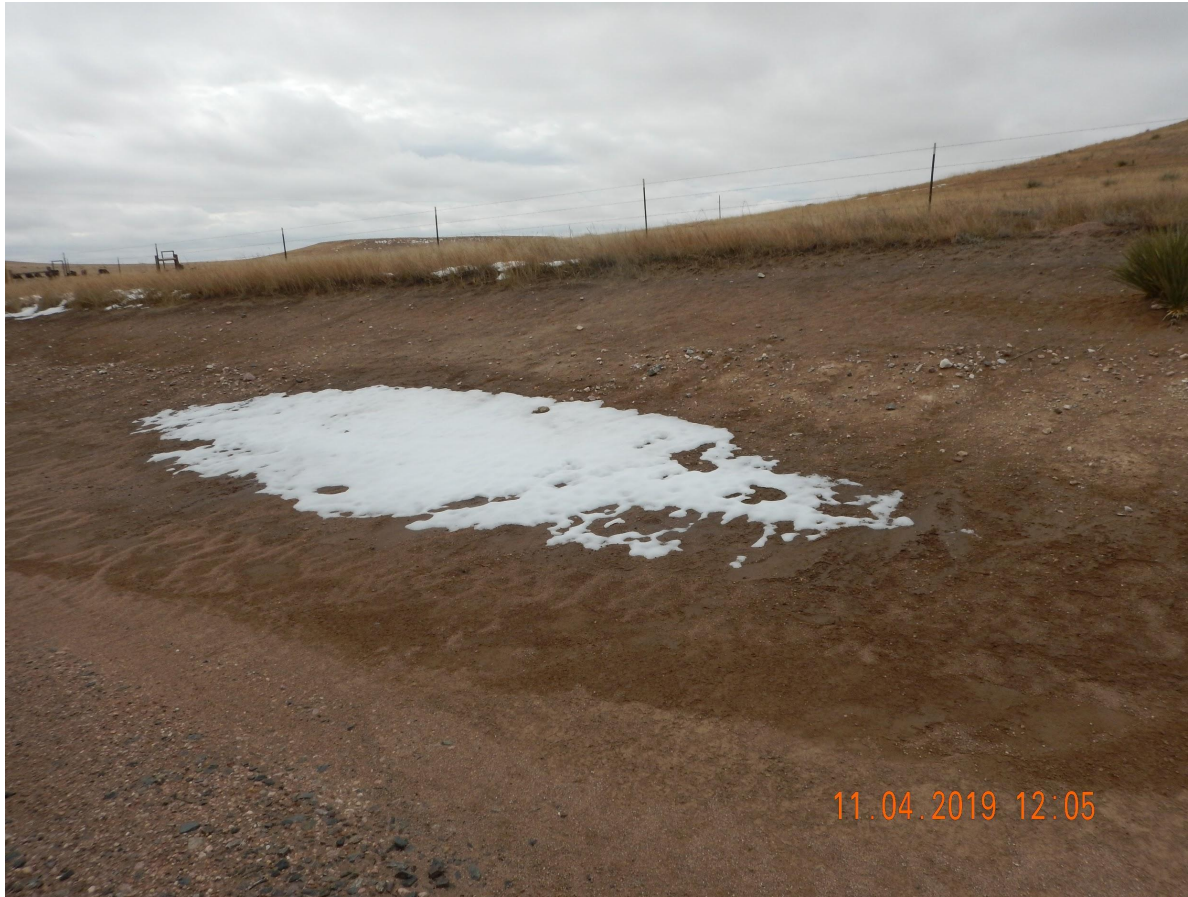
**Photo 5.** Photo taken from the western well pad, facing West. Operator claims that the western cut slope was properly stabilized. This photo illustrates that the cut slope has not been properly stabilized, as it remains in the same condition. There is no indication that a BMP has been installed or implemented.
