Inspection Photos
Location Name: Jacobucci Jean 2
Location ID: 333139

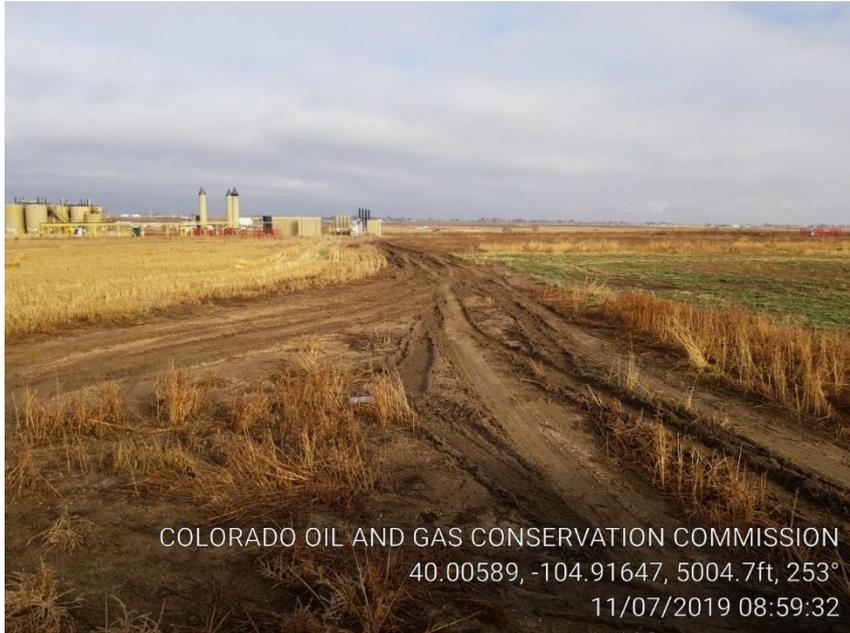
Pic 1 lease road BMP failing

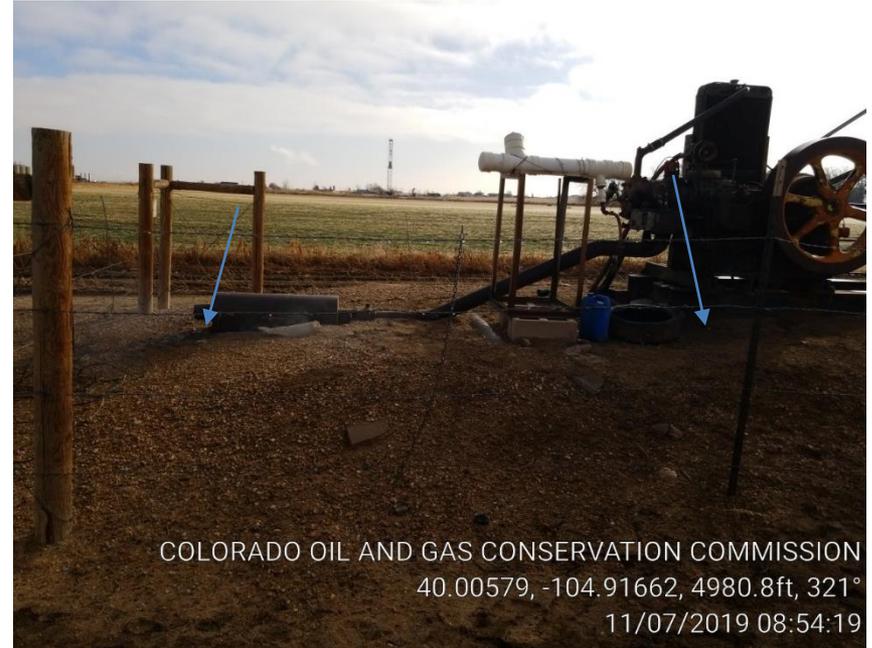
Pic 2 stained soil around exhaust and pumping unit motor
