Inspection Photo
Location Name: State 2-14
API: 05-099-06886

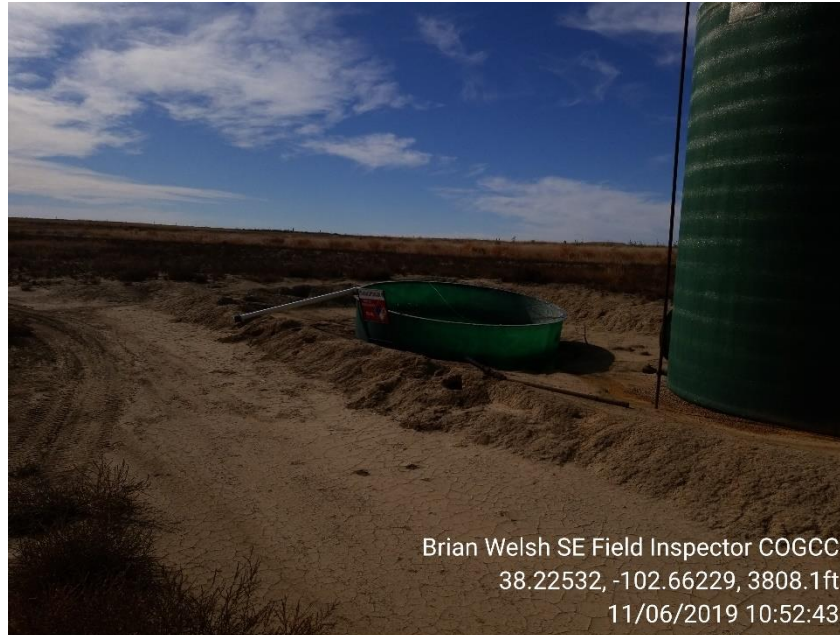
Erosion around leaning water tank
