Inspection Photos

Operator: Catamount Energy
Location/API #: 007-06095
Date: 11-1-2019

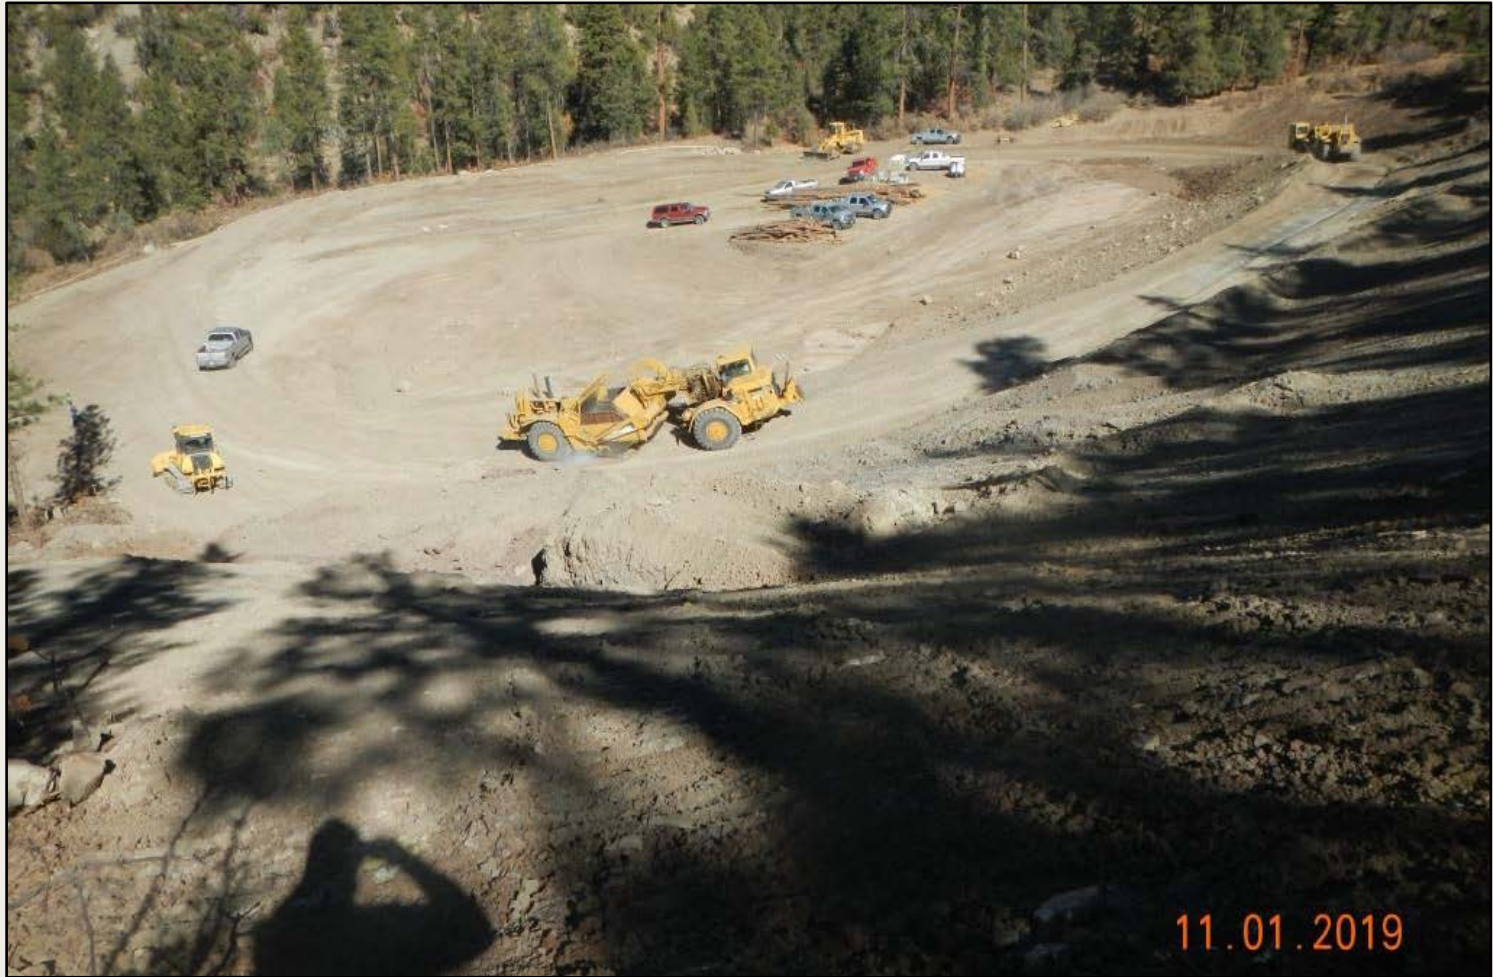
Photo 1. View of the project area from the southwestern corner facing center. Active construction is occurring at this time.

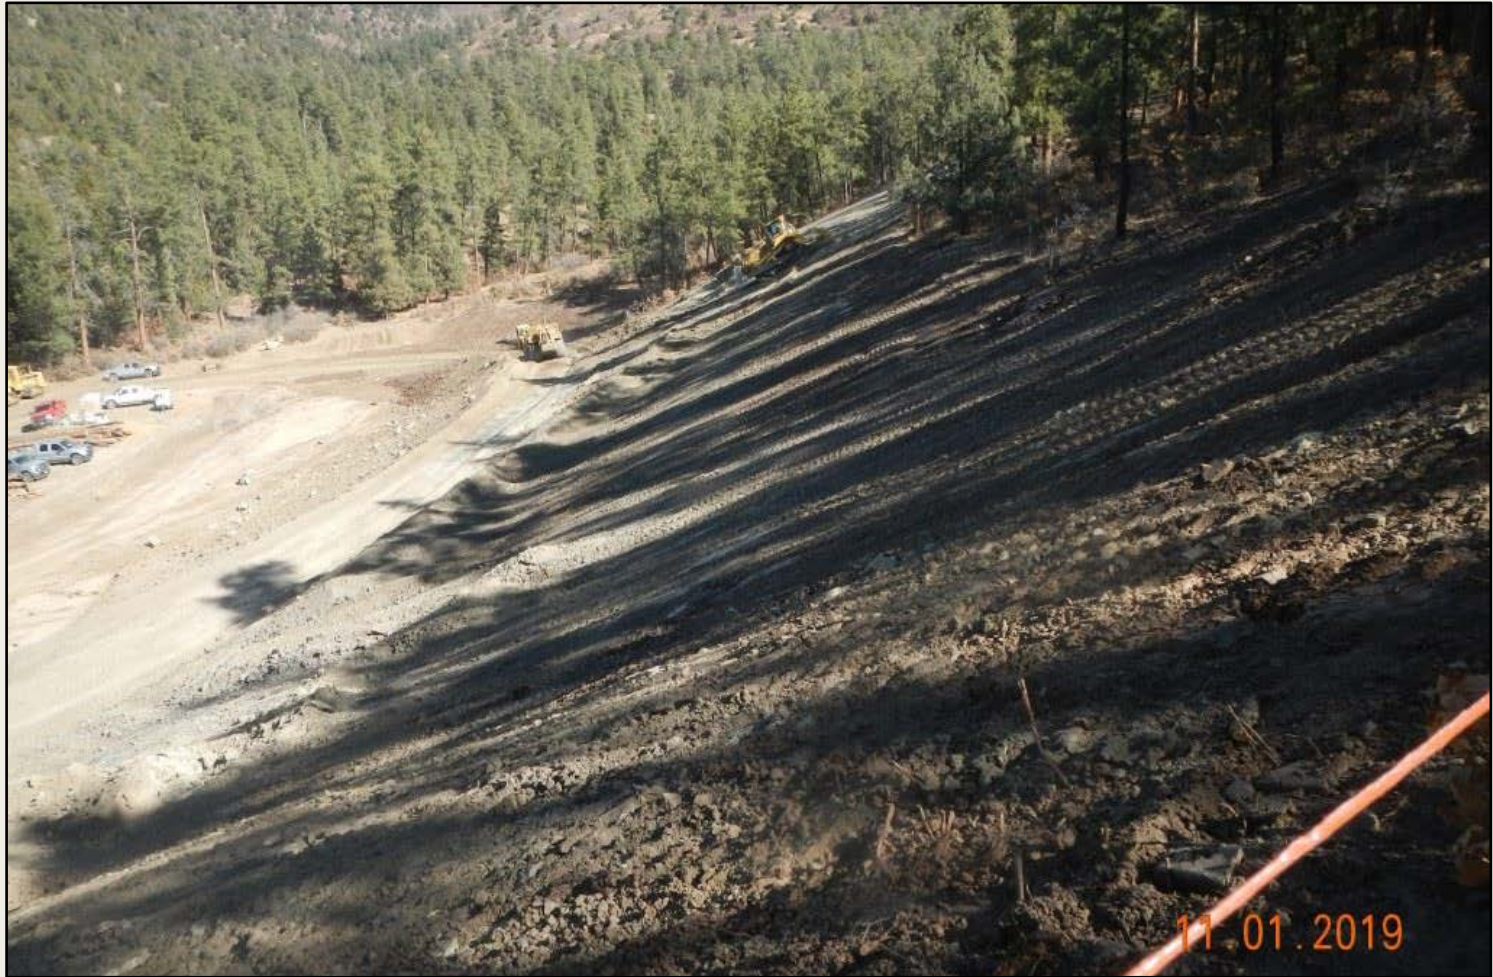
Photo 2. View of the southeastern cut-slope from the southern corner facing northward. Long-term stabilization measures will be needed to stabilize steep cut-slopes.

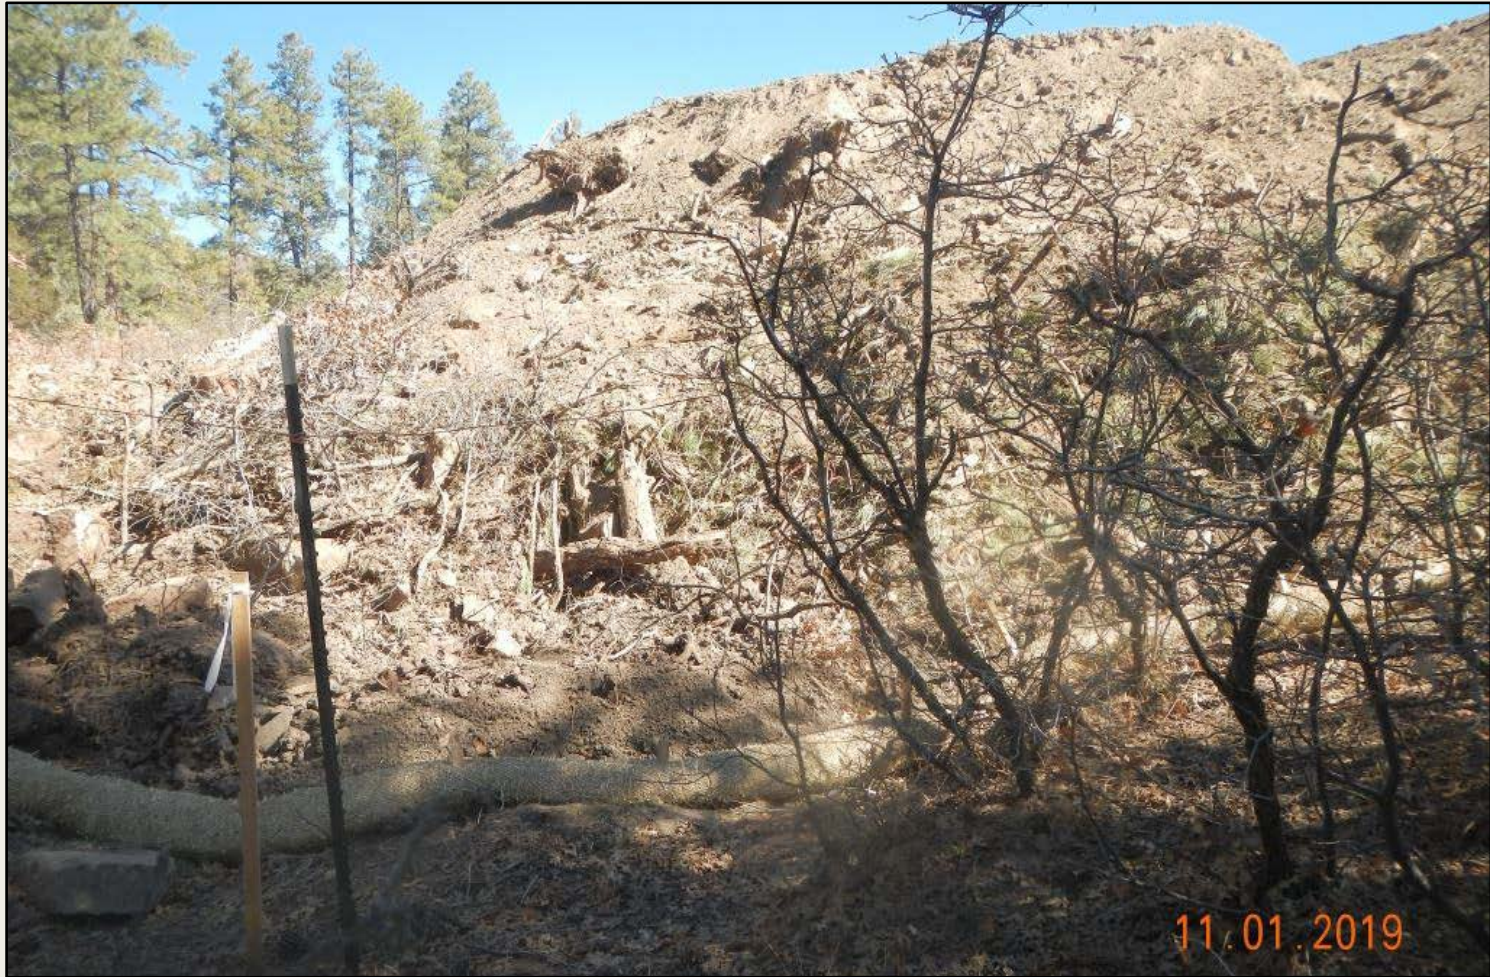
Photo 3. View of topsoil pile within the southwestern project area. Topsoil was in process of being moved to the northwestern project area, per communication with onsite construction staff. Stormwater controls in this portion of the project area are not sufficient to prevent downstream movement of sediment from soil and debris piles.

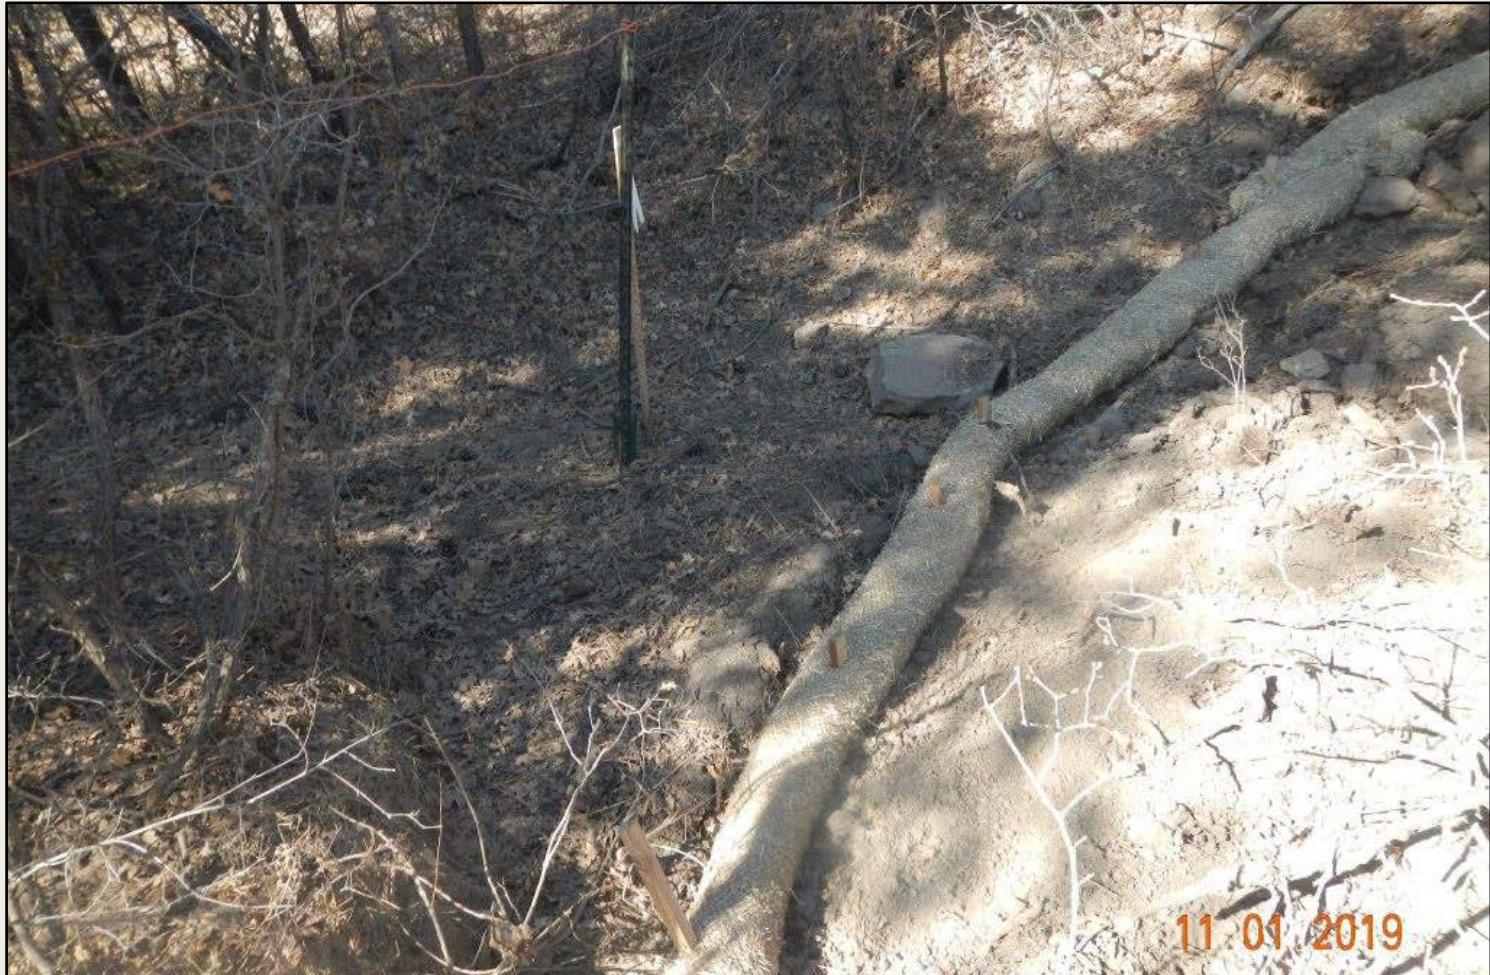
Photo 4. View facing downstream of Photo 3, within the southwestern project area, showing wattle/trench beneath topsoil and debris pile. These stormwater controls are not sufficient to contain volume of material upslope from here during a significant precipitation event. This area drains to an ephemeral drainage that flows toward Salt Creek.

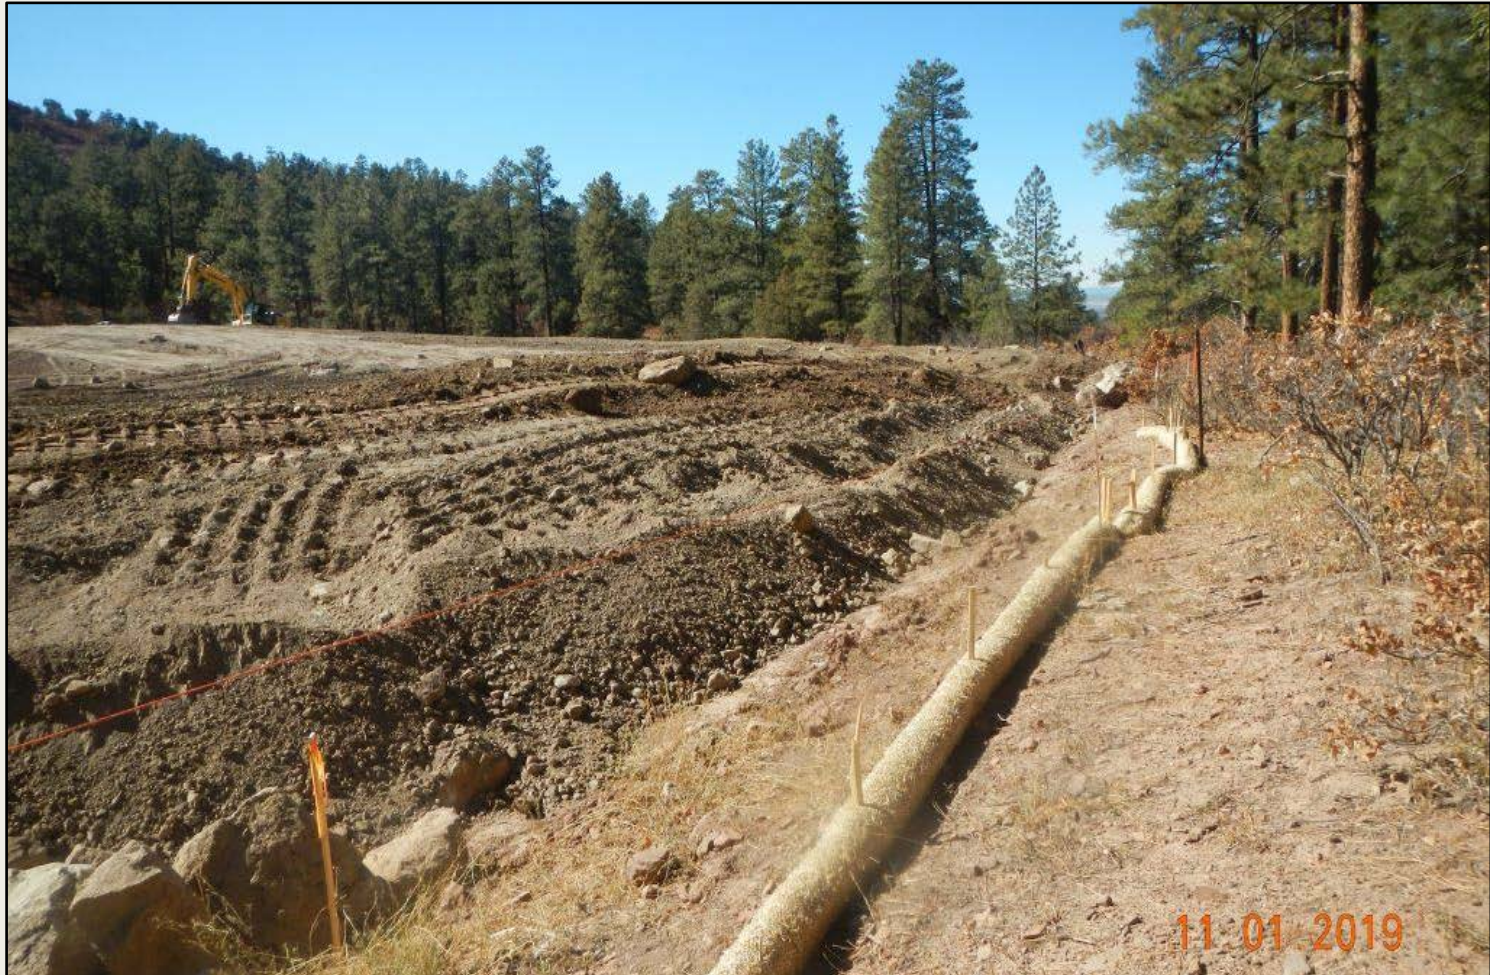
Photo 5. View of the northern project area from the northern corner facing westward. Wattles and trenching are in place.

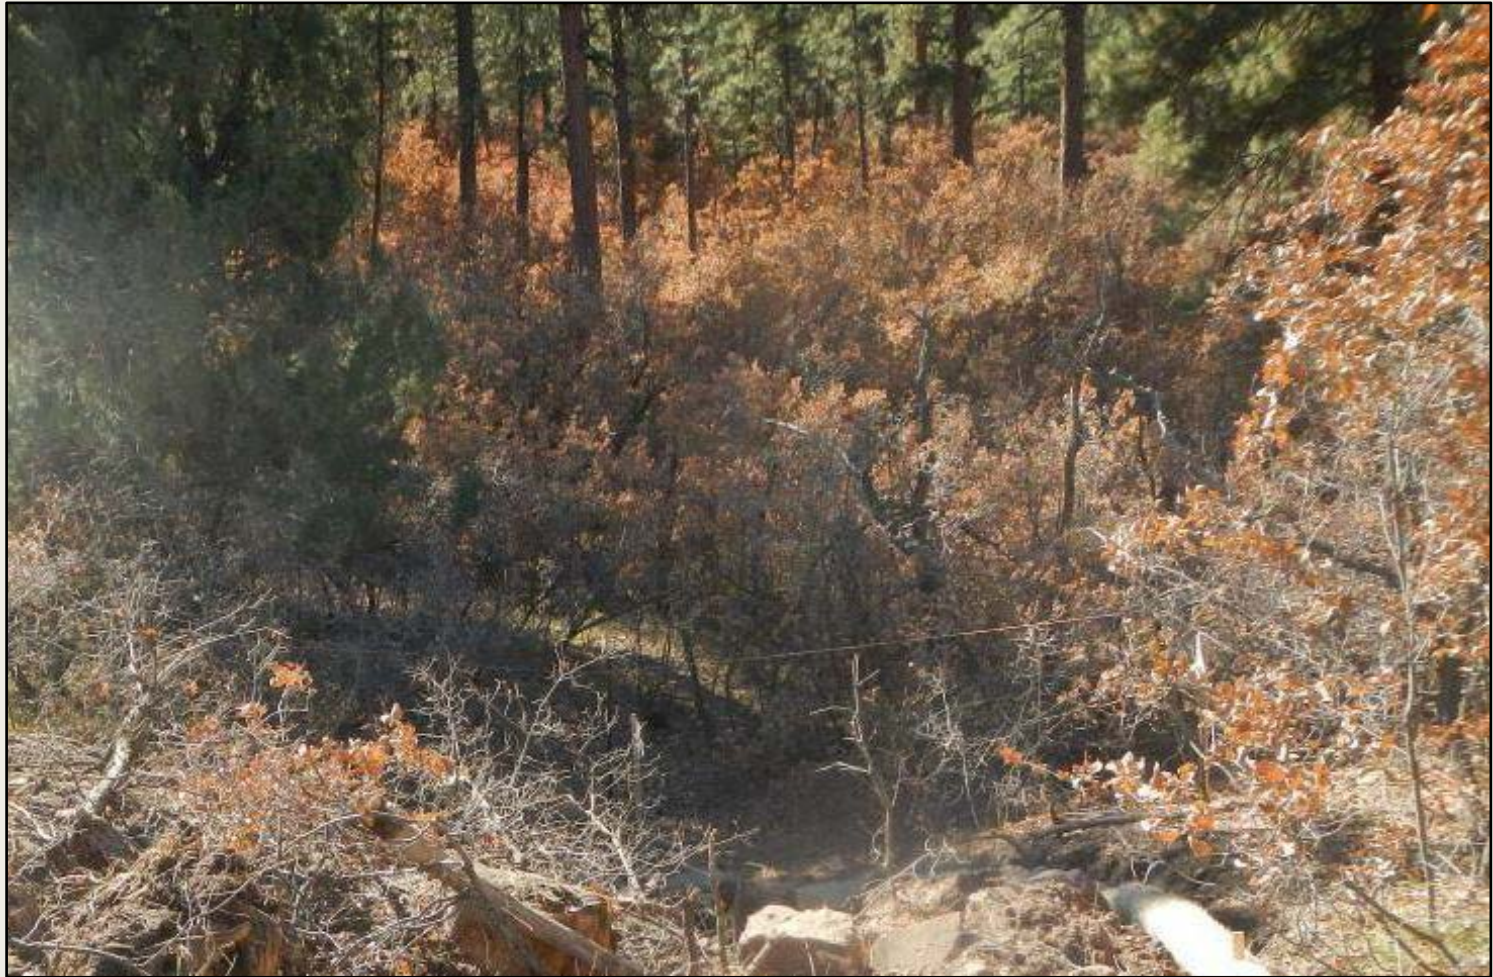
Photo 6. View of reference area vegetation, in photo background, beyond project disturbance/wattles/fencing, comprised largely of ponderosa pine forest with gambel oak understory.
