Inspection Photos

API: 05-009-05182

Operator: TROJAN OIL & GAS COMPANY

Inspection Date: 11/12/2019

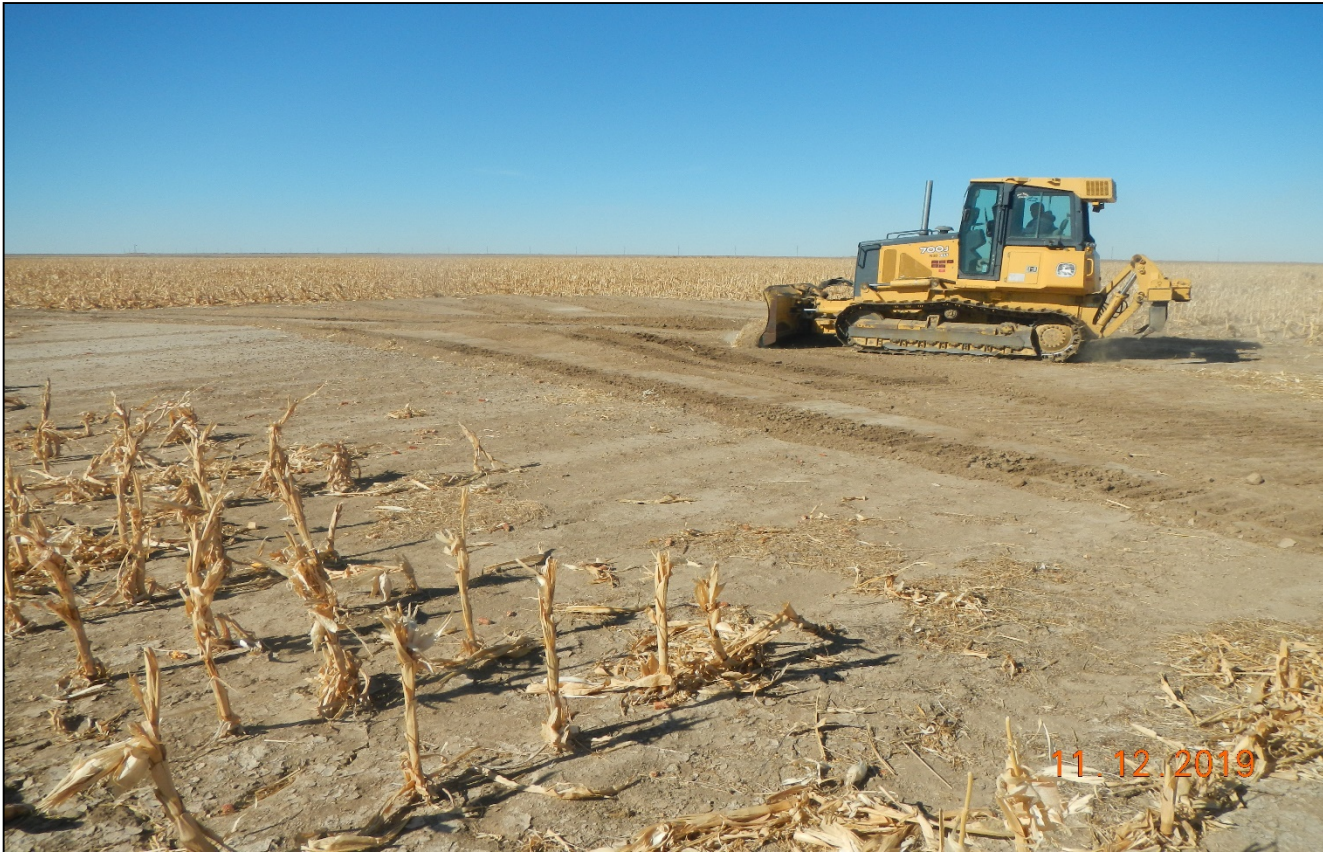
Photo 1. The location was leveled with the dozer.

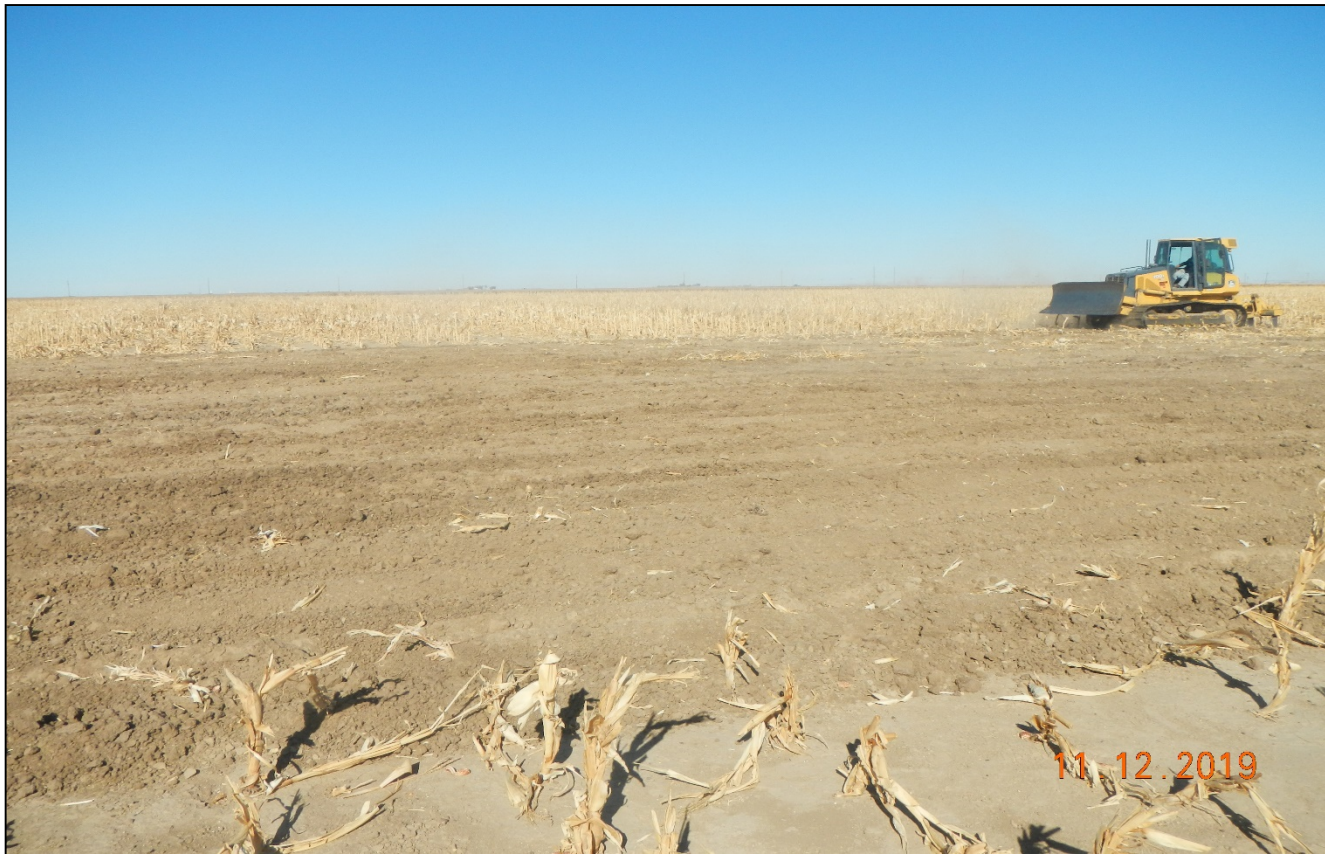
Photo 2. The location was then decompacted from east to west.

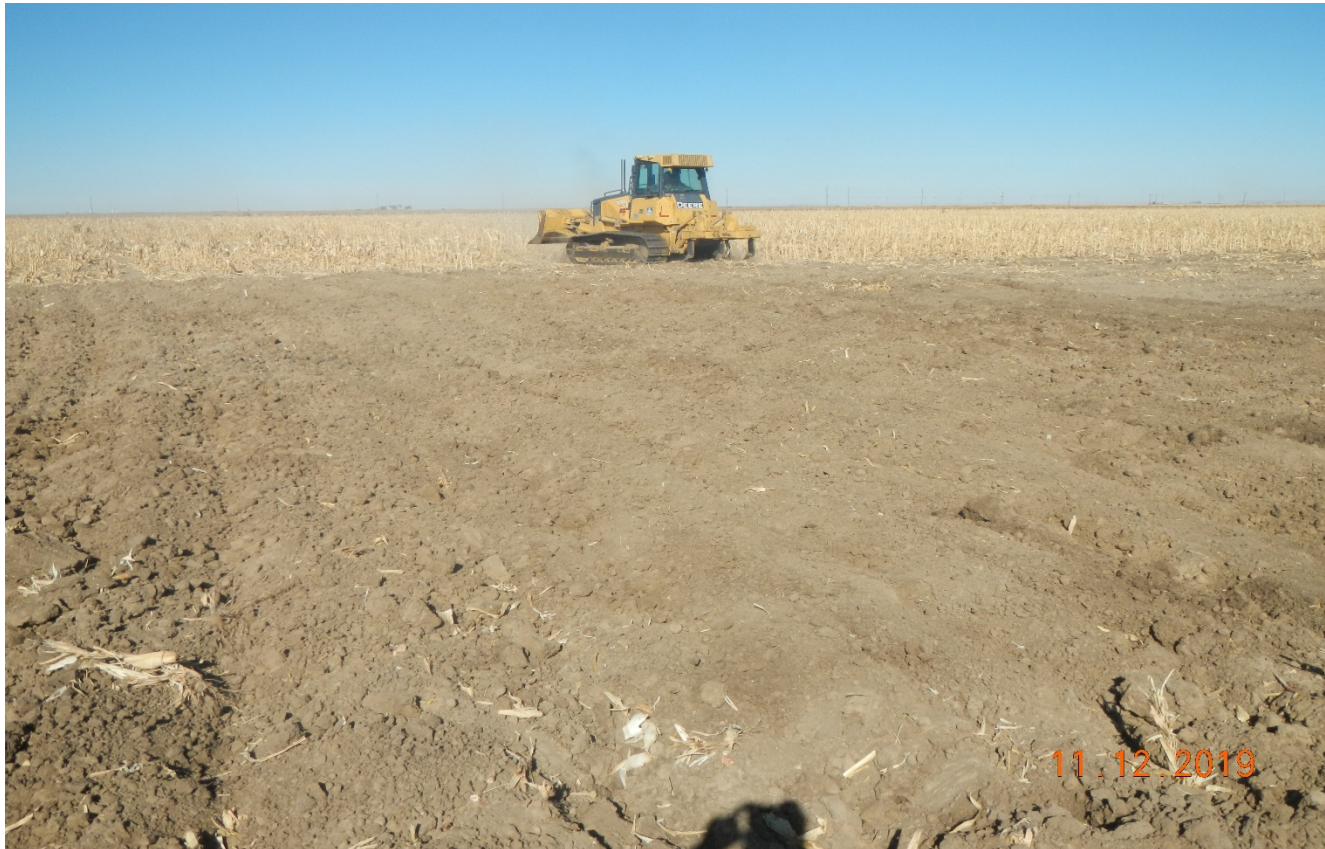
Photo 3. Cross ripping was performed from south to north.

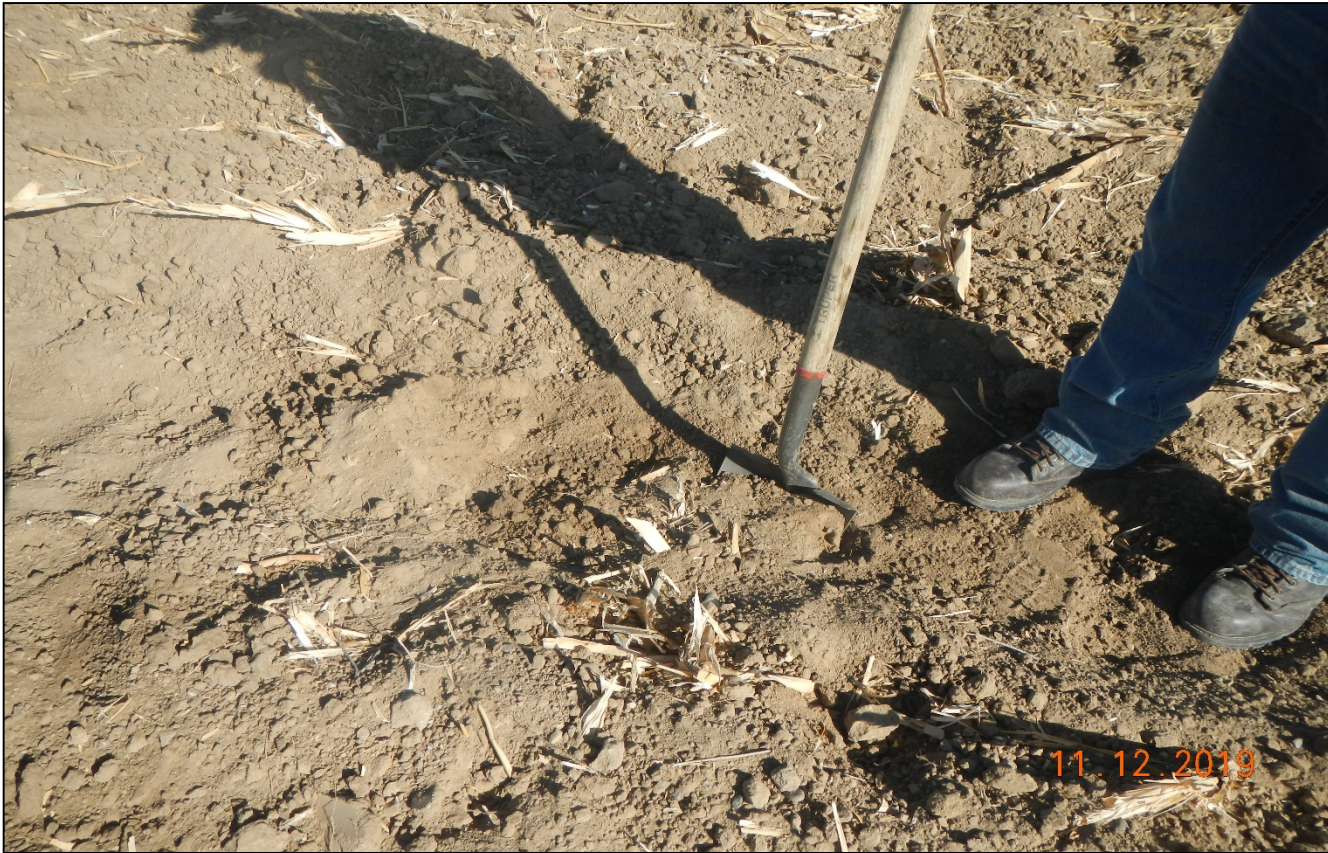
Photo 4. Soil was properly decompacted to 18 inches.

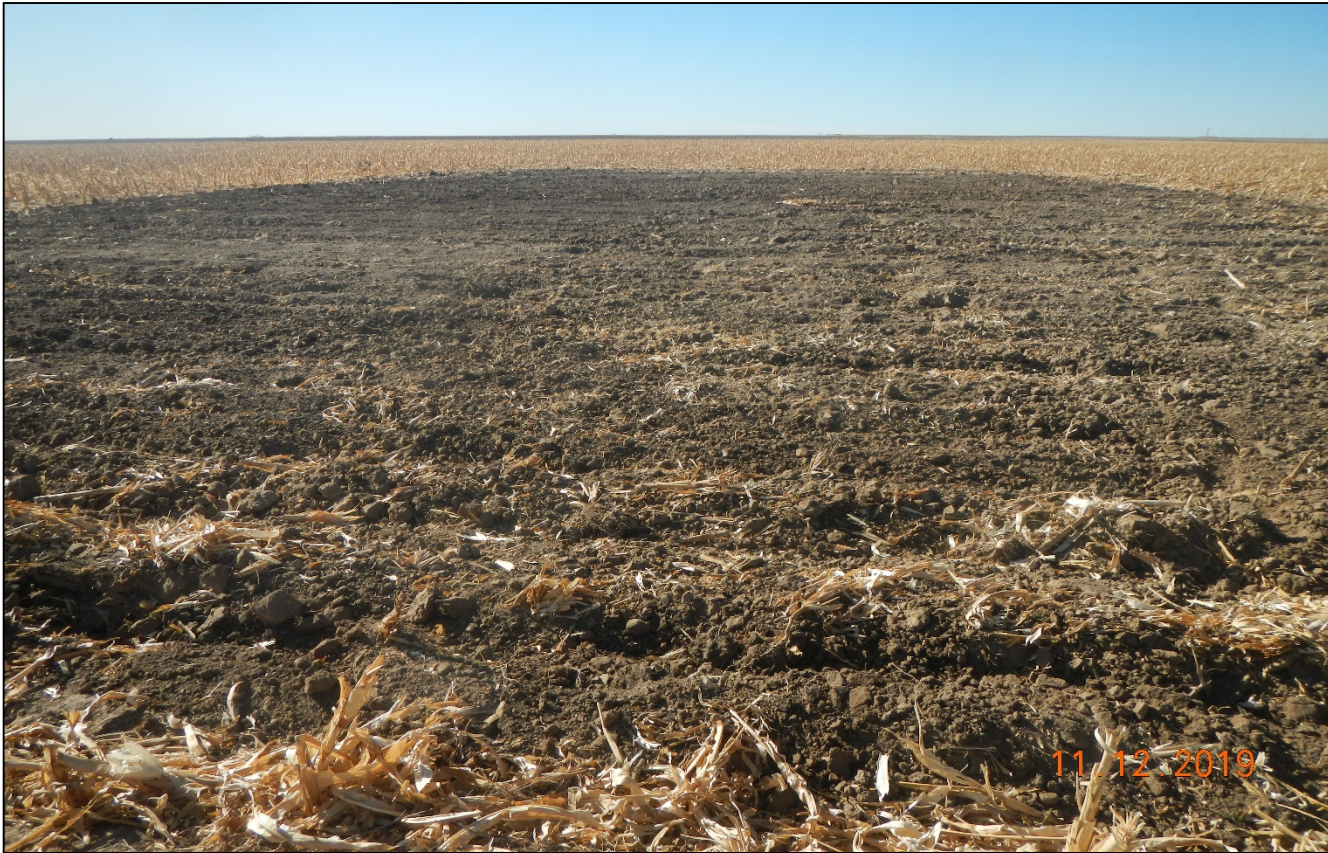
Photo 5. Facing west toward the location. The soils were cross ripped to 18 inches.

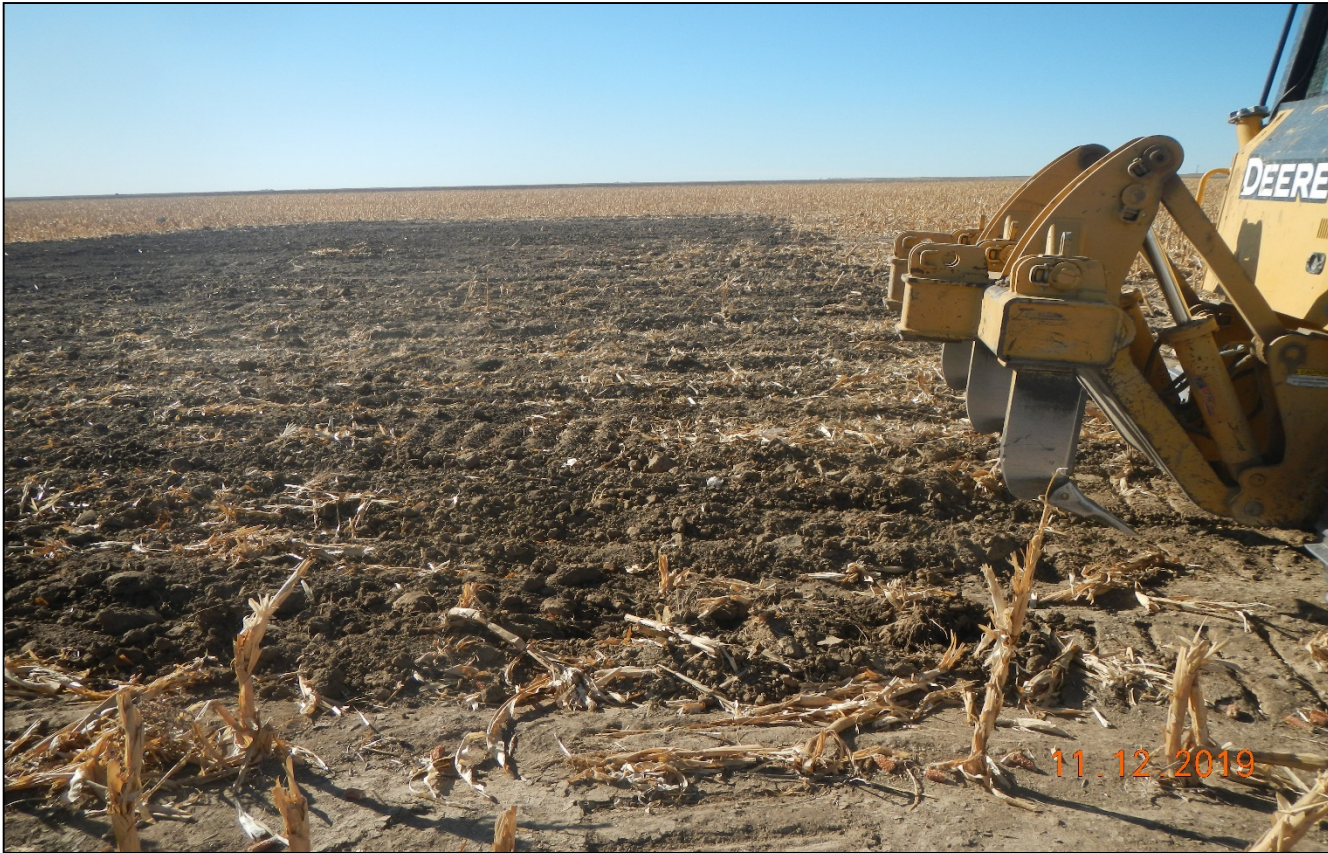
Photo 6. Facing west showing the area that was decompacted and the dozer ripper used for decompaction.
