Inspection Photos
Operator: Hilcorp Energy
Location/API #: 067-08632
Date: 11-6-2019

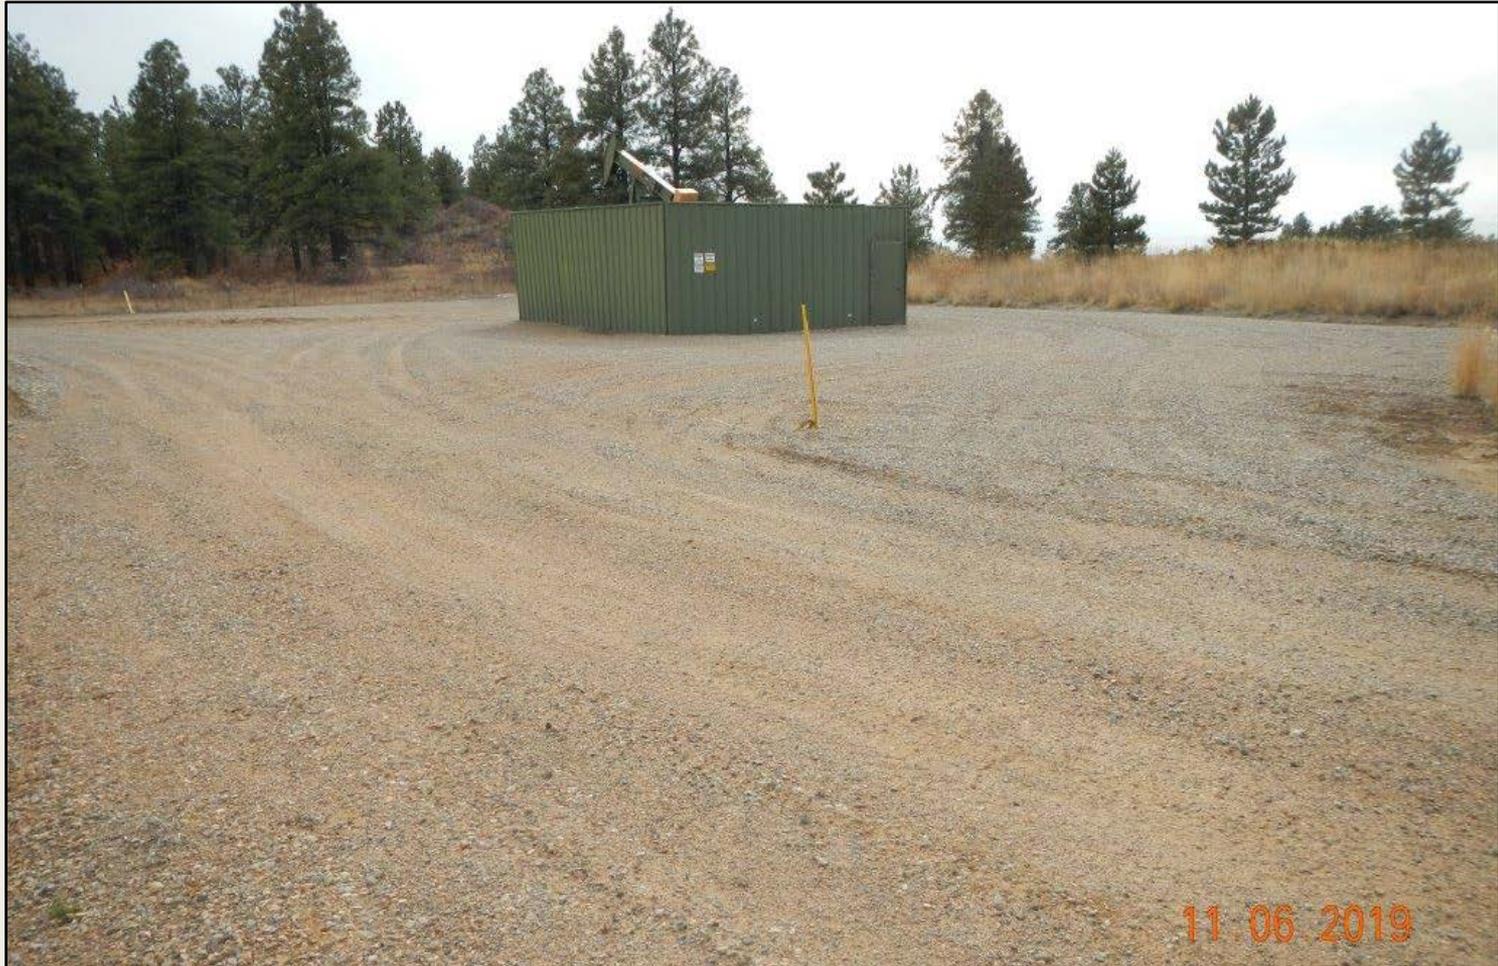
Photo 1. View of the project area from the well pad entrance facing center.

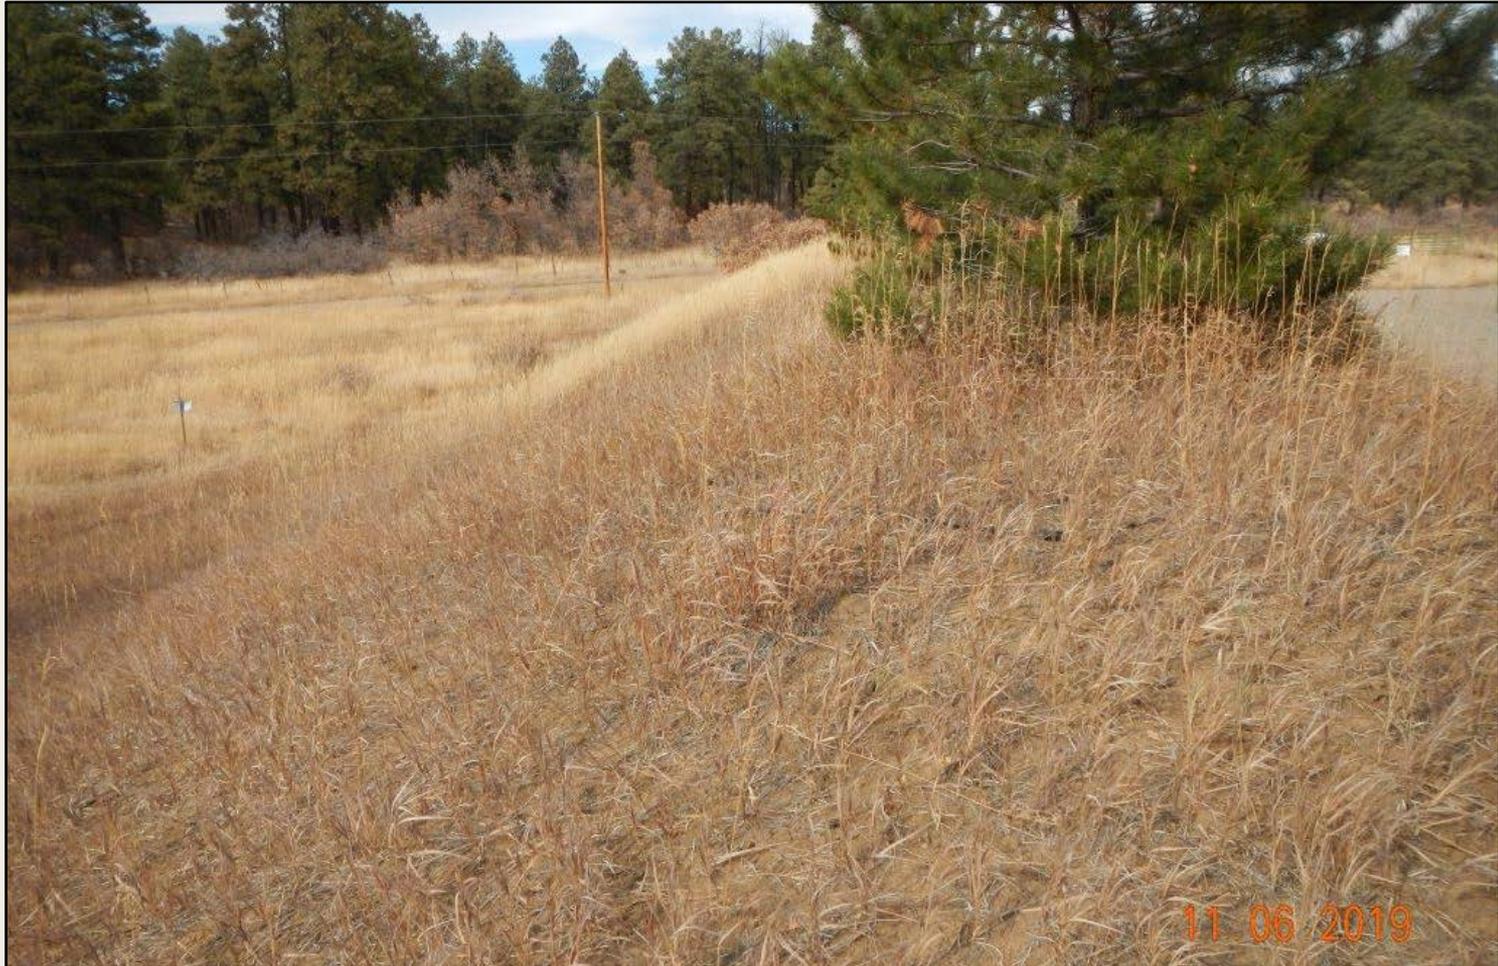
Photo 2. View of the western project area from the southwestern corner facing northward. Revegetation is progressing here, largely with smooth brome.

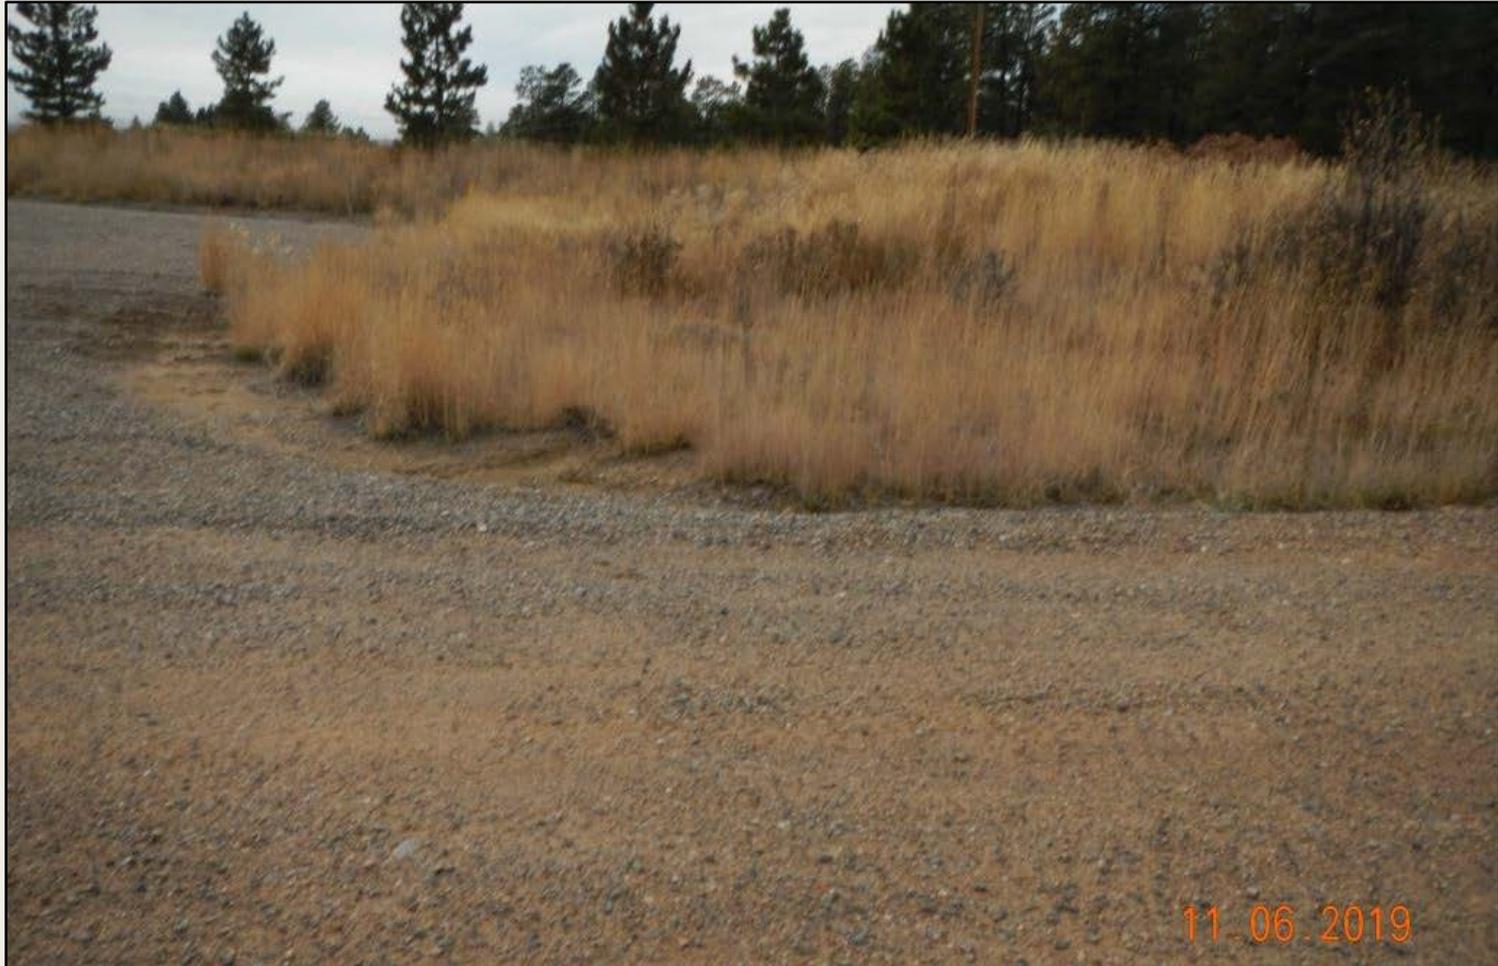
Photo 3. View of the northern project area from the well pad entrance facing westward.
